FIELD REPORT – LYNNWOOD RECREATION CENTER – FIELD REPORT

REPORT #01

Date: September 11th, 2013

Location(s) of Work: Natatorium roof.

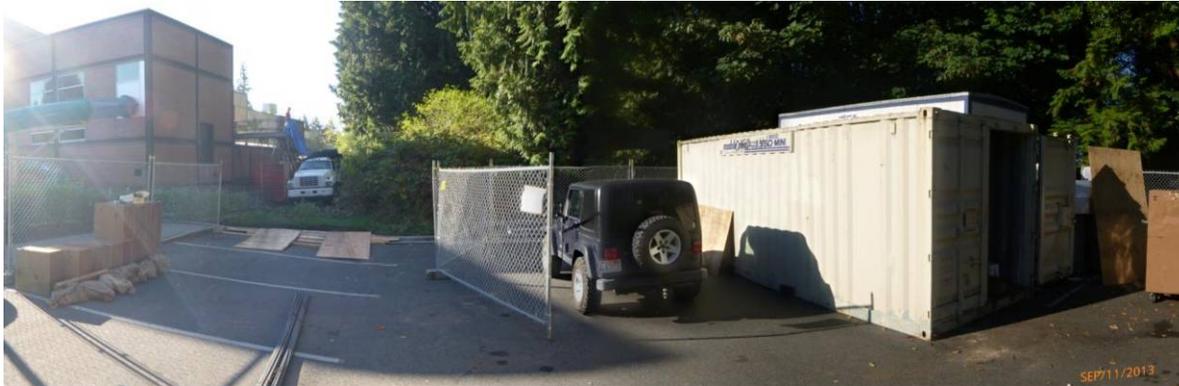
- 1.1 The contractor lay down area is located at the northwest corner of the Lynnwood Recreation Center. Roof access is located at the northwest corner of the Natatorium Roof.

Overview of the lay down area taken facing south.

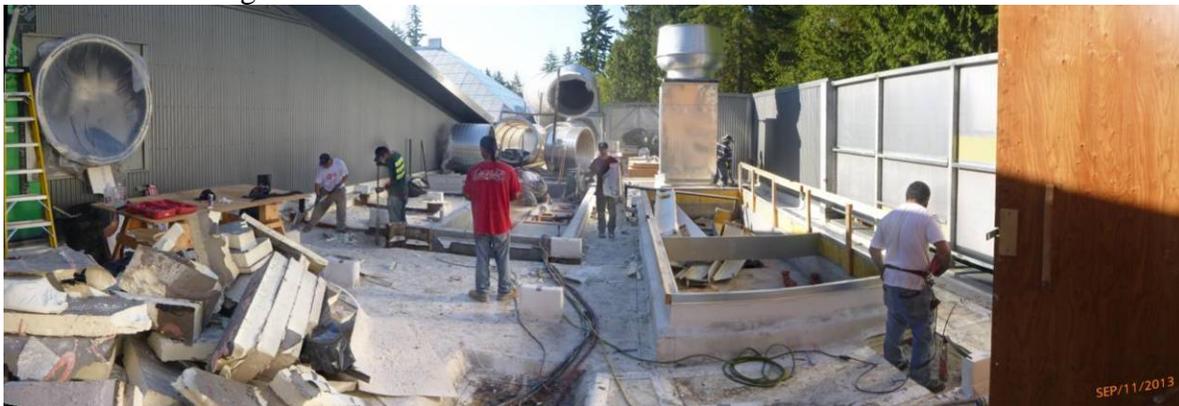
- 1.2 Queen City Roofing is removing the existing roof assembly down to the concrete deck. Holmberg is demolishing the concrete curb to the east.

Overview of the Natatorium Roof taken facing south.

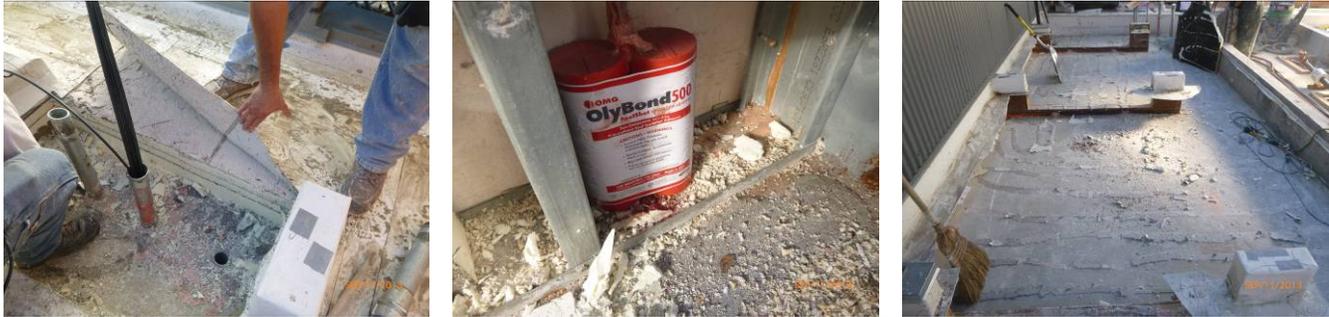
1.2a The existing roof assembly appears to be layers of flat stock and tapered polyisocyanurate insulation, coverboard and TPO membrane. This system appears to have been installed utilizing OlyBond 500 roof insulation adhesive which is found disposed of in a wall cavity. No vapor barrier is installed over the concrete deck.

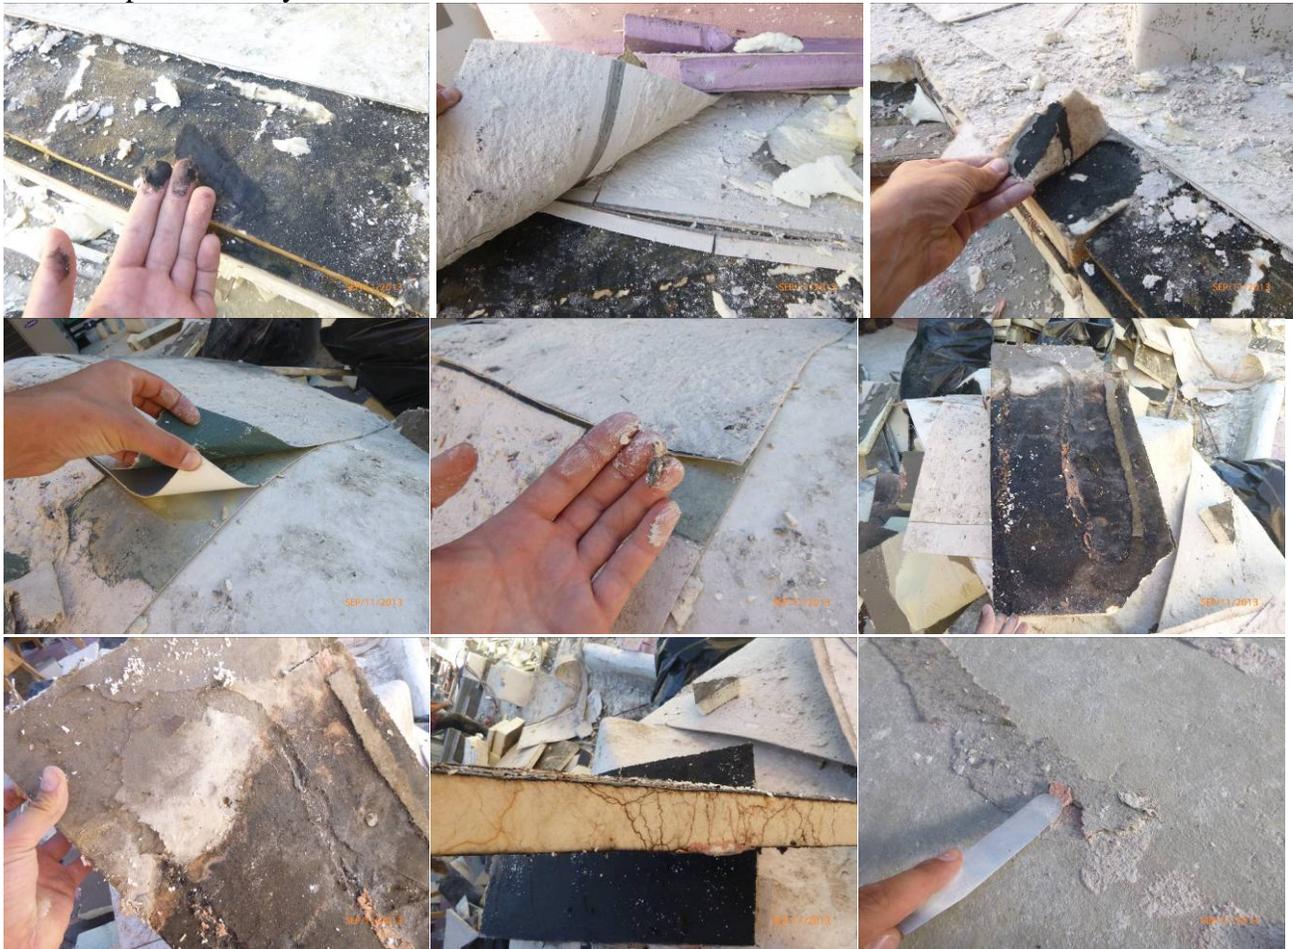
1.3 The below photographs are examples of the general condition of the existing roofing as it is removed. The existing roofing material is observed as wet and damaged. Facers on the coverboard and insulation are delaminated. Organic growth is observed on the polyiso insulation. The OlyBond adhesive separates easily from the concrete roof deck.

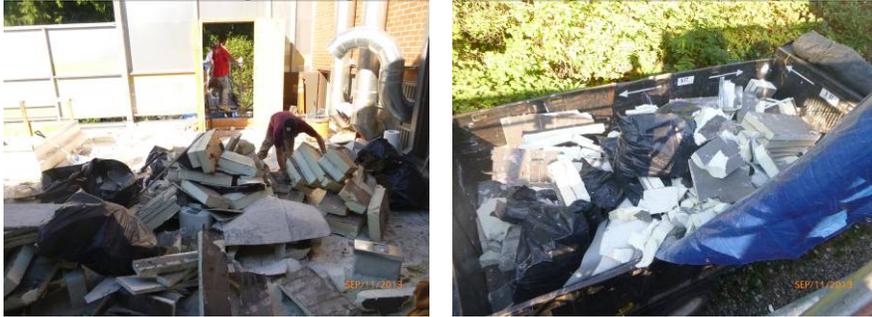
1.3a The existing roofing is removed and placed in a dump-truck.

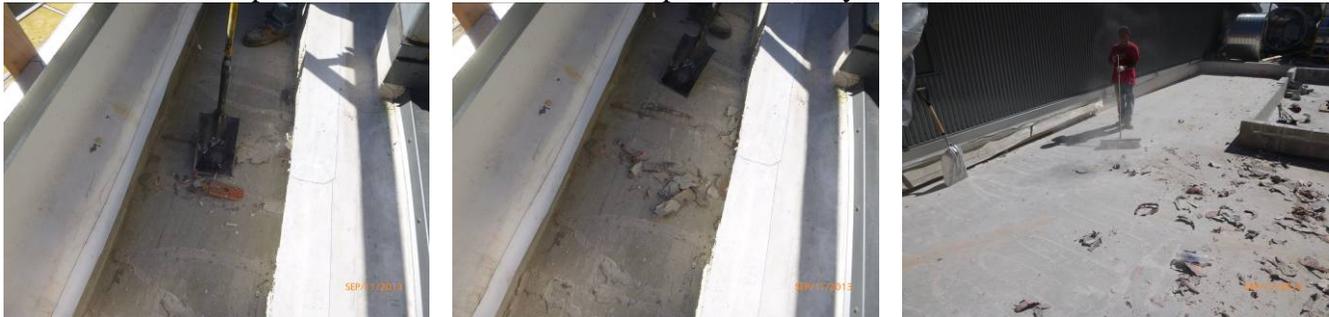
1.3b Spud shovels are utilized to remove insulation adhesive from the concrete deck and debris are swept up. Per conversation with Rich Kerns, (Foreman, QCR) this is preparatory work prior to the installation of the new vapor retarder layer. Recommended that all surfaces be free of debris, free of voids and deformities prior to the installation of the vapor retarder layer.

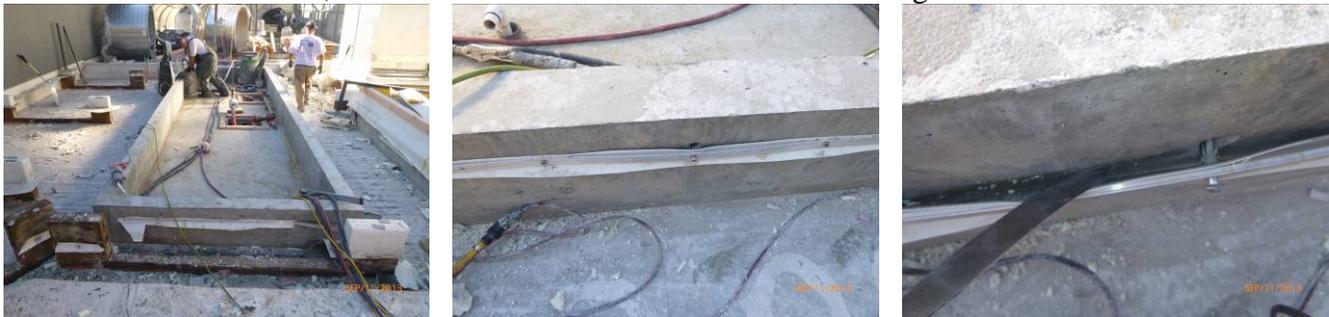
1.4 At concrete curbs, no sealant is observed behind the baseflashing termination.

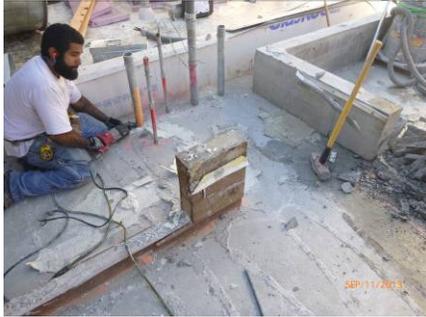
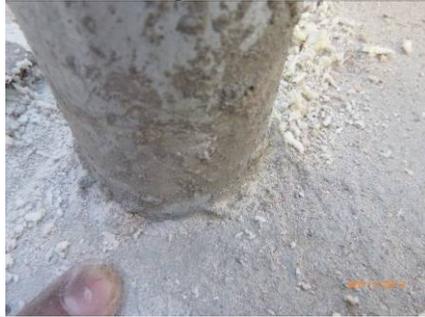
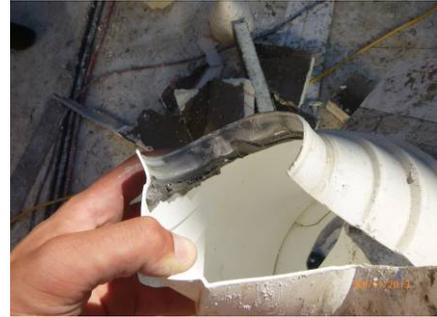
1.5 At pipe penetrations in general, sealant is not observed at the base of penetrations. Sealant is observed at the interior of TPO penetration flashings.

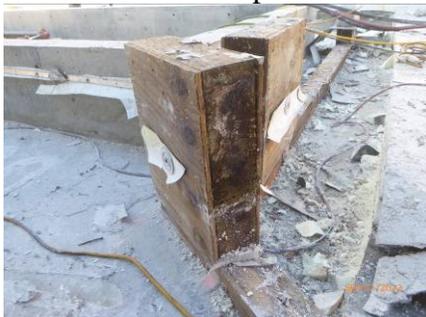
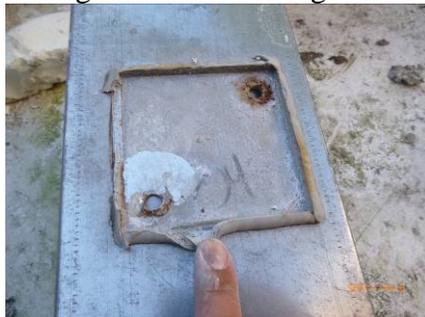
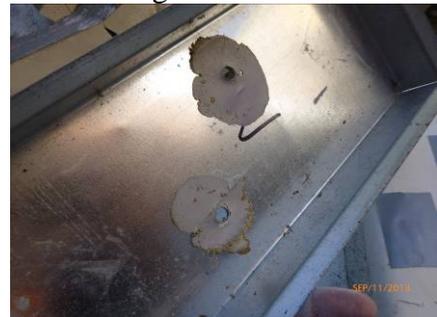
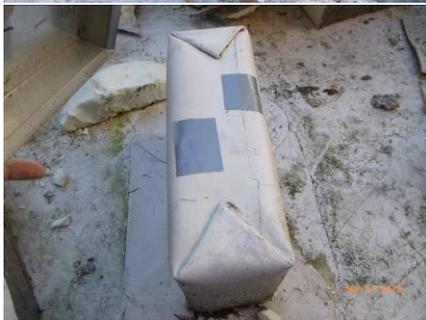
1.6 At HVAC duct curbs pressure treated wood appears to have been installed. The cap flashing is observed as having sealant at the perimeter of where a support leg was seated. Sealant is observed on the interior around bolt penetrations. Existing TPO baseflashing is observed as turning onto the curbs.

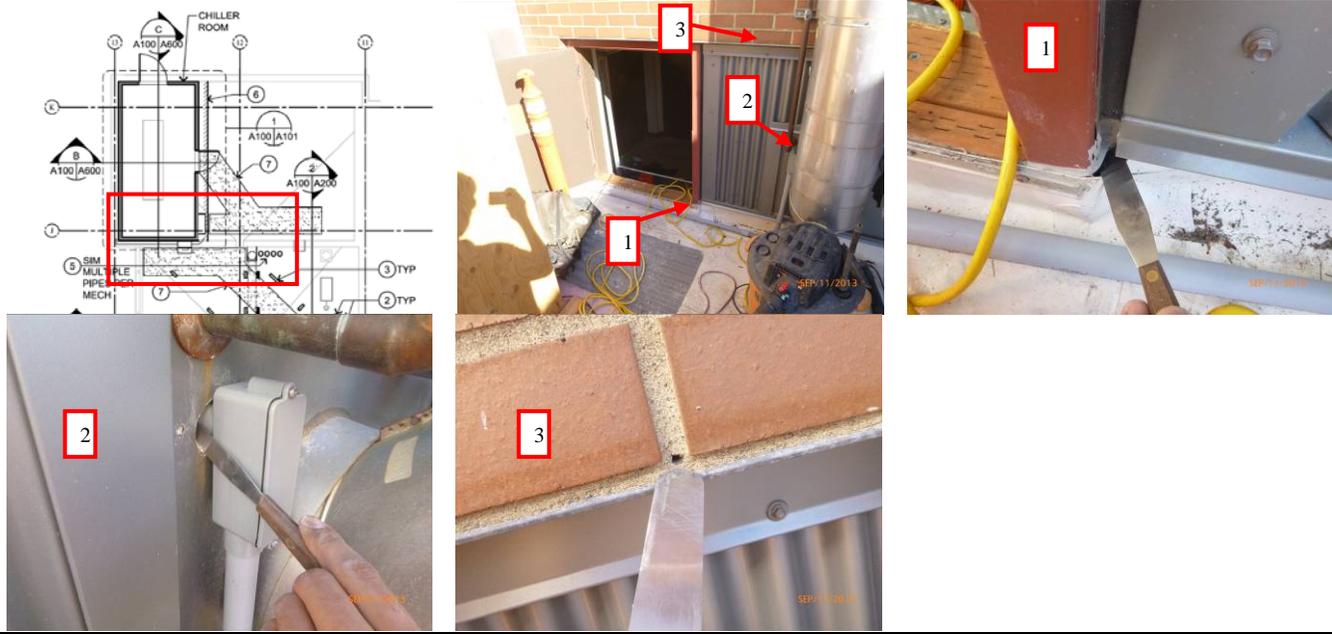
- 1.7 At the chiller room access door existing discrepancies are observed.
In Item 1, an area in the baseflashing is observed as unadhered and open.
In Item 2 a conduit penetration does not appear to be sealed.
In Item 3 a weep hole in the masonry is partially blocked.
These items are observations of existing conditions at the north side of the Natatorium Roof.

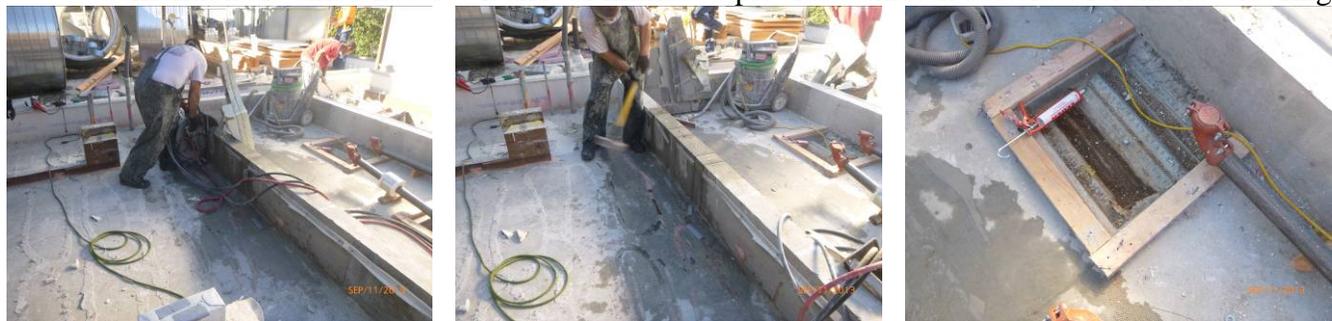
- 1.8 Holmberg is demolishing the concrete curb at the east side of the Natatorium Roof. Per conversation with Holmberg, the existing openings are to be infilled with self-leveling grout or ledgers and plywood. Recommend that the curb demo is sequenced with the Roofing Contractor to prevent damage to the new vapor retarder layer. Also recommend that any deformities or voids created during or due to the curb demolition are smoothed down and/ or infilled to provide a smooth substrate for the new roofing.

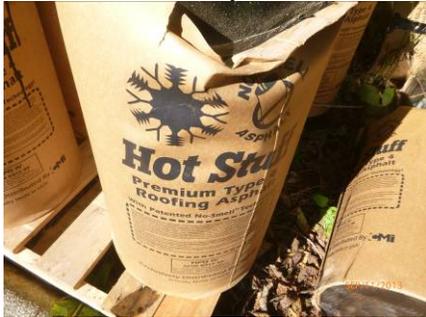
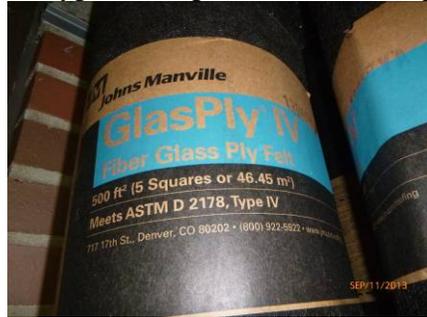
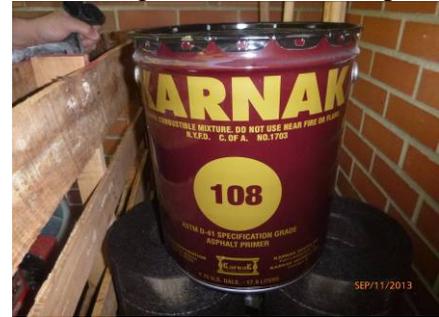
1.9 The following materials are observed onsite and are listed in the order shown below: Hot Stuff Type IV asphalt, John Manville GlasPly IV plysheet, Karnak 108 primer. Per conversation with Rich Kerns (Foreman, QCR) the roof deck is to be cleaned and primed prior to the installation of the new vapor retarder layer which is to be a Type IV (2-ply) set in hot asphalt with a glaze-coat of hot asphalt over.

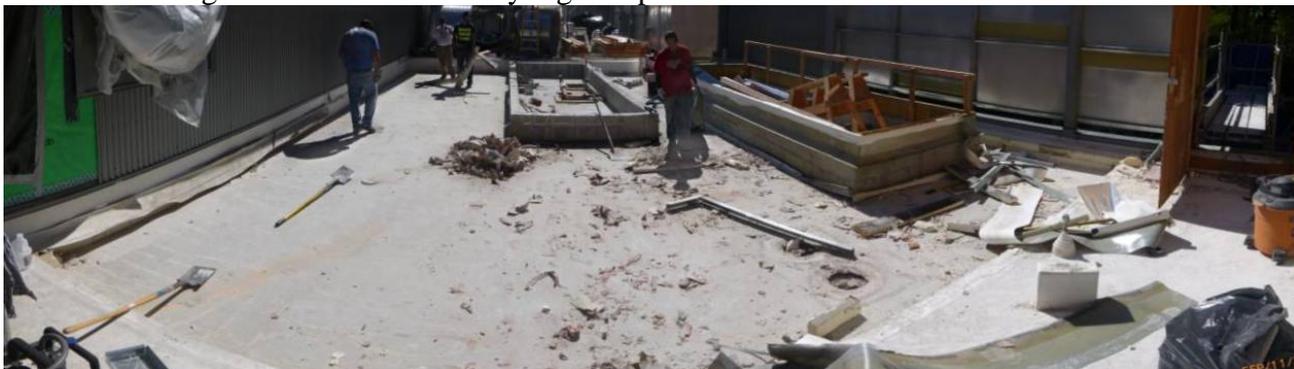
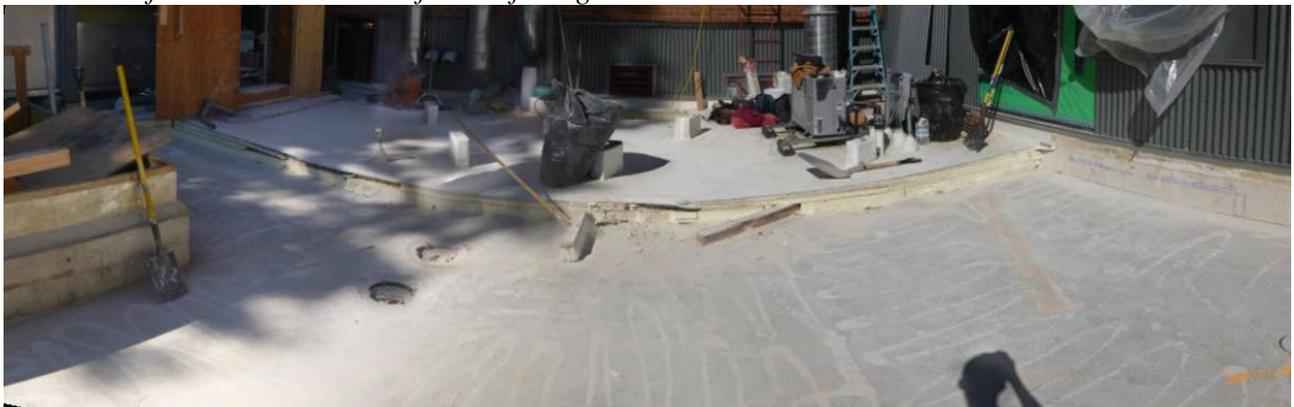
1.10 The photos below are taken at this writer's departure from the site visit and depict progress in the removal of existing roofing and the concrete curb to the east. Per conversation with Rich Kerns (Foreman, QCR) the roof will be left open overnight and no night seal will be installed. Recommend that a night seal is installed every night to protect the interior of the structure.

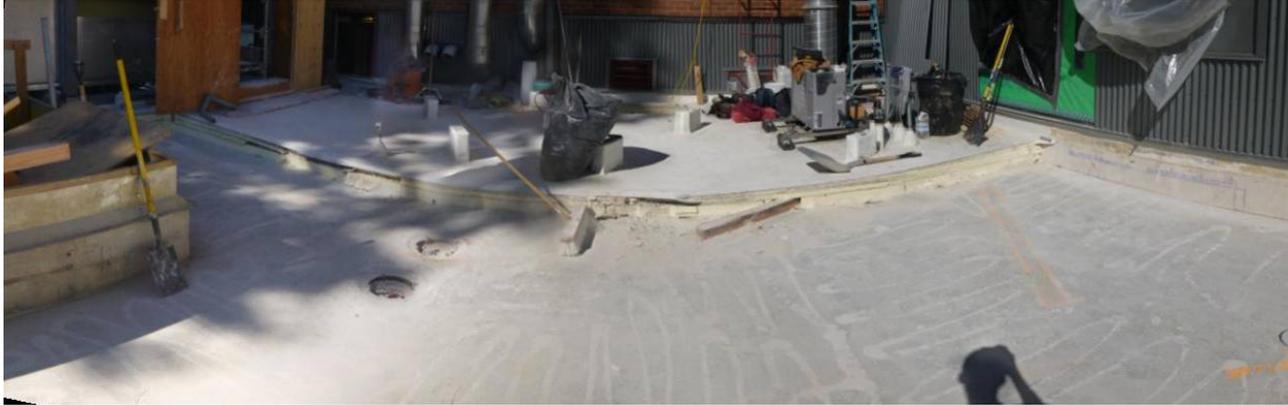
- 1.11 Recommended the installation of a night seal every night. Per conversation with Rich Kerns, (Foreman, QCR) the roof should be allowed to dry prior to the installation of a new vapor retarder layer.

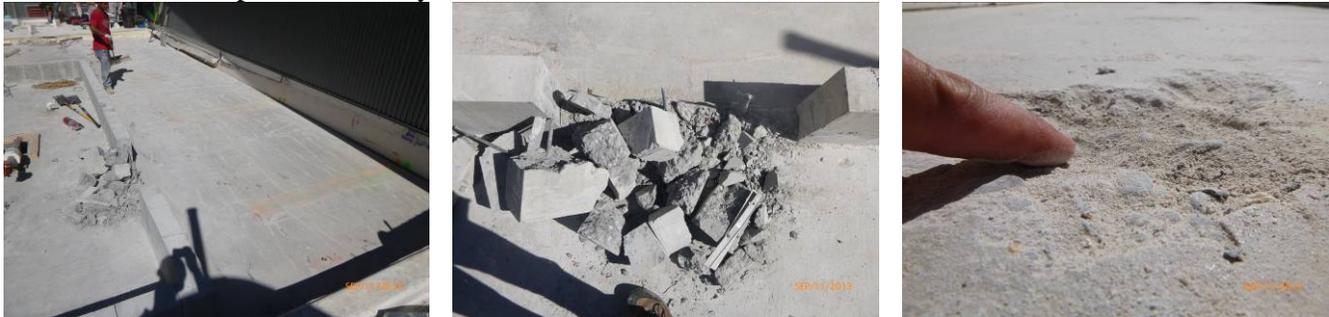
- 1.12 At the concrete curb to the east it is recommend that the substrate be corrected prior to the installation of the new vapor retarder layer.
