FIELD REPORT – LYNNWOOD RECREATION CENTER – FIELD REPORT
REPORT #10

Job No. 10-100622B1

Date: October 14th, 2013
Page 1 of 11

Location(s) of Work: Southeast & Southwest of the Natatorium Roof

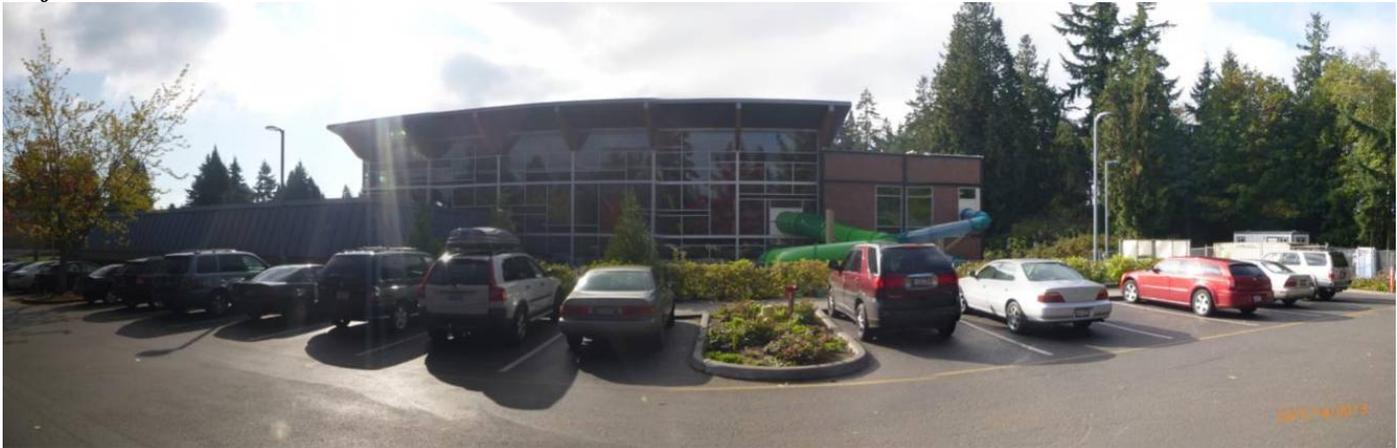
Photo of the Lynnwood Recreation Center building taken facing southeast.

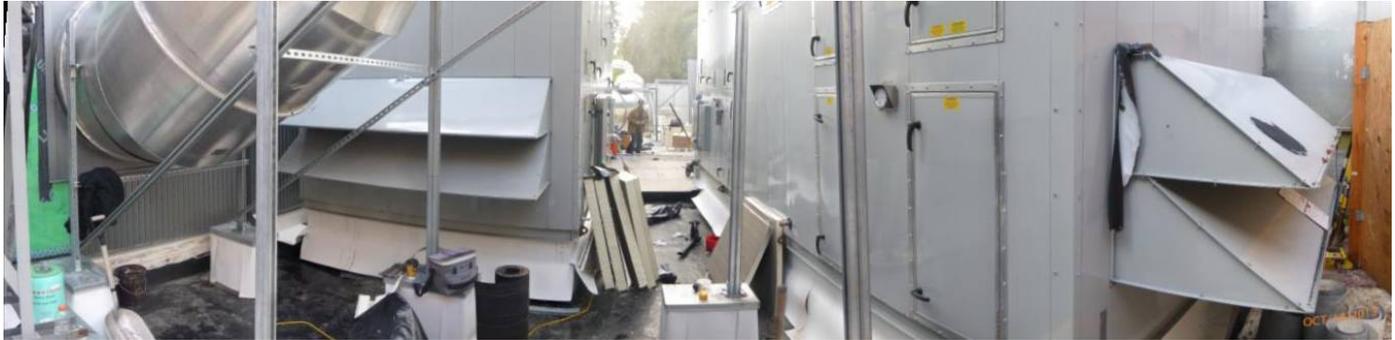
10.1 Queen City Roofing is installing new roofing at the west and south sides of the air handling unit that is located at the west side of the Natatorium roof.

Overview of the Natatorium Roof taken facing south

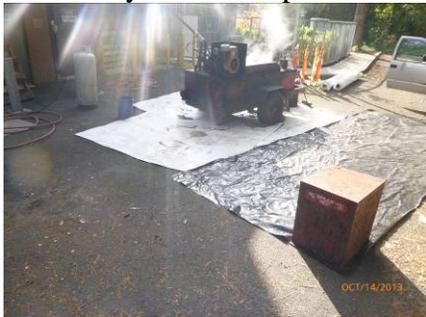
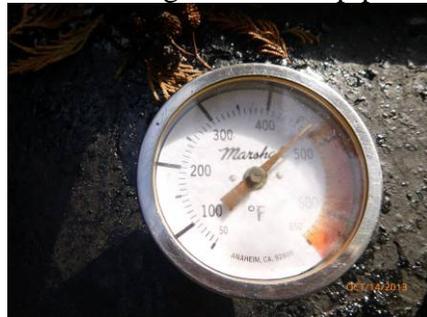
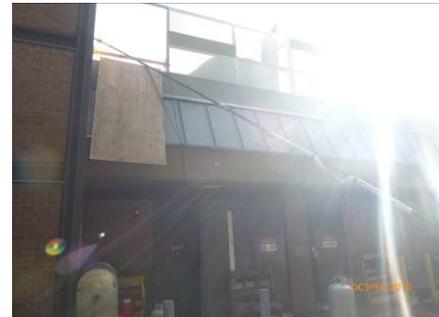
10.2 An asphalt kettle is staged below the southwest corner of the Natatorium Roof. TPO membrane and polyethylene sheeting is in place below the kettle which is observed at a heat of approximately 480°F. Plywood is in place between the building and the hot pipe.

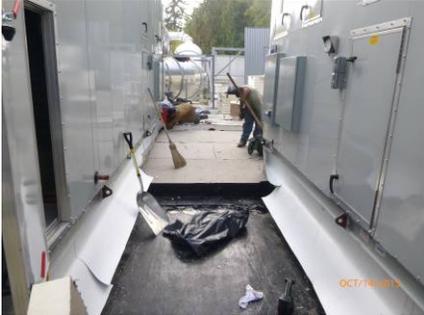
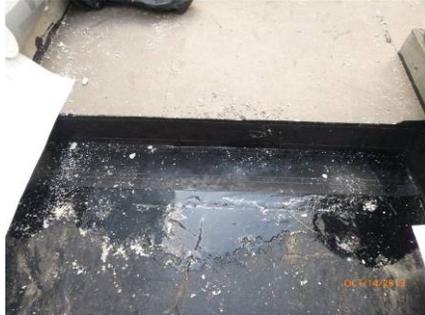
10.2b A plysheet is turned up against the new tapered insulation as a means of night seal. Per conversation with Rich Kerns (Foreman, QCR) the areas to the north of this location of work are to be roofed in during this week.

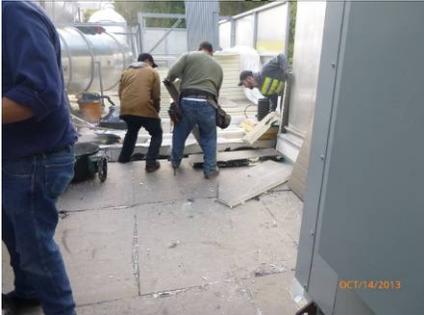
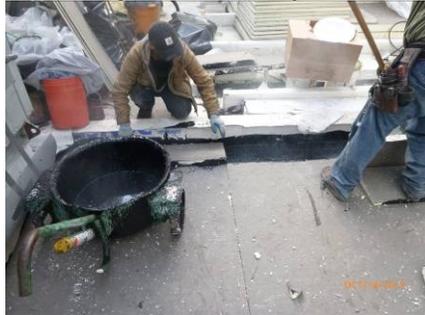
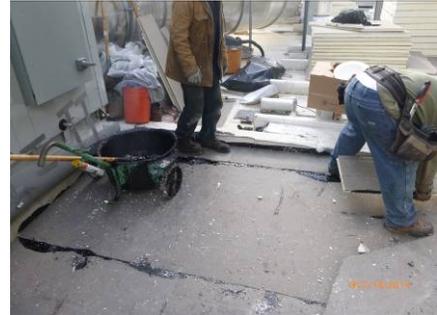
10.2c Insulation is set into moppings of hot asphalt and is walked in to promote adhesion. The tapered insulation appears to be offset at the joints from layers below.

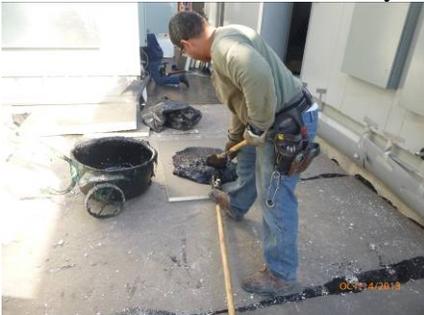
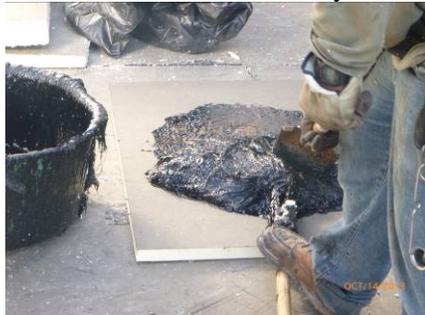
10.2d The asphalt mop is cleaned over a piece of scrap insulation prior to the crew taking lunch. Per conversation with Rich Kerns, DensDeck coverboard is to be set in moppings of hot asphalt and TPO membrane is to be fully adhered and welded at the day's location of work during this workday.

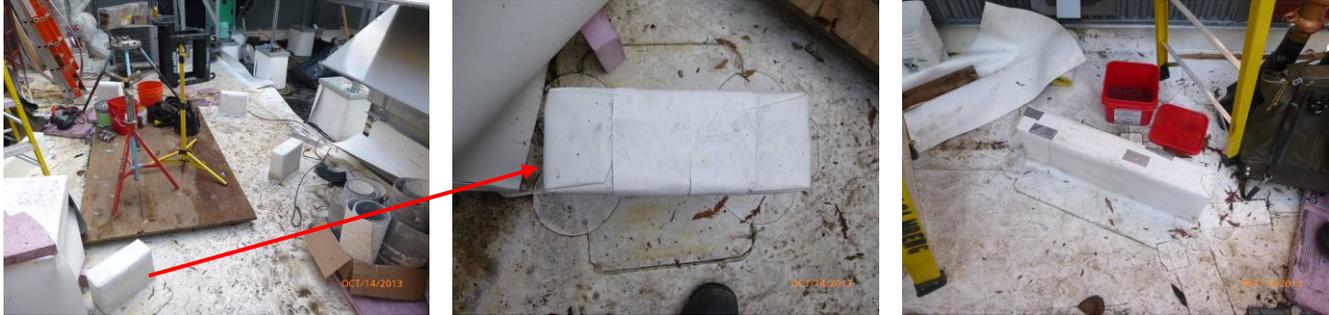
10.3 At the existing sleepers to the north and south of the roof replacement unsupported TPO membrane appears to be welded over the through bolt openings in the baseflashing. Per conversation with Rich Kerns, this is a work in progress in some locations. Item is noted as an observation.

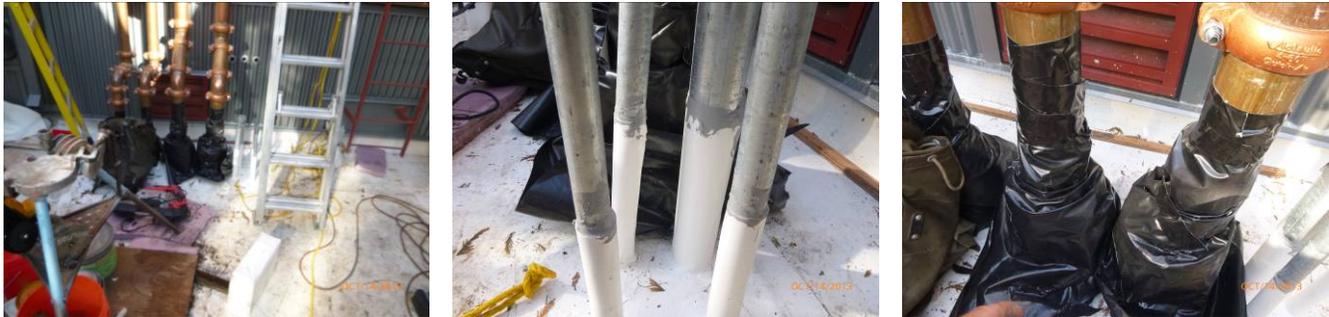
10.4 At the north side of the Natatorium Roof, it is recommended that steel draw-bands are installed at the through roof penetrations. Sealant appears to be installed and per conversation with Rich Kern, (Foreman, QCR) this is a work in progress. The copper through roof penetrations are temped over with duct tape and polyethylene sheeting as a means to prevent water intrusion into the building and existing roof. Item is noted as an observation.

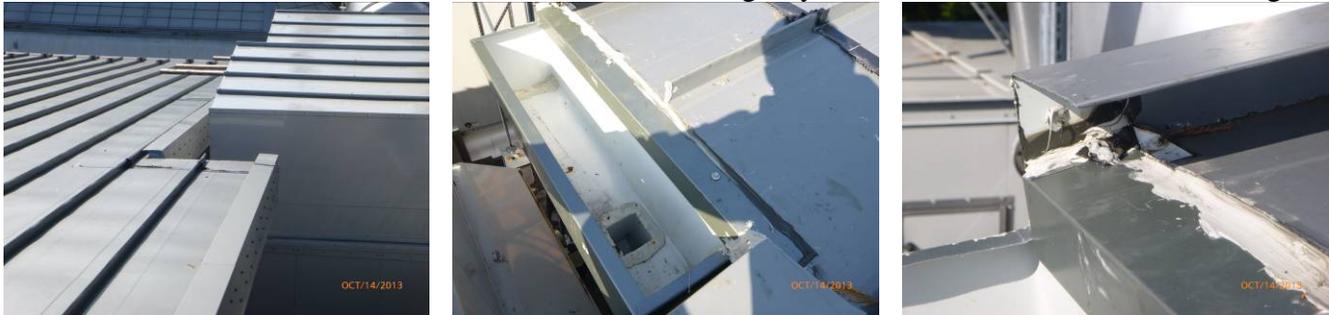
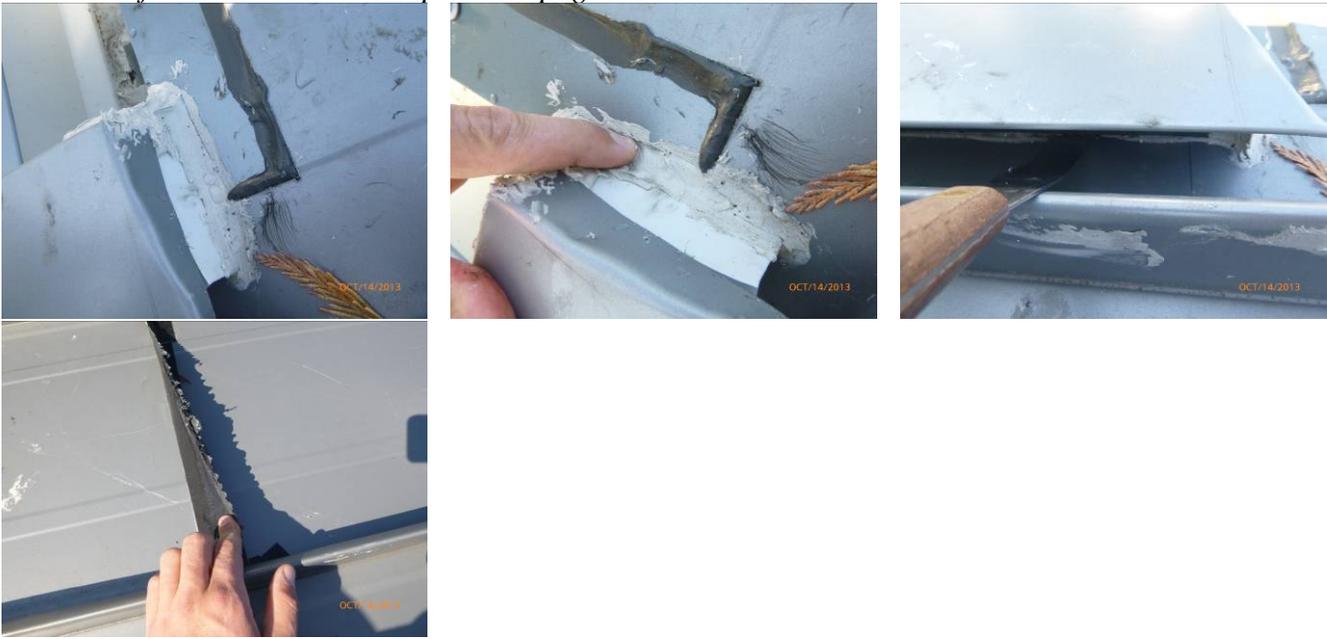
10.5 At the sawcut at the upper east metal roof, the metal panel does not turn up in a vertical leg. It appears that sealant is utilized as the main defense against water intrusion at most transitions in this area of work. Duct tape that was installed as a part of the night seal is still in place. This is a previously noted Problems and Solutions Item (Item 8.8 on pages below) and will be updated. It is recommended that transitions in the sheet metal re-installation be integrally flashed with sheet metal vertical legs.

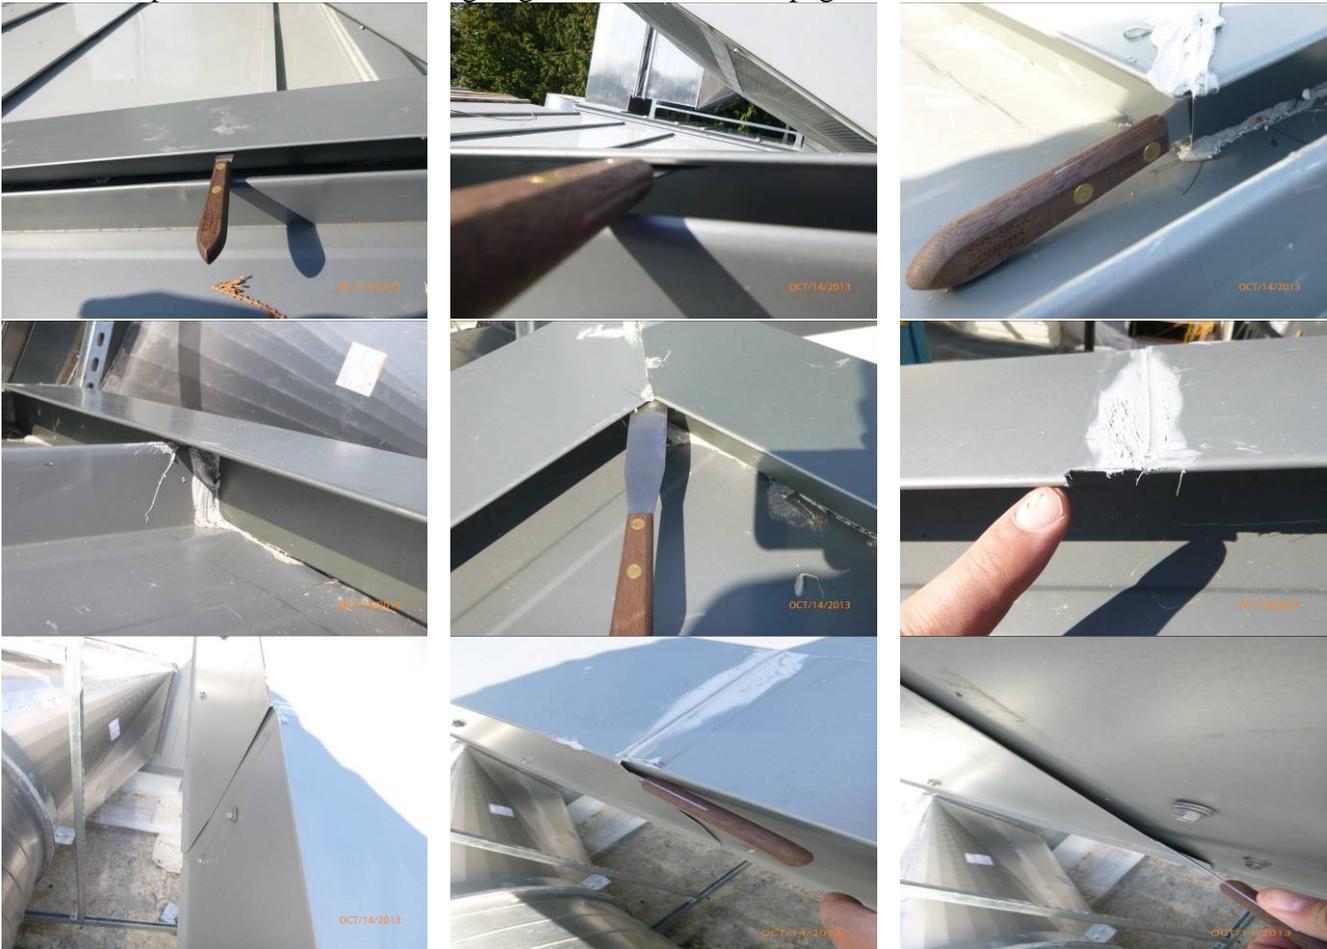
10.5a Several voids are present in the re-installation of the sheet metal fascia and metal roof panels. This will be updated in Item 8.8 in Ongoing Problems Items on pages below.

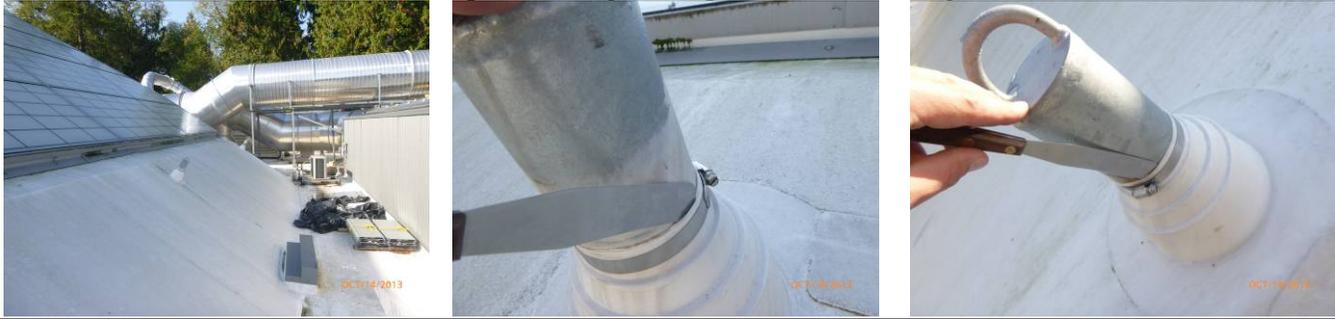
10.6 As an existing condition, at the roof areas to the southeast of the Natatorium Roof, sealant does not appear to be applied at the tops of through roof penetration flashings.

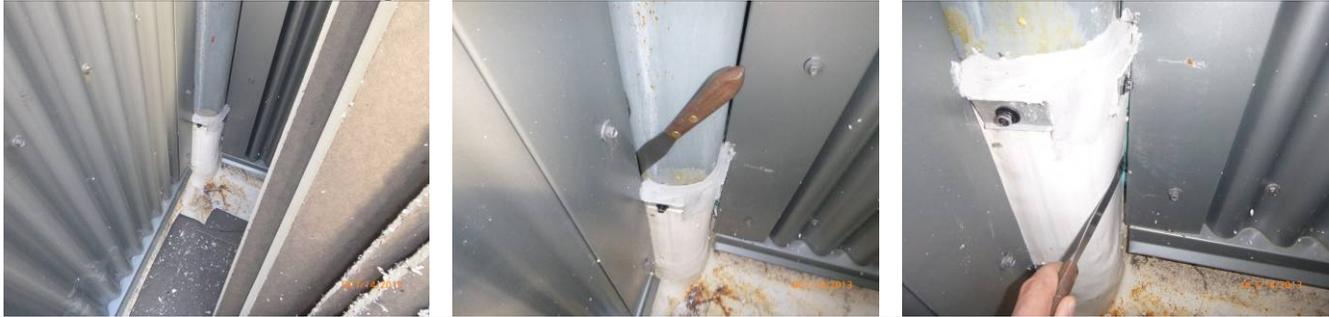
10.7 As an existing condition, this writer is unable to verify how the structural corner is flashed. What is visually accessible is portions of termination bar secured with gasketed fasteners with sealant applied at the top edge. It is recommended that the termination at the top edge of the TPO baseflashing (that will tie into the new roofing) is continuous.

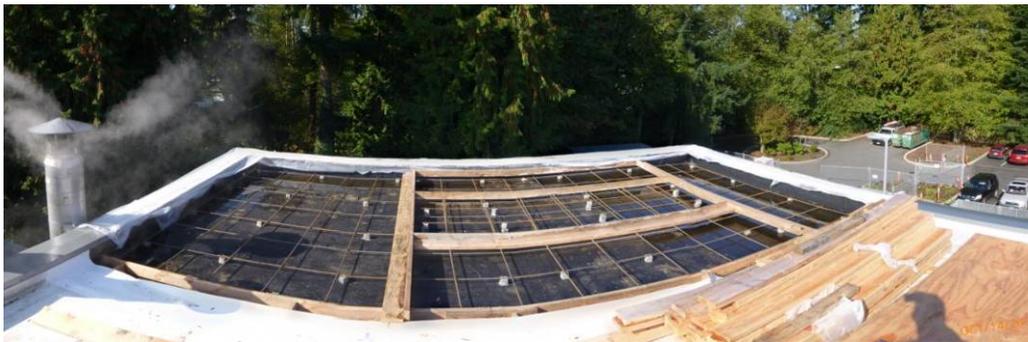
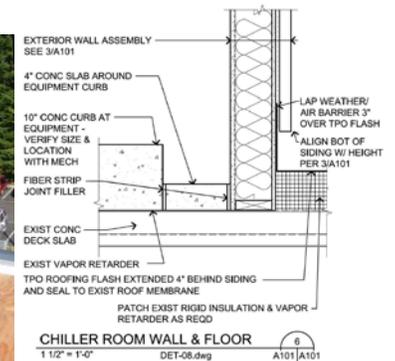
10.8 At the chiller room roof, rebar and other form-work is in place above the previously installed vapor barrier. This appears to be work performed to accommodate the new chiller room which is to be a concrete slab poured over the previously installed vapor retarder layer. Recommend that care be taken to prevent damage to the vapor retarder layer.

Overview of the chiller room roof taken facing west.

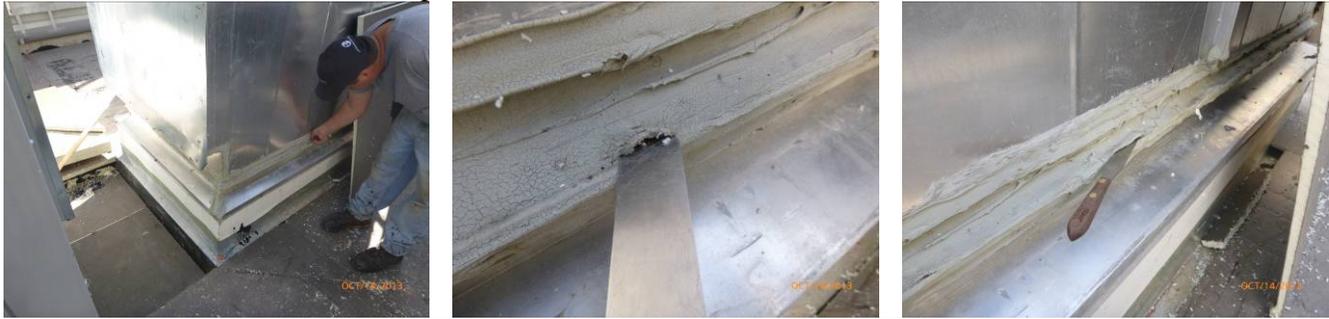
10.9 The HVAC unit at the southwest corner of the Natatorium roof has voids in the existing sealant. Per conversation with the construction team, this is a know condition that actively leaks. Sealant appears to have been applied in profusion as a means of mitigating the problem. It is recommended that this situation be addressed to prevent water intrusion into the new roof areas that surround this unit.

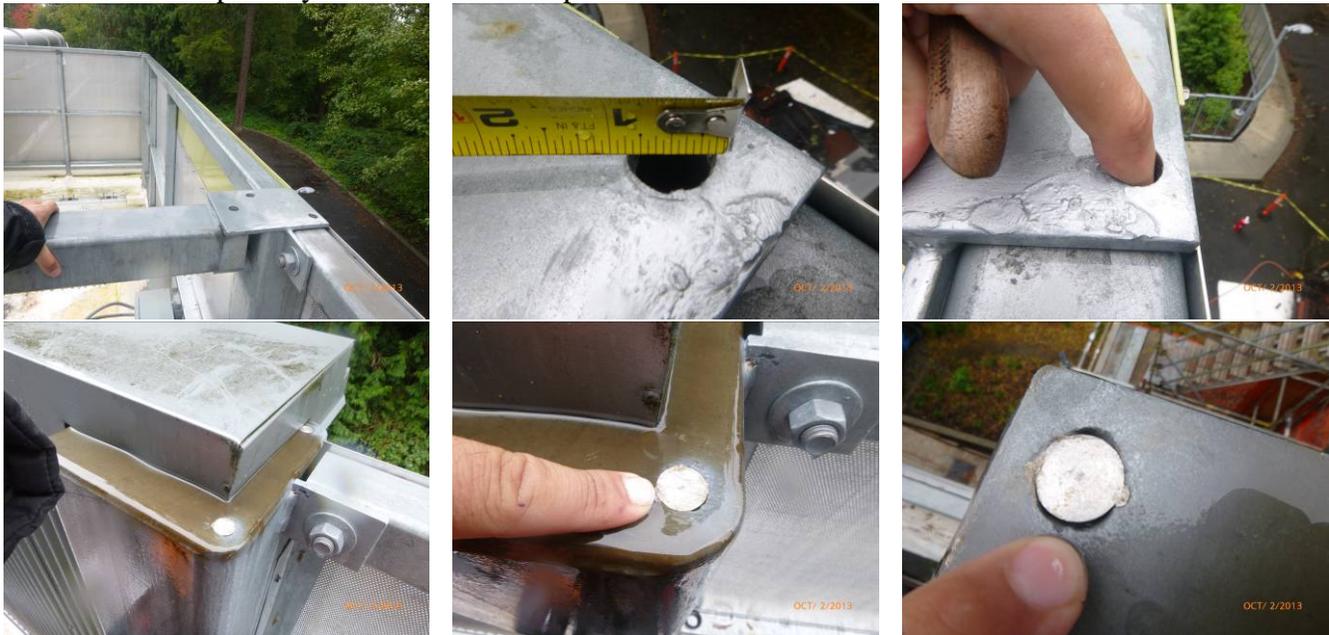
8.4 At the tops of screen wall supports (west elevation of the Natatorium Roof, typical of all large screen wall supports) through holes are observed at the top plates. Some holes appear to be infilled with metal. Recommend that all locations where water will enter are infilled or capped as needed to prevent water from funneling into the column and throughout the roof system below.

Update FR#10 – 10/14/2013: Item is unresolved. Per conversation with Keith Skore, these locations were temporarily sealed with duct tape in the interim.

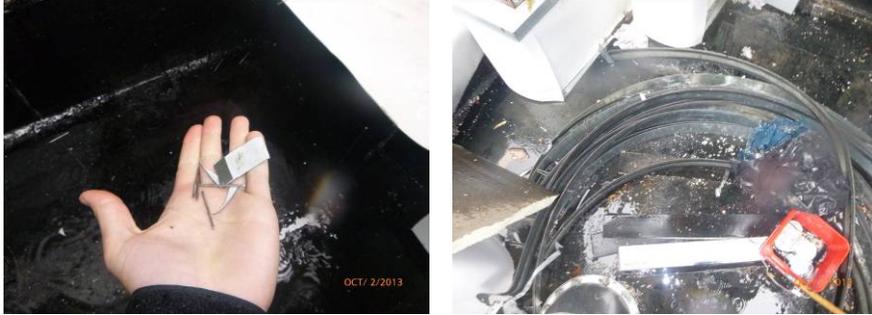
8.5 Recommend that any sheet metal sharps, fasteners and other debris are removed from the new vapor retarder layer to prevent damage.

Update FR#10 – 10/14/2013: Item is unresolved.

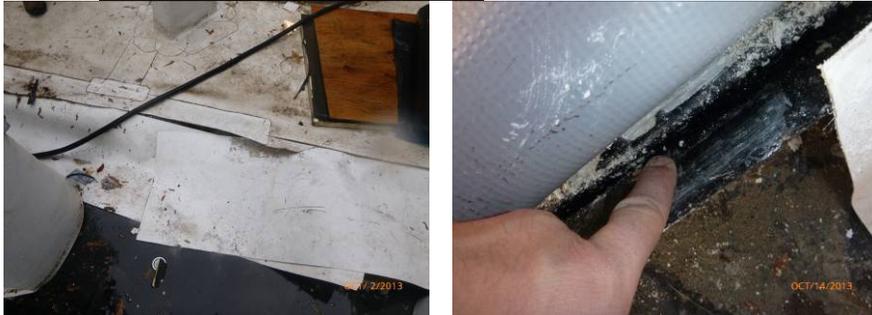
8.6 The night seal at the north end of the Natatorium roof is insufficient in some locations allowing water into the existing roof assembly. The roof to the north was previously observed as wet along with the existing roof that was removed to the south.

Update FR#10 – 10/14/2013: Item is unresolved.

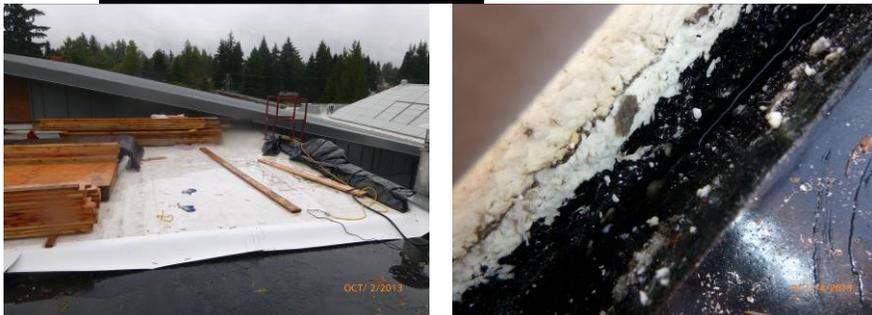
8.7 The absence of a night seal at the chiller room roof allowed water to migrate into the existing roof to the east. The roof to the east was previously observed as wet along with the existing roof that was removed to the west.

Update FR#10 – 10/14/2013: Item is unresolved.

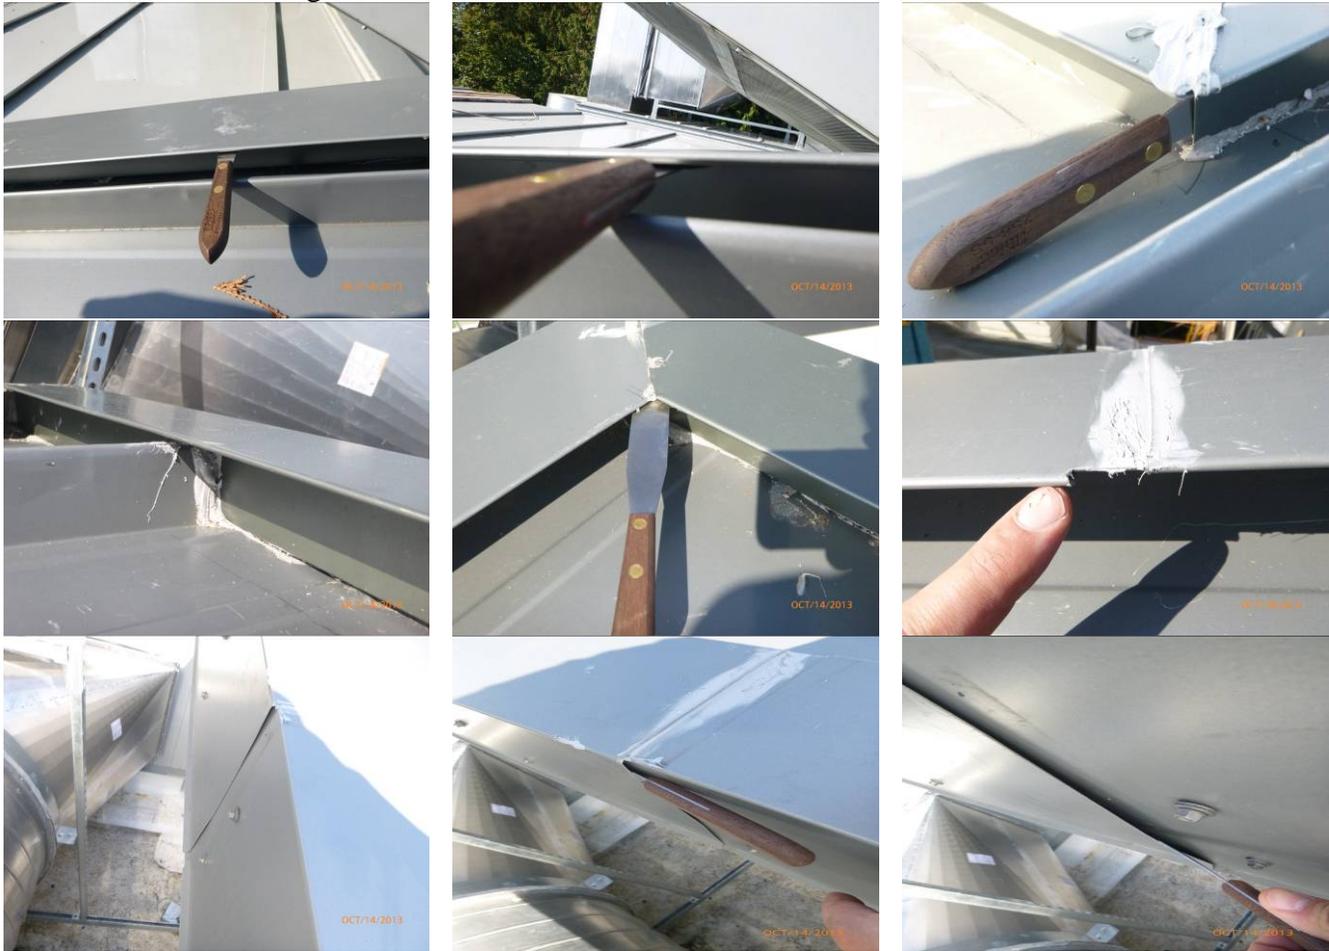
8.8 The sheet metal re-installation at the sawcut in the roof above is ongoing. This writer is unable to verify if the metal panel is notched into a vertical leg behind the flashing enclosure at the fascia. Sealant is observed bleeding out from underneath the roof panel. This area will be further reviewed in dry conditions.

Update FR#10 – 10/14/2013: Item is unresolved. Item is updated to reflect more generally observed conditions during this site visit.

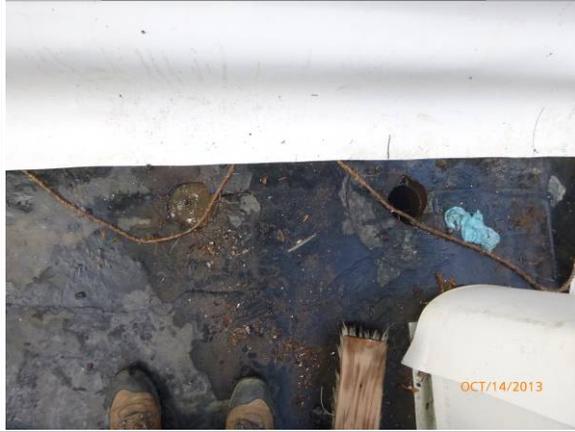
5.6 The roof drain overflow at the northwest corner of the Natatorium Roof is plugged. This writer cannot verify why the roof drain is plugged during this site visit. Recommend that the overflow is unplugged in the event of a heavy rain and that the drains are protected from debris entering and clogging the drainage pipes.

Update FR#10 – 10/14/2013: Item is unresolved.

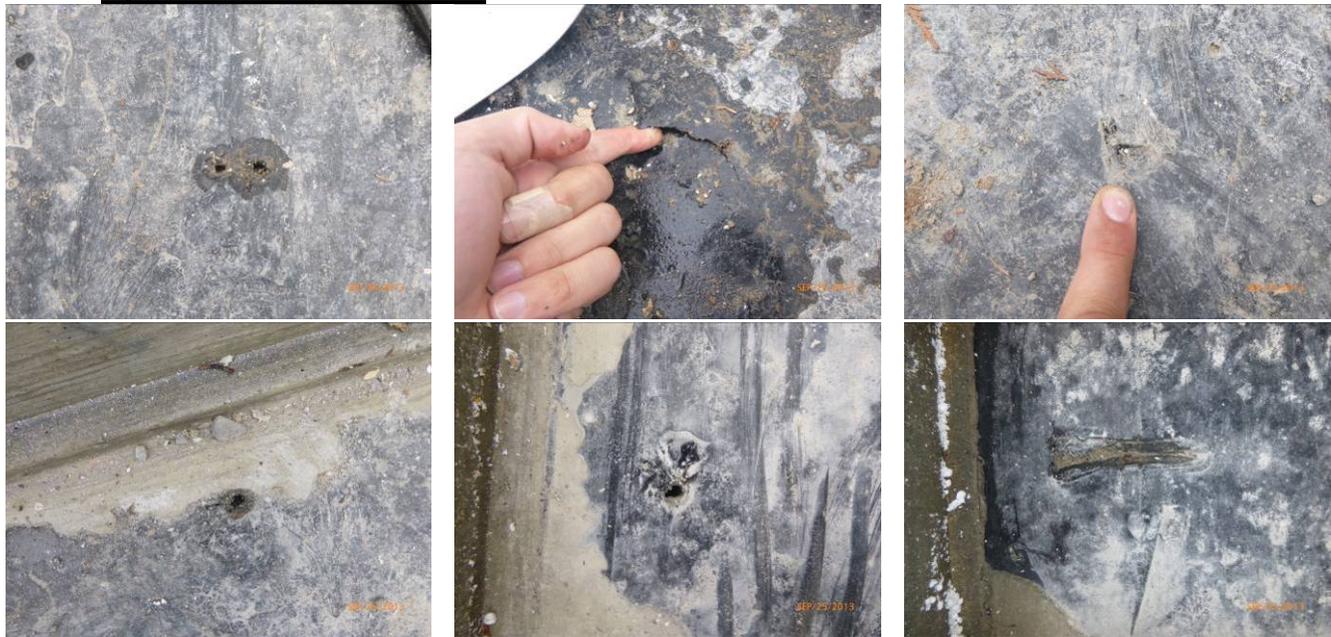
5.8 The vapor retarder layer at the Natatorium Roof is damaged in general. The construction team has been aware that construction sequencing would more than likely damage the vapor retarder layer. Per conversation with Rich Kerns (Foreman, QCR) the temporary roof/ vapor retarder layer is to be repaired with moppings of hot asphalt and plysheet as needed during construction.

Update FR#10 – 10/14/2013: Item is unresolved.

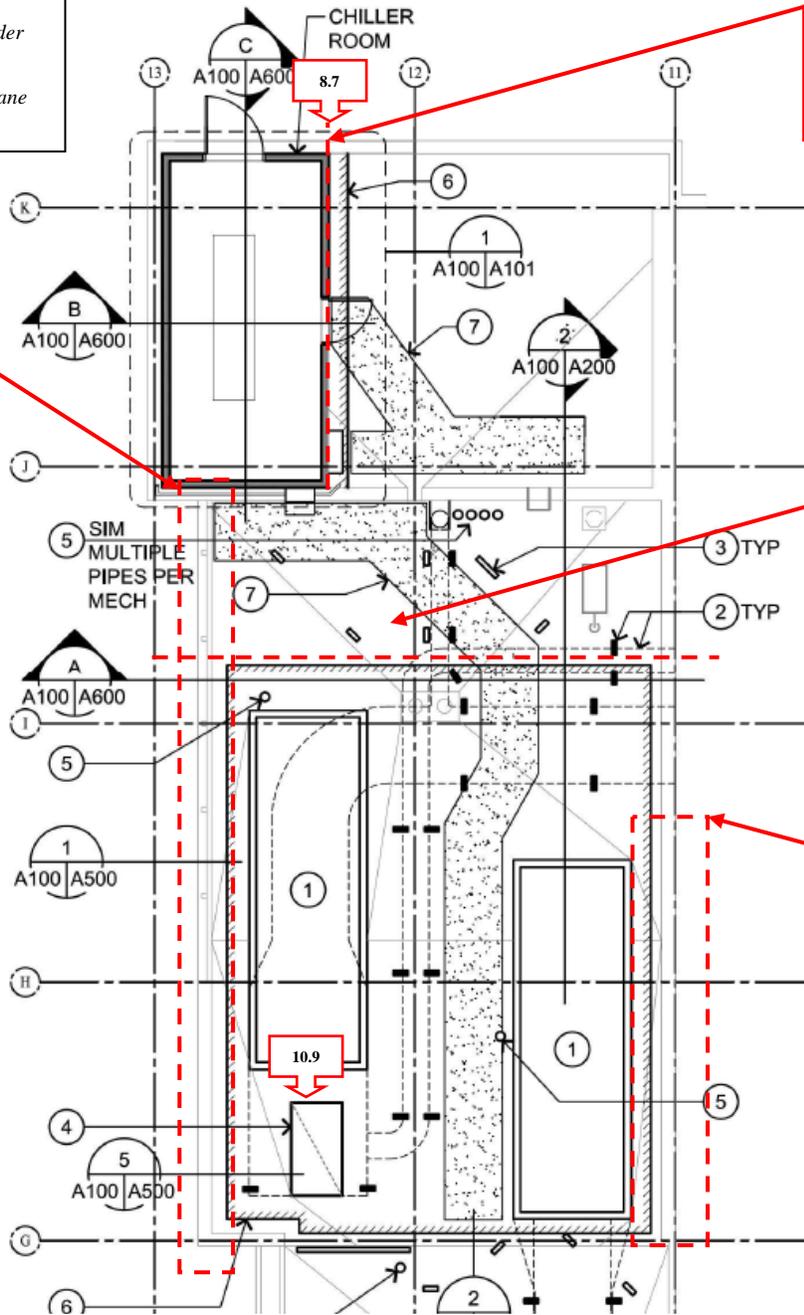
Roof Progress Plan / Locator Map:

Item 8.4: Infill holes in top plates at screen wall structure.

East of this line (approx.) the remainder of the Natatorium roof is wet and damaged as an existing condition.

North of this line (approx.) the remainder of the Natatorium roof is wet and damaged as an existing condition.

Problems Item 8.8 – sheet metal re-installation at the upper steep slope roof to accommodate new HVAC.
