FIELD REPORT – LYNNWOOD RECREATION CENTER – FIELD REPORT

REPORT #11

Date: October 15th, 2013

Location(s) of Work: Natatorium Roof in general.

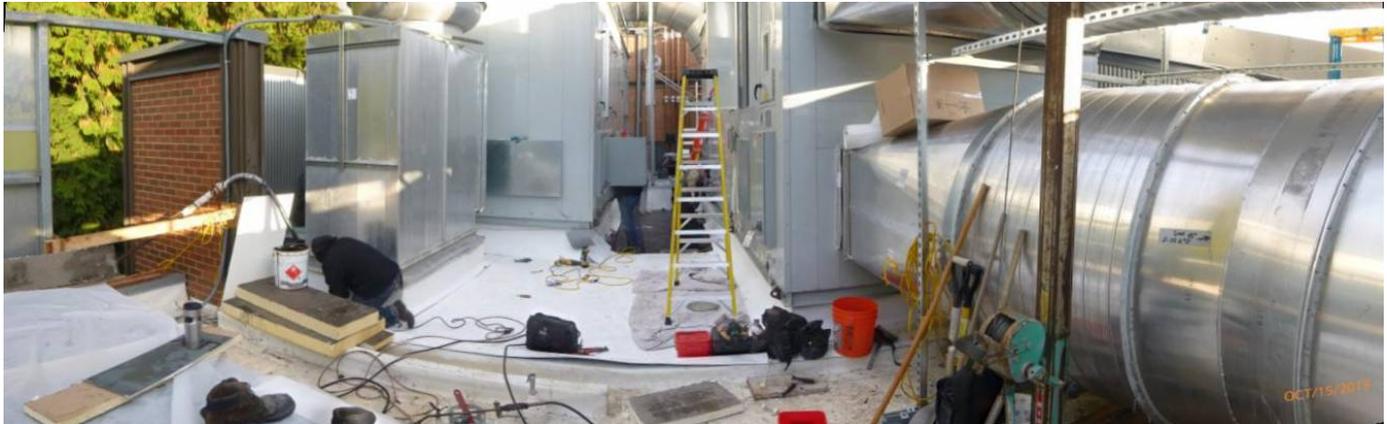
11.1 Queen City Roofing is installing new roofing at the west and south sides of the air handling unit that is located at the west side of the Natatorium Roof.

Overview of the Natatorium Roof taken facing north

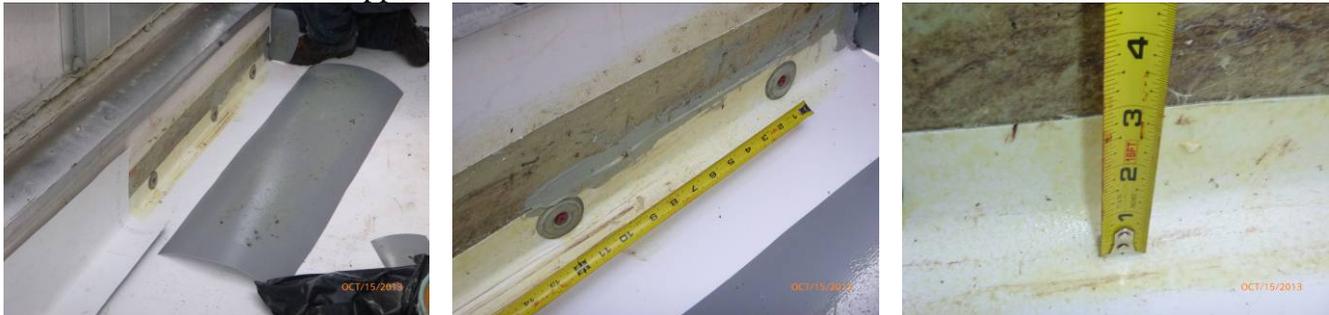
11.2 TPO field membrane is turned up approximately 3-inches onto the concrete curb and is mechanically fastened at 12-inch approximate intervals.

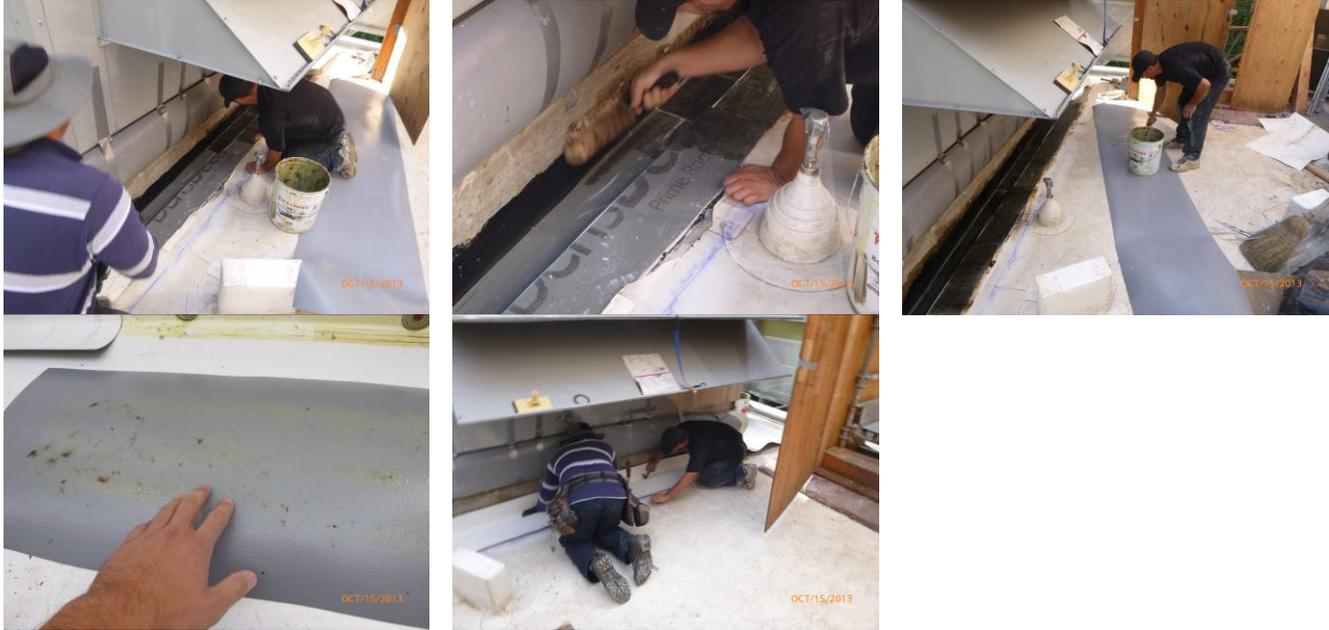
11.2a Firestone UltraPly bonding adhesive is rolled onto the concrete curb, DensDeck Prime coverboard and backside of the TPO membrane and is allowed to tack off. The baseflashing is then rolled into place utilizing silicone rollers to promote adhesion.

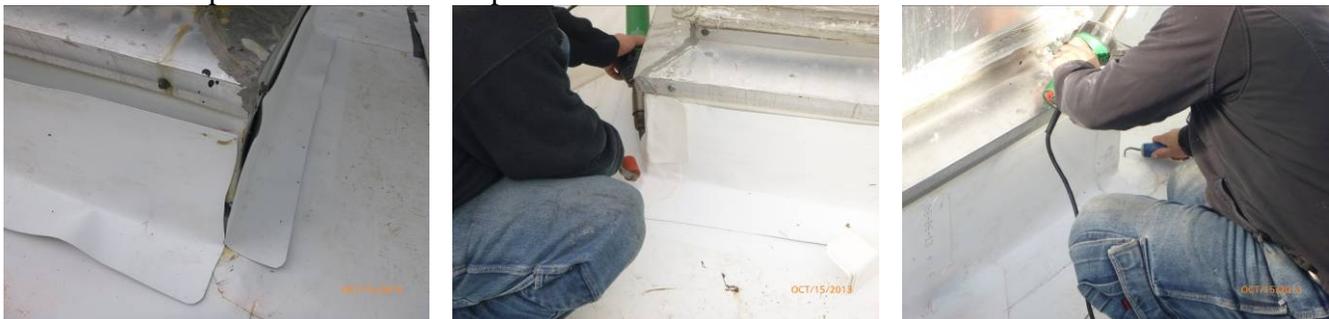
11.2b At the existing HVAC unit at the southwest corner of the Natatorium Roof the new baseflashing is slit to prevent membrane build-up at the corner. This is performed because the new baseflashing is to be welded onto a portion of the existing which should turn up and onto the top of the curb. Outside corners and unsupported membrane is welded over the corner utilizing a hand-held hot air welder and silicone roller to promote adhesion. A probe is utilized to test the seams.

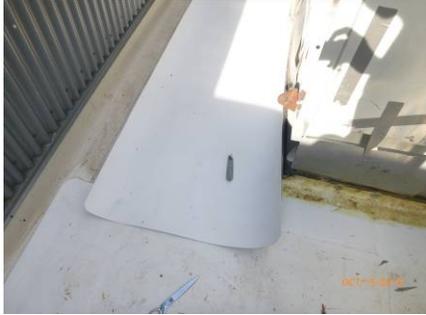
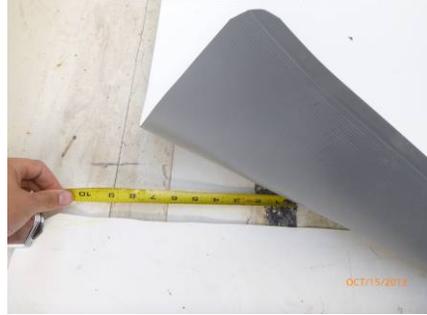
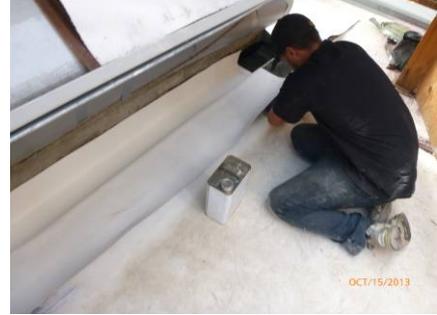
11.2c TPO field membrane is observed as lapping over onto existing roof approximately 6-inches. Membrane cleaner is utilized to clean the existing membrane prior to welding. The existing roofing is observed as being wet and the moisture has the potential to transfer over into the new roofing assembly. This is a known issue and has been discussed with the construction team.

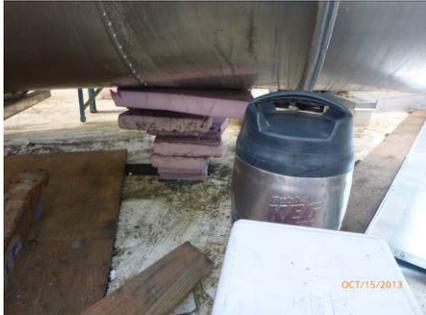
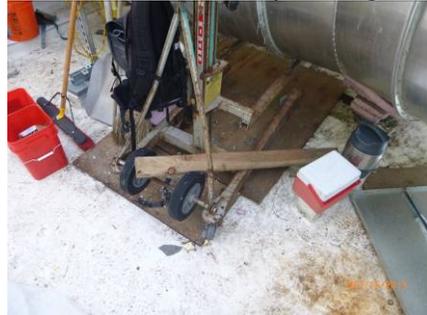
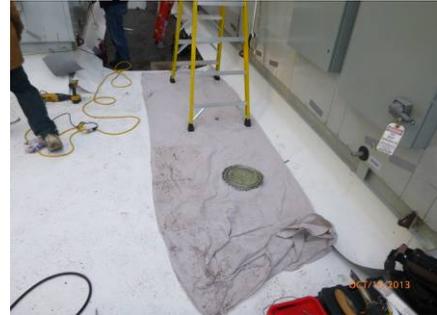
11.3 At the new and existing roof, dunnage appears to be in place below materials and other trade's work. It is recommended that the roof is reviewed and any damage should be repaired.

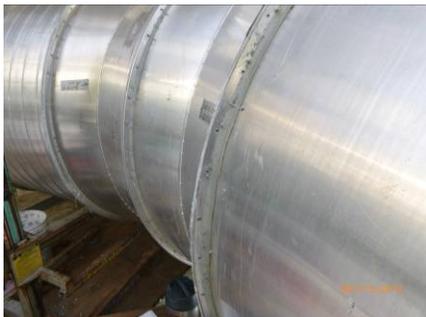
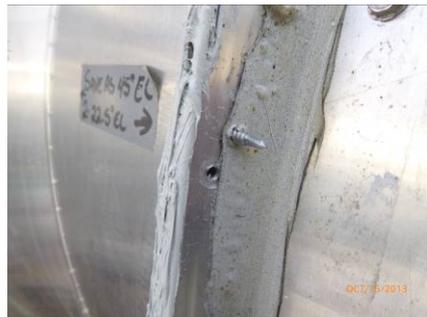
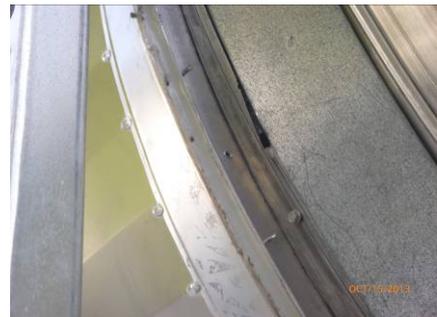
11.4 At the ducts to the southeast of the Natatorium Roof, it appears that some ducts were reinstalled and new penetrations are made at the joints. The existing penetrations are a potential for water intrusion into the ducts which could migrate into the building. Per conversation with Keith Skore (City of Lynnwood) sealant was installed at the interior seams in the ducts that were reinstalled.

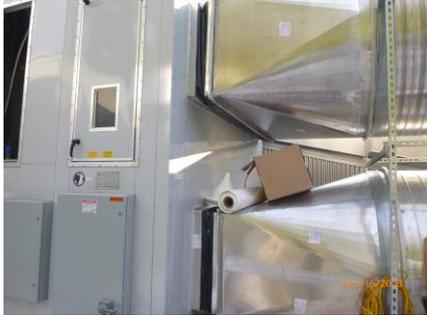
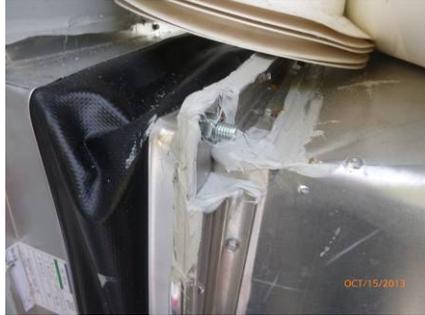
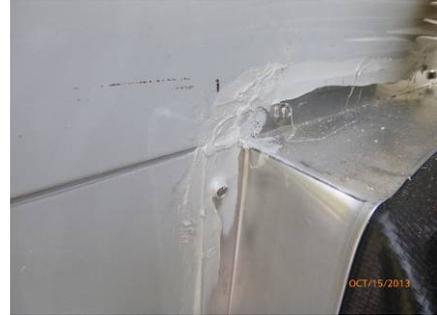
11.4a The duct work leading to the new air handling units are reviewed. It appears that sealant is applied at the seams and bolt penetrations in the ductwork. It is recommended that the ducts be sealed to provide a complete and continuous watertight system.

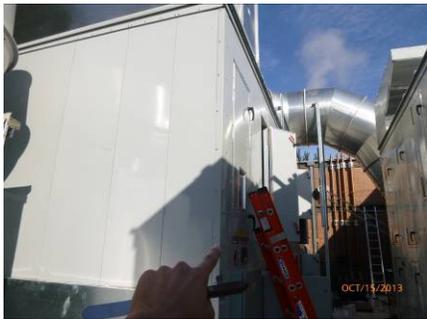
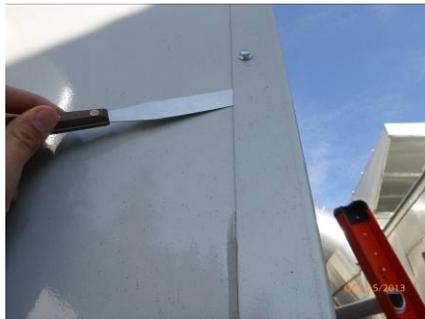
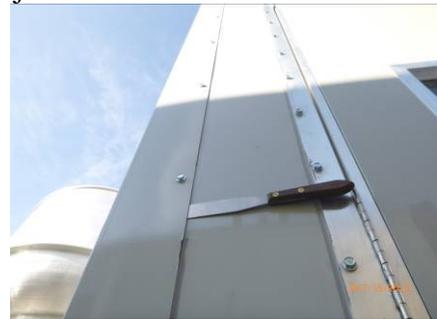
11.4b At the new air handling unit at the west side of the Natatorium Roof the southeast corner of the unit lacks sealant. This unit was manufactured and delivered to the jobsite. Item is noted as an observation.

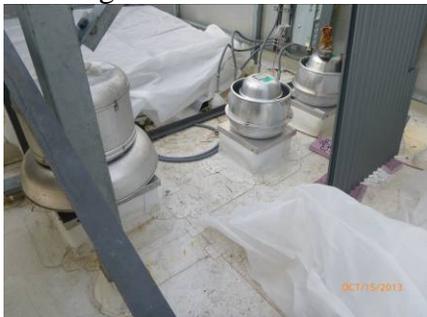
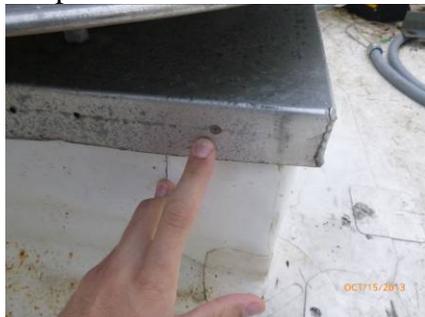
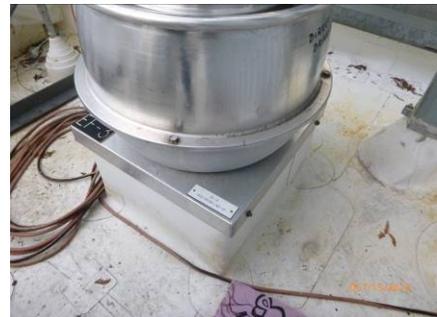
11.5 As an existing condition, many curb mounted units at the roof south of the Natatorium Roof lack fasteners or are not sufficiently attached to the curbs. It is recommended that a minimum of two gasketed fasteners are installed per side of each curb-mounted unit.

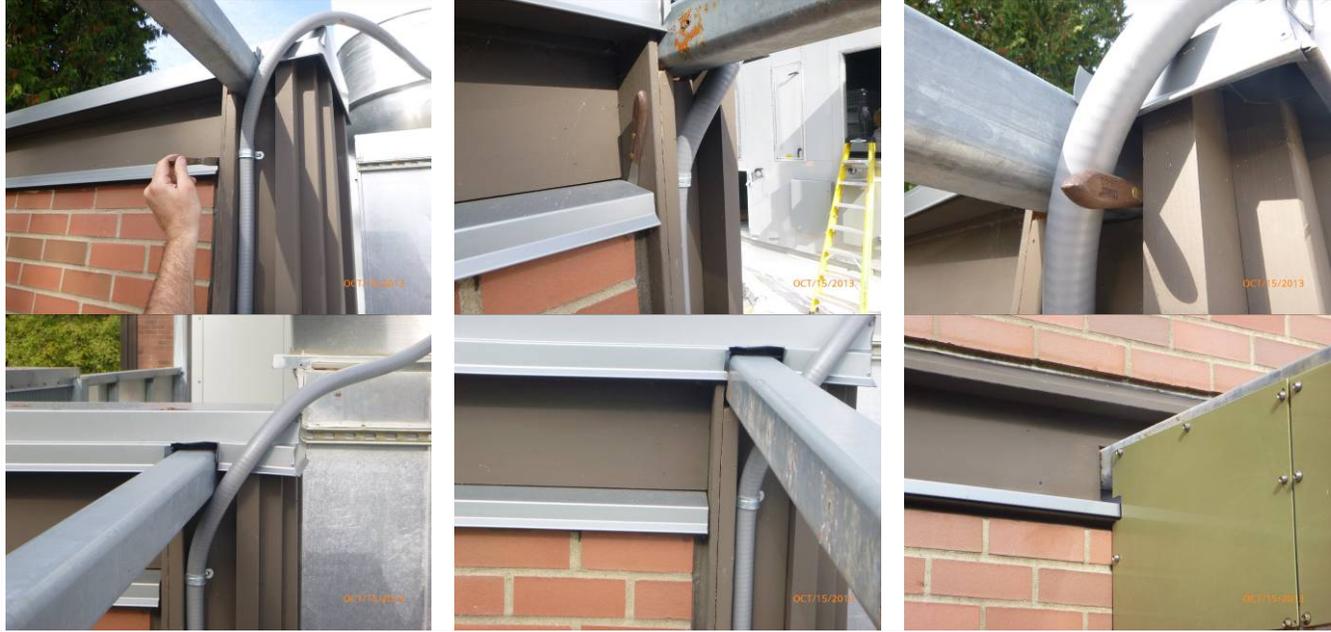
11.6 As an existing condition, many voids are observed in the flashing at the tops of masonry courses and screen-wall supports to wall transitions. These conditions appear to be a potential for water intrusion and damage to the building.

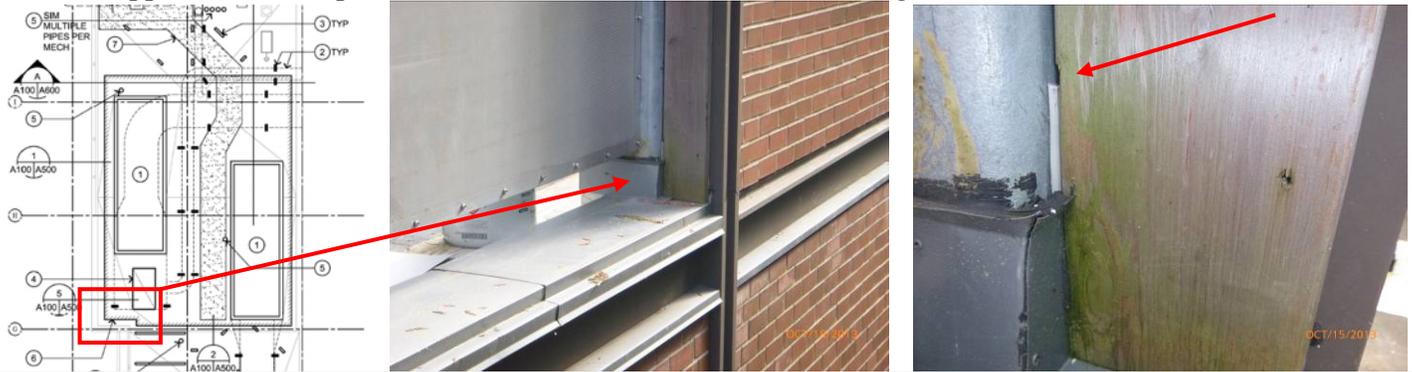
11.7 This observation is an existing condition. At the screen wall transitioning it appears that the existing TPO baseflashing is visible. It does not appear that the baseflashing is terminated behind the screen wall support. This is a potential for water intrusion into the building.

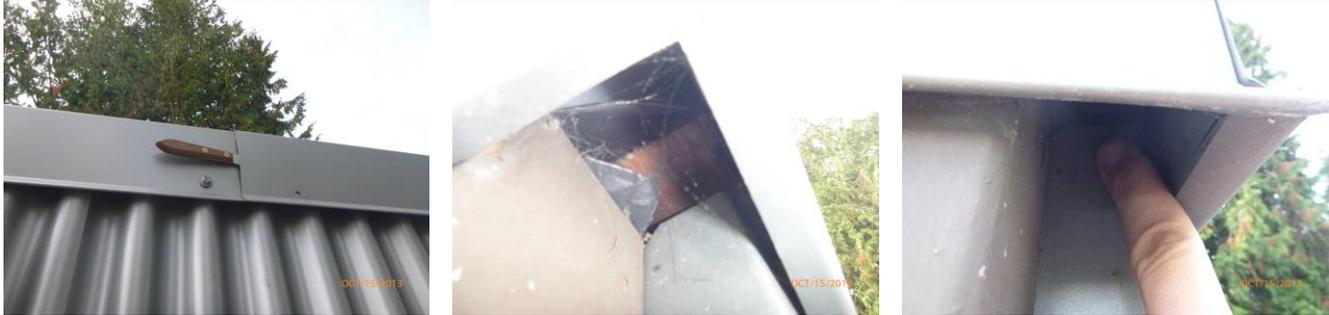
11.8 The following observation is an existing condition. At the southwest corner of the Natatorium Roof coping seams at the top of the wall appear to be lacking sealant. Voids are present and the wood nailer is visible. A sanded self adhered membrane should be installed to lap over the wood nailer on either side of the top of parapet.

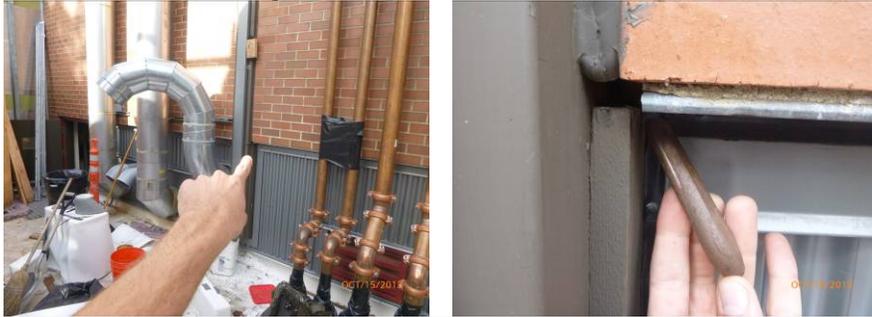
11.9 As an existing condition, at the north elevation of the Natatorium Roof wall (approximate center) a void is observed to the left of the masonry lintel. This condition is a potential for water intrusion and damage to the building.

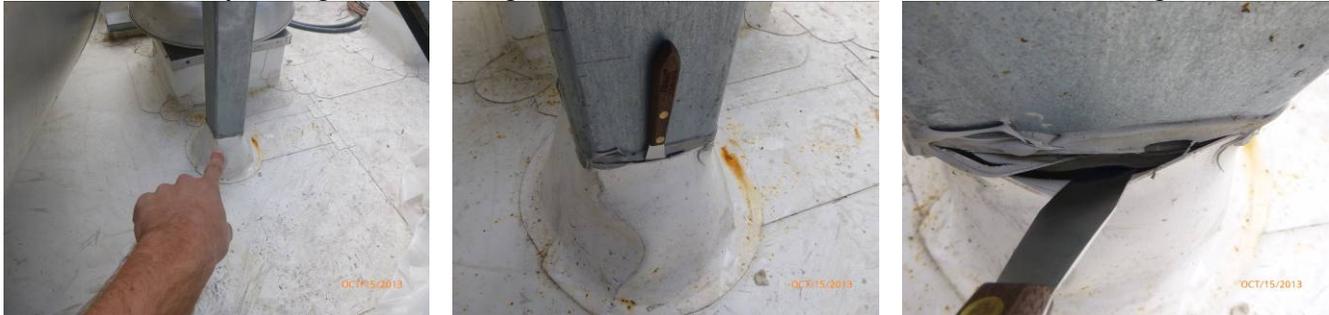
11.10 The following observation is an existing project condition. At the roof to the south of the Natatorium Roof many through roof flashings lack steel draw-bands and/or the sealant is failing.

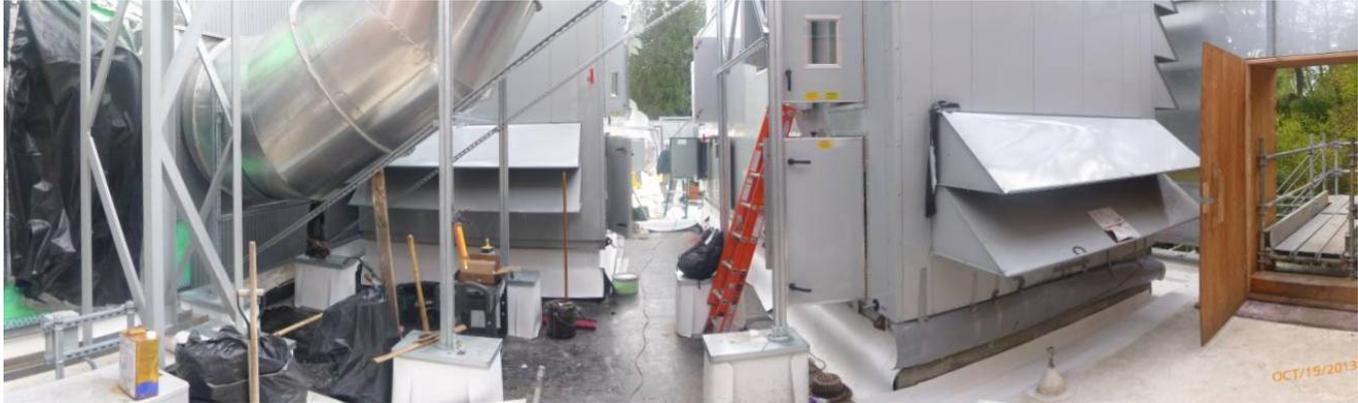
11.11 The following photo is taken at this writer's departure from the onsite inspection and depicts progress in the installation of the new roof. This writer is to return for a punchlist inspection when the new roofing is installed at the Natatorium and chiller room roof areas.

Overview of the Natatorium Roof taken facing south

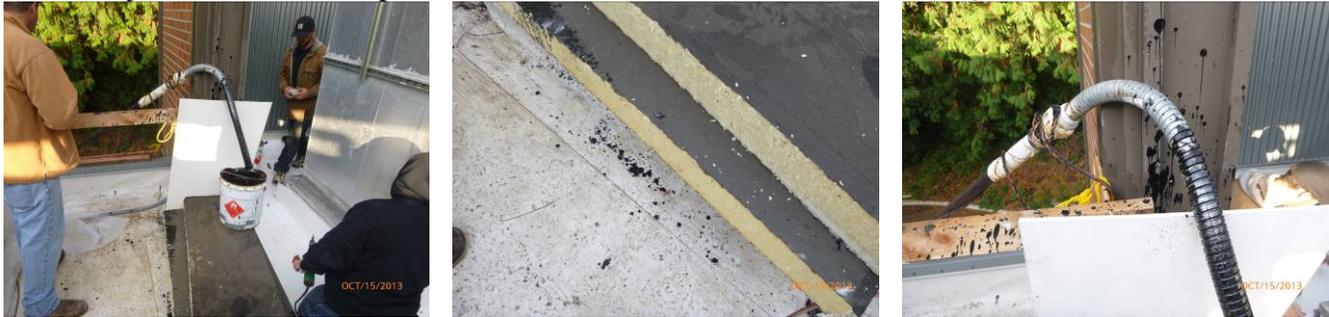
11.12 At the southwest corner of the new roof (asphalt pouring station) asphalt splatters onto the trim behind and onto the existing roof membrane to the south. It was observed that measures were taken to protect adjacent surfaces and per conversation with Rich Kerns (Foreman, QCR) this will be addressed.

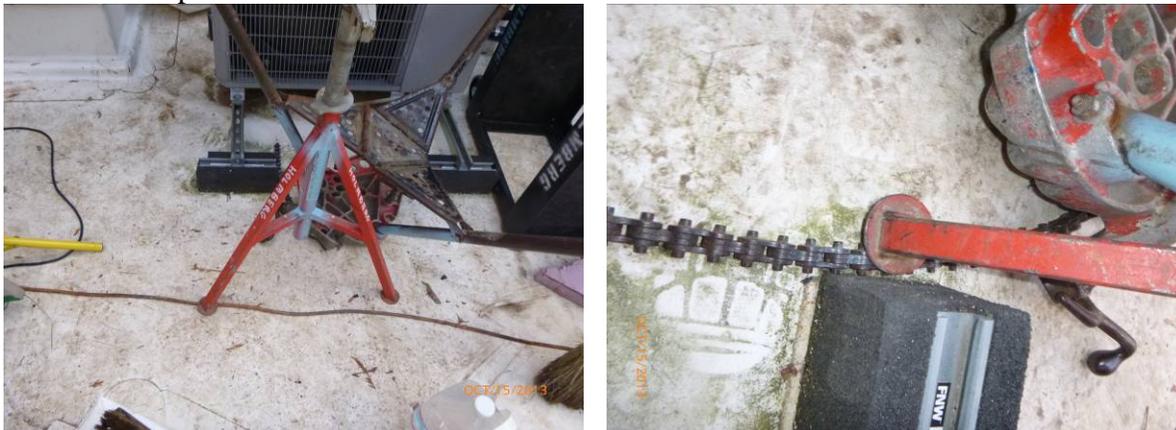
11.13 Other trade's work and various materials/tools are staged above the existing roof membrane to the north and south of the HVAC replacement. It is recommended that the existing roof membrane is reviewed and repaired as needed.

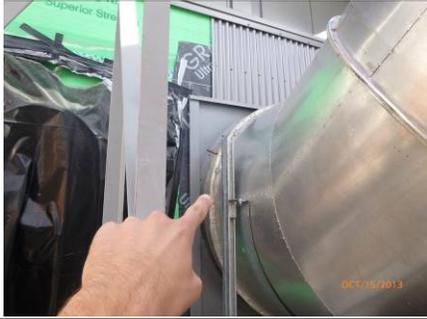
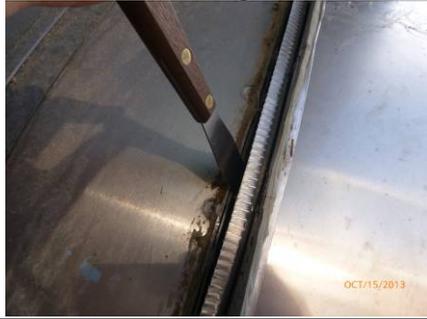
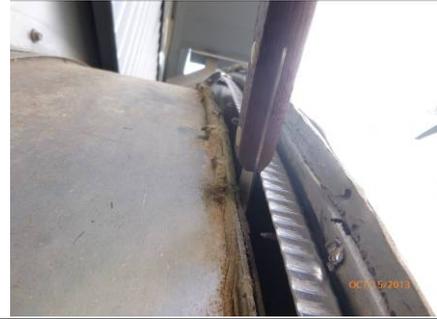
11.14 Near the duct to wall transition (east elevation) a seam is open in the duct. This condition appears to be at the circumference of the duct. It is recommended that all bolt penetrations, seams and joins in the duct work are continuously sealed and watertight.

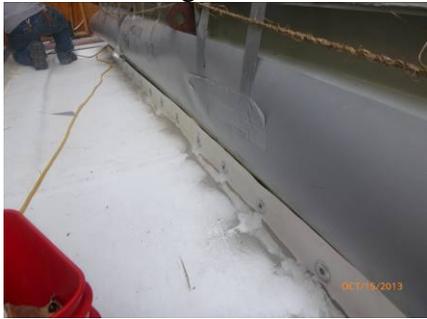
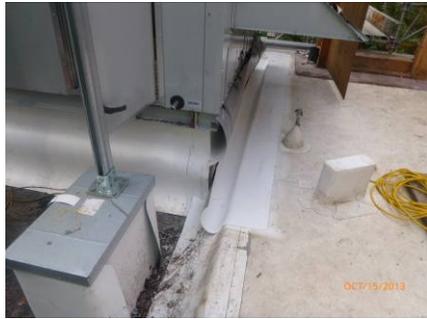
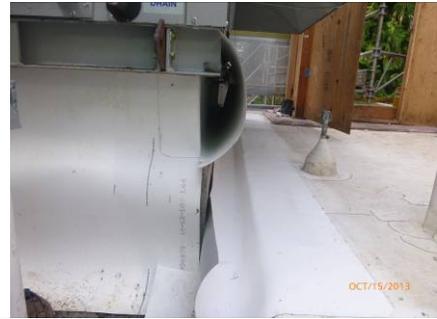
11.15 The night seal around the west HVAC unit is insufficient.

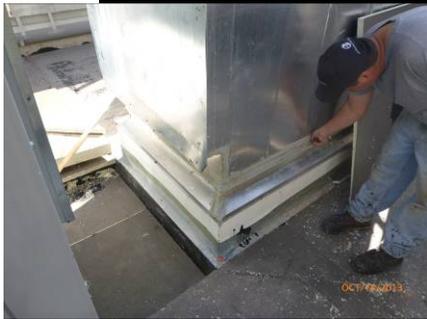
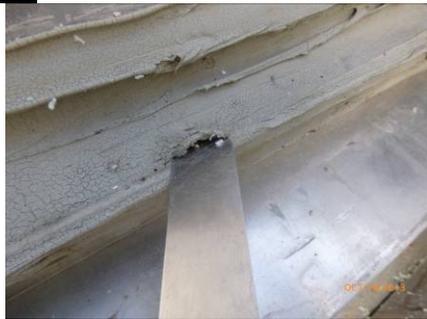
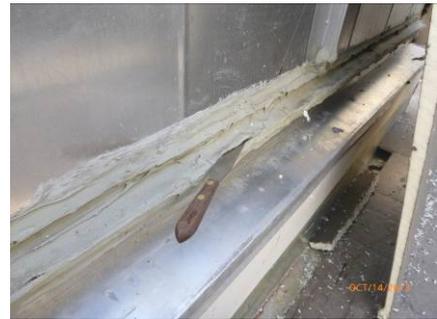
10.9 The HVAC unit at the southwest corner of the Natatorium Roof has voids in the existing sealant. Per conversation with the construction team, this is a know condition that actively leaks. Sealant appears to have been applied in profusion as a means of mitigating the problem. It is recommended that this situation be addressed to prevent water intrusion into the new roof areas that surround this unit.

Update FR#11 – 10/15/2013: Item is unresolved.

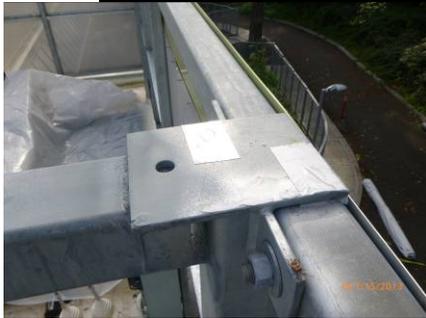
8.4 At the tops of screen wall supports (west elevation of the Natatorium Roof, typical of all large screen wall supports) through holes are observed at the top plates. Some holes appear to be infilled with metal. Recommend that all locations where water will enter are infilled or capped as needed to prevent water from funneling into the column and throughout the roof system below.

Update FR#09 – 10/03/2013: Item is unresolved.

Update FR#10 – 10/14/2013: Item is unresolved. Per conversation with Keith Skore, these locations were temporarily sealed with duct tape in the interim.

Update FR#11 – 10/15/2013: Item is unresolved.

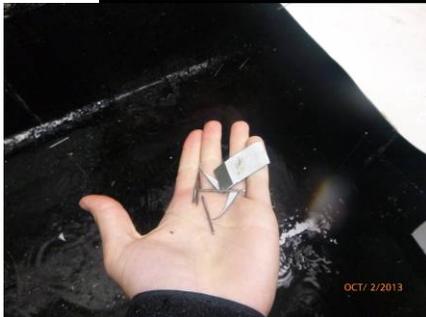
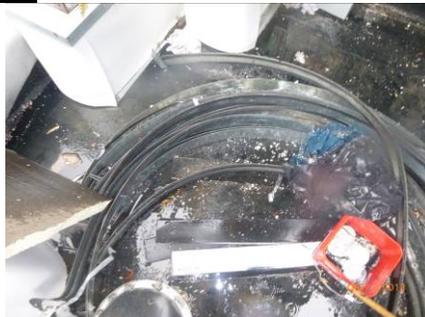
8.5 Recommend that any sheet metal sharps, fasteners and other debris are removed from the new vapor retarder layer to prevent damage.

Update FR#11 – 10/15/2013: Item is unresolved.

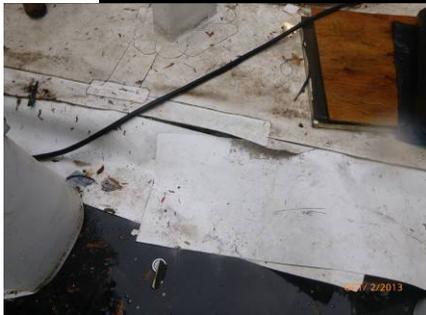
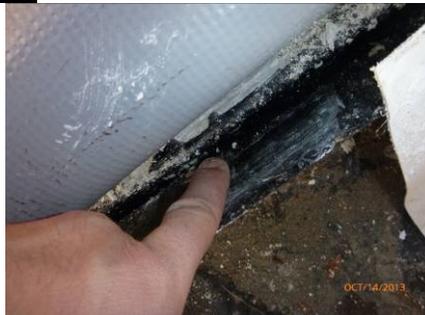
8.6 The night seal at the north end of the Natatorium Roof is insufficient in some locations allowing water into the existing roof assembly. The roof to the north was previously observed as wet along with the existing roof that was removed to the south.

Update FR#11 – 10/15/2013: Item is unresolved.

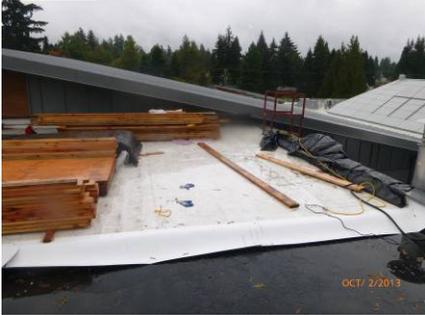
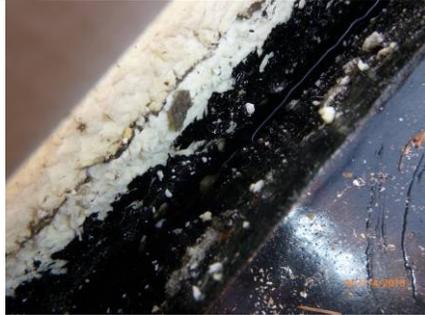
8.7 The absence of a night seal at the chiller room roof allowed water to migrate into the existing roof to the east. The roof to the east was previously observed as wet along with the existing roof that was removed to the west.

Update FR#11 – 10/15/2013: Item is unresolved.

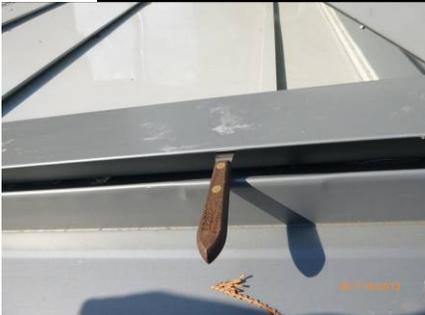
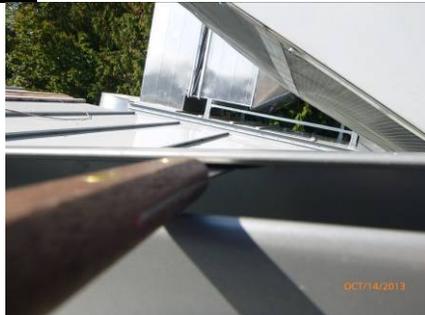
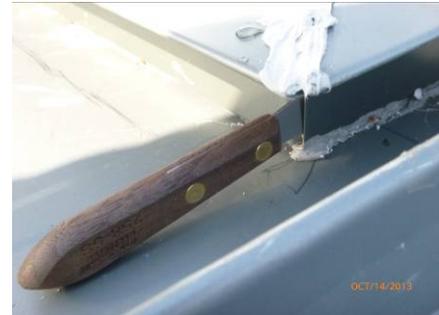
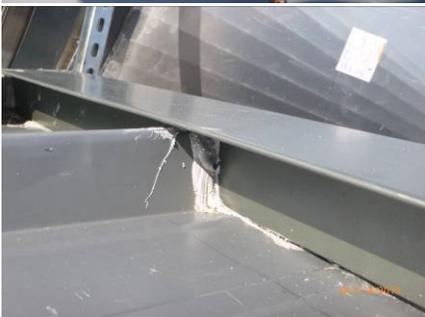
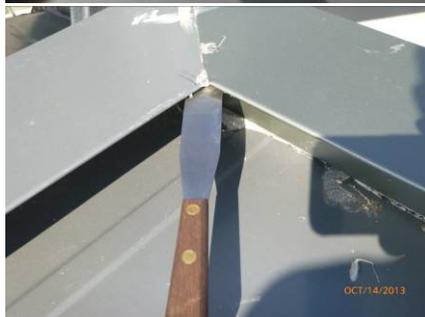
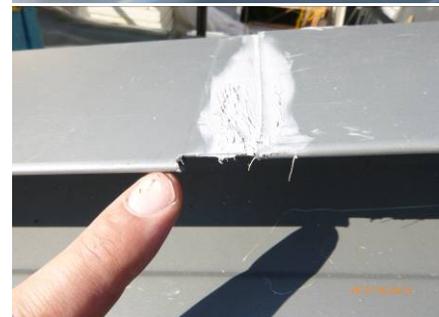
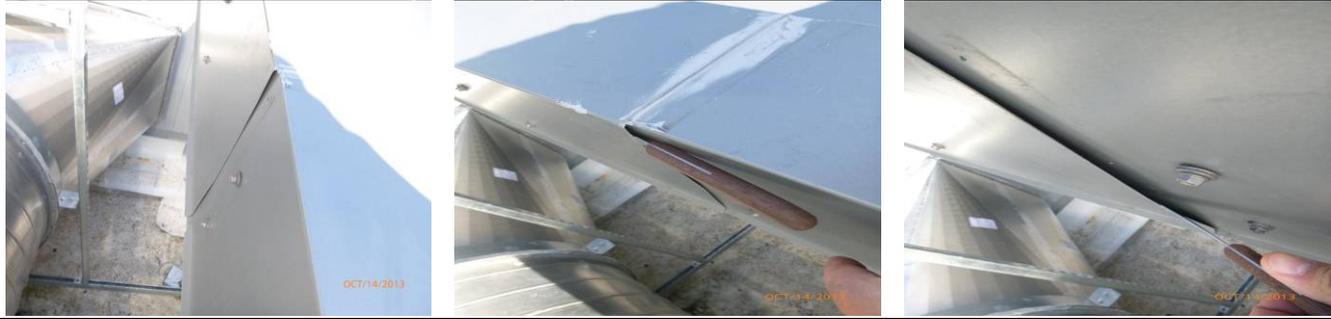
8.8 The sheet metal re-installation at the sawcut in the roof above is ongoing. This writer is unable to verify if the metal panel is notched into a vertical leg behind the flashing enclosure at the fascia. Sealant is observed bleeding out from underneath the roof panel. This area will be further reviewed in dry conditions.

Update FR#10 – 10/14/2013: Item is unresolved. Item is updated to reflect more generally observed conditions during this site visit.

Update FR#11 – 10/15/2013: Item is unresolved.

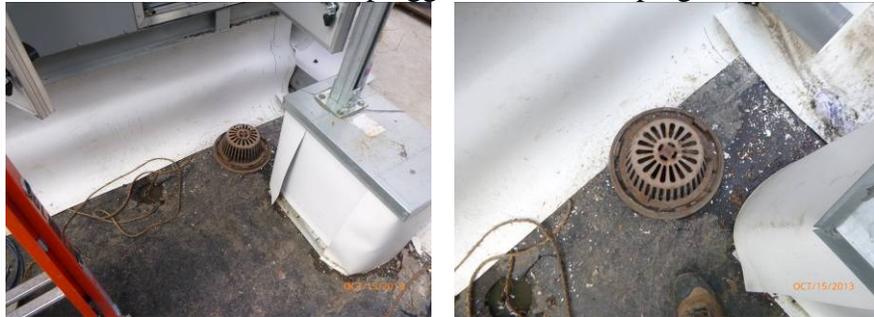
5.6 The roof drain overflow at the northwest corner of the Natatorium Roof is plugged. This writer cannot verify why the roof drain is plugged during this site visit. Recommend that the overflow is unplugged in the event of a heavy rain and that the drains are protected from debris entering and clogging the drainage pipes.

Update FR#11 – 10/15/2013: Item is unresolved. Drain basket is temporarily installed over the drain. The overflow is still plugged with a drain plug.

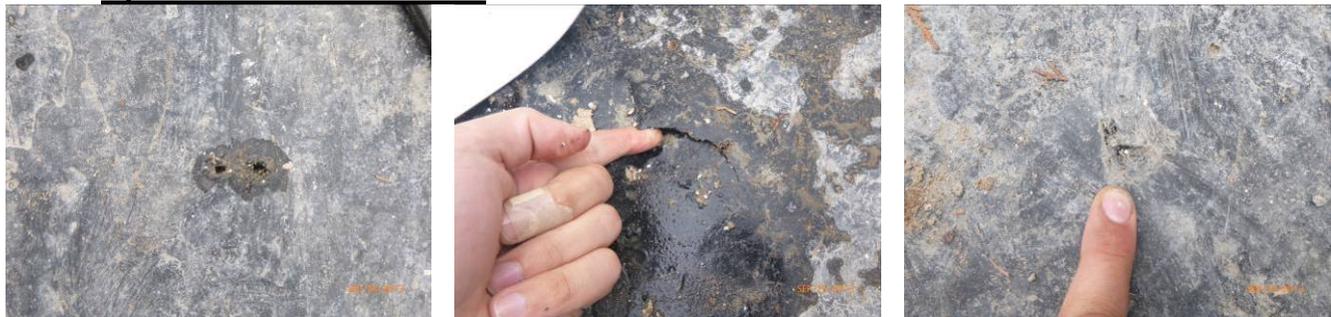
5.8 The vapor retarder layer at the Natatorium Roof is damaged in general. The construction team has been aware that construction sequencing would more than likely damage the vapor retarder layer. Per conversation with Rich Kerns (Foreman, QCR) the temporary roof/ vapor retarder layer is to be repaired with moppings of hot asphalt and plysheet as needed during construction.

Update FR#11 – 10/15/2013: Item is unresolved.

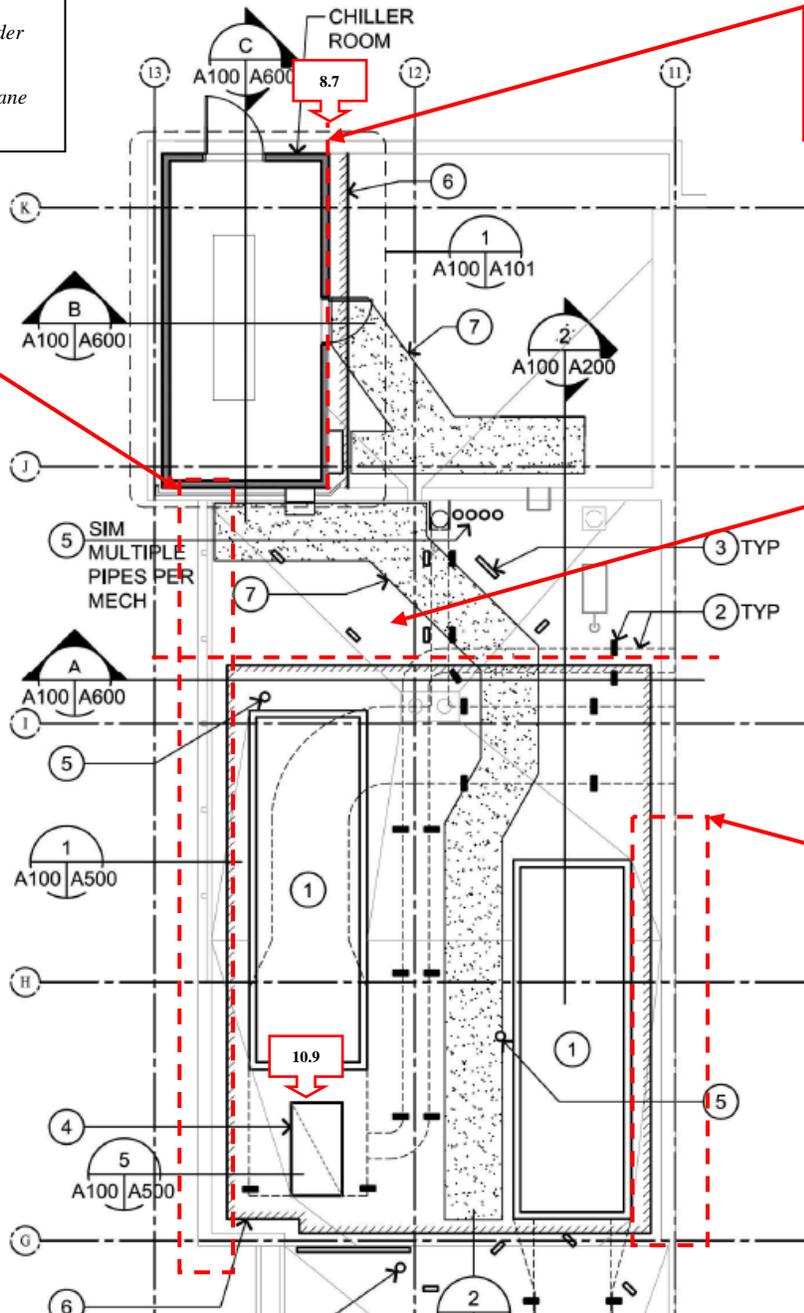
Roof Progress Plan / Locator Map:

Item 8.4: Infill holes in top plates at screen wall structure.

East of this line (approx.) the remainder of the Natatorium roof is wet and damaged as an existing condition.

North of this line (approx.) the remainder of the Natatorium roof is wet and damaged as an existing condition.

Problems Item 8.8 – sheet metal re-installation at the upper steep slope roof to accommodate new HVAC.
