FIELD REPORT – LYNNWOOD RECREATION CENTER – FIELD REPORT
REPORT #12

Job No. 10-100622B1

Date: January 3rd, 2014
Page 1 of 12

This writer was onsite with Shane West, Wetherholt and Associates, Inc. to perform a punchlist inspection of the upper and lower roof areas that were re-roofed. Hand-written copy of Field Notes #12 was reviewed with Keith Skore (City of Lynnwood) and is left in the onsite job trailer for storage. The following items were observed, noted and/or discussed regarding the roof.

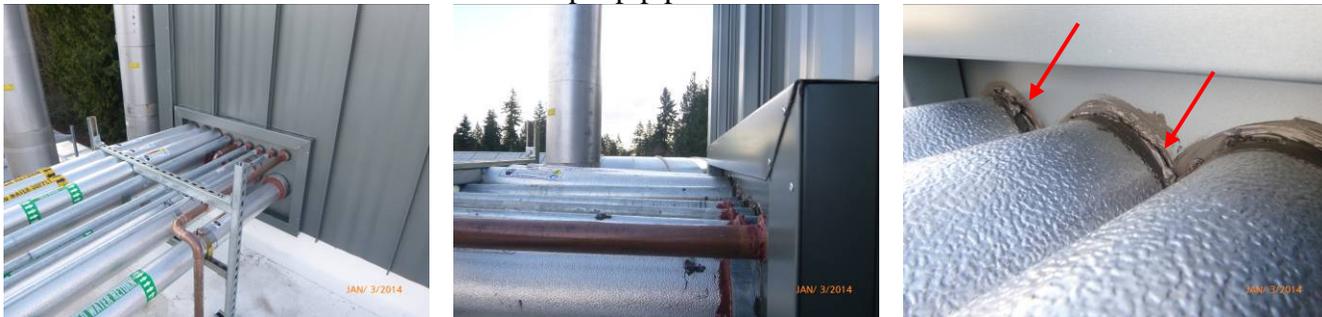
12.2 At the southeast corner of the penthouse the new insulated pipes are sloped towards the wall and the sealant joints that were recently installed appear to be failing. This writer is unable to determine if any other measures of flashing are present but recommends that a sheet metal enclosure of positive slope away from the wall be installed to shield the penetrations from the elements. Project detail 8/A101 calls for a sheet metal hood to cover multiple pip penetrations that should be installed.

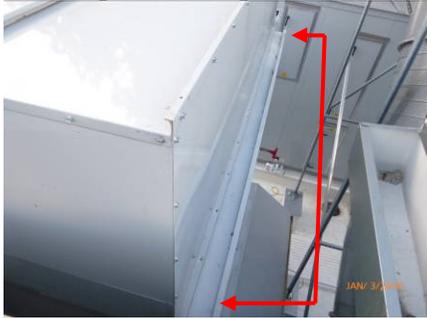
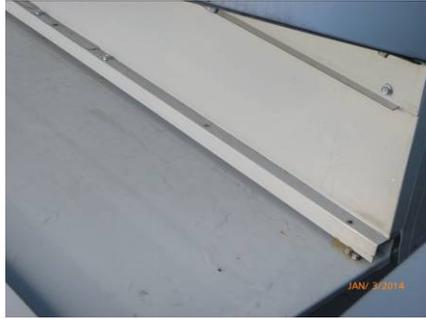
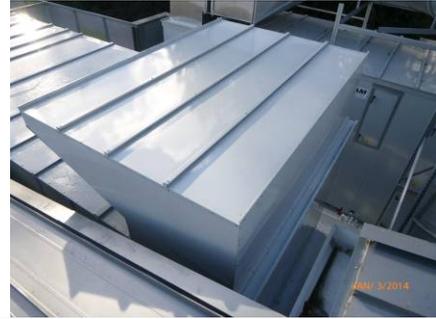
12.3 At the top of the new HVAC unit to the east a large exhaust vent is missing all the fasteners on the north side of the vent and some on the south side. The vent is easily moved by hand and should be secured to prevent displacement.

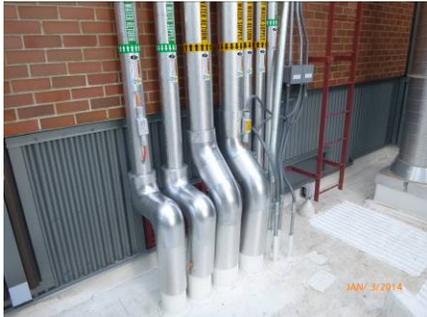
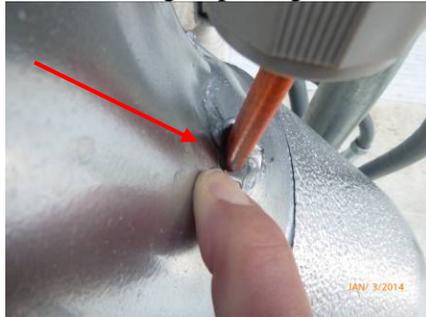
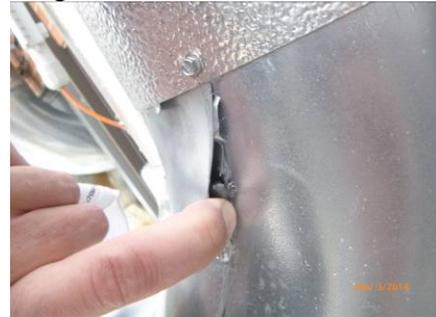
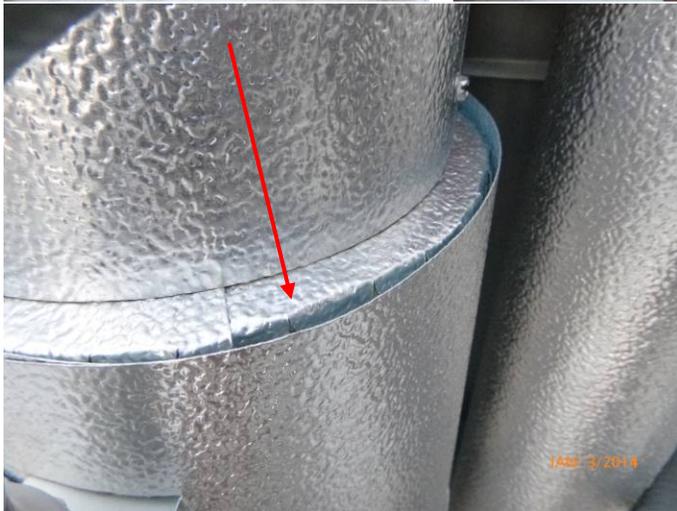
12.4 At the new insulated pipes on the north side of the natatorium roof many openings are observed in the insulation cladding. This writer is unable to determine whether the through roof penetrations below are sealed at the top terminating edge of the TPO flashings. If not sealed per manufacturer's requirements, this could result in water intrusion through openings in the cladding.

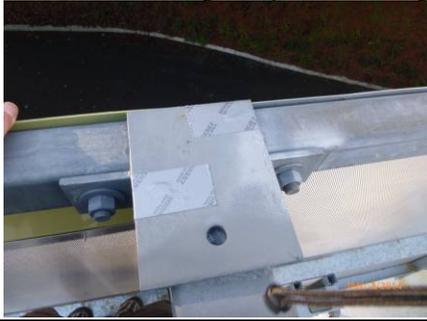
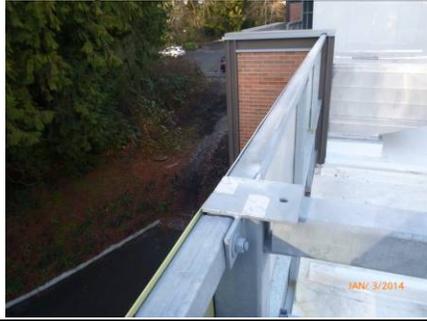
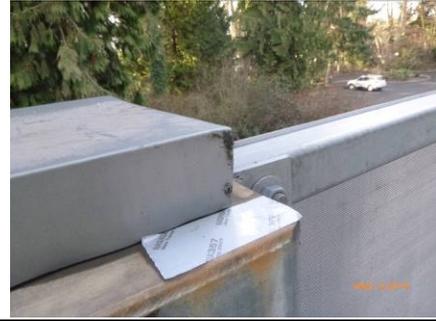
12.5 As noted on pages below in Incomplete Problematic Issues Item 8.4, the galvanizing davits at the top plates of the screen wall supports are a potential source for water to enter the roof. Duct tape is installed as a temporary means of preventing water entry.

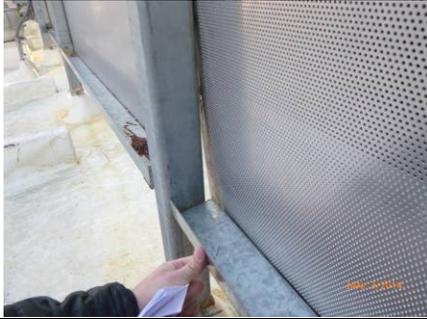
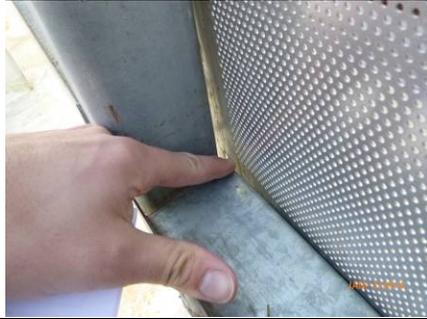
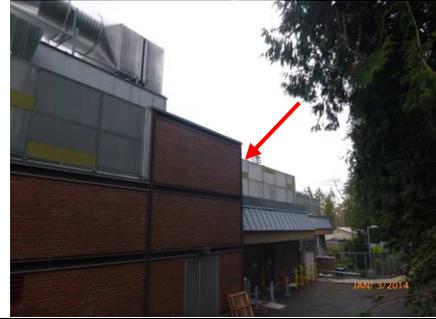
12.6 At the west side of the natatorium roof a panel in the screen wall is loose. This panel was removed to allow temporary access for hot asphalt from below. It is recommended that this panel be re-secured.

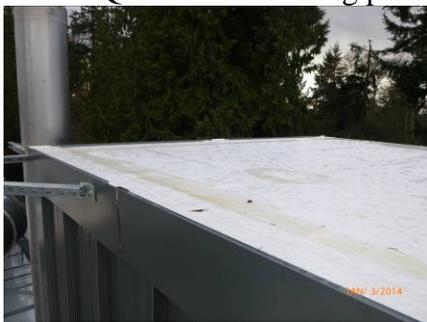
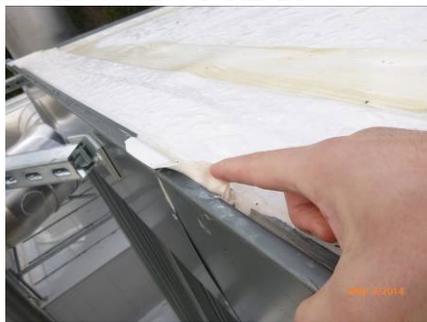
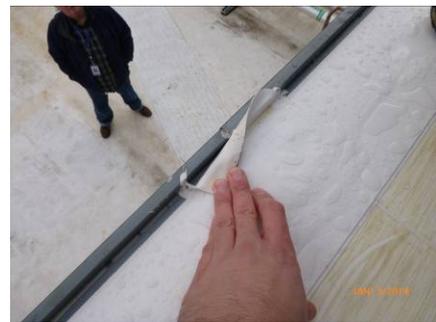
12.7 At the chiller room penthouse roof (east side) the splice patches installed over the joints in the edge metal are not well adhered. Further, GP sealant should have been utilized at the edges of what should be QuickSeam flashing per Firestone detail UT-RE-21.

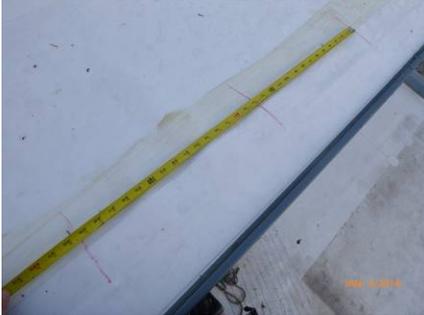
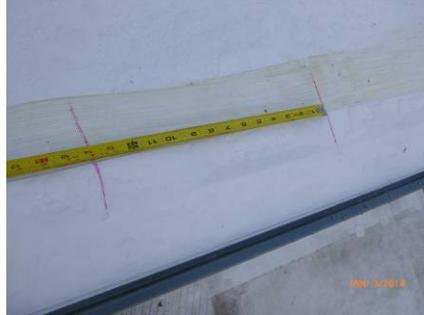
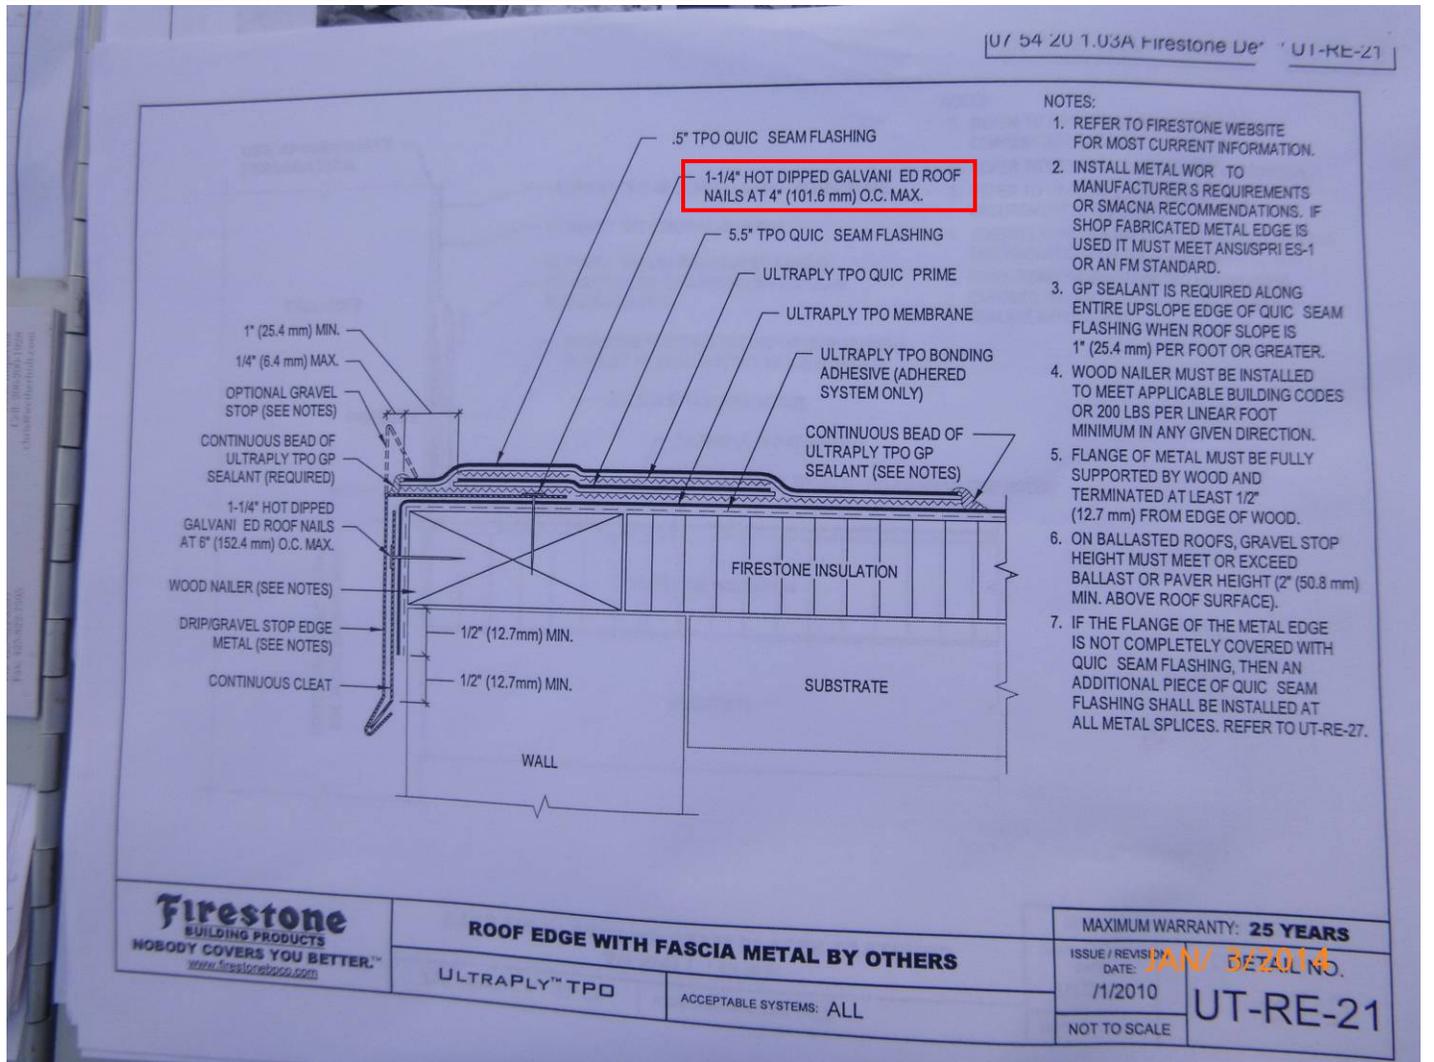
12.8 At the east side of the chiller room penthouse roof, the edge metal is fastened at approximately 14-inch intervals and should have been fastened every 4-inches on center per Firestone detail UT-RE-21 as shown below. Also, the detail calls for two layers of Quic Seam Flashing and it appears that only one was installed. Required fasteners and Quic Seam Flashing should be added to meet manufacturer’s requirements. The manufacturer should review and provide an approved repair detail.

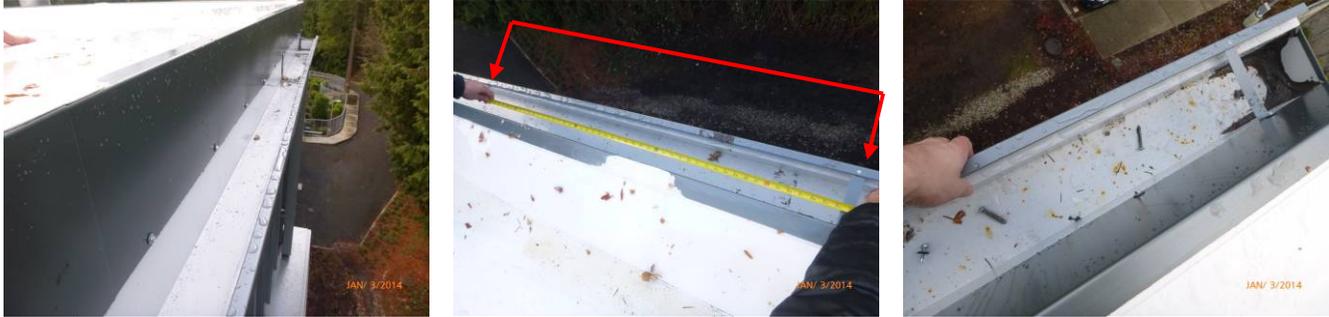
12.9 At the west side of the chiller room penthouse roof the gutter is attached to the sheet metal drip edge flashing at approximately 12-inch intervals with gasketed screws. Further the gutter clips are pop-riveted to the gutter (not clipped in via a hemmed sheet metal edge) occurring at approximately 5-foot intervals (SMACNA indicates straps should be installed at 36 inches on center max). The gutter doesn't appear to be adequately attached. Appropriate attachment should be reviewed by the construction and design team for resolution.

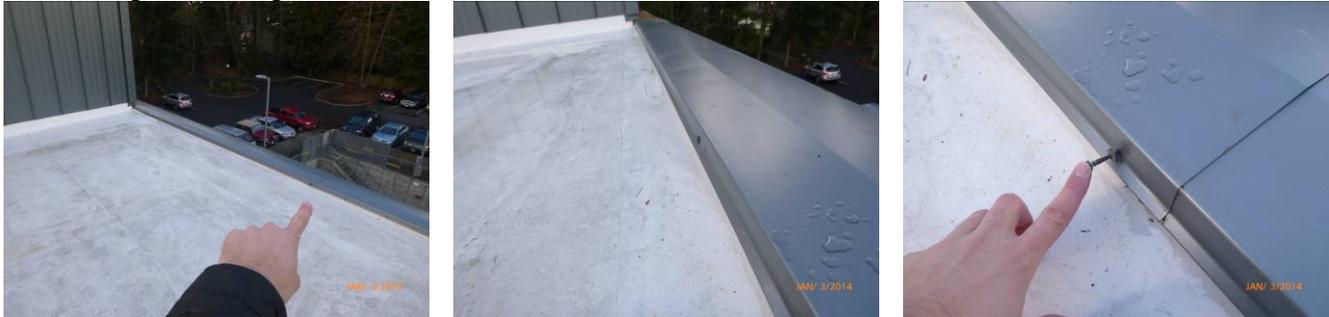
12.10 At the north side of the chiller room roof, a length of sheet metal coping is not secured. This was reportedly removed to facilitate the installation of the new roof and penthouse and should be re-secured to prevent displacement.

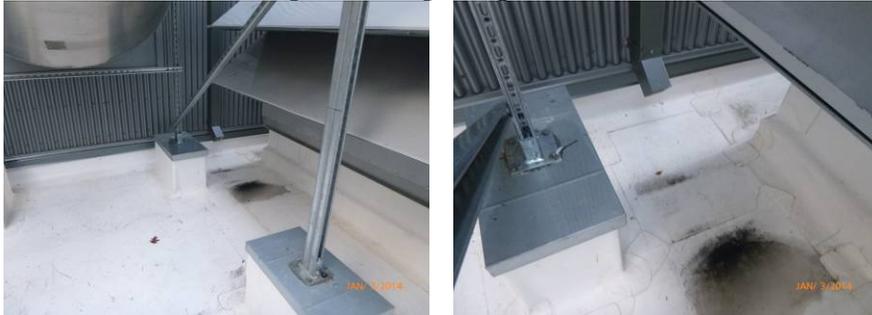
12.11 At the east side of the natatorium roof, it is recommended that walk pad membrane be installed below the new downspout as a splash pad.

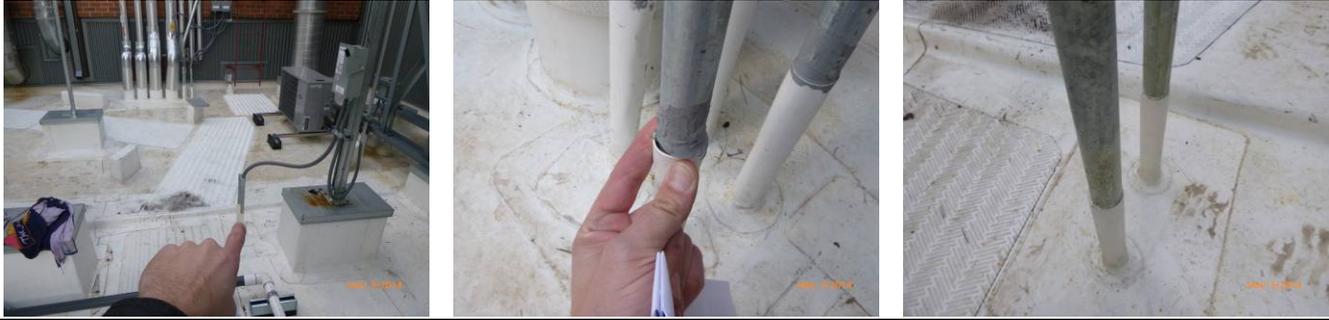
12.12 At the north side of the natatorium roof various through roof penetrations are lacking stainless steel draw-bands and sealant. Sealant and draw-band clamps should be installed.

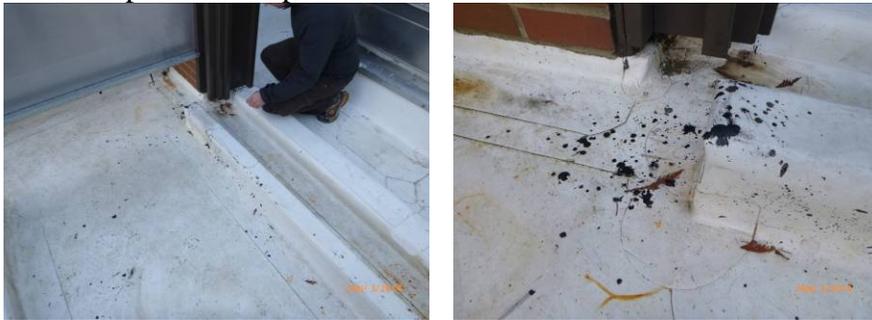
11.12 At the southwest corner of the new roof (asphalt pouring station) asphalt splatters onto the trim behind and onto the existing roof membrane to the south. It was observed that measures were taken to protect adjacent surfaces and per conversation with Rich Kerns (Foreman, QCR) this will be addressed.

Update FR#12 – 01/03/2014: Item is unresolved. It appears that the trim was painted or cleaned but asphalt is still present on the roof surface.

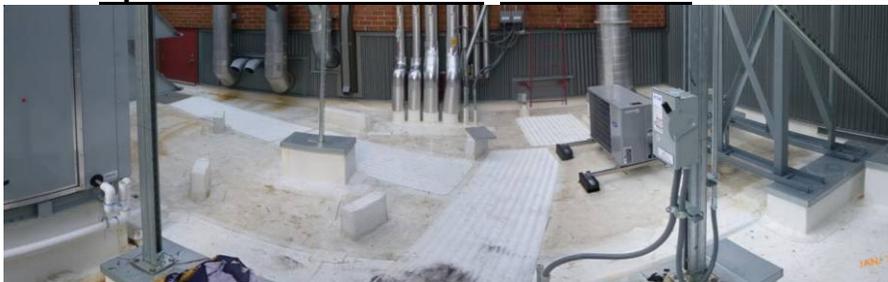
11.13 Other trade's work and various materials/tools are staged above the existing roof membrane to the north and south of the HVAC replacement. It is recommended that the existing roof membrane is reviewed and repaired as needed.

Update FR#12 – 01/03/2014: Item is closed. Site is demobilized and equipment is removed.

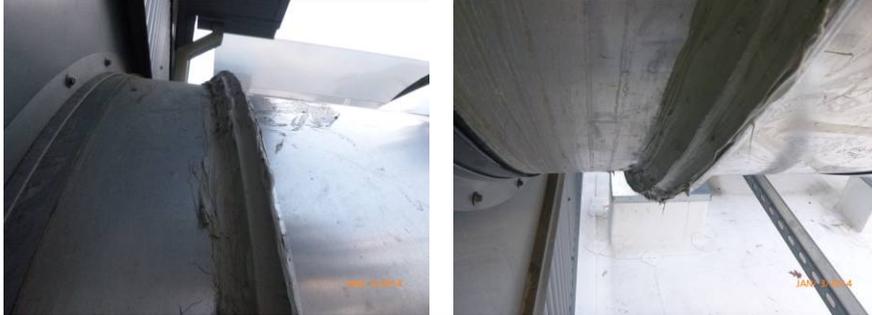
11.14 Near the duct to wall transition (east elevation) a seam is open in the duct. This condition appears to be at the circumference of the duct. It is recommended that all bolt penetrations, seams and joins in the duct work are continuously sealed and watertight.

Update FR#12 – 01/03/2014: Item is closed. It appears that sealant is installed around the joint.

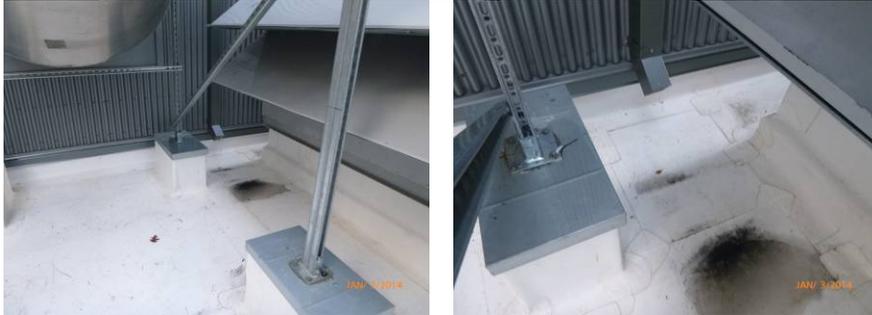
11.15 The night seal around the west HVAC unit is insufficient.

Update FR#12 – 01/03/2014: Item is closed. The new roof is installed at this area.

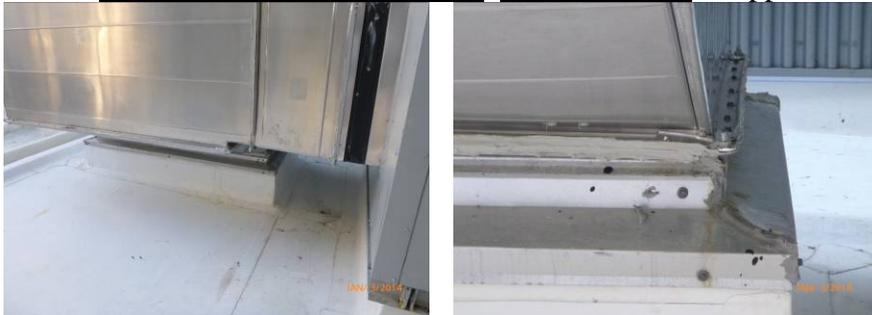
10.9 The HVAC unit at the southwest corner of the Natatorium Roof has voids in the existing sealant. Per conversation with the construction team, this is a know condition that actively leaks. Sealant appears to have been applied in profusion as a means of mitigating the problem. It is recommended that this situation be addressed to prevent water intrusion into the new roof areas that surround this unit.

Update FR#11 – 10/15/2013: Item is unresolved.

Update FR#12 – 01/03/2014: Item is closed. It appears that a new unit is now in place at this location.

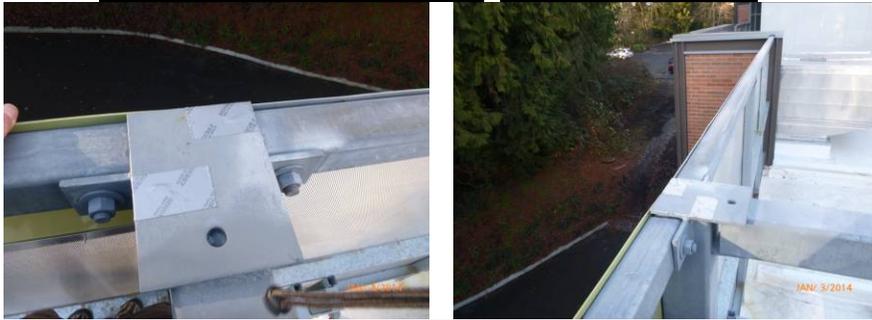
8.4 At the tops of screen wall supports (west elevation of the Natatorium Roof, typical of all large screen wall supports) through holes are observed at the top plates. Some holes appear to be infilled with metal. Recommend that all locations where water will enter are infilled or capped as needed to prevent water from funneling into the column and throughout the roof system below.

Update FR#10 – 10/14/2013: Item is unresolved. Per conversation with Keith Skore, these locations were temporarily sealed with duct tape in the interim.

Update FR#11 – 10/15/2013: Item is unresolved.

Update FR#12 – 01/03/2014: **Item is unresolved.**

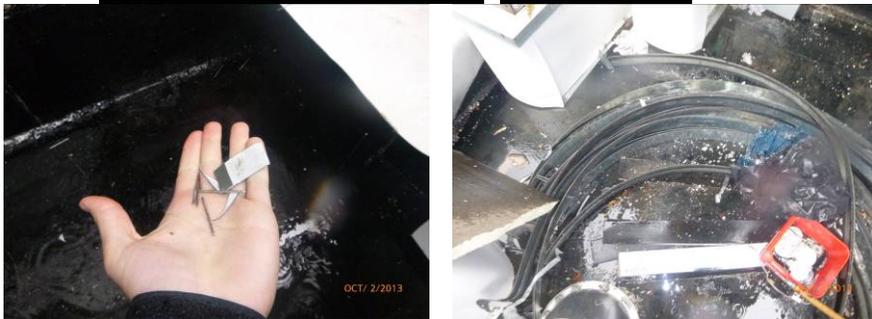
8.5 Recommend that any sheet metal sharps, fasteners and other debris are removed from the new vapor retarder layer to prevent damage.

Update FR#10 – 10/14/2013: Item is unresolved.

Update FR#11 – 10/15/2013: Item is unresolved.

Update FR#12 – 01/03/2014: **Item is closed.** Debris has been removed.

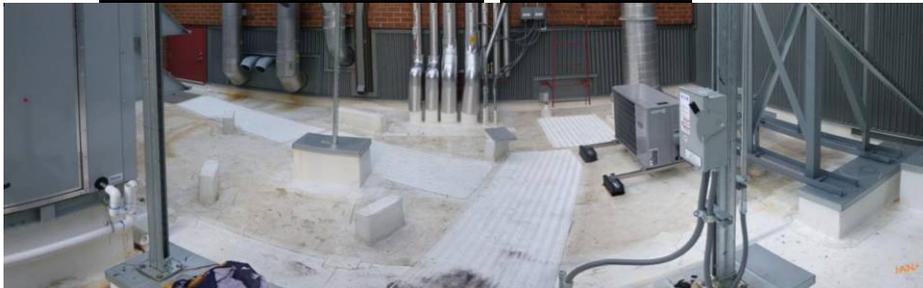
8.6 The night seal at the north end of the Natatorium Roof is insufficient in some locations allowing water into the existing roof assembly. The roof to the north was previously observed as wet along with the existing roof that was removed to the south.

Update FR#11 – 10/15/2013: Item is unresolved.

Update FR#12 – 01/03/2014: **Item is closed.** The new roof is installed at this transition.

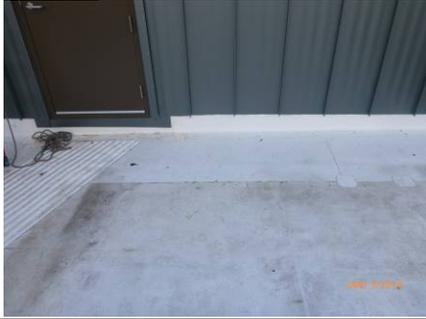
8.7 The absence of a night seal at the chiller room roof allowed water to migrate into the existing roof to the east. The roof to the east was previously observed as wet along with the existing roof that was removed to the west.

Update FR#10 – 10/14/2013: Item is unresolved.

Update FR#11 – 10/15/2013: Item is unresolved.

Update FR#12 – 01/03/2014: **Item is closed.** The new roof is installed at this transition.

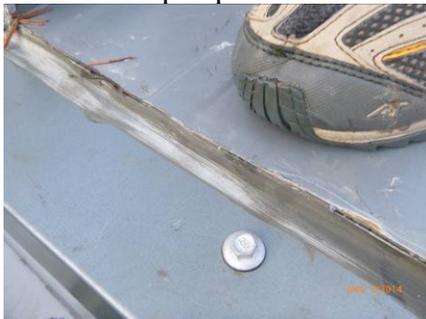
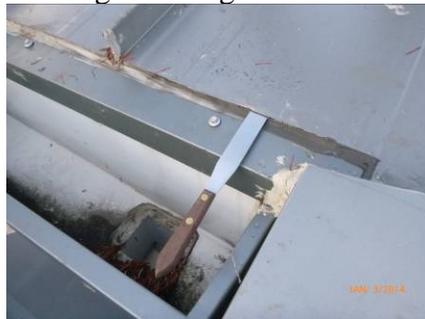
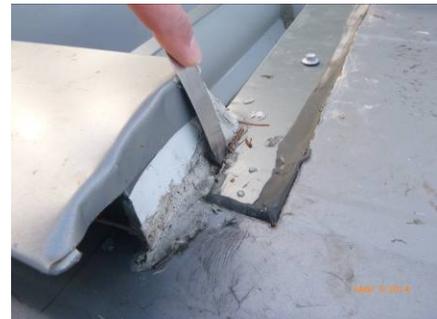
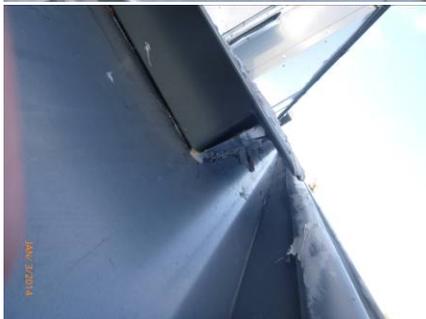
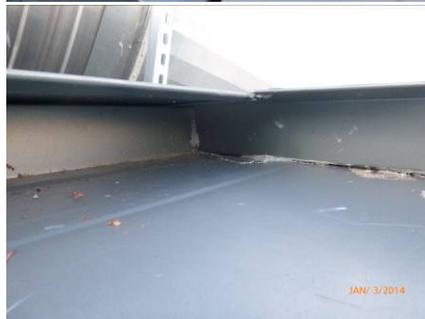
8.8 The sheet metal re-installation at the sawcut in the roof above is ongoing. This writer is unable to verify if the metal panel is notched into a vertical leg behind the flashing enclosure at the fascia. Sealant is observed bleeding out from underneath the roof panel. This area will be further reviewed in dry conditions.

Update FR#10 – 10/14/2013: Item is unresolved. Item is updated to reflect more generally observed conditions during this site visit.

Update FR#11 – 10/15/2013: Item is unresolved.

Update FR#12 – 01/03/2014: **Item is unresolved.** Water is observed below the upper sawcut (running east and west, the slope runs north and south) as the sheet metal work is reliant on sealant as a typical condition. It should be understood this detailing is dependent on exposed sealants and will be difficult to maintain weathertight. In order to properly detail this location, it appears that the affected roof panels would need to be replaced and a custom soldered sheet metal flashing installed to provide closure over the upslope end of the new rake edge flashing.

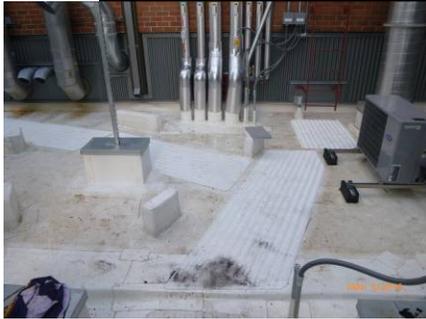
5.8 The vapor retarder layer at the Natatorium Roof is damaged in general. The construction team has been aware that construction sequencing would more than likely damage the vapor retarder layer. Per conversation with Rich Kerns (Foreman, QCR) the temporary roof/ vapor retarder layer is to be repaired with moppings of hot asphalt and plysheet as needed during construction.

Update FR#10 – 10/14/2013: Item is unresolved.

Update FR#11 – 10/15/2013: Item is unresolved.

Update FR#12 – 01/03/2014: Item is closed. New roofing is installed over the vapor retarder layer.

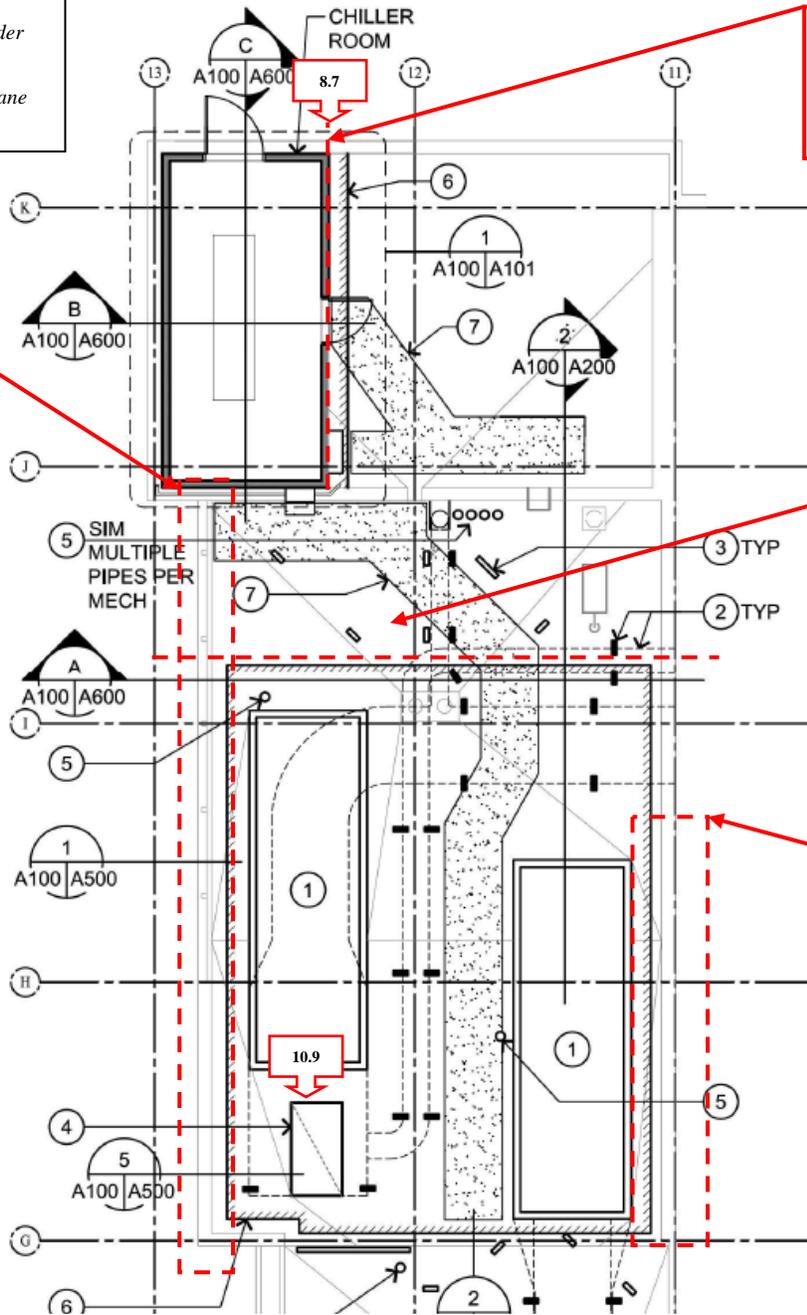
Roof Progress Plan / Locator Map:

Item 8.4: Infill holes in top plates at screen wall structure.

East of this line (approx.) the remainder of the Natatorium roof is suspected to be wet and damaged as an existing condition.

North of this line (approx.) the remainder of the Natatorium roof is suspected to be wet and damaged as an existing condition.

Problems Item 8.8 – sheet metal re-installation at the upper steep slope roof to accommodate new HVAC.
