**FIELD REPORT – LYNNWOOD RECREATION CENTER – FIELD REPORT**

REPORT #03

Date: September 13<sup>th</sup>, 2013

**Location(s) of Work:** Natatorium roof.

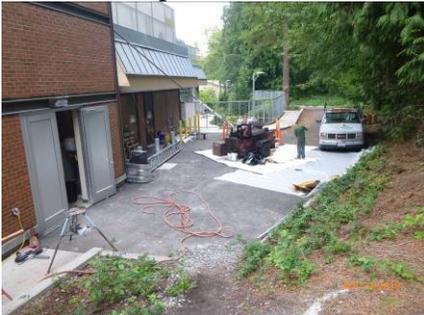
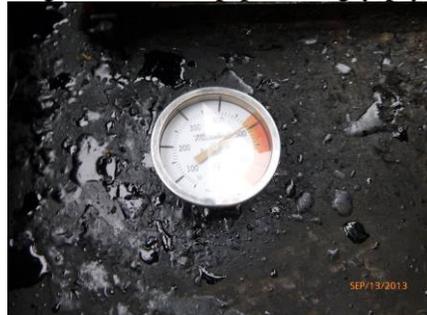
3.1 Queen City Roofing is installing the vapor retarder layer and temporary roof at the Natatorium Roof. Southwest of the Natatorium Roof an asphalt kettle is being fed Type IV asphalt and is observed as having a temperature reading of approximately 550°F. The hot pipe is wrapped and a piece of plywood is in place between the building and the hot pipe. Singly ply membrane is in place under the kettle.

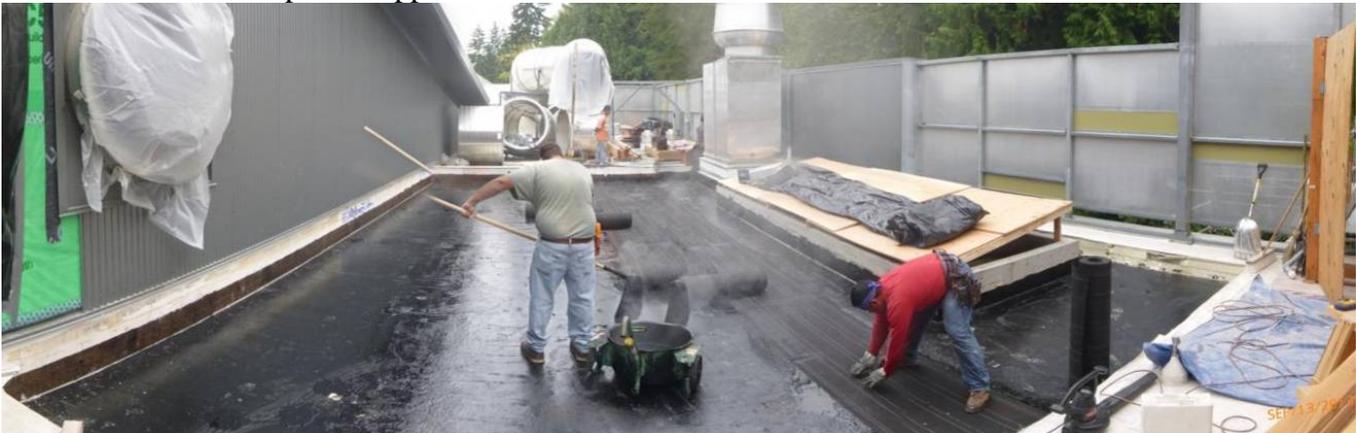
3.1a Queen City Roofing is installing the vapor retarder layer and temporary roof at the Natatorium Roof. The temporary roof consists of an asphalt glaze-coat over two plies of Type IV asphaltic ply sheets adhered to the primer-applied concrete deck.

*Overview of the Natatorium Roof taken facing south.*

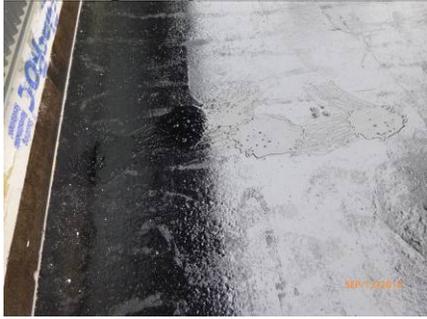
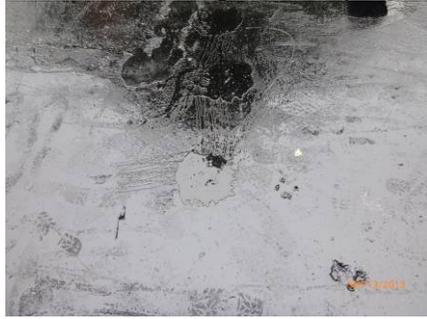
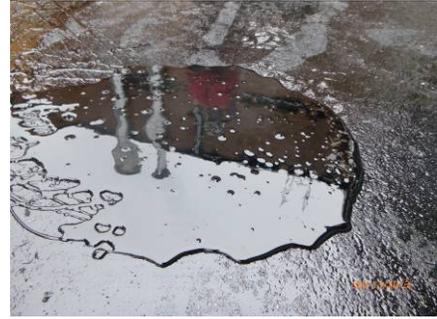
3.2 The concrete deck has been coated with asphalt primer, which is observed as turning up vertical surfaces. Per conversation with Rich (Foreman, QCR) hot asphalt is utilized to infill small areas of spalling found at the surface of the concrete prior to laying the ply sheets.

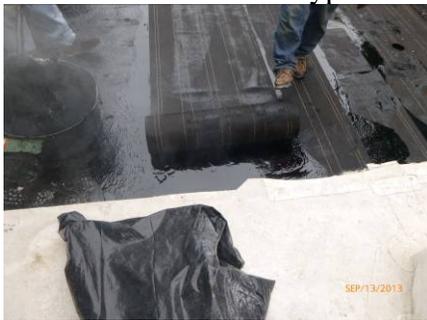
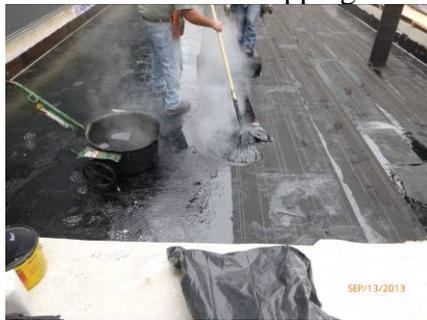
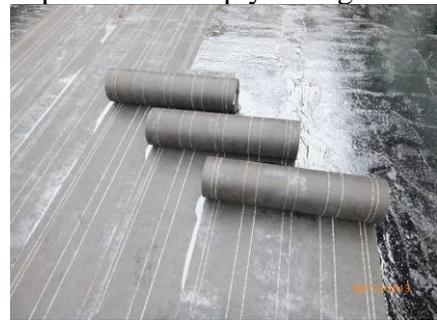
3.2a John Manville Type IV Plysheet is rolled into moppings of hot asphalt in a two ply configuration.

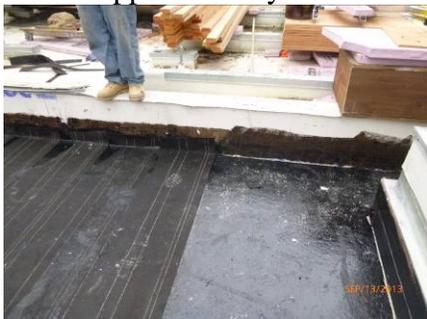
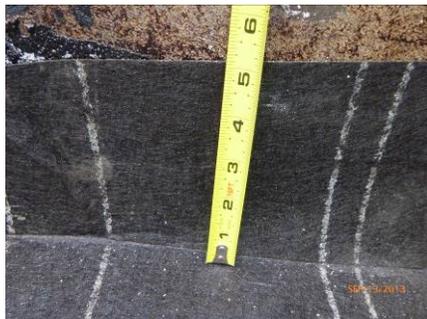
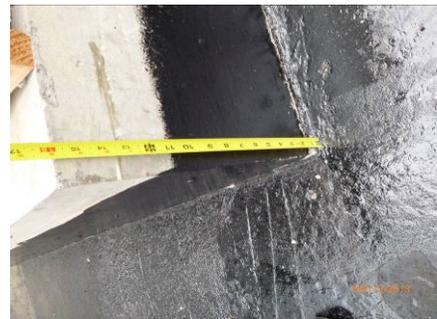
3.2b At the curb on the north side of the roof the field plies turn up the curb approximately 5-inches and approximately 10-inches at HVAC unit curbs.

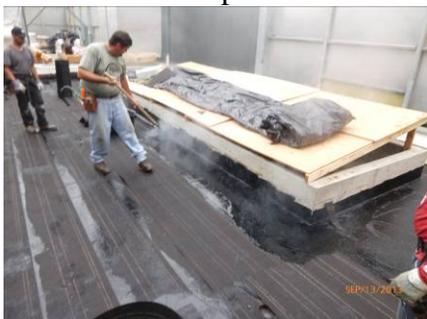
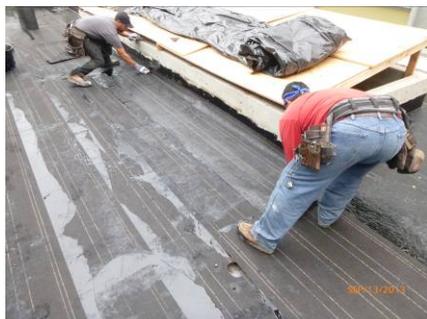
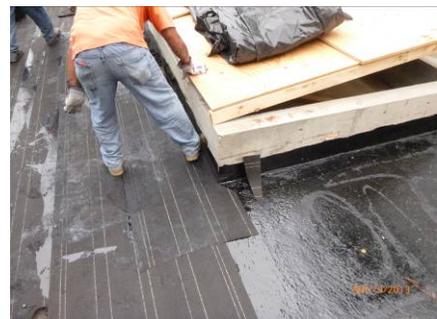
3.2c Baseflashing plies are set in a mopping of hot asphalt to achieve two layers of plysheet at the HVAC unit curb perimeter.

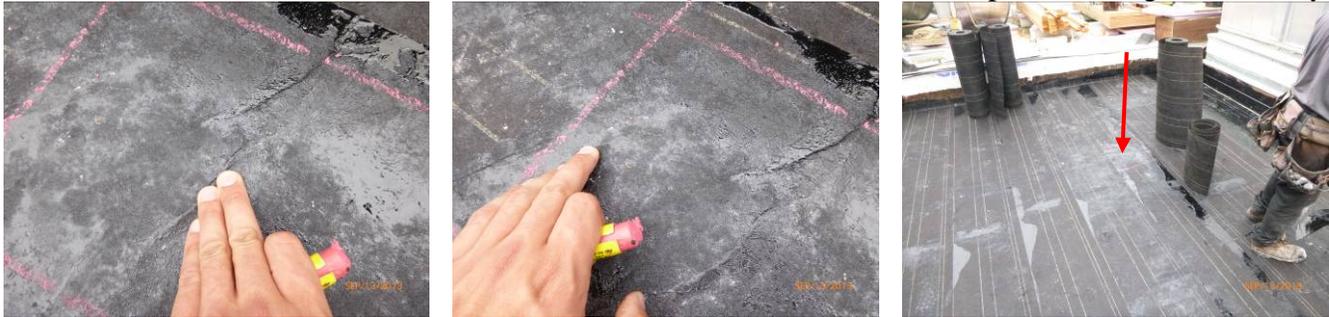
3.3 At the southwest corner of the Natatorium Roof an area of deflection is observed and marked in red keel. Per conversation with Rich (Foreman, QCR) this area will be repaired during the workday.

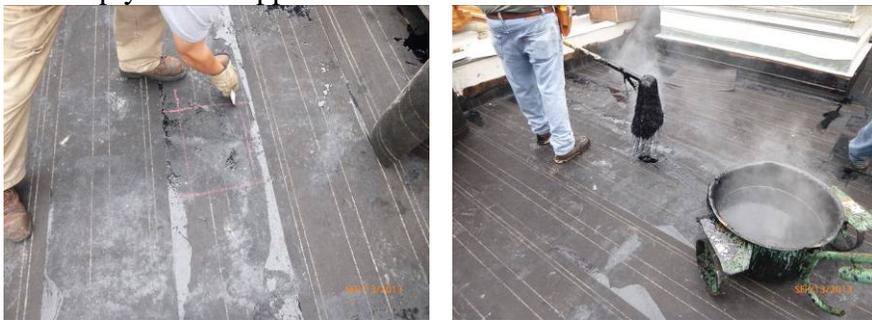
3.3a The area of deflection is cut and sliced to lay flat. The area is infilled with hot asphalt and a patch of plysheet is applied over the affected area.

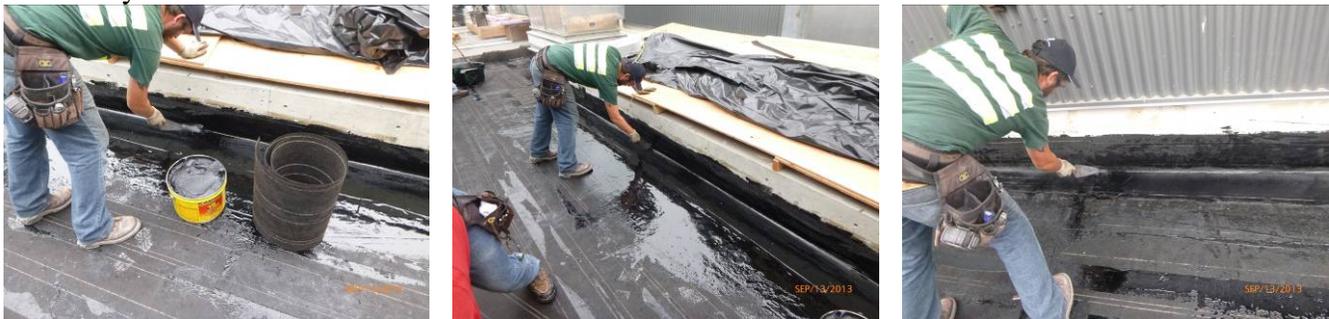
3.4 Karnak roof cement is applied at voids and the top terminating edge of the temporary roof/vapor retarder layer.

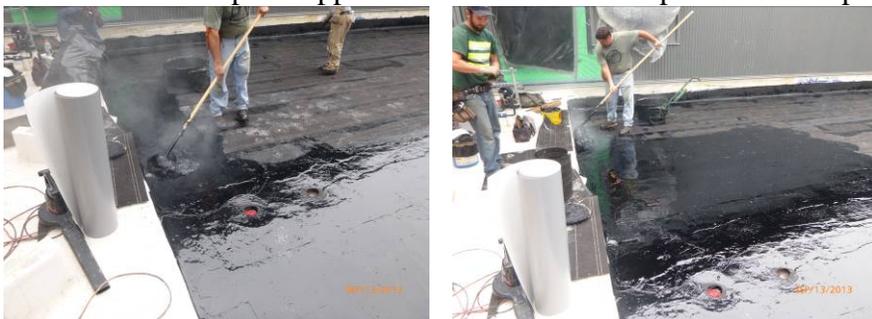
3.5 Hot asphalt is mop applied over the two-ply as part of the temporary roof/vapor retarder installation. The hot asphalt appears to be continuous to provide a complete glaze-coat.

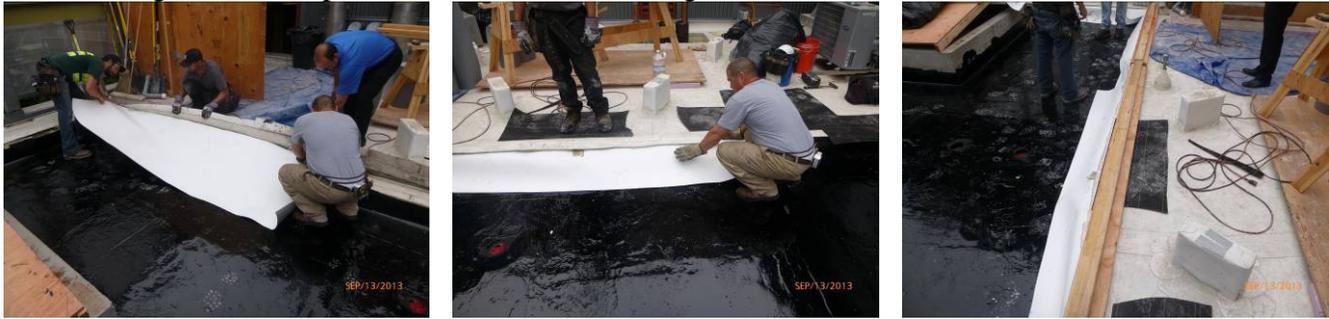
3.6 Single-ply membrane is placed under the existing membrane and laps over the new vapor retarder layer. Weights are then placed over as a means of night seal.

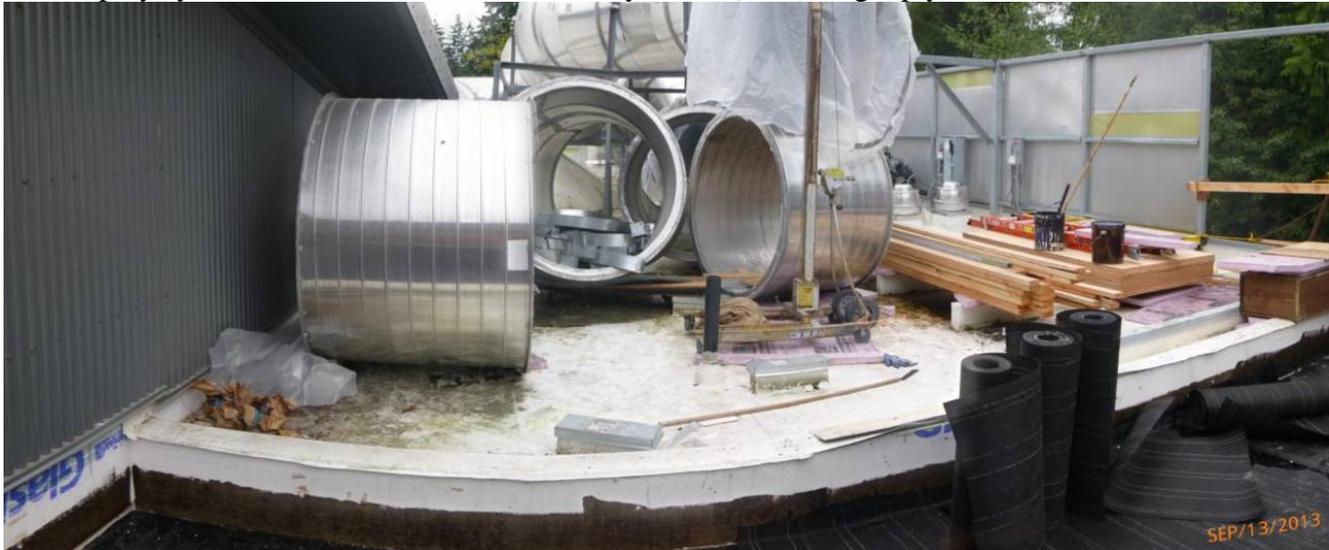
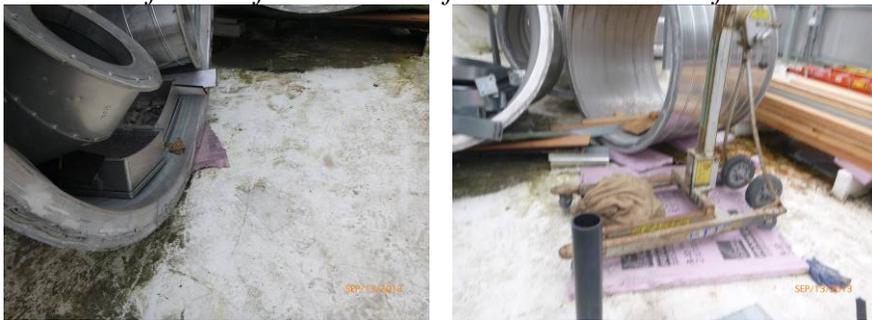
*Overview of the roof to the south of the Natatorium Roof.*

3.7 Recommend that the roof to the south of the Natatorium Roof (where new ductwork is staged) is monitored. At this time, it appears that dunnage is placed under new ducts. Be aware that Extruded polystyrene has been known to chemically affect (burn) single ply membrane.

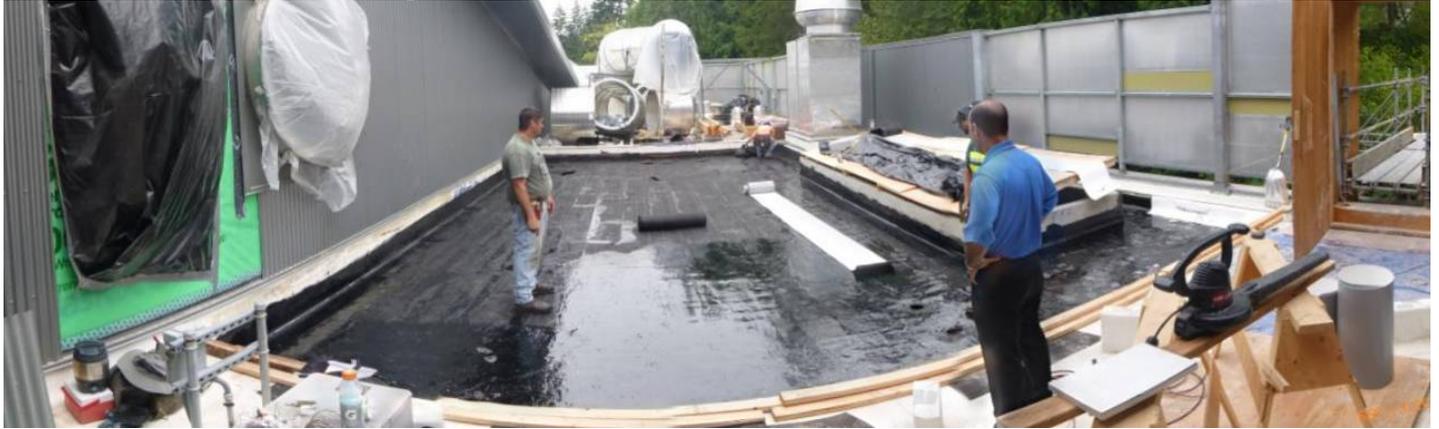
3.8 The overview below is taken at this writer’s departure from the site inspection and depicts progress of the installation of the vapor retarder layer.

*Overview of the Natatorium Roof taken facing south.*

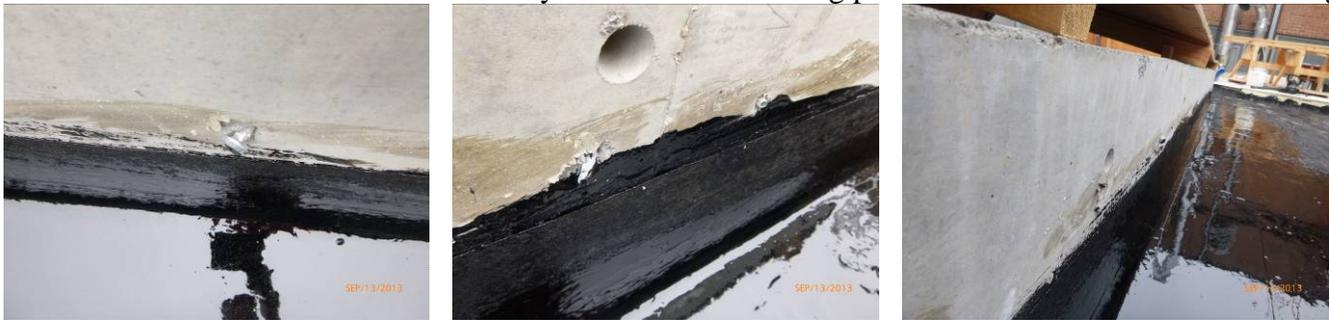
3.9 At the existing HVAC curb on the west side of the roof there are fasteners protruding from the concrete. It is recommended that the masonry fasteners be removed prior to the installation of new roofing.

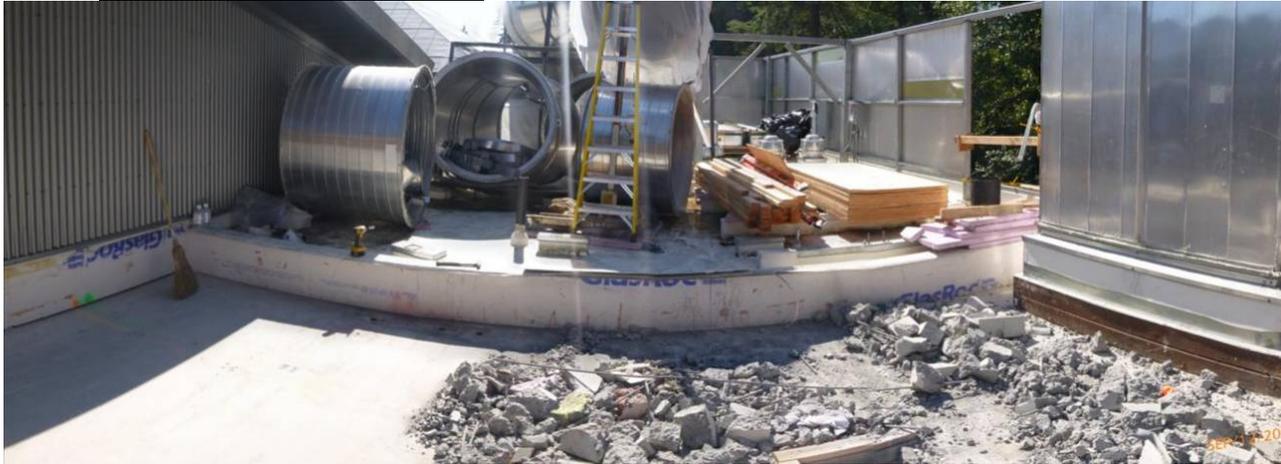
- 2.4 Per Wetherholt recommendation, the existence of a vapor retarder layer should be verified at the adjacent roof located south of the Natatorium Roof. If the adjacent roof was installed without a vapor barrier there is a possibility that water vapor may transfer over into the new roof assembly and damage the components. Per conversation with Anton Woody (GC, Holmberg) this is out of the scope of his contract but the construction team is aware of this issue.

**Update FR#03 – 09/13/2013: Item is unresolved**

*Overview of the separator curb at the south end of the Natatorium Roof taken facing south.*

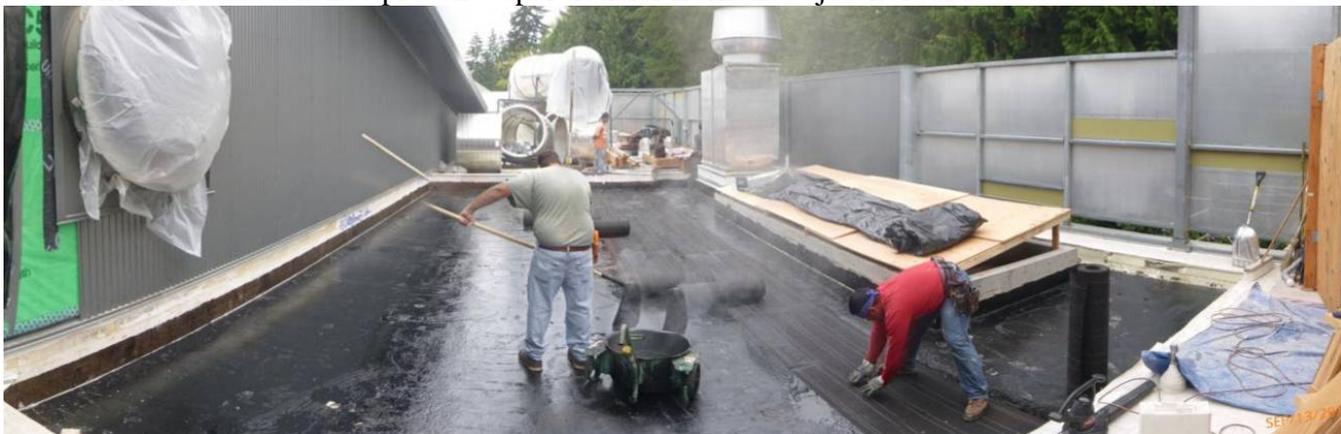
- 1.11 Recommended the installation of a night seal. Per conversation with Rich Kerns, (Foreman, QCR) the roof should be allowed to dry prior to the installation of a new vapor retarder layer.

**Update FR#03 – 09/13/2013: Item is closed.** The temporary roof is installed during this site visit and measures are taken to prevent vapor transfer from the adjacent roof.

*Overview of the Natatorium Roof taken facing south.*
