FIELD REPORT – LYNNWOOD RECREATION CENTER – FIELD REPORT

REPORT #04

Date: September 19th, 2013

Location(s) of Work: Natatorium roof.

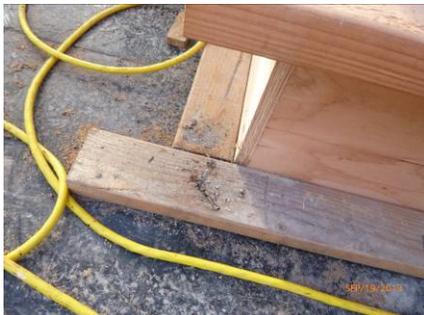
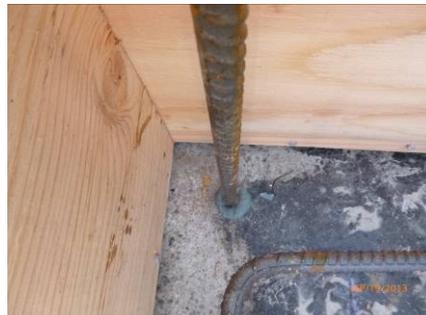
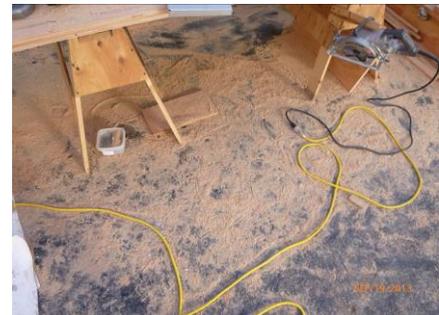
4.1a At the curbs located on the Natatorium Roof, concrete forms are fastened through the new temporary roof/ vapor retarder layer. Rebar is installed through the temporary roof/ vapor retarder layer. Per conversation with Rich (Foreman, QCR) the temporary roof will be turned up the curb after the concrete is cured to provide a continuous temporary roof/ vapor retarder layer. Recommend that temporary protection is installed below sawhorses and that area is reviewed for damage. In the interim between concrete cure and the temporary roof installation all holes in the temp roof as a result of concrete forms should be sealed.

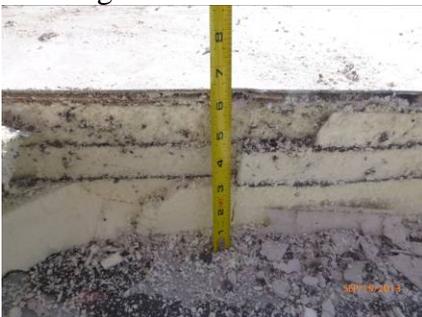
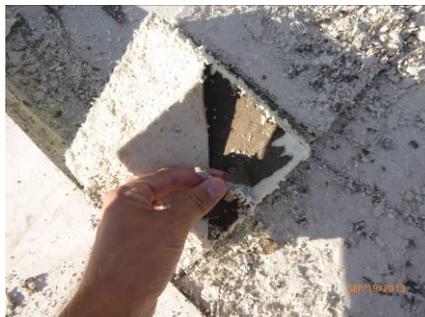
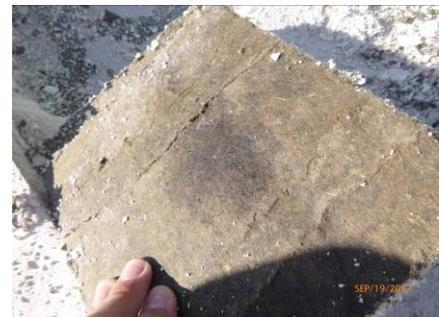
4.2a The existing assembly is observed to be a single ply membrane over coverboard and polyiso insulation set in insulation adhesive over the concrete roof deck. No vapor retarder layer or temporary roof is observed. Roofing layers are delaminated, wet and are observed as having what appears to be organic growth.

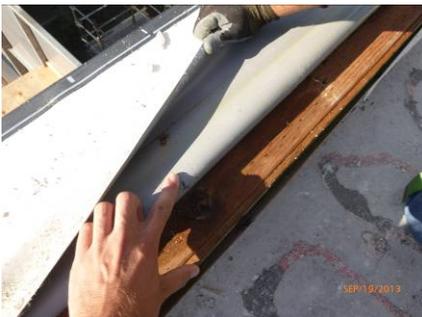
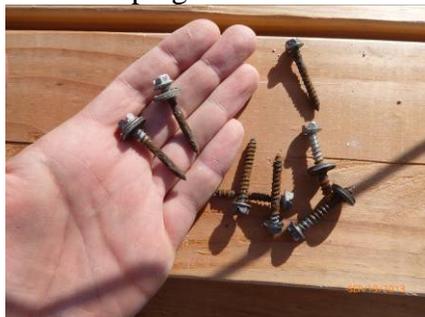
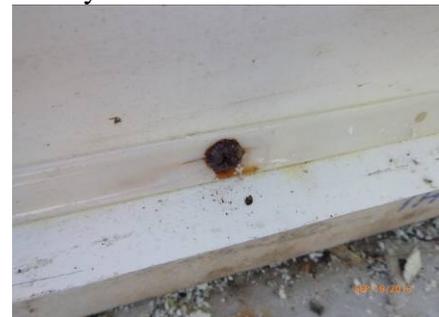
4.2b The existing coping is removed. No adhesive is observed on the baseflashing or substrate. Fasteners that secure the termination bar and coping are observed to be severely deteriorated and covered in rust.

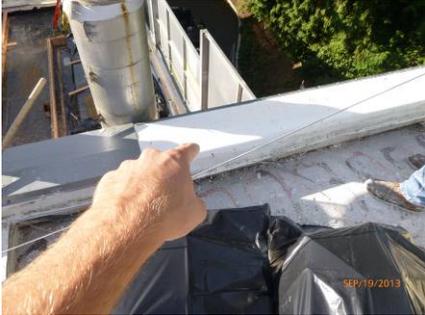
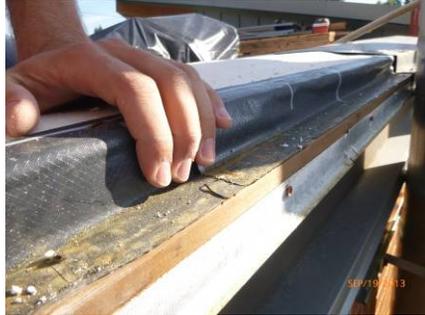
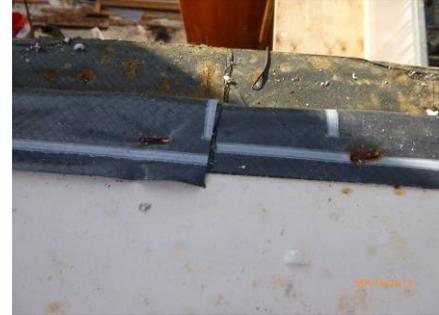
4.2c The coping is removed. Self-adhering membrane is stripping in the exterior edge of the wall however does not turn down past the wood nailer onto the sheet metal cleat. The self-adhering membrane is stapled at the laps, and the staples are corroded.

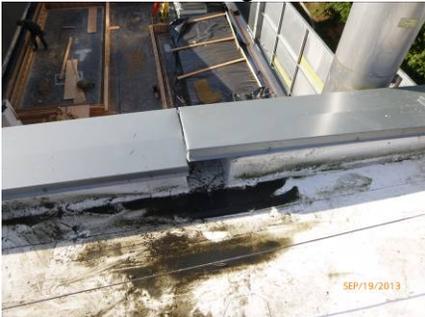
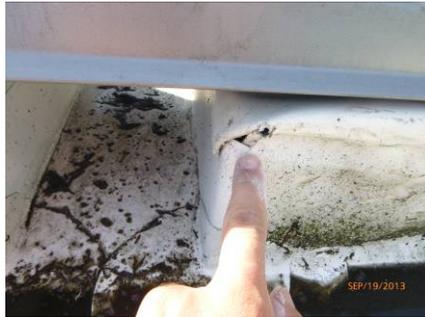
4.2d At the scupper at the south side of the chiller room roof, voids are observed in the membrane baseflashing.

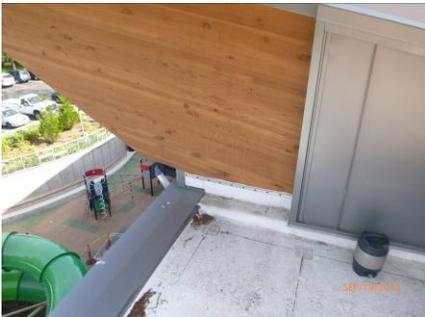
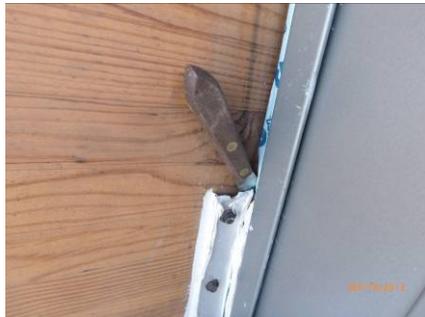
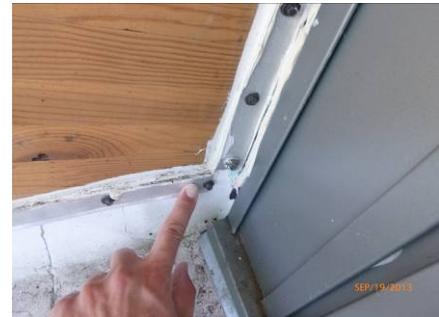
4.3e At the roof to wall transition (northwest corner of the chiller room roof) voids are observed in the baseflashing membrane. The sealant at the top of the termination bar appears to be has adhesively failed.

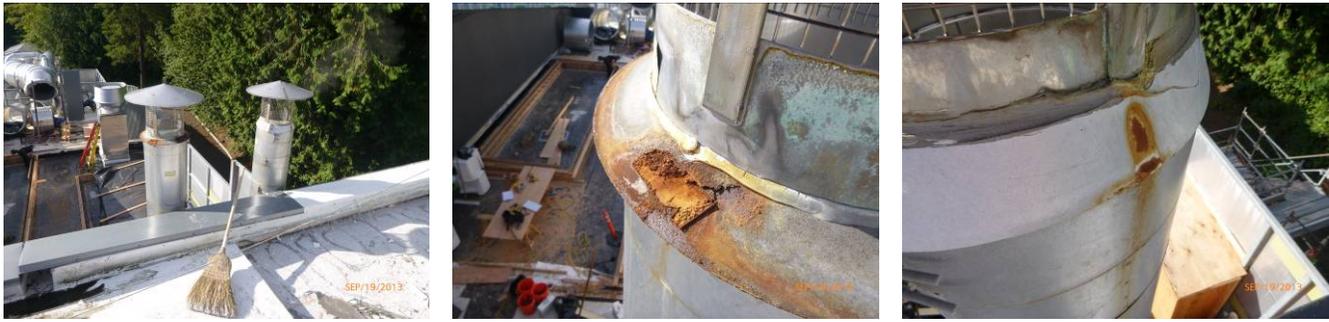
4.3f At the south side of the chiller room roof. Stainless vents and rain collars are observed as corroded.

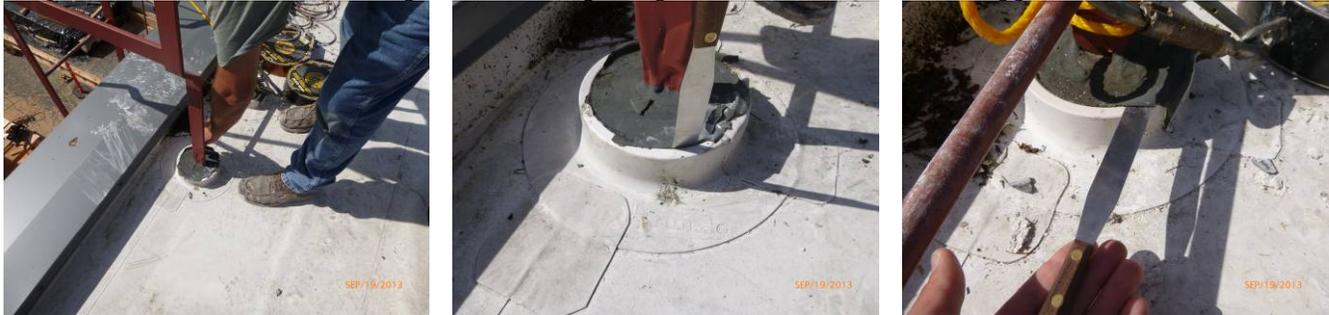
4.3g At the ladder, voids are present in the pitch pocket detail around the supports.

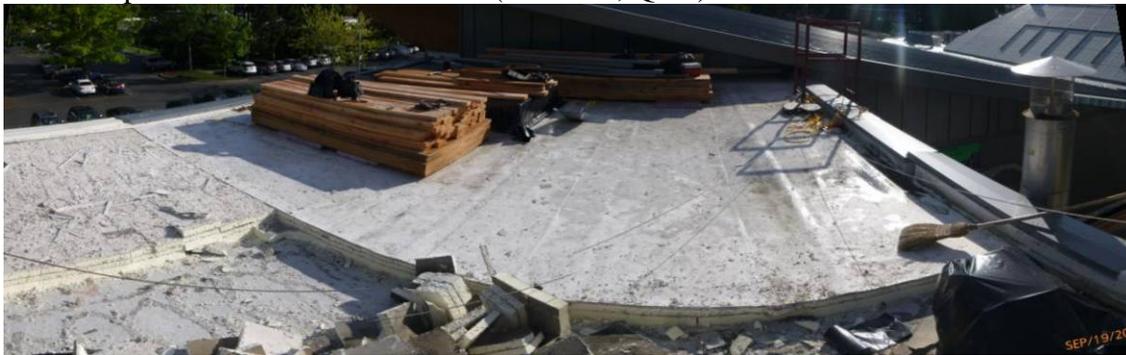
4.3h New roofing is to be installed adjacent the existing roof to remain. Recommend that the temporary roof/vapor retarder layer encapsulate wet and damaged insulation of the roof to remain. Item within this report are discussed with Rich (Foreman, QCR) and are noted as observations.

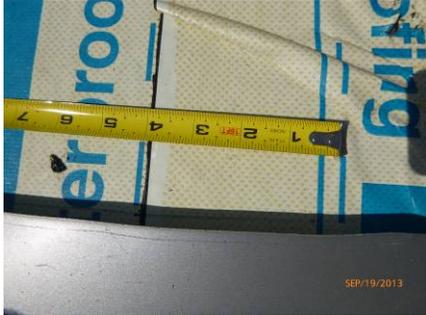
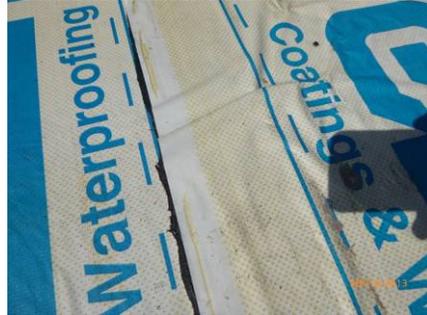
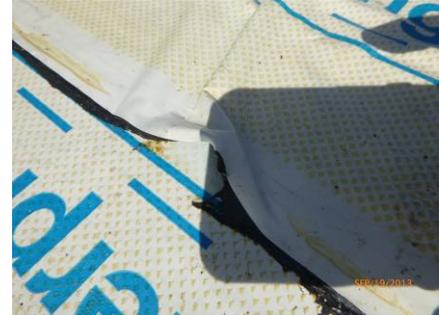
4.4a Carlisle WIP 300HT self adhered vapor retarder layer is observed installed with 4-inch laps (approximate) running perpendicular to the slope of the roof. Wrinkles and unadhered areas are observed where the metal roof panels are removed.

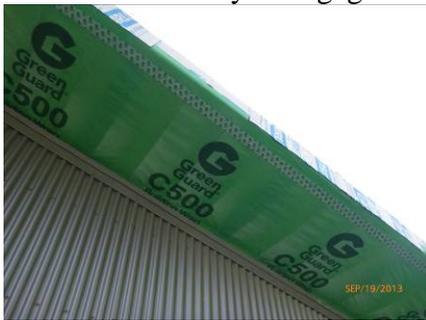
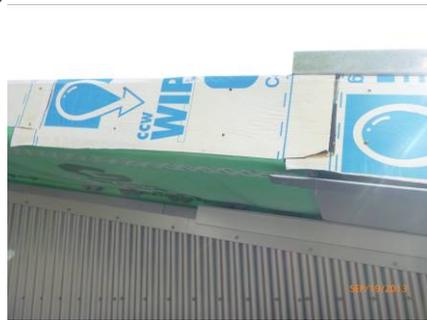
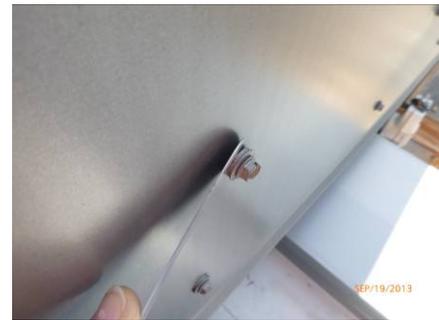
4.4b Green Guard C500 is installed at the soffits and turn onto the roof fascia. Self-adhered roof membrane above turns over the C500 assembly at the fascia. Many gasketed fasteners at the fascia metal are not seated fully to engage the gasket.

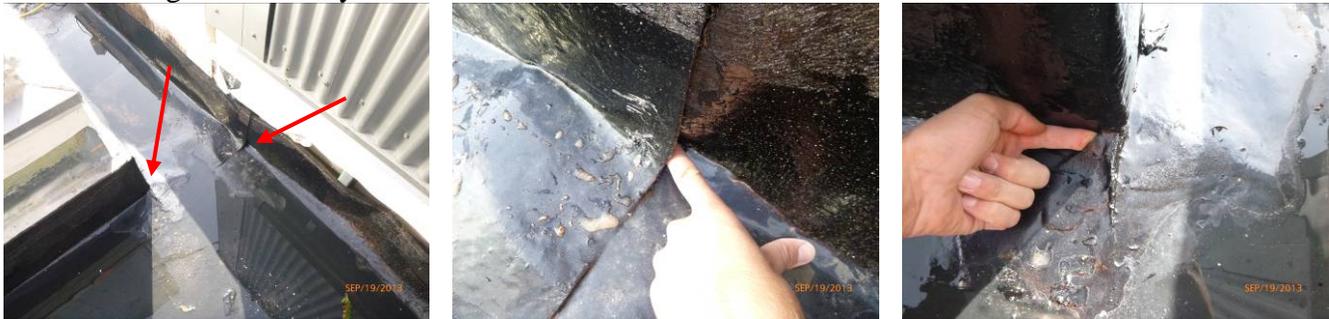
- 4.6 At the southwest corner of the Natatorium Roof, voids are observed in the temporary roof/ vapor retarder layer. Per conversation with Rich Kerns (Foreman, QCR) these locations are to be repaired during this workday.

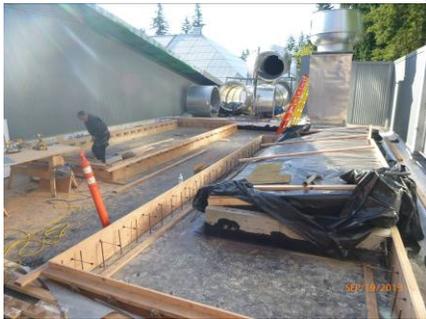
- 3.9 At the existing HVAC curb on the west side of the roof there are fasteners protruding from the concrete. It is recommend the masonry fasteners be removed prior to the installation of new roofing.
Update FR#04 – 09/19/2013: Item is closed. A new curb is to be installed around the existing curb that remains. New roofing is to be installed onto the new curb.

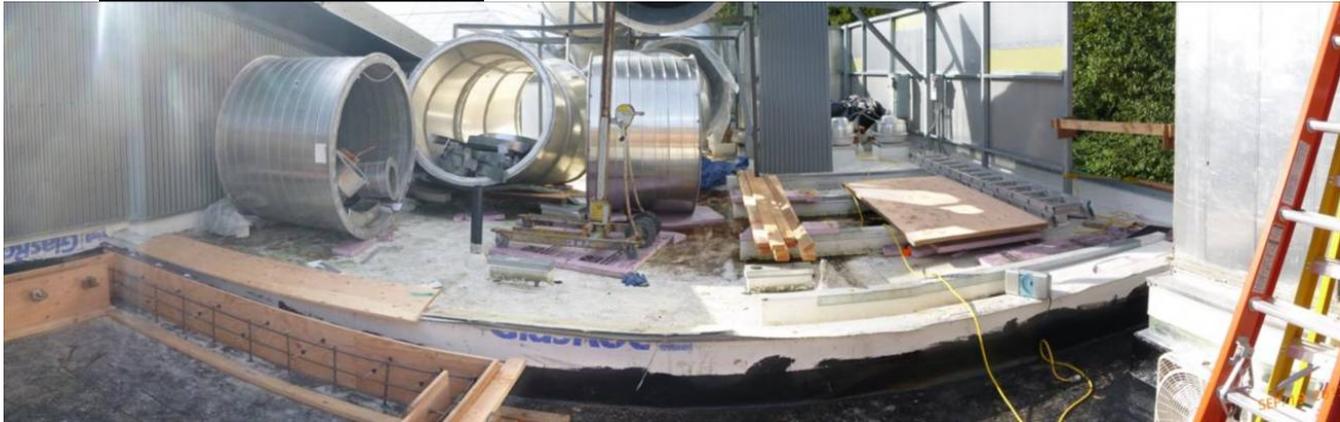
Overview of the separator curb at the south end of the Natatorium Roof taken facing south.

2.4 Per Wetherholt recommendation, the existence of a vapor retarder layer should be verified at the adjacent roof located south of the Natatorium Roof. If the adjacent roof was installed without a vapor barrier there is a possibility that water vapor may transfer over into the new roof assembly and damage the components. Per conversation with Anton Woody (GC, Holmberg) this is out of the scope of his contract but the construction team is aware of this issue.

Update FR#03 – 09/13/2013: Item is unresolved

Update FR#04 – 09/19/2013: Item is unresolved

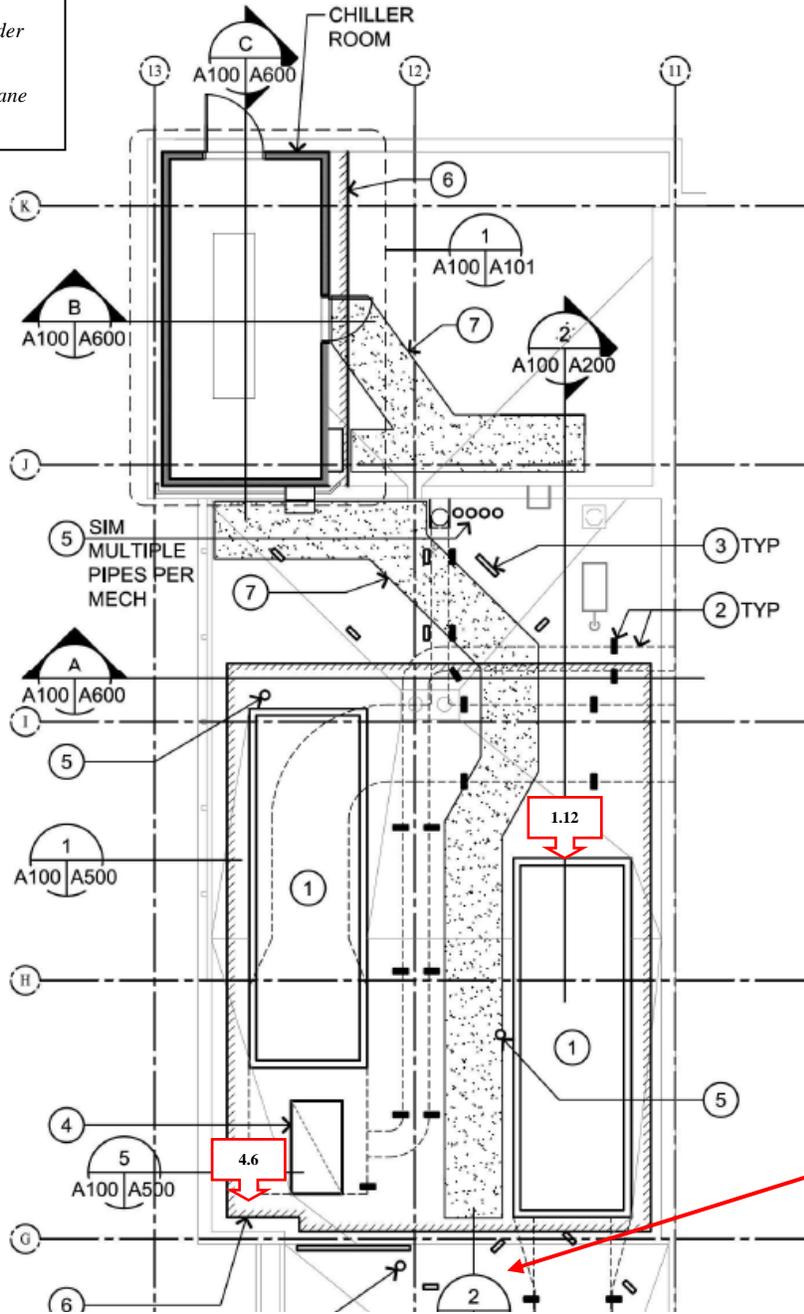
CASC Roof Progress Plan / Locator Map:

Recommend verifying the presence of a vapor retarder layer over the deck south of Natatorium Roof.
