FIELD REPORT – LYNNWOOD RECREATION CENTER – FIELD REPORT

REPORT #05

Date: September 25th, 2013

Location(s) of Work: Natatorium roof.

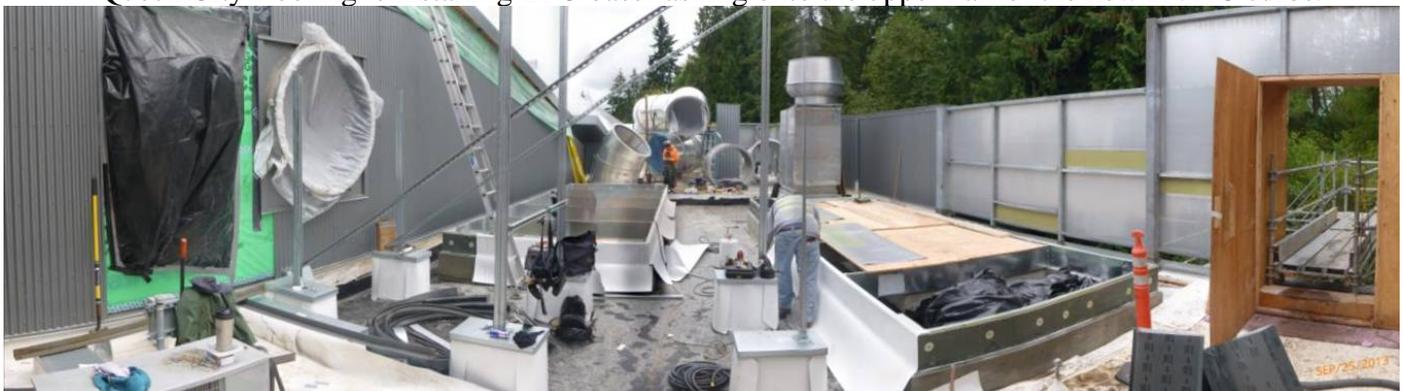
- 5.1 Delta Construction is installing unistrut supports for the new HVAC ductwork at the Natatorium Roof. Queen City Roofing is installing TPO baseflashing onto the upper half of the new HVAC curbs.

Overview of the Natatorium Roof taken facing southeast.

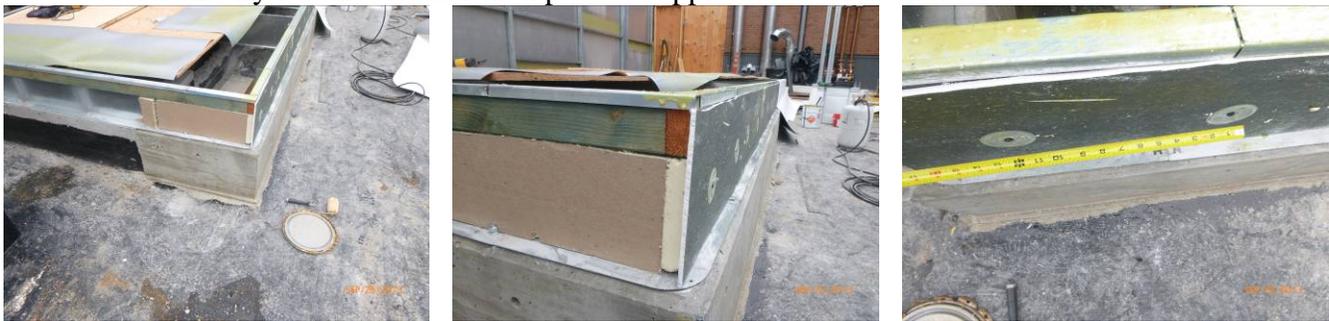
- 5.2 The concrete curbs have been poured during a previous site visit. The existing curb to the west has been extended (extended to the east) and the curb at the east side of the Natatorium Roof is new. Flat stock insulation is inserted into the cavity of the metal HVAC curb and ¼-inch DensDeck coverboard is mechanically fastened with 3-inch plates at approximate 12-inch intervals.

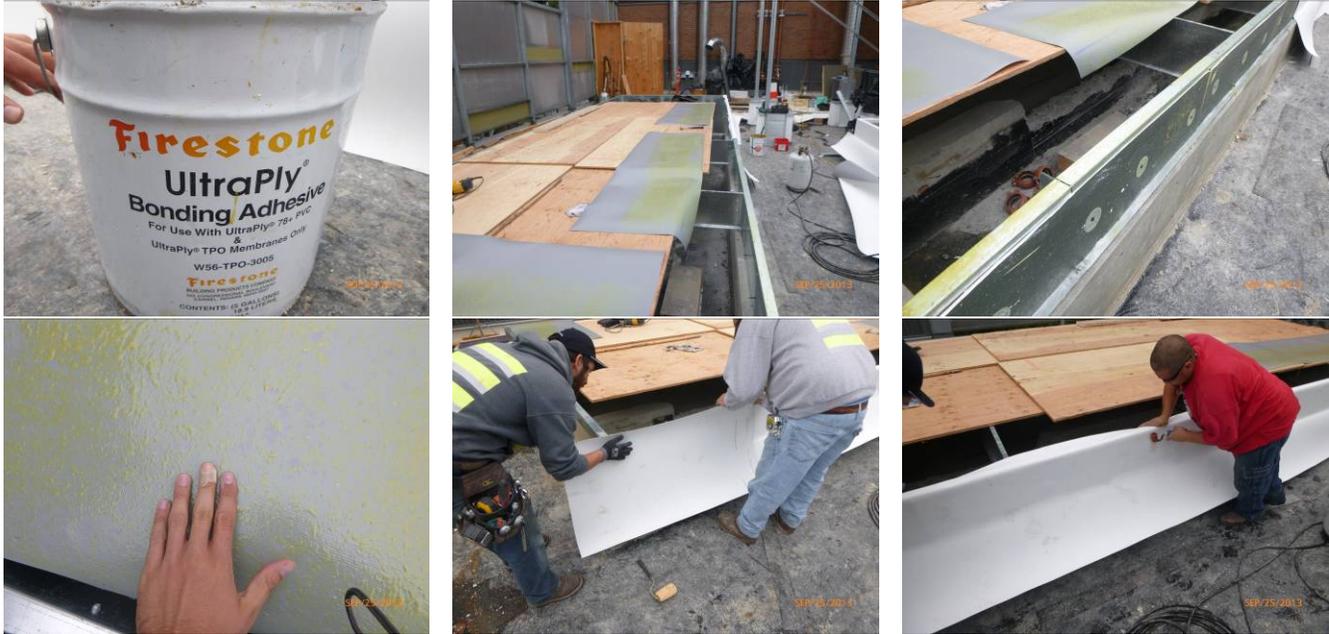
5.2a Firestone UltraPly Bonding Adhesive is roller applied onto the coverboard, top of the metal supports and onto the backside of the Firestone TPO membrane. The adhesive is allowed to flash off and then the membrane is set into place. Rollers are utilized over the membrane to promote adhesion.

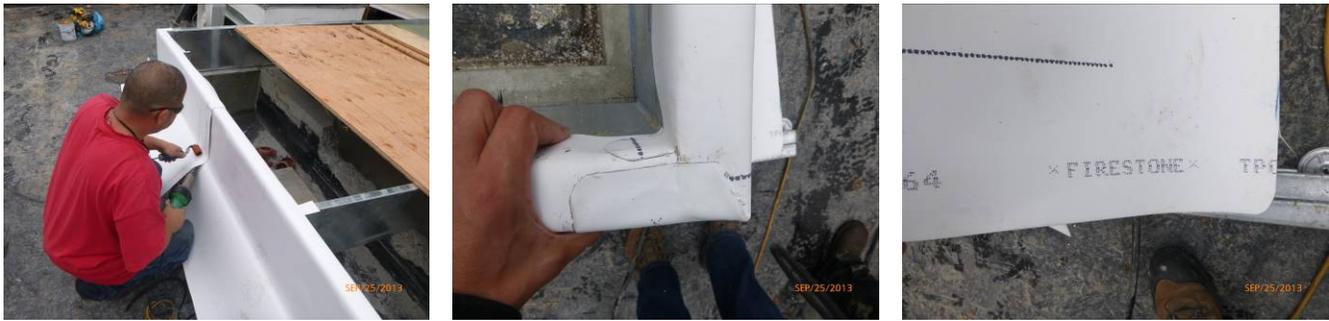
5.2b The seams in the upper half of the baseflashing membrane are welded utilizing a hand-held hot air welder and silicone roller to promote adhesion. Corners are welded on the inside with the membrane turning approximately 2-inches down into the interior of the curb. No labels are observed for the Firestone TPO membrane on site at this time.

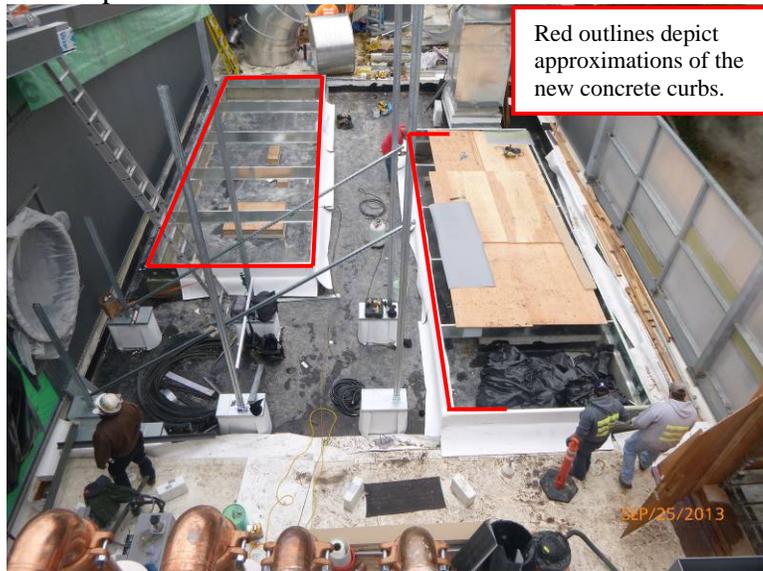
5.2c Per conversation with Rich Kerns (Foreman, QCR) the concrete that was recently poured is still green (or curing of moisture) and that the vapor retarder layer is to be installed tomorrow (9/26/2013) to continue the temporary roof up the new curbs. Also per conversation a 20 ton crane is scheduled for Friday of this week which means that the baseflashing is to be installed as soon as possible. Recommended that the new concrete is allowed to cure prior to installing asphaltic roofing. Item is provided as an observation.

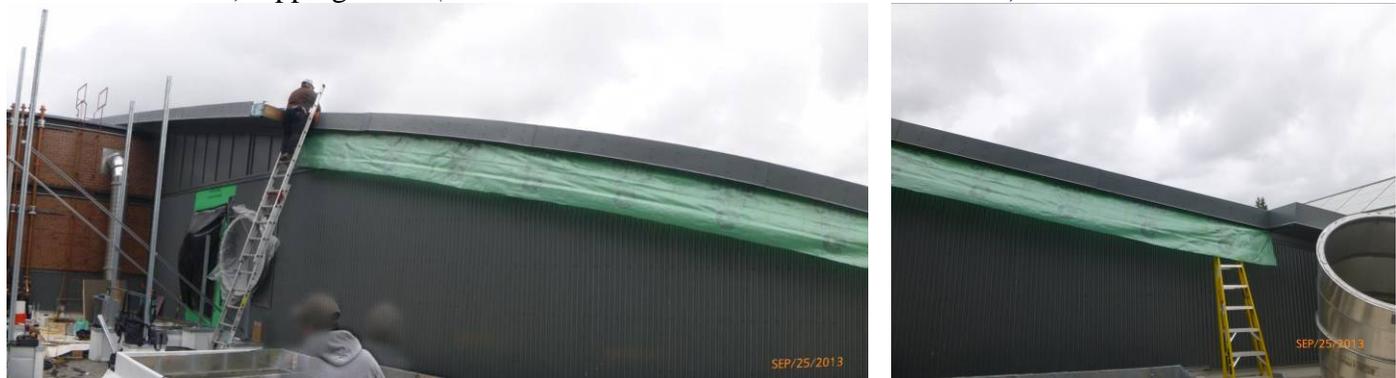
5.3 The upper steep slope roof above the Natatorium Roof is cut out to accommodate new HVAC units that are too tall for the area. Recommended that Green Guard C500 weather resistant barrier (WRB) at the soffit is continuous and wrapped up the fascia sequenced with the vapor retarder layer (beneath the metal roof) lapping over. (See *New Problems/Solutions Item 5.7 below*)

Overview of the sawcut at the upper sloped roof taken facing east.

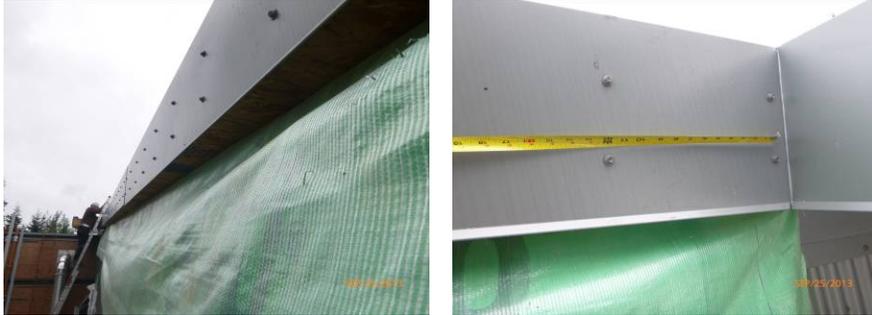
5.3a The existing metal fascia is retained and re-installed with two rows of gasketed fasteners at approximate 12-inch intervals.

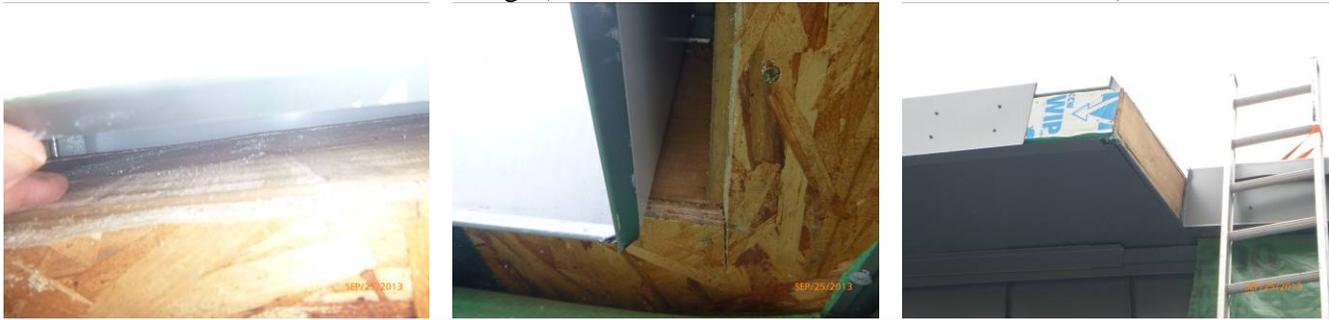
5.3b The WRB and vapor retarder layer are not continuous and the sheet metal is installed over bare wood at the fascia. Recommend that the sheet metal is removed the WRB continued onto the fascia with new self-adhered roof membrane lapping over to complete the air barrier. Carlisle WHT 300 is previously installed below the metal roofing. *(See New Problems/Solutions Item 5.7 below)*

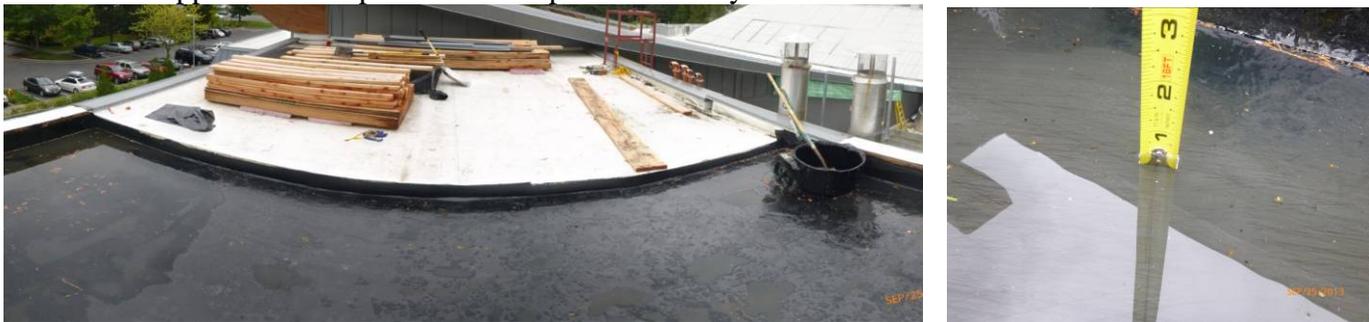
5.4 At the upper roof above the chiller room the temporary vapor retarder layer is installed with a glazing of hot asphalt over. Per conversation with Rich (Foreman, QCR) the temporary roof consists of John Manville Type 1V two-ply set in moppings of Type IV hot asphalt. Standing water is observed at 1/2-inch approximate depth over the vapor retarder layer.

Overview of the roof above the chiller room taken facing east.

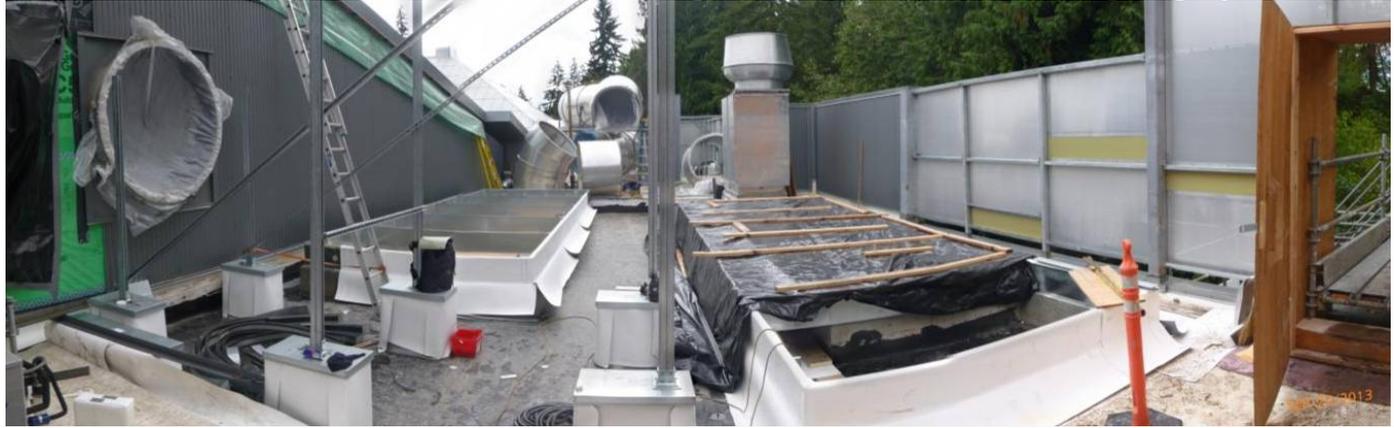
5.5 The overview photo is taken at this writer's departure from the site visit and depicts progress.

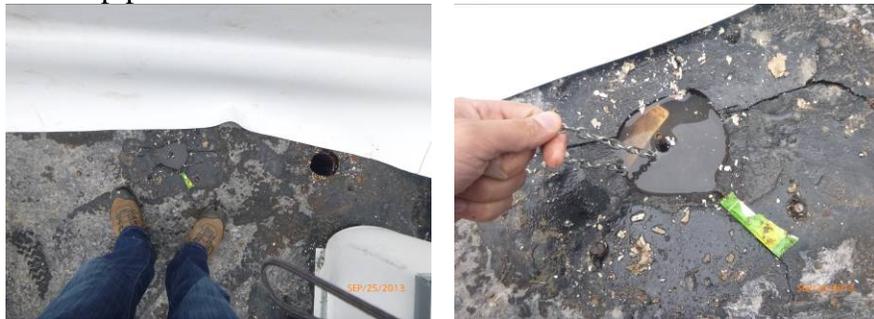
5.6 The roof drain overflow at the northwest corner of the Natatorium Roof is plugged. This writer cannot verify why the roof drain is plugged during this site visit. Recommend that the overflow is unplugged in the event of a heavy rain and that the drains are protected from debris entering and clogging the drainage pipes.

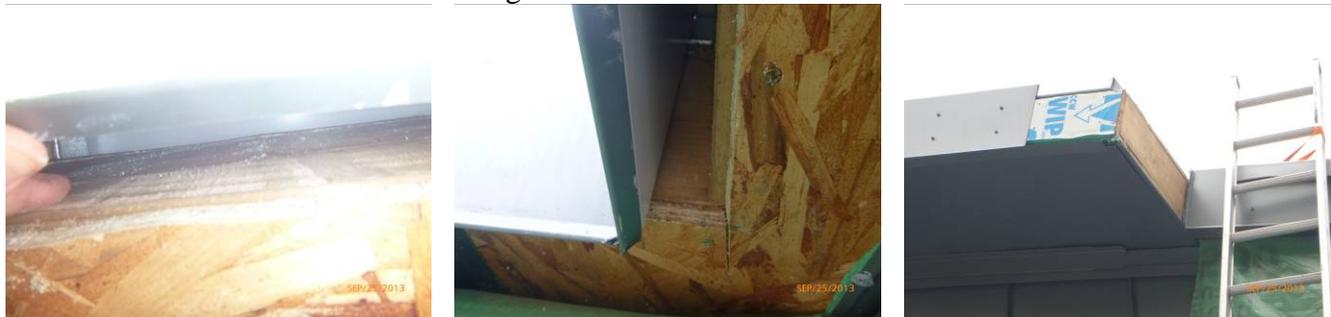
5.7 The WRB and vapor retarder layer are not continuous and the sheet metal is installed over bare wood at the fascia. Recommend that the sheet metal is removed the WRB continued onto the fascia with new self-adhered roof membrane lapping over to complete the air barrier. Carlisle WHT 300 is previously installed below the metal roofing.

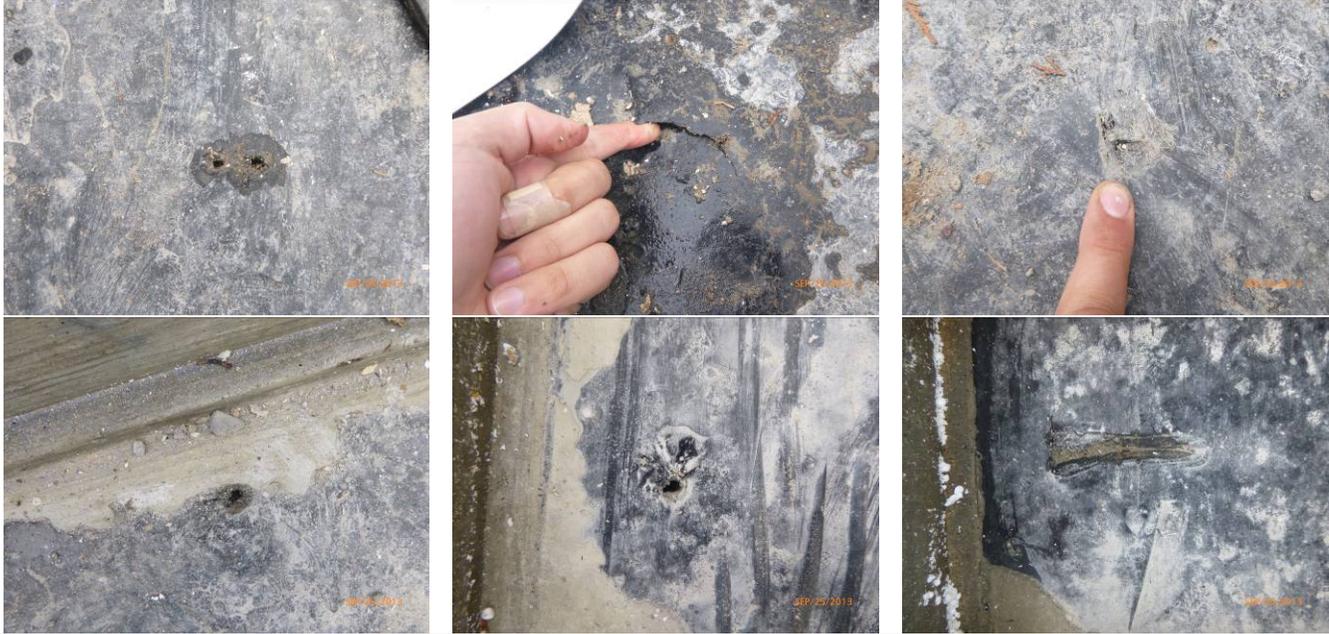
5.8 The vapor retarder layer at the Natatorium Roof is damaged in general. The construction team has been aware that construction sequencing would more than likely damage the vapor retarder layer. Per conversation with Rich Kerns (Foreman, QCR) the temporary roof/ vapor retarder layer is to be repaired with moppings of hot asphalt and plysheet as needed during construction.

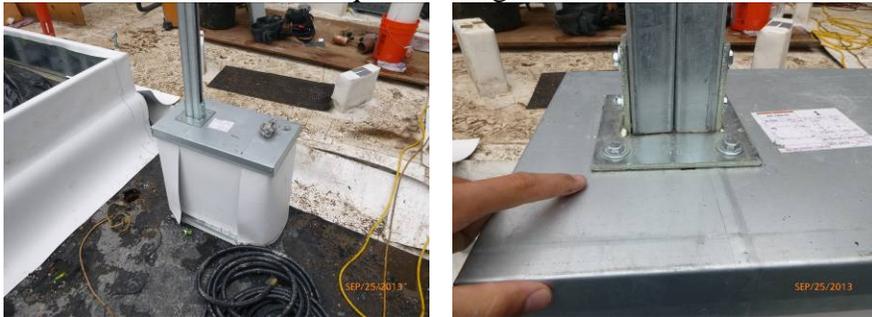
5.9 TPO wrapped curbs are installed at the Natatorium Roof. Supports for the new ductwork are bolted through the membrane at the top of the curb. Recommend that waterblock (Firestone S20) sealant is injected into the bolt penetrations and that the unistrut plate is embedded into sealant to prevent water intrusion and subsequent damage to the new roof.

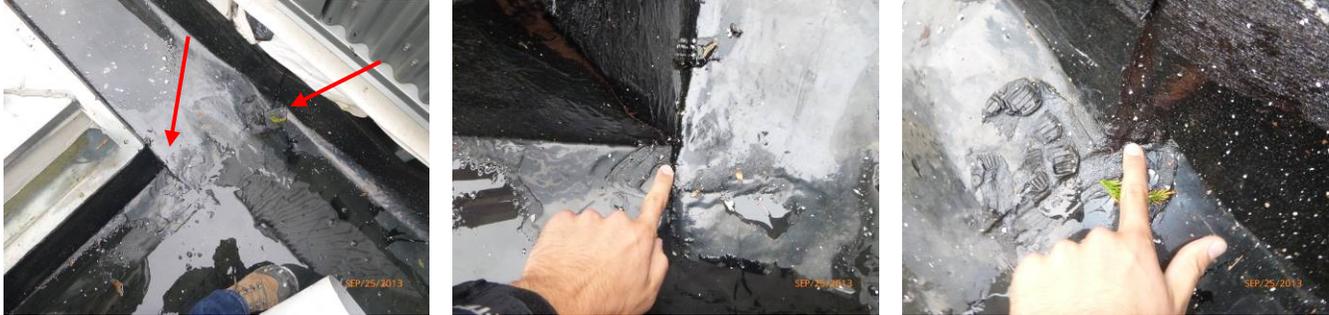
4.6 At the southwest corner of the Natatorium Roof, voids are observed in the temporary roof/ vapor retarder layer. Per conversation with Rich Kerns (Foreman, QCR) these locations are to be repaired during this workday.

Update FR#05 – 09/25/2013: Item is closed. Roof cement appears to have been applied at the fishmouths.

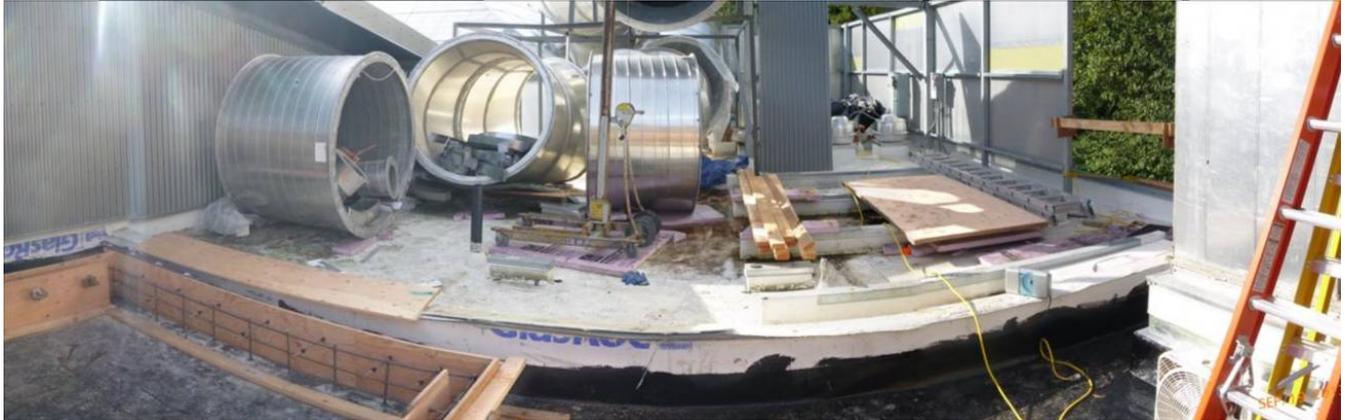
2.4 Per Wetherholt recommendation, the existence of a vapor retarder layer should be verified at the adjacent roof located south of the Natatorium Roof. If the adjacent roof was installed without a vapor barrier there is a possibility that water vapor may transfer over into the new roof assembly and damage the components. Per conversation with Anton Woody (GC, Holmberg) this is out of the scope of his contract but the construction team is aware of this issue.

Update FR#05 – 09/25/2013: Item is unresolved. No work is performed to open up this roof area yet.

Overview of the separator curb at the south end of the Natatorium Roof taken facing south.

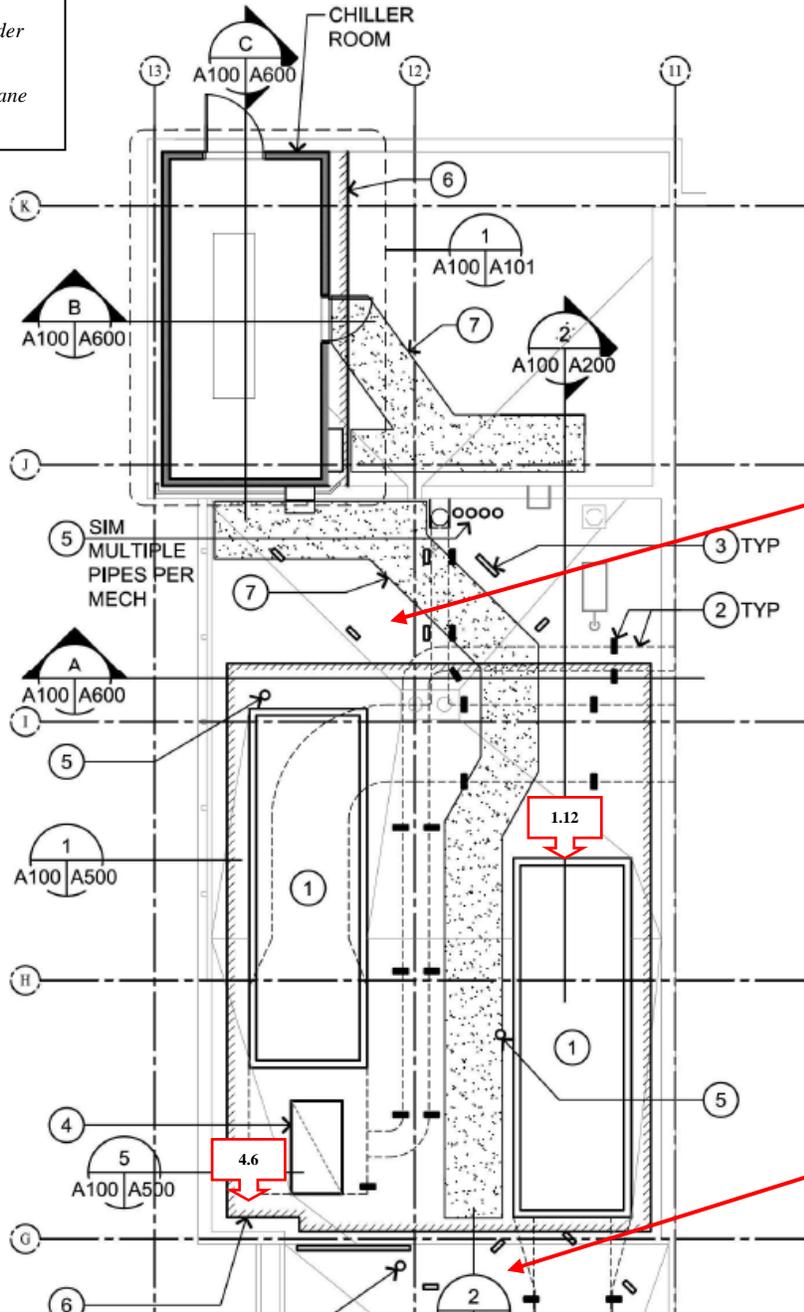
CASC Roof Progress Plan / Locator Map:

North of this line (approx.) the remainder of the Natatorium roof is wet and damaged as an existing condition.

Recommend verifying the presence of a vapor retarder layer over the deck south of Natatorium Roof.
