**FIELD REPORT – LYNNWOOD RECREATION CENTER – FIELD REPORT**  
REPORT #06

Job No. 10-100622B1

Date: September 26<sup>th</sup>, 2013  
Page 1 of 9

**Location(s) of Work:** Natatorium roof, HVAC Replacement.

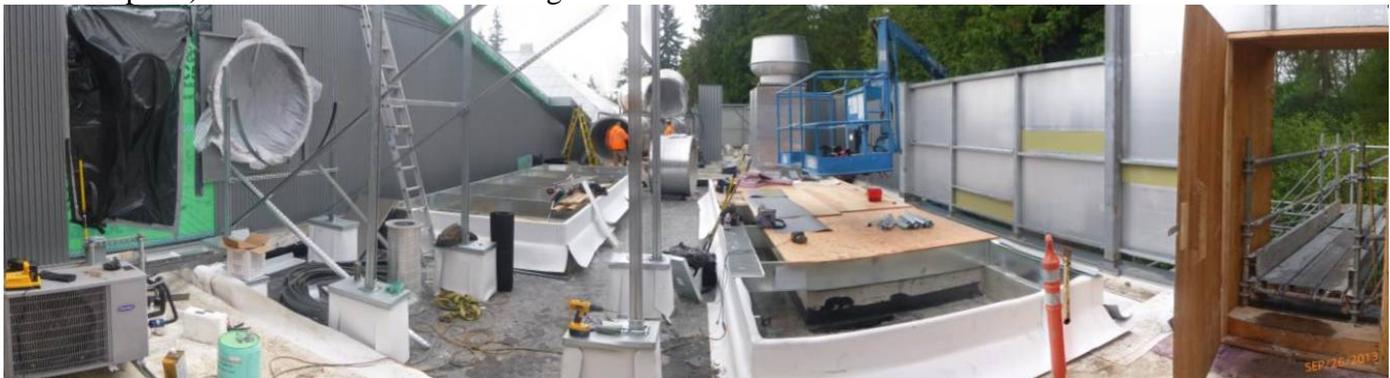
- 6.1 Delta Construction is installing unistrut supports for the new HVAC ductwork at the Natatorium Roof. Queen City Roofing is installing tapered insulation and coverboard (set in hot moppings of Type IV asphalt) under the TPO baseflashing at the east HVAC curb.

*Overview of the Natatorium Roof taken facing south.*

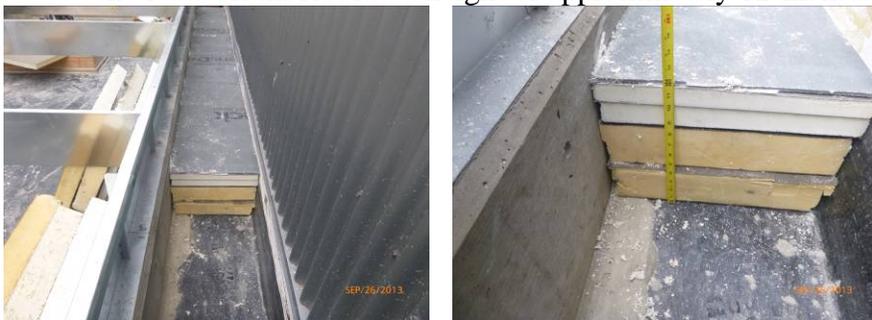
- 6.2 Flat stock and tapered insulation with coverboard over are loose fitted at the curb and east elevation of the Natatorium Roof to a height of approximately 12-inches.

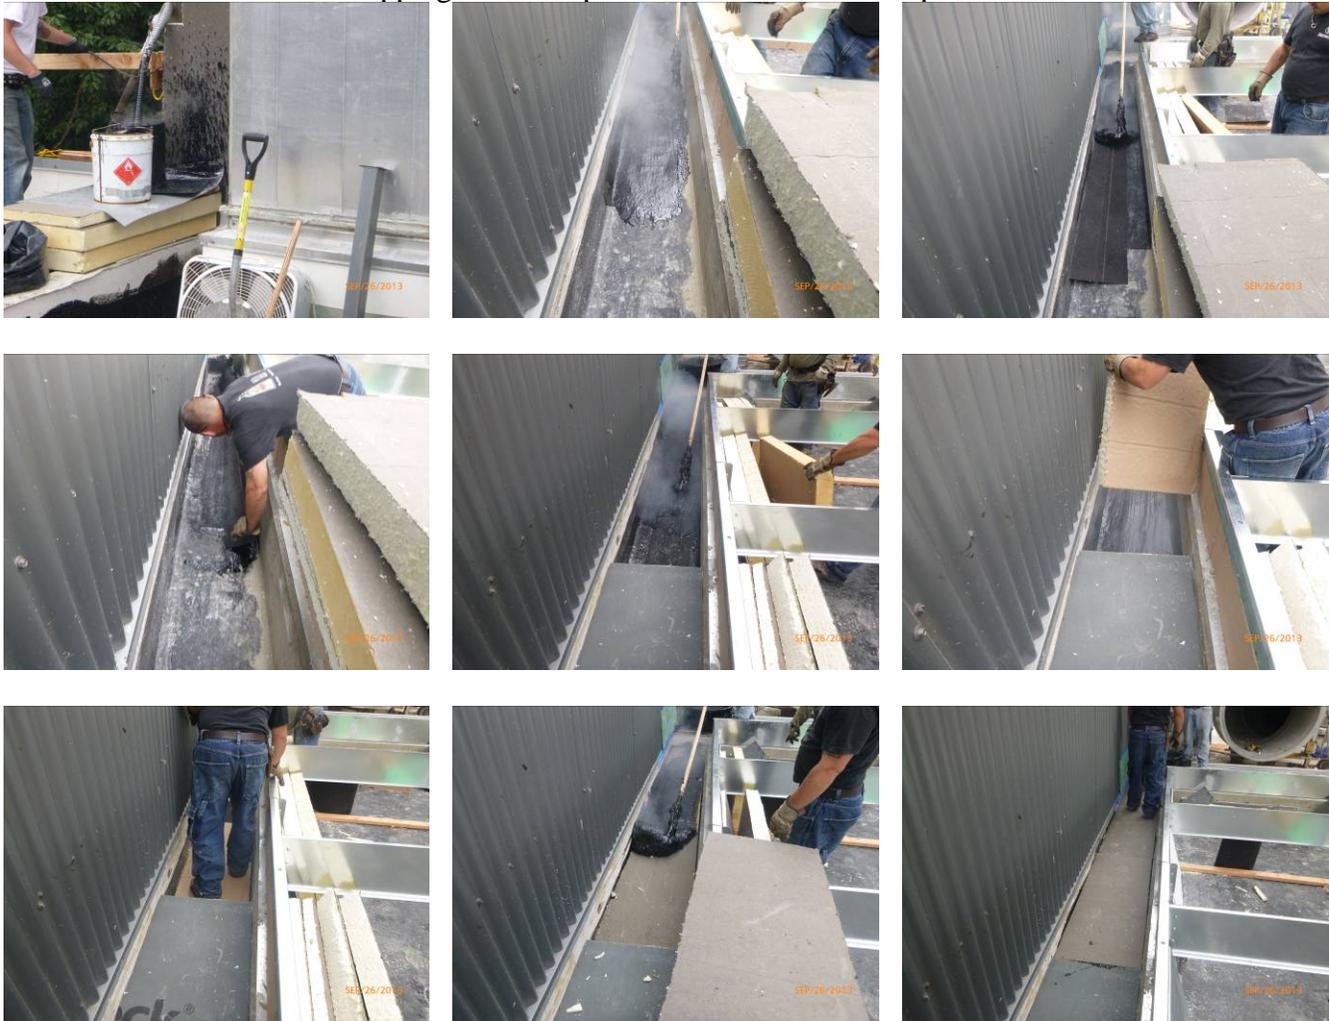
6.2a Scrap insulation is set up behind the hot pour which splatters due to water being in the bucket. This bucket is set aside until water has evaporated. A mopping of asphalt is applied onto the plysheet which is turned up the curb. The process is repeated with an additional plysheet to make a 2-ply application. Insulation is set in moppings of hot asphalt and are walked in to promote adhesion.

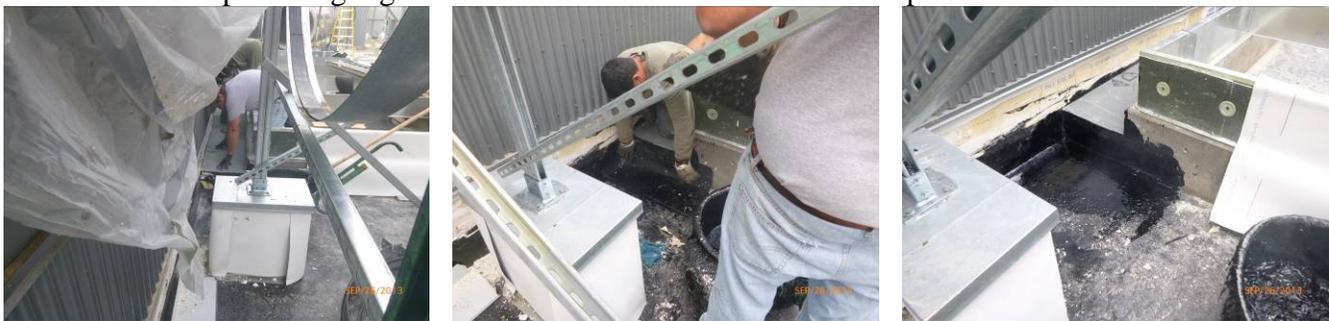
6.2b 1/4-inch DensDeck coverboard is set in moppings of hot asphalt and are pressed in to promote adhesion. The north and west ends of the insulation are capped with ply sheet set in moppings of hot asphalt as a means of providing night seal as these smaller areas are roofed prior to the installation of HVAC units.

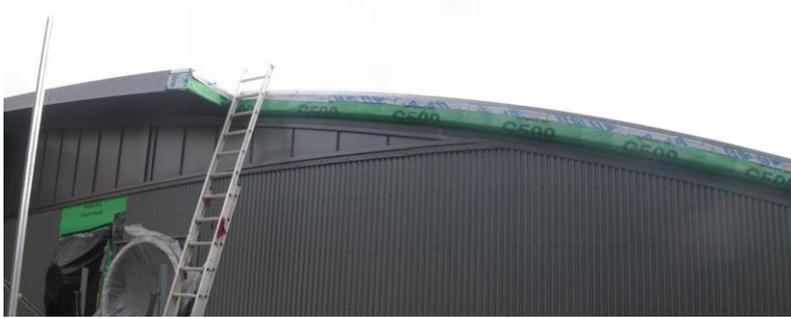
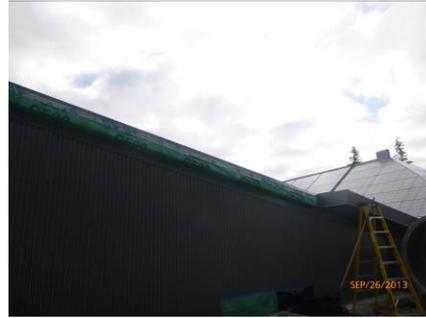
6.3 At the sawcut into the metal roof above, the metal roofing that was installed over bare wood is removed during this site visit.

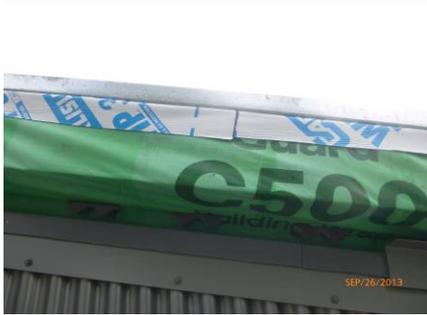
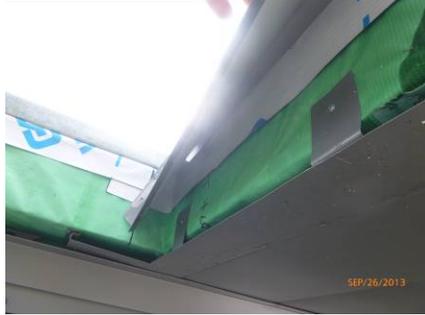
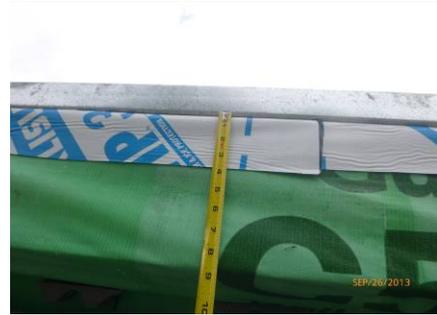
6.3a Self adhered membrane is applied lapped over the weather resistant barrier approximately 4-inches onto the fascia. The self adhered membrane appears to wrap corner transitions in a water shedding fashion.

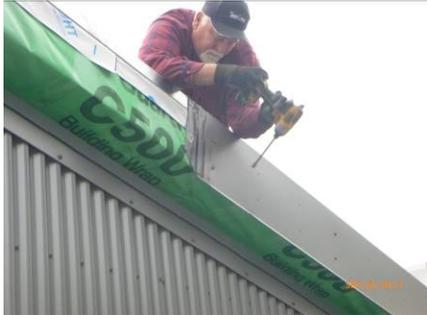
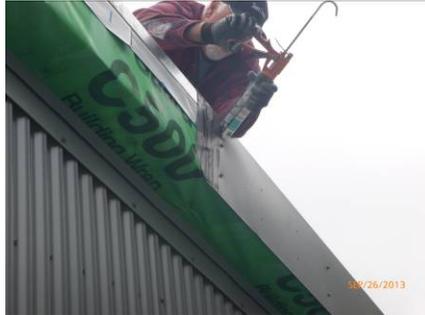
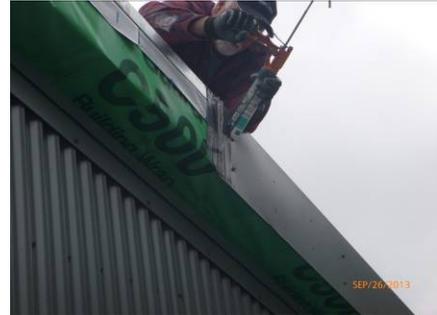
6.3b Sealant is applied at joints in the sheet metal fascia which is then mechanically attached at the points of previous attachment. Recommend metal is installed with new points of attachment to provide positive attachment of the metal. Item is noted as an observation.

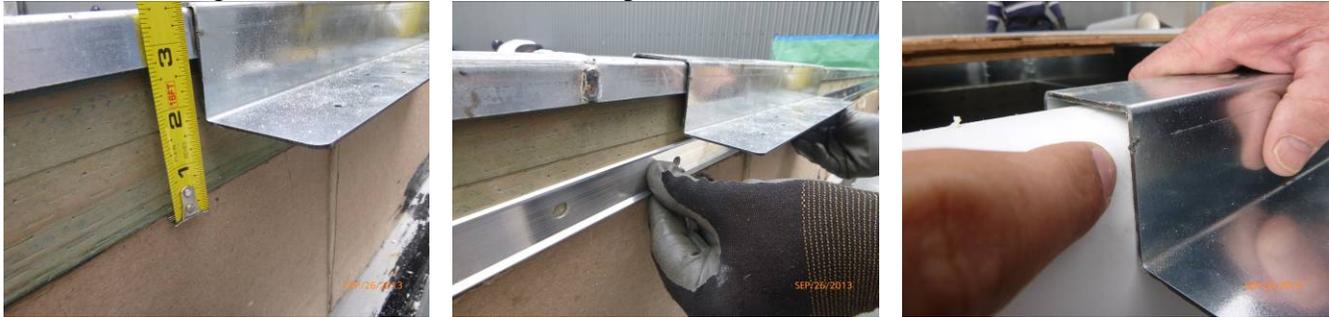
6.4 The seismic clips that are installed at the top of the curb (prior to the placement of HVAC units) present clearance issues for the installation of the skirt flashing (as depicted in Detail 4 sheet A500). The clips are too tight and the nailer is too short to provide sufficient mechanical attachment for a termination bar.

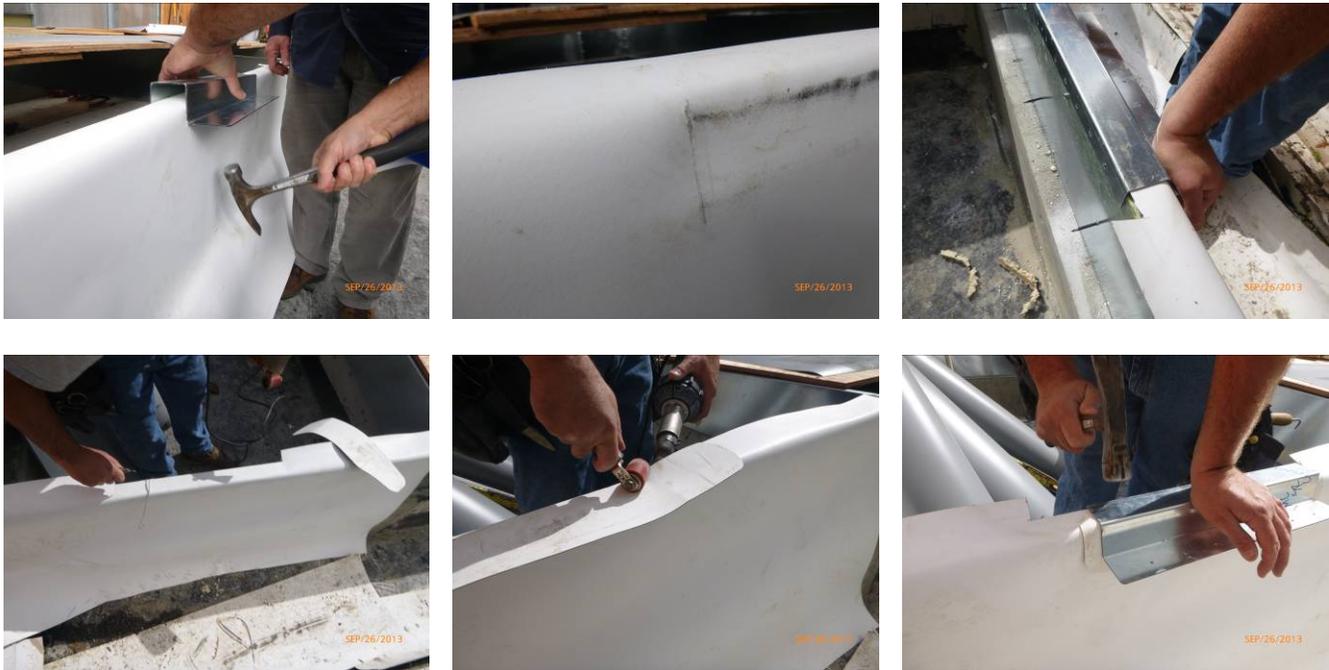
6.4a Per conversation with Rich Kerns, the locations where the seismic clips are to be installed over the TPO baseflashing may be damaged during installation or during HVAC unit movement. Recommended that the baseflashing that turns into the curb is removed from the interior of the curb and welded onto the exterior face to accomplish a protective layer without generating too much build-up. This recommended installation procedure was performed at one seismic clip location as a mock-up for review by the design team. See *New Problems/ Solutions* Item 6.5 below.

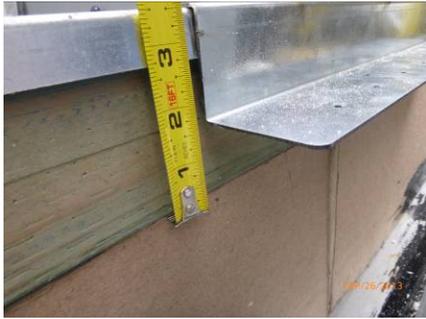
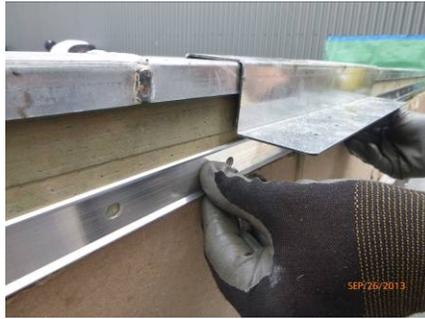
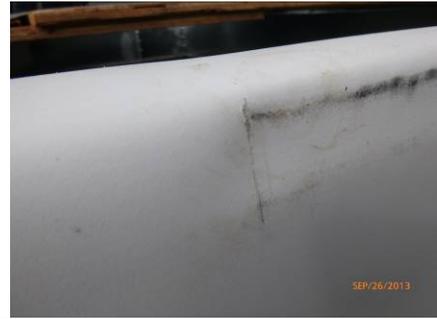
6.5 The new HVAC unit seismic clips present a clearance issue for the installation of either a new skirt flashing or termination bar. Recommend that the TPO membrane turns into the interior of the HVAC unit be removed at the clip. At seismic clip locations recommend that the sacrificial TPO layer be heat welded onto the exterior face to provide protection of the roof membrane without causing clearance issues.

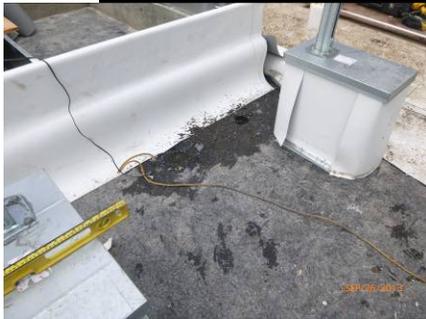
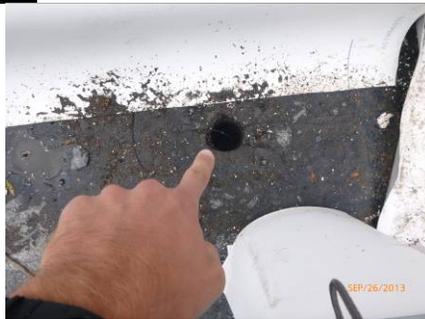
5.6 The roof drain overflow at the northwest corner of the Natatorium Roof is plugged. This writer cannot verify why the roof drain is plugged during this site visit. Recommend that the overflow is unplugged in the event of a heavy rain and that the drains are protected from debris entering and clogging the drainage pipes.

**Update FR#06 – 09/26/2013: Item is unresolved**

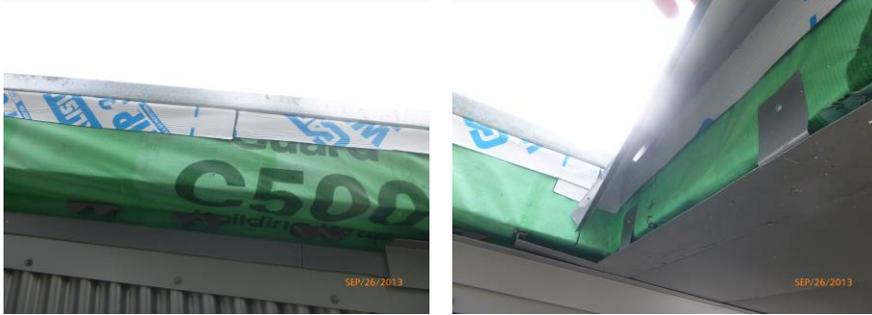
5.7 The WRB and vapor retarder layer are not continuous and the sheet metal is installed over bare wood at the fascia. Recommend that the sheet metal is removed the WRB continued onto the fascia with new self-adhered roof membrane lapping over to complete the air barrier. Carlisle WHT 300 is previously installed below the metal roofing.

**Update FR#06 – 09/26/2013: Item is closed.** Locations appear to have been repaired.

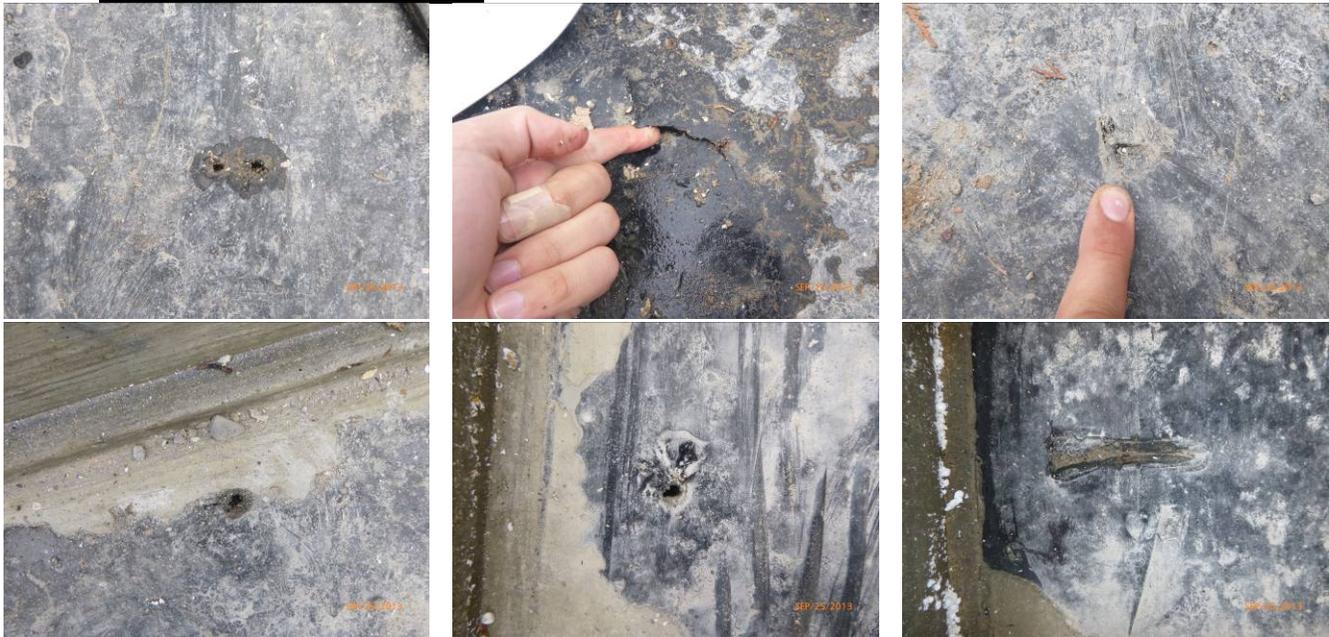
5.8 The vapor retarder layer at the Natatorium Roof is damaged in general. The construction team has been aware that construction sequencing would more than likely damage the vapor retarder layer. Per conversation with Rich Kerns (Foreman, QCR) the temporary roof/ vapor retarder layer is to be repaired with moppings of hot asphalt and plysheet as needed during construction.

**Update FR#06 – 09/26/2013: Item is unresolved.**

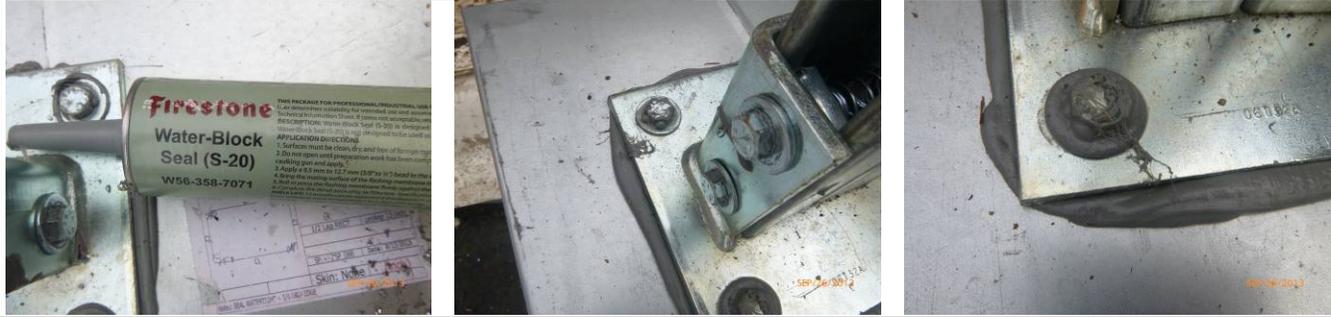
5.9 TPO wrapped curbs are installed at the Natatorium Roof. Supports for the new ductwork are bolted through the membrane at the top of the curb. Recommend that waterblock (Firestone S20) sealant is injected into the bolt penetrations and that the unistrut plate is embedded into sealant to prevent water intrusion and subsequent damage to the new roof.

**Update FR#06 – 09/26/2013: Item is closed.** Locations appear to have been set in sealant.

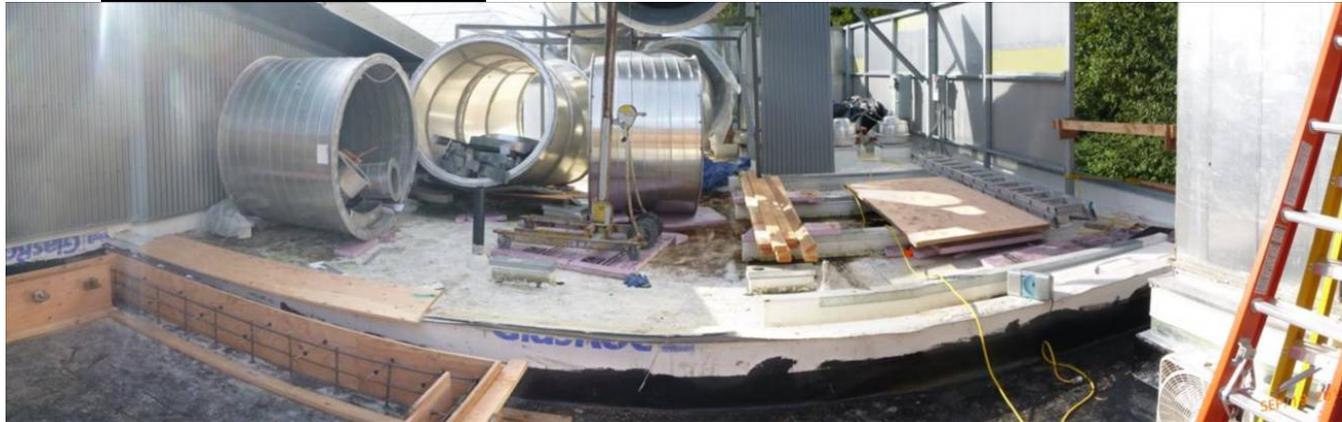
2.4 Per Wetherholt recommendation, the existence of a vapor retarder layer should be verified at the adjacent roof located south of the Natatorium Roof. If the adjacent roof was installed without a vapor barrier there is a possibility that water vapor may transfer over into the new roof assembly and damage the components. Per conversation with Anton Woody (GC, Holmberg) this is out of the scope of his contract but the construction team is aware of this issue.

**Update FR#06 – 09/26/2013: Item is unresolved.**

*Overview of the separator curb at the south end of the Natatorium Roof taken facing south.*
