FIELD REPORT – LYNNWOOD RECREATION CENTER – FIELD REPORT

REPORT #07

Job No. 10-100622B1

Location(s) of Work: Natatorium roof, HVAC Replacement.

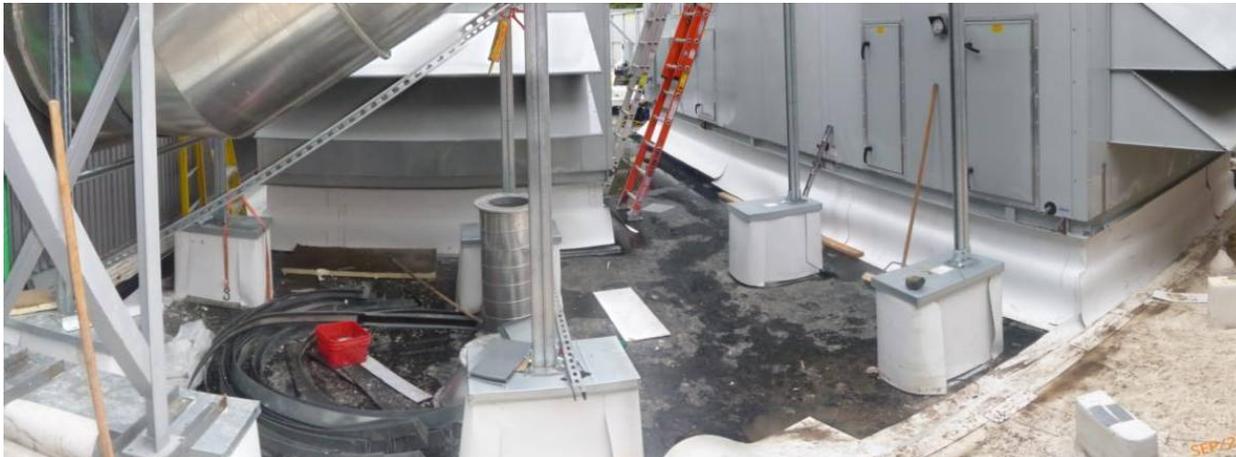
7.1 The new HVAC units are installed above the new HVAC curbs. New TPO membrane is installed between the east side of the HVAC unit and the east elevation wall.

Overview of the Natatorium Roof taken facing south.

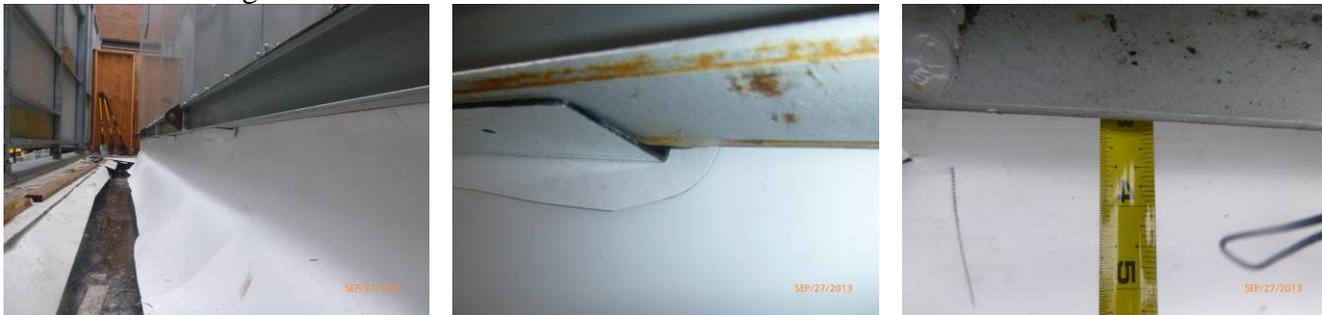
7.2 Per Conversation with Keith Skore (City of Lynnwood), the TPO membrane has been cut from the inside of the HVAC units at seismic clips. Sacrificial TPO membrane is heat welded onto the exterior face of the baseflashing membrane. The HVAC flashing comes down approximately 3-inches onto the baseflashing.

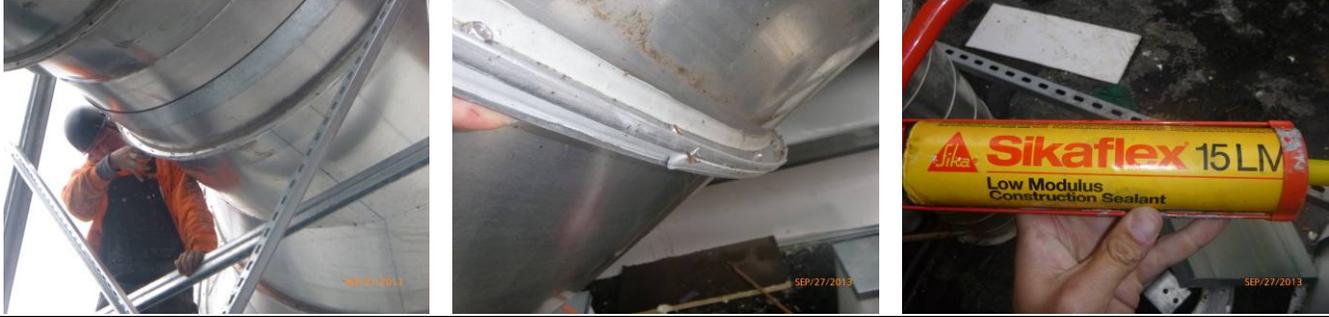
7.3 Sikaflex 15LM sealant appears to be tooled into seams and joins of the new HVAC ductwork.

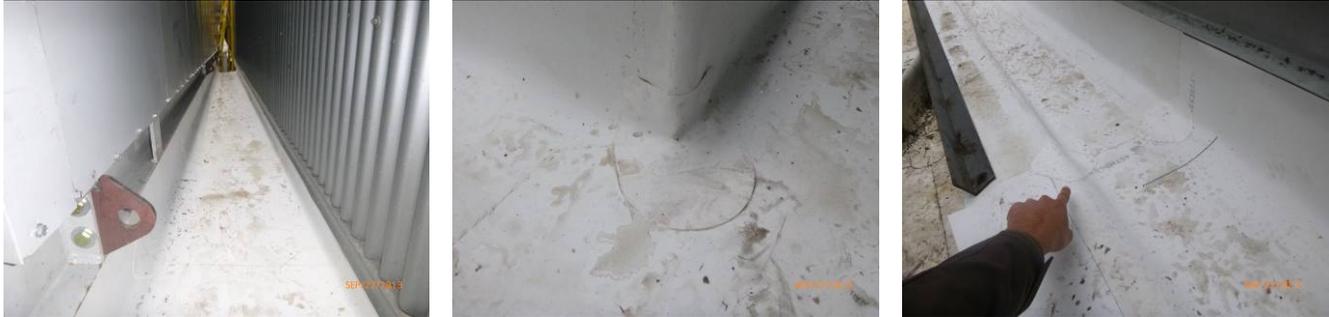
7.4 TPO membrane is installed during the previous workday. Firestone TPO outside corner patches are installed at outside corners. TPO patches are installed at roof-to-wall transitions in the seams. Per conversation with Rich Kerns (Foreman, QCR) this area of the new roof is installed prior to the arrival of new HVAC units due to clearance issues.

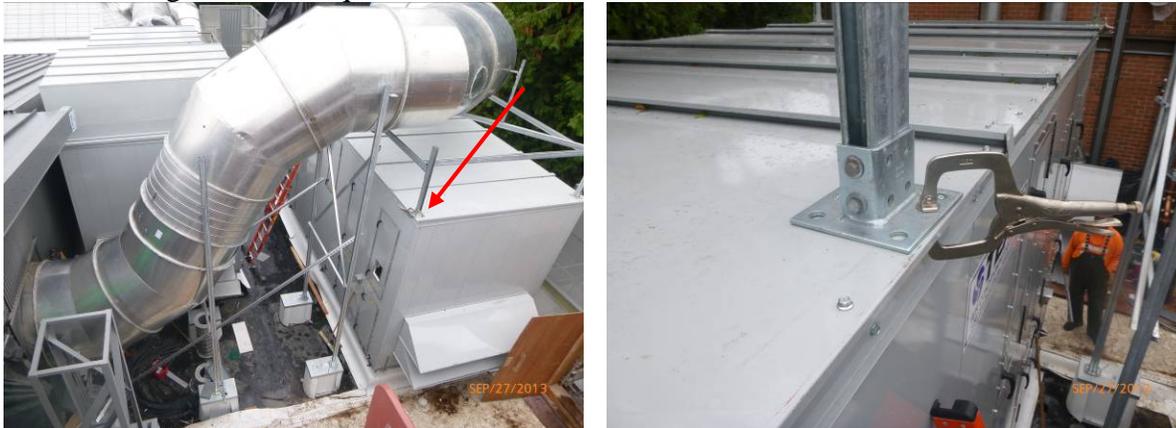
7.5 At the top of the HVAC unit to the west, the unistrut bases that support the duct work above the unit are a work in progress. Per conversation with Greg (Delta Construction) the unistrut bolt penetrations through the unit require sealant. Item is noted as an observation.

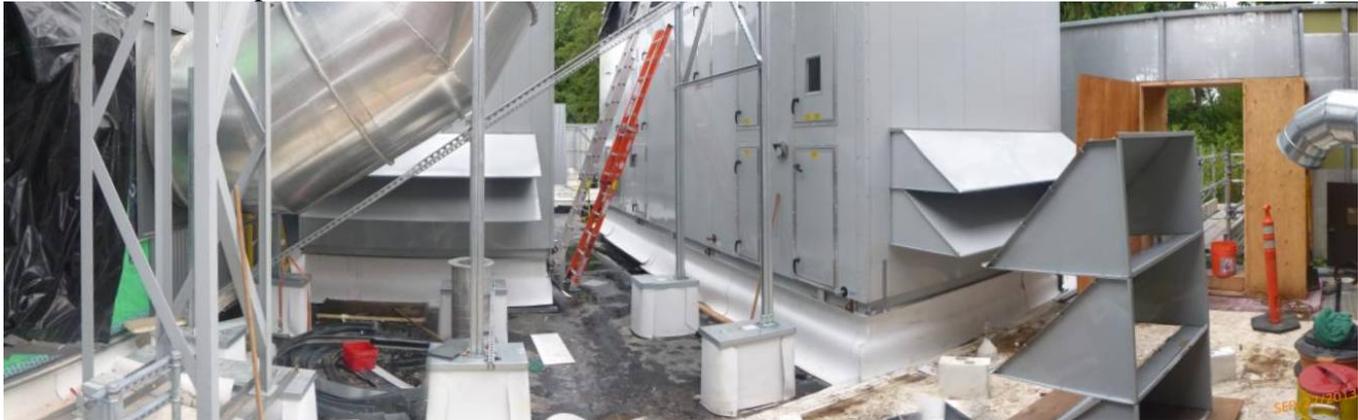
7.6 The overview photo is taken at this writer's departure from the site visit and depicts progress in the HVAC unit placement.

Overview of the Natatorium Roof taken facing north.

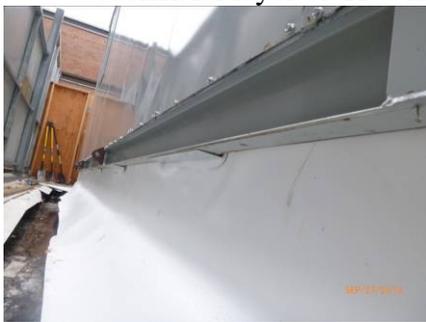
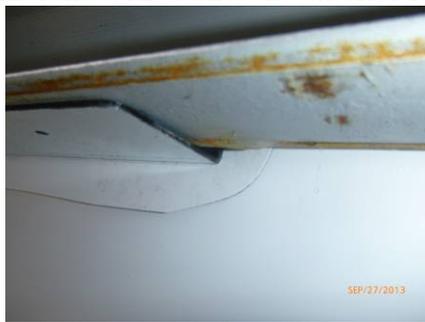
6.5 The new HVAC unit seismic clips present a clearance issue for the installation of either a new skirt flashing or termination bar. Recommend that the TPO membrane turns into the interior of the HVAC unit be removed at the clip. At seismic clip locations recommend that the sacrificial TPO layer be heat welded onto the exterior face to provide protection of the roof membrane without causing clearance issues.

Update FR#07 – 09/27/2013: Item is closed. HVAC units are installed over seismic clips with a sacrificial layer of TPO membrane turned onto the exterior face of the baseflashing.

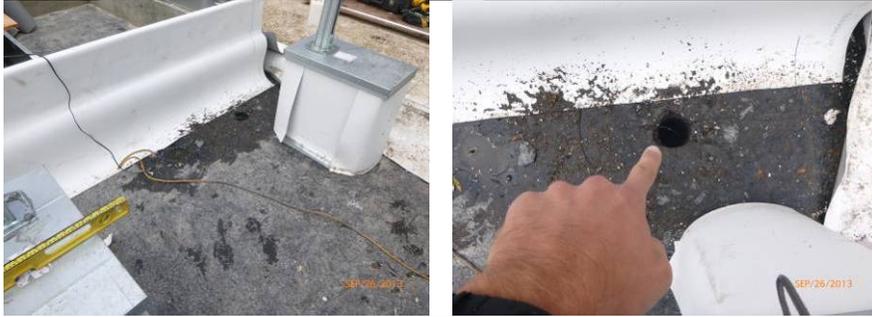
5.6 The roof drain overflow at the northwest corner of the Natatorium Roof is plugged. This writer cannot verify why the roof drain is plugged during this site visit. Recommend that the overflow is unplugged in the event of a heavy rain and that the drains are protected from debris entering and clogging the drainage pipes.

Update FR#07 – 09/27/2013: Item is unresolved

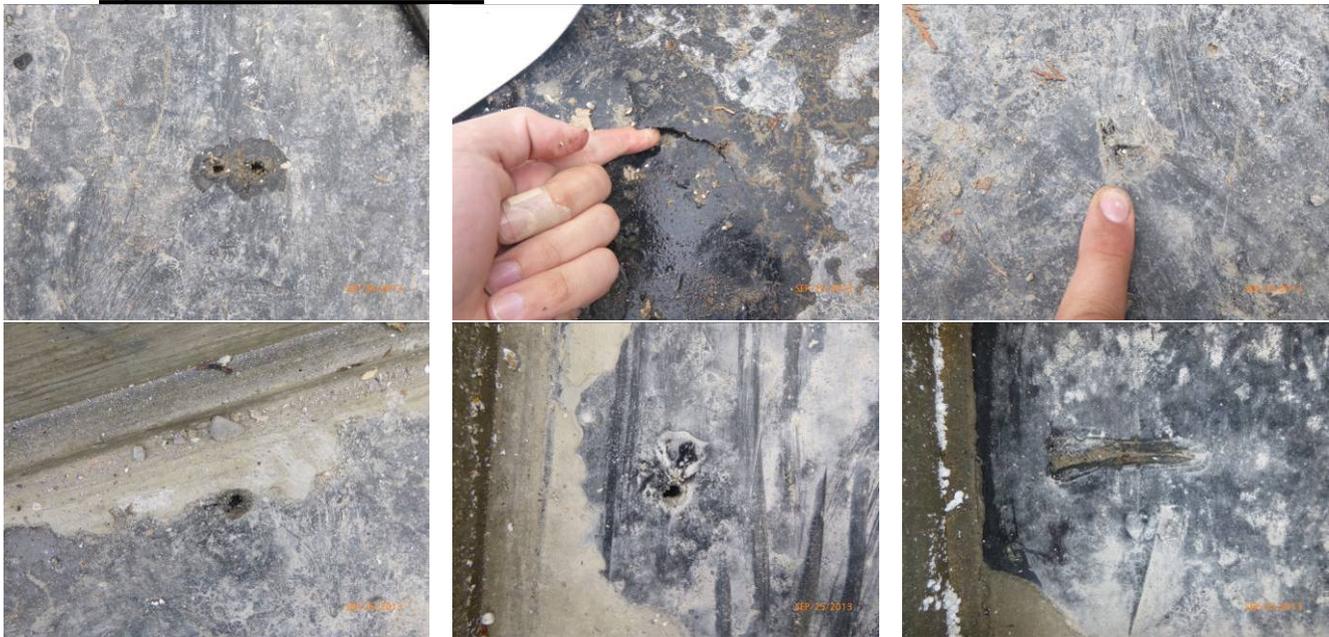
5.8 The vapor retarder layer at the Natatorium Roof is damaged in general. The construction team has been aware that construction sequencing would more than likely damage the vapor retarder layer. Per conversation with Rich Kerns (Foreman, QCR) the temporary roof/ vapor retarder layer is to be repaired with moppings of hot asphalt and plysheet as needed during construction.

Update FR#07 – 09/27/2013: Item is unresolved.

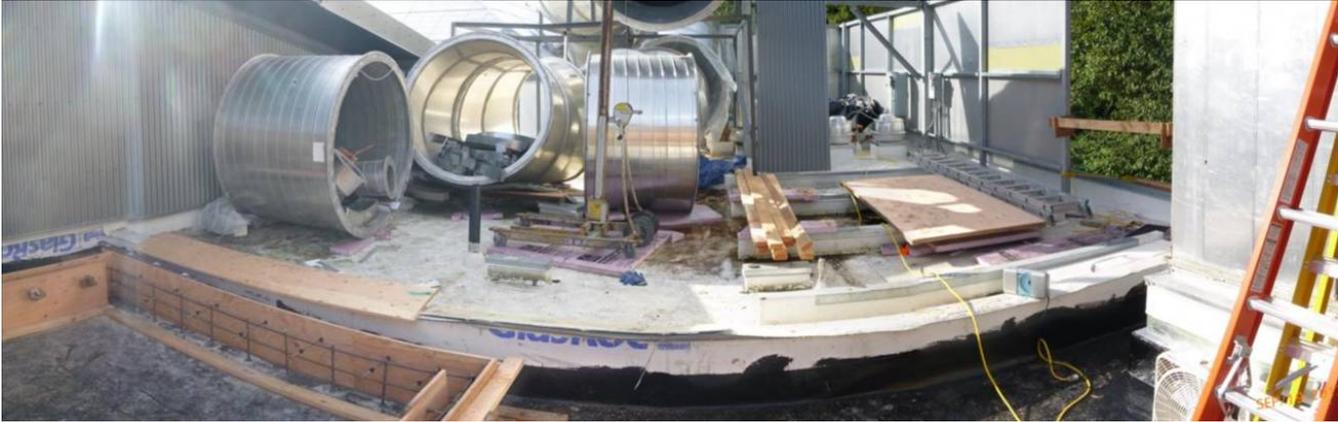
- 2.4 Per Wetherholt recommendation, the existence of a vapor retarder layer should be verified at the adjacent roof located south of the Natatorium Roof. If the adjacent roof was installed without a vapor barrier there is a possibility that water vapor may transfer over into the new roof assembly and damage the components. Per conversation with Anton Woody (GC, Holmberg) this is out of the scope of his contract but the construction team is aware of this issue.
- Update FR#04 – 09/19/2013: Item is unresolved
- Update FR#05 – 09/25/2013: Item is unresolved. No work is performed to open up this roof area yet.
- Update FR#06 – 09/26/2013: Item is unresolved.
- Update FR#07 – 09/27/2013: Item is unresolved.**

Overview of the separator curb at the south end of the Natatorium Roof taken facing south.

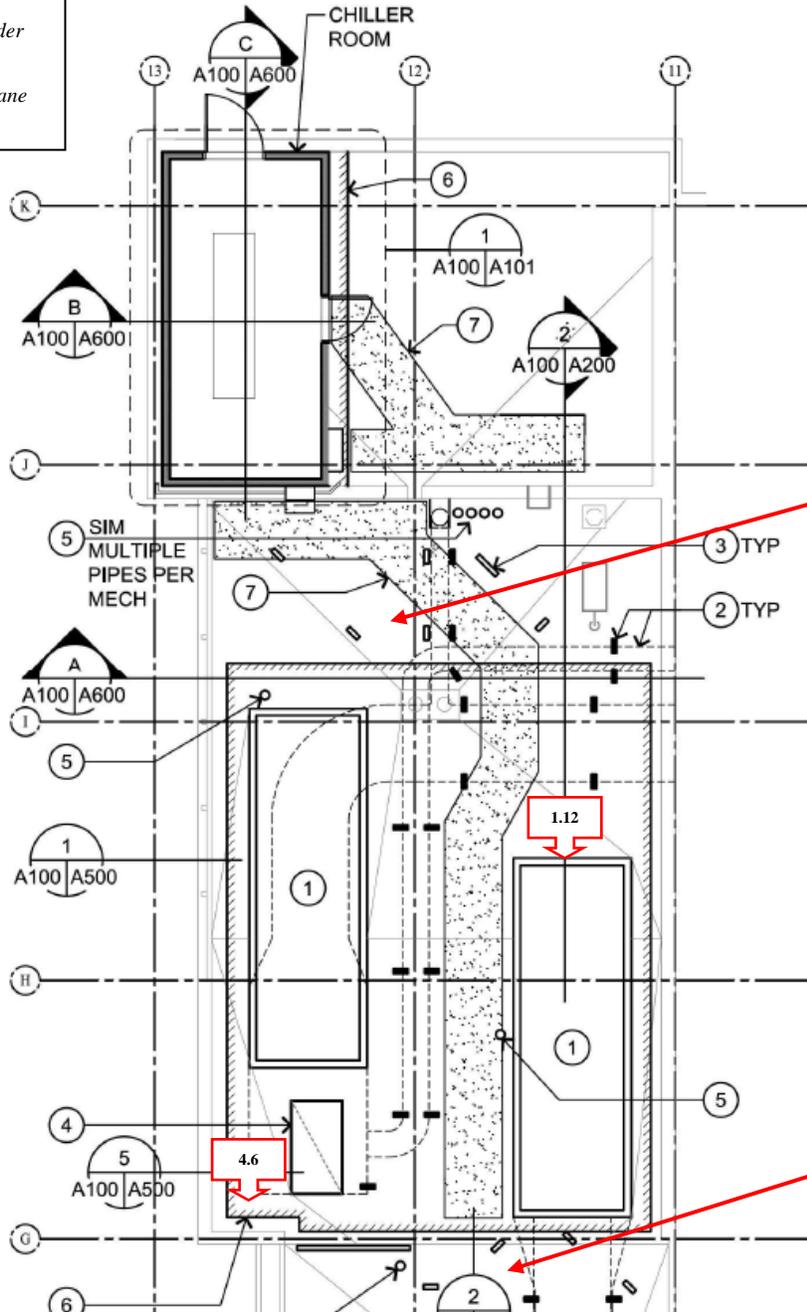
CASC Roof Progress Plan / Locator Map:

North of this line (approx.) the remainder of the Natatorium roof is wet and damaged as an existing condition.

Recommend verifying the presence of a vapor retarder layer over the deck south of Natatorium Roof.
