FIELD REPORT – LYNNWOOD RECREATION CENTER – FIELD REPORT

REPORT #08

Job No. 10-100622B1

Date: October 2nd, 2013

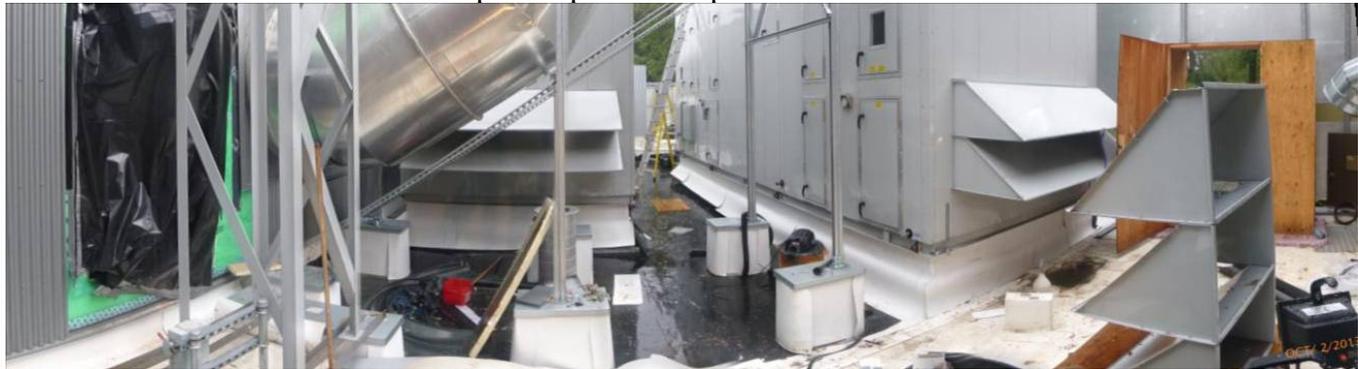
8.1 The Natatorium roof is reviewed following the heavy rain. Some sheet metal work, including the installation of the new downspout is performed prior to arrival on site.

Overview of the Natatorium Roof taken facing south.

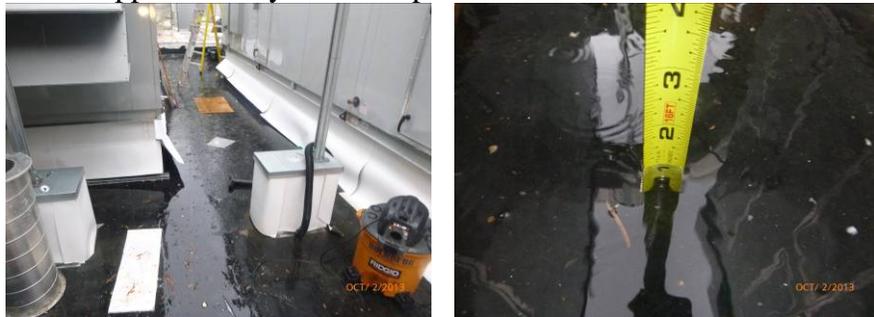
8.2 Following the recent heavy rains, the natatorium temporary roof is observed to have water collecting at approximately 1-inch depth in some locations.

Continued from Item 8.2 on the previous page.

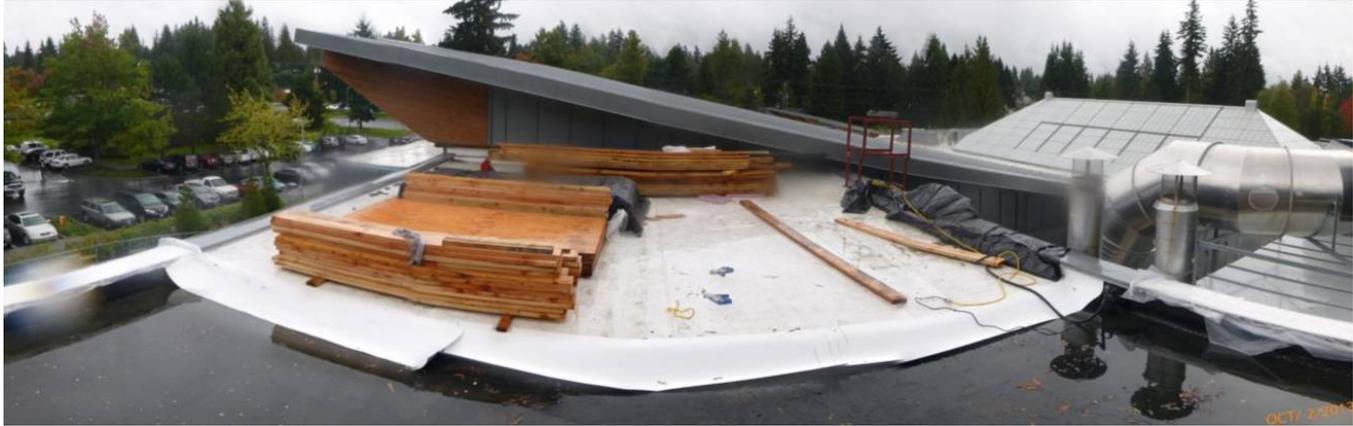
8.2a At the chiller room roof, standing water is also observed as collecting over the new vapor retarder layer. A pump is routing water to the roof drain at the lower roof above the natatorium.

Overview of the roof above the chiller room taken facing east.

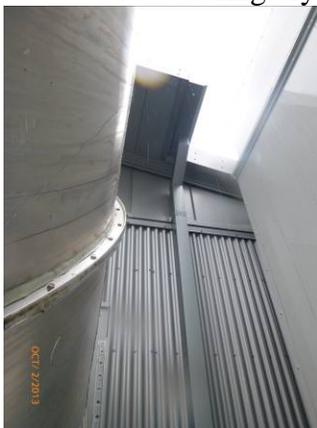
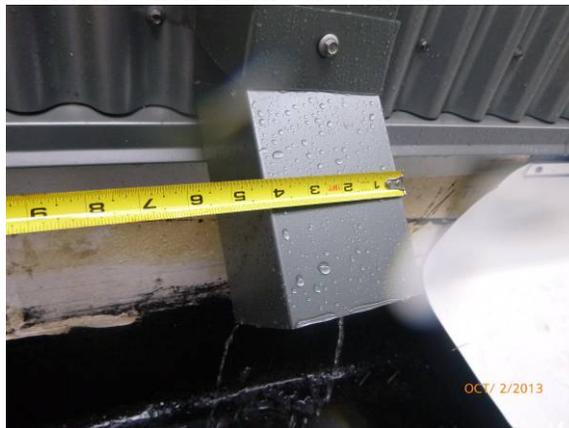
8.3 At the north end of the upper sheet metal roof (cut back to accommodate new HVAC units) a 4-inch downspout is observed mechanically fastened with gasketed fasteners. This writer will review the area above during dry conditions when the metal deck dries out.

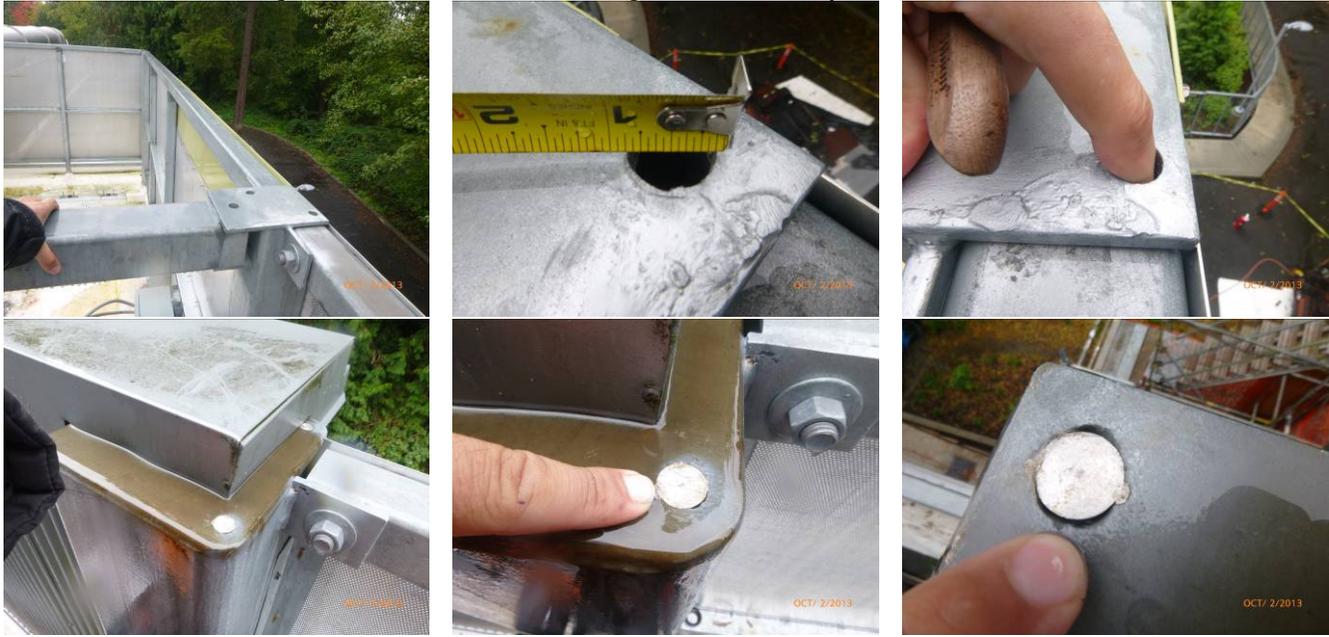
8.4 At the tops of screen wall supports (west elevation of the Natatorium Roof, typical of all large screen wall supports) through holes are observed at the top plates. Some holes appear to be infilled with metal. Recommend that all locations where water will enter are infilled or capped as needed to prevent water from funneling into the column and throughout the roof system below.

Item 8.4: Infill holes in top plates at screen wall structure.

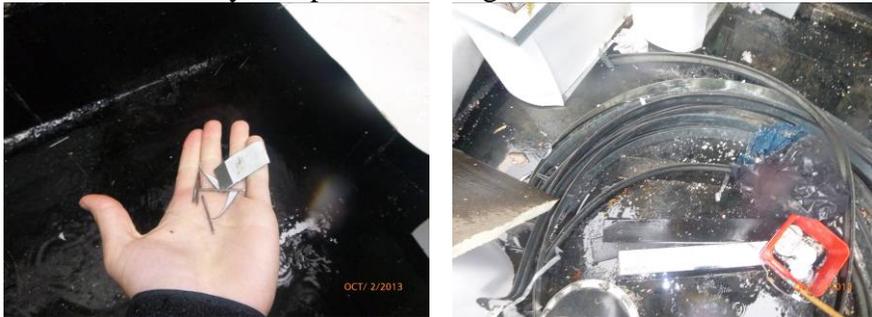
8.5 Recommend that any sheet metal sharps, fasteners and other debris are removed from the new vapor retarder layer to prevent damage.

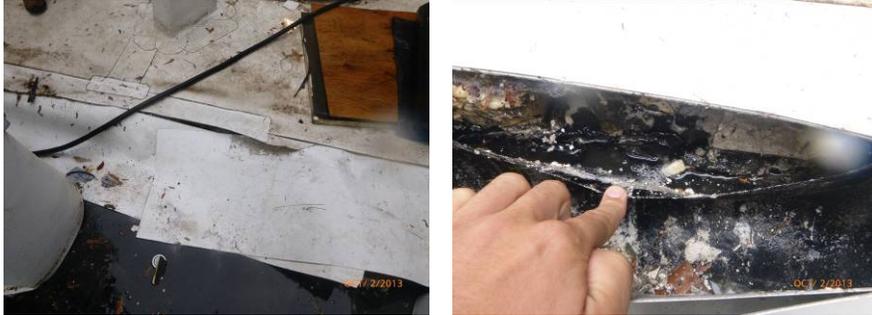
8.6 The night seal at the north end of the Natatorium roof is insufficient in some locations allowing water into the existing roof assembly. The roof to the north was previously observed as wet along with the existing roof that was removed to the south.

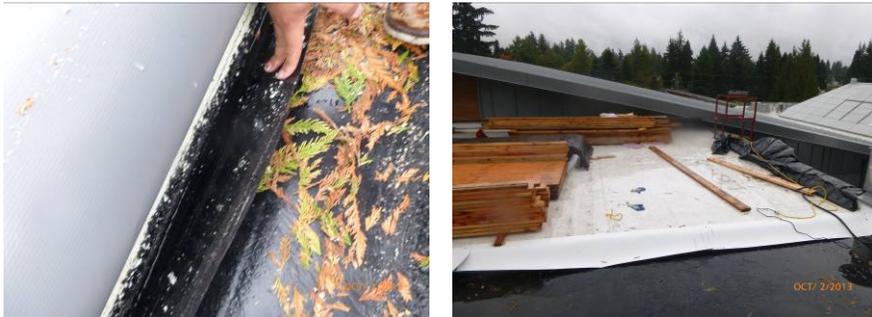
8.7 The absence of a night seal at the chiller room roof allowed water to migrate into the existing roof to the east. The roof to the east was previously observed as wet along with the existing roof that was removed to the west.

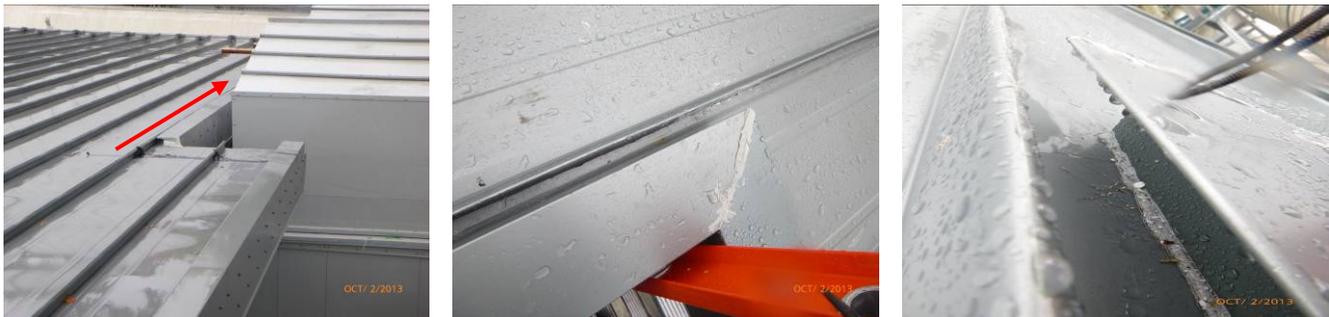
8.8 The sheet metal re-installation at the sawcut in the roof above is ongoing. This writer is unable to verify if the metal panel is notched into a vertical leg behind the flashing enclosure at the fascia. Sealant is observed bleeding out from underneath the roof panel. This area will be further reviewed in dry conditions.

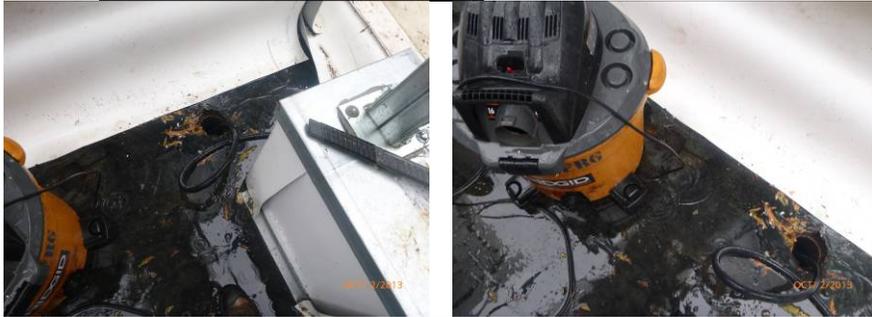
5.6 The roof drain overflow at the northwest corner of the Natatorium Roof is plugged. This writer cannot verify why the roof drain is plugged during this site visit. Recommend that the overflow is unplugged in the event of a heavy rain and that the drains are protected from debris entering and clogging the drainage pipes.

Update FR#08 – 10/02/2013: Item is unresolved

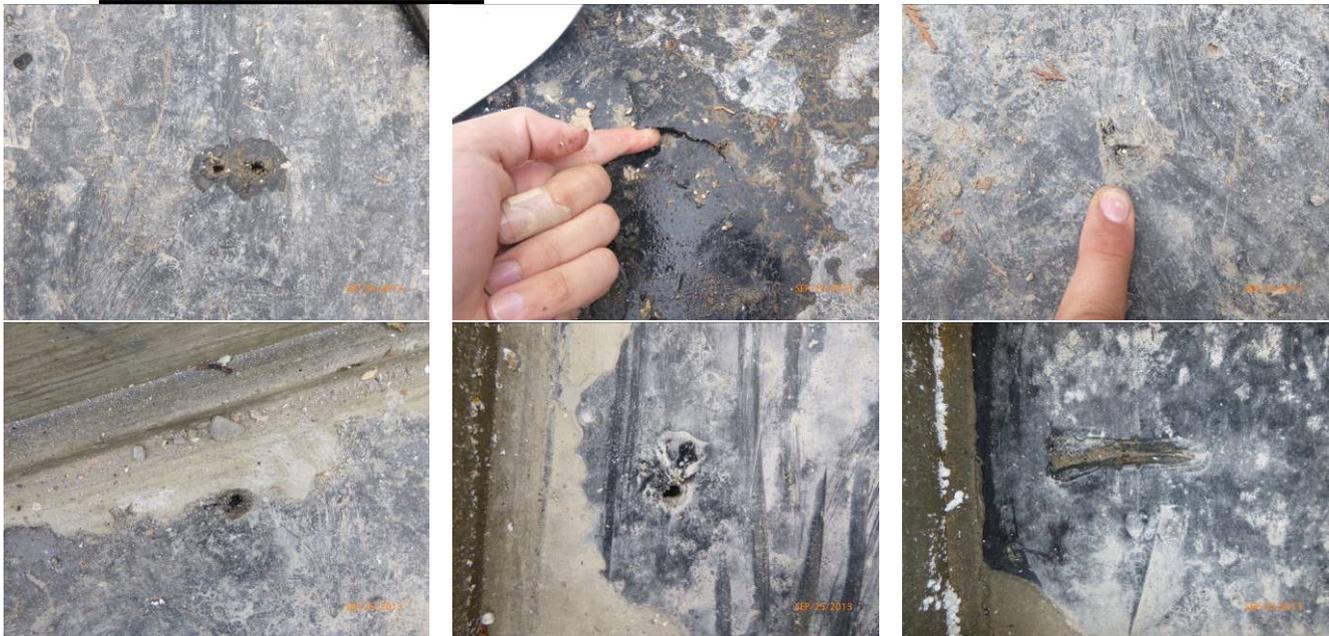
5.8 The vapor retarder layer at the Natatorium Roof is damaged in general. The construction team has been aware that construction sequencing would more than likely damage the vapor retarder layer. Per conversation with Rich Kerns (Foreman, QCR) the temporary roof/ vapor retarder layer is to be repaired with moppings of hot asphalt and plysheet as needed during construction.

Update FR#08 – 10/02/2013: Item is unresolved

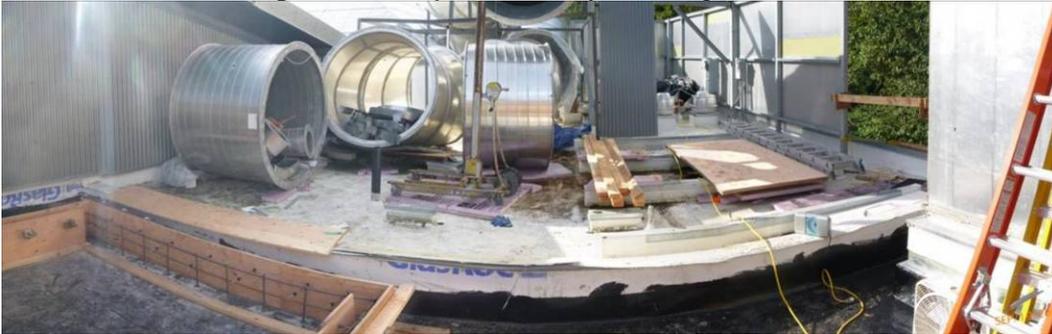
- 2.4 Per Wetherholt recommendation, the existence of a vapor retarder layer should be verified at the adjacent roof located south of the Natatorium Roof. If the adjacent roof was installed without a vapor barrier there is a possibility that water vapor may transfer over into the new roof assembly and damage the components. Per conversation with Anton Woody (GC, Holmberg) this is out of the scope of his contract but the construction team is aware of this issue.

Overview of the separator curb at the south end of the Natatorium Roof taken facing south

- Update FR#08 – 10/02/2013: Item is unresolved.** Per conversation with Keith Skore (City of Lynnwood, Project Manager) this roof is to be cut into and investigated tomorrow during better weather. Work is to be performed by Queen City Roofing Foreman, Richie Kerns.
