FIELD REPORT – LYNNWOOD RECREATION CENTER – FIELD REPORT

REPORT #09

Job No. 10-100622B1

Location(s) of Work: Southeast & Southwest of the Natatorium Roof

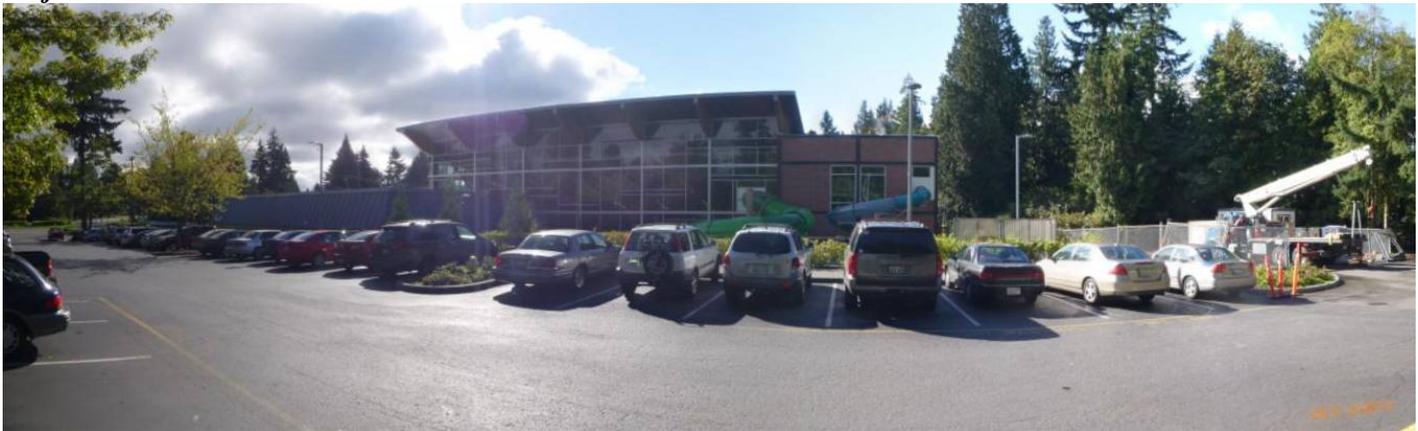
Photo of the Lynnwood Recreation Center building taken facing southeast.

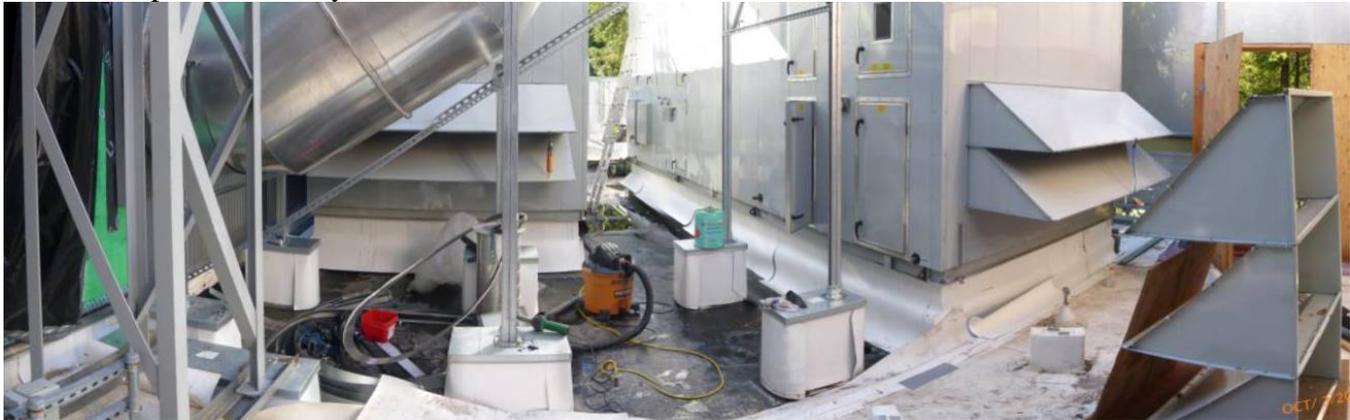
9.1 The roof south of the Natatorium roof is opened up to verify the system components and the presence of a vapor retarder layer.

Overview of the Natatorium Roof taken facing south

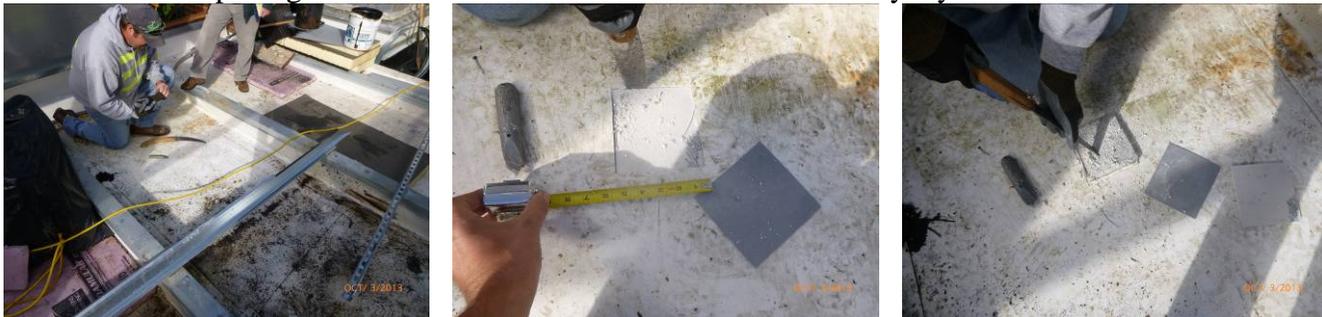
9.2 An opening (5-inch approximate square) is cut through the existing roof to the southwest of the Natatorium roof. The roof assembly appears visibly dry. This test cut area is at the top of a deep cricket and the opening would have to be widened to remove the many layers of flat stock insulation.

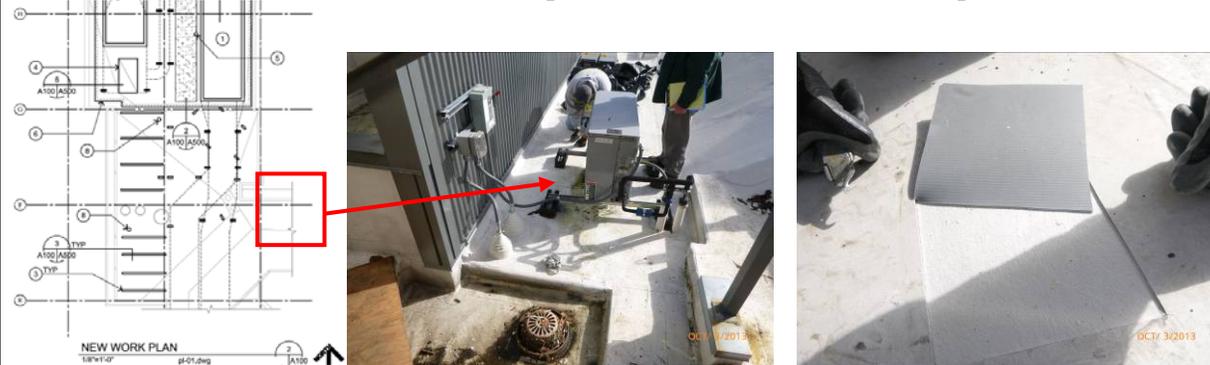
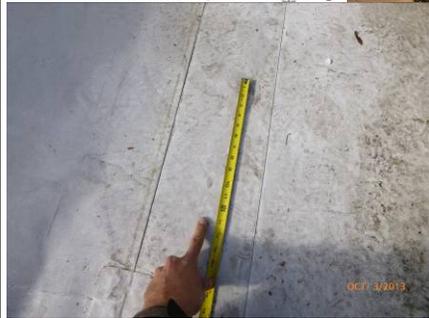
9.3 An opening is cut in to the existing roof just southeast of the Natatorium Roof. No adhesive is observed on the coverboard or backside of the TPO membrane. This appears to be a mechanically fastened system from the observed fastener plates below the membrane at laps.

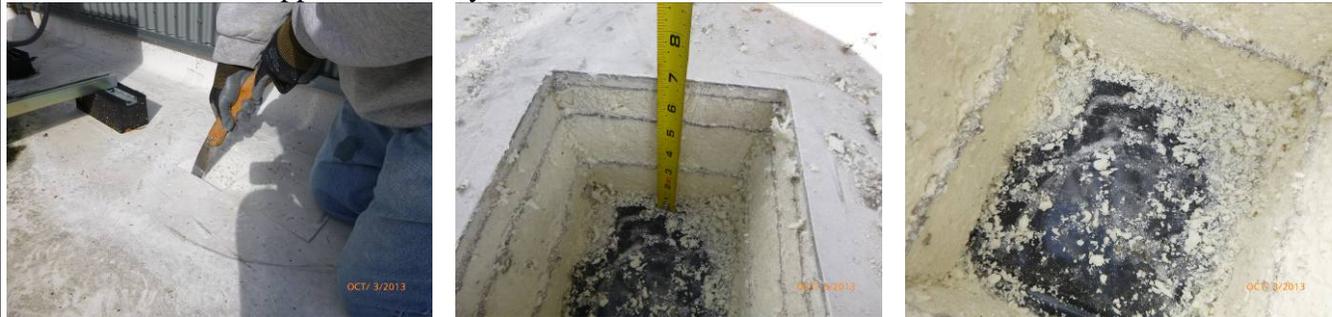
9.3a A hand-saw is utilized to cut through the layers of the roof assembly. The assembly consists of polyethylene vapor retarder layer with tapered polyiso insulation, 1/4-inch coverboard and mechanically fastened TPO membrane. The deck substrate cannot be identified from above. The roof assembly in this location appears to be dry.

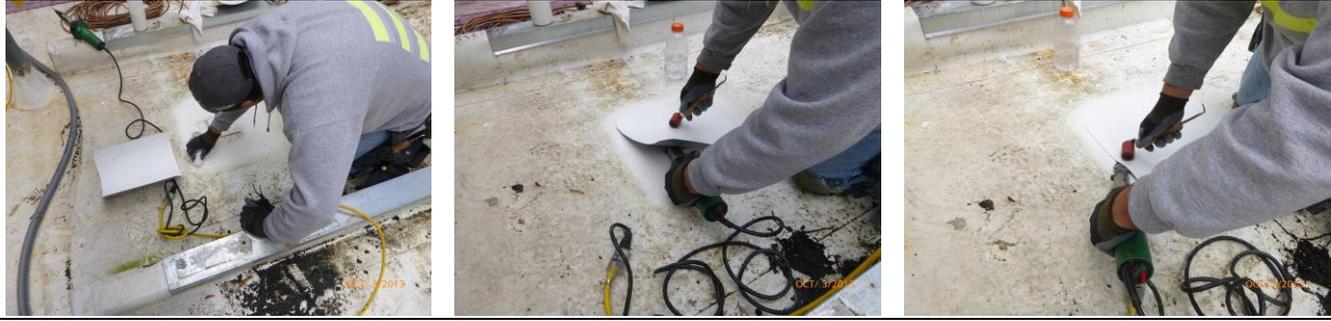
9.4 The test cuts are patched with new TPO membrane heat fused to the existing roof membrane.

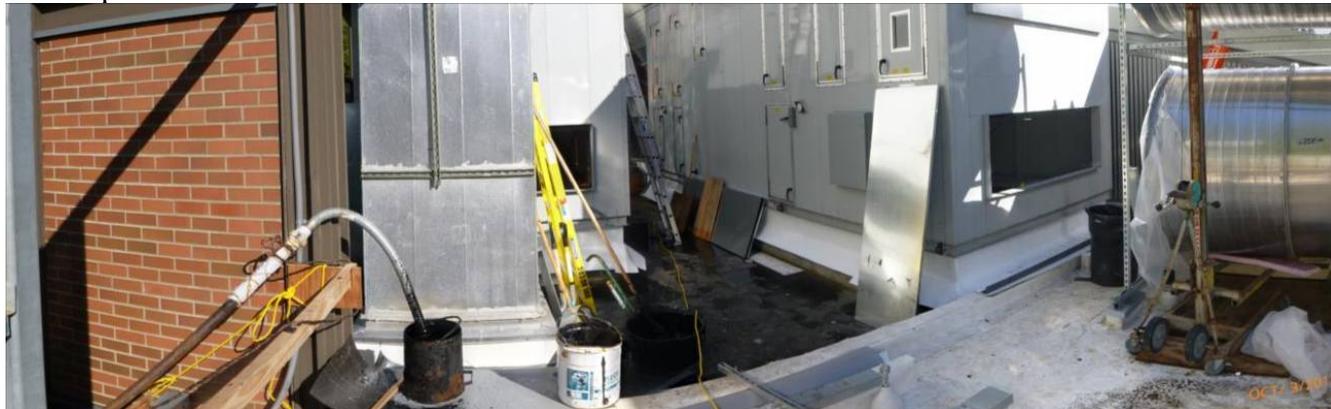
9.5 The overview photo is taken at this writer's departure from the visit. Per conversation with Rich Kerns (Foreman, QCR) work is to commence mid-week (week of October the 7th) during a longer stretch of predicted fair weather.

Overview of the Natatorium Roof taken facing northeast.

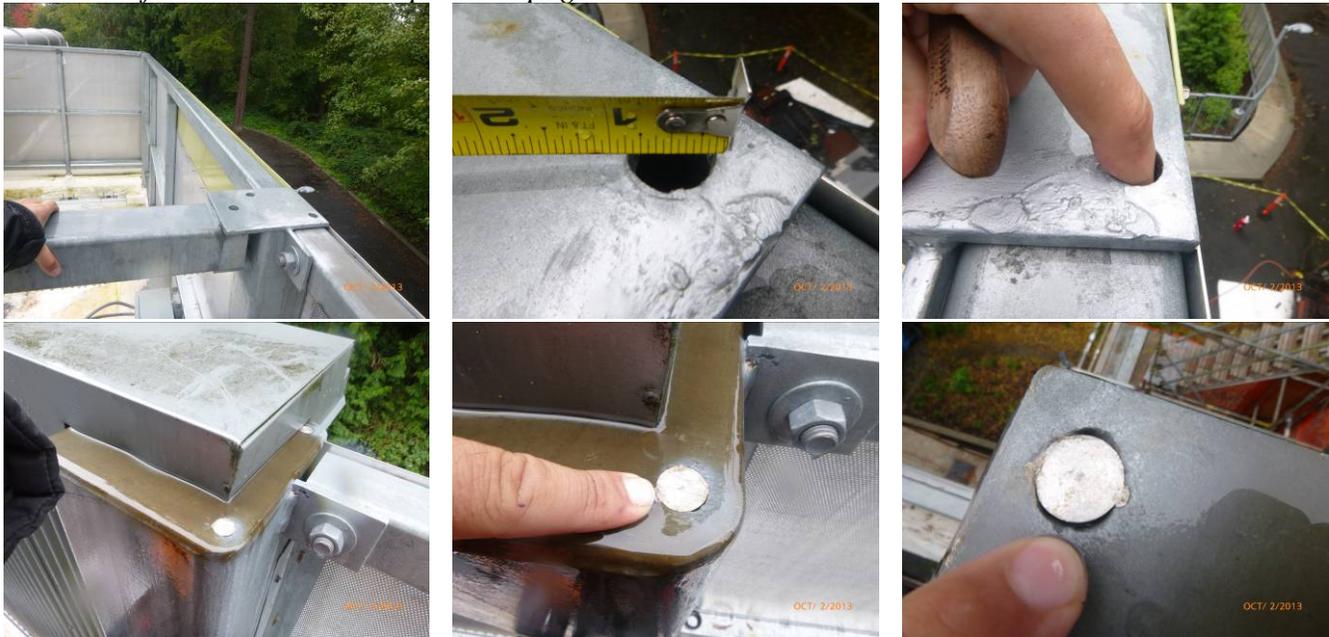
Continued from Item 8.4 on the previous page.

8.4 At the tops of screen wall supports (west elevation of the Natatorium Roof, typical of all large screen wall supports) through holes are observed at the top plates. Some holes appear to be infilled with metal. Recommend that all locations where water will enter are infilled or capped as needed to prevent water from funneling into the column and throughout the roof system below.

Update FR#09 – 10/03/2013: Item is unresolved

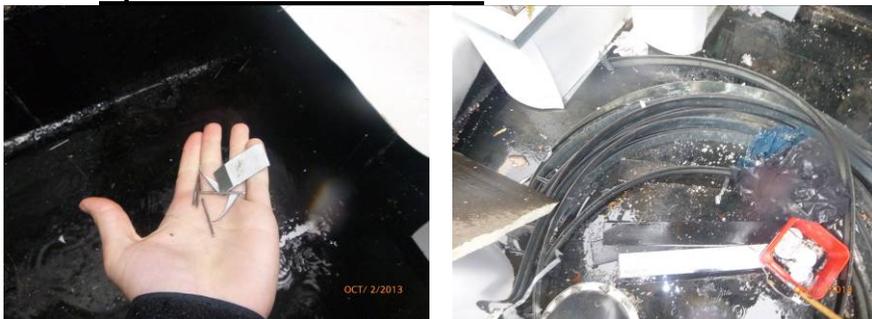
8.5 Recommend that any sheet metal sharps, fasteners and other debris are removed from the new vapor retarder layer to prevent damage.

Update FR#09 – 10/03/2013: Item is unresolved

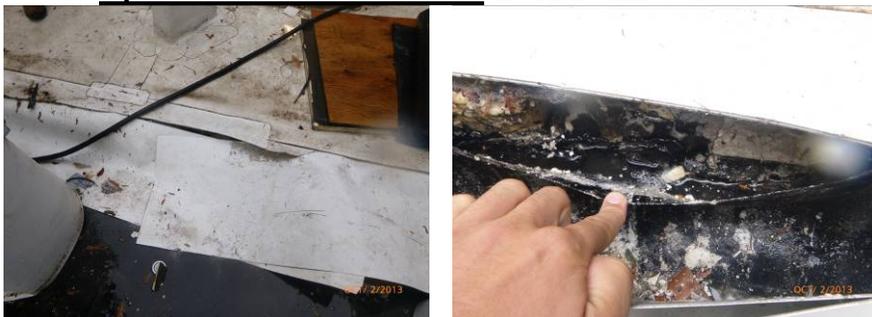
8.6 The night seal at the north end of the Natatorium roof is insufficient in some locations allowing water into the existing roof assembly. The roof to the north was previously observed as wet along with the existing roof that was removed to the south.

Update FR#09 – 10/03/2013: Item is unresolved

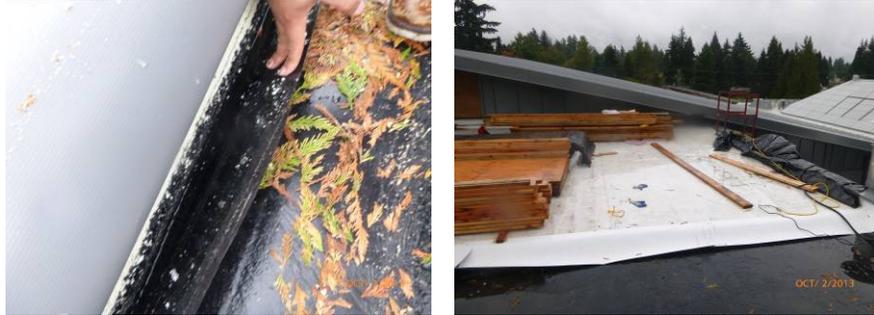
8.7 The absence of a night seal at the chiller room roof allowed water to migrate into the existing roof to the east. The roof to the east was previously observed as wet along with the existing roof that was removed to the west.

Update FR#09 – 10/03/2013: Item is unresolved

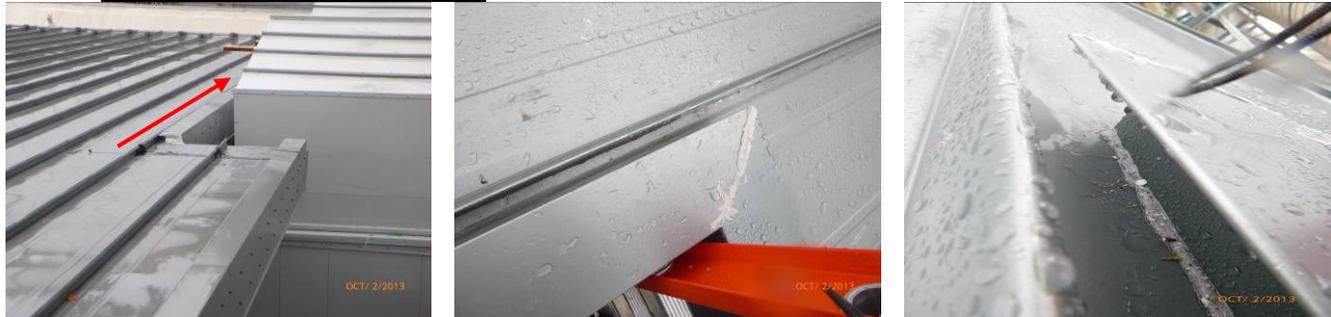
8.8 The sheet metal re-installation at the sawcut in the roof above is ongoing. This writer is unable to verify if the metal panel is notched into a vertical leg behind the flashing enclosure at the fascia. Sealant is observed bleeding out from underneath the roof panel. This area will be further reviewed in dry conditions.

Update FR#09 – 10/03/2013: Item is unresolved

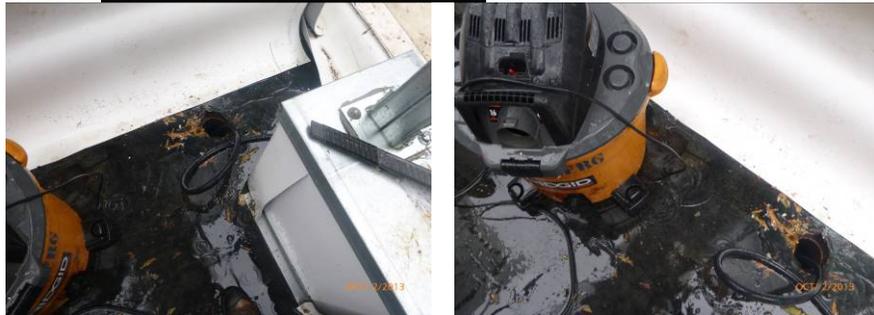
5.6 The roof drain overflow at the northwest corner of the Natatorium Roof is plugged. This writer cannot verify why the roof drain is plugged during this site visit. Recommend that the overflow is unplugged in the event of a heavy rain and that the drains are protected from debris entering and clogging the drainage pipes.

Update FR#09 – 10/03/2013: Item is unresolved

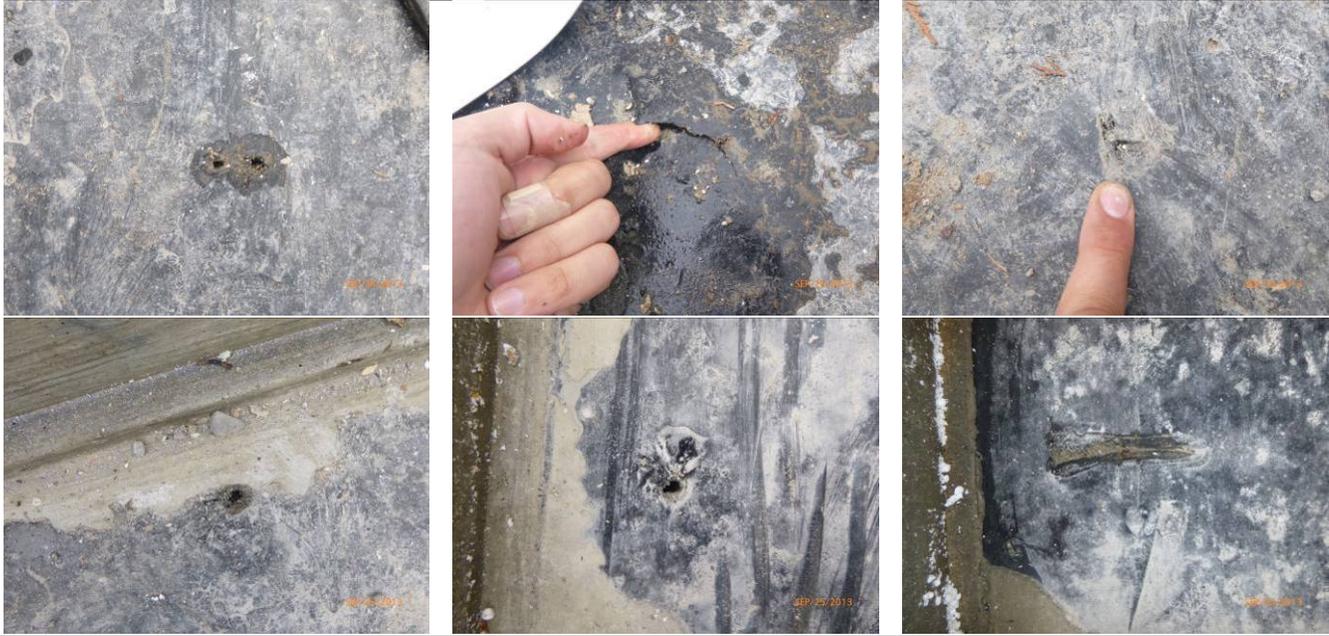
5.8 The vapor retarder layer at the Natatorium Roof is damaged in general. The construction team has been aware that construction sequencing would more than likely damage the vapor retarder layer. Per conversation with Rich Kerns (Foreman, QCR) the temporary roof/ vapor retarder layer is to be repaired with moppings of hot asphalt and plysheet as needed during construction.

Update FR#09 – 10/03/2013: Item is unresolved

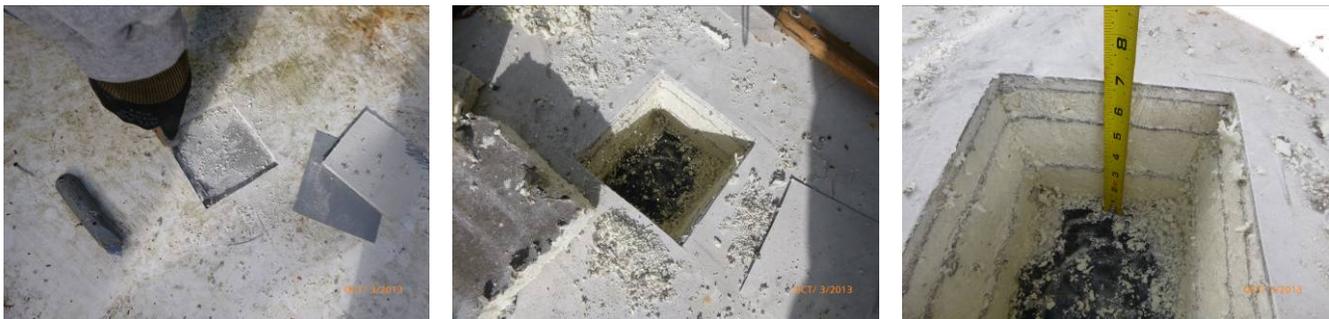
2.4 Per Wetherholt recommendation, the existence of a vapor retarder layer should be verified at the adjacent roof located south of the Natatorium Roof. If the adjacent roof was installed without a vapor barrier there is a possibility that water vapor may transfer over into the new roof assembly and damage the components. Per conversation with Anton Woody (GC, Holmberg) this is out of the scope of his contract but the construction team is aware of this issue.

Update FR#09 – 10/04/2013: Item is closed. A vapor retarder was present at the location of the test cut.

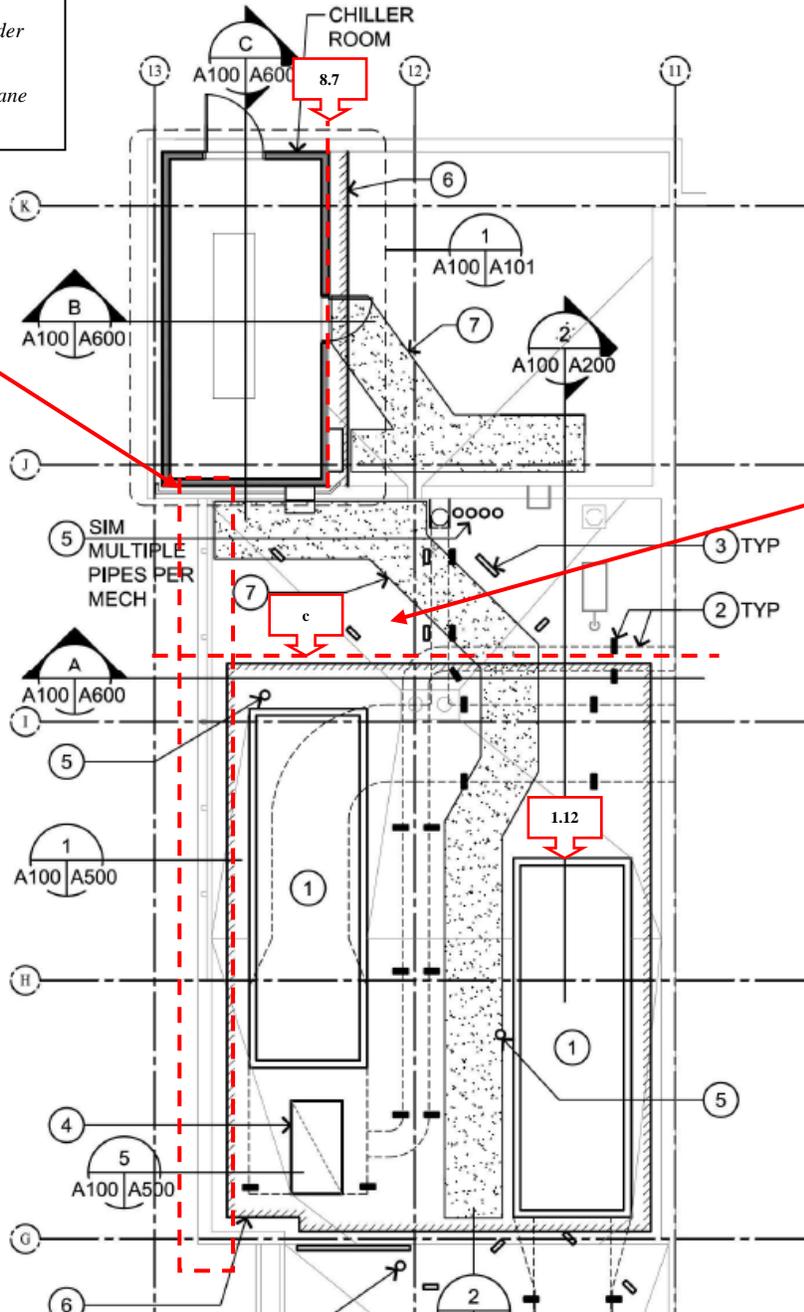
Roof Progress Plan / Locator Map:

Item 8.4: Infill holes in top plates at screen wall structure.

North of this line (approx.) the remainder of the Natatorium roof is wet and damaged as an existing condition.
