Preliminary Roof Infrared Survey Report

Lynnwood Recreation Center
18900 44th Avenue West
Lynnwood, Washington

SITE VISITS – September 4 and 11, 2013

Project No. 1006-22B1
October 18, 2013

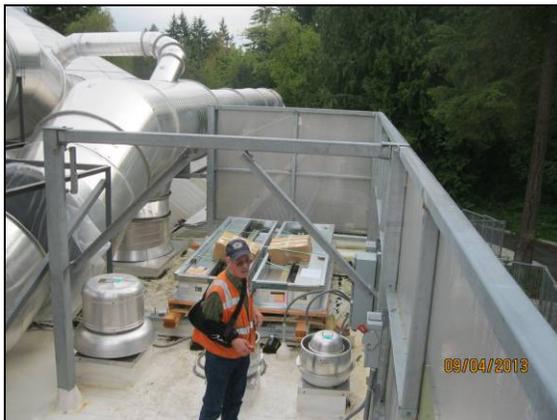
- Galvanizing holes atop the sight screen posts along the west and south perimeter of the northwest roof area were open to water entry. These skyward facing openings allow a point of water entry into the hollow tube steel, possibly migrating out at the base into the roofing assembly. This item was pointed out to Holmberg and Mr. Skore as requiring attention.

Context view of sight screen

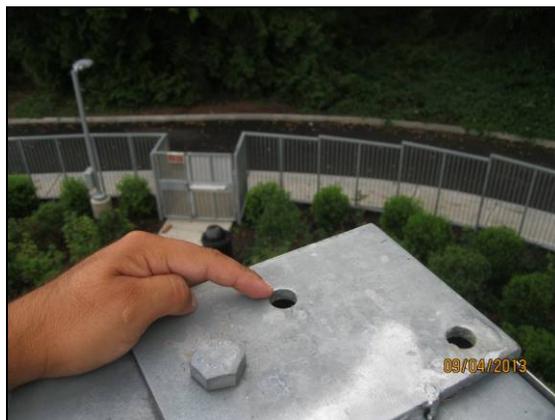
Top of sight screen showing open galvanizing holes

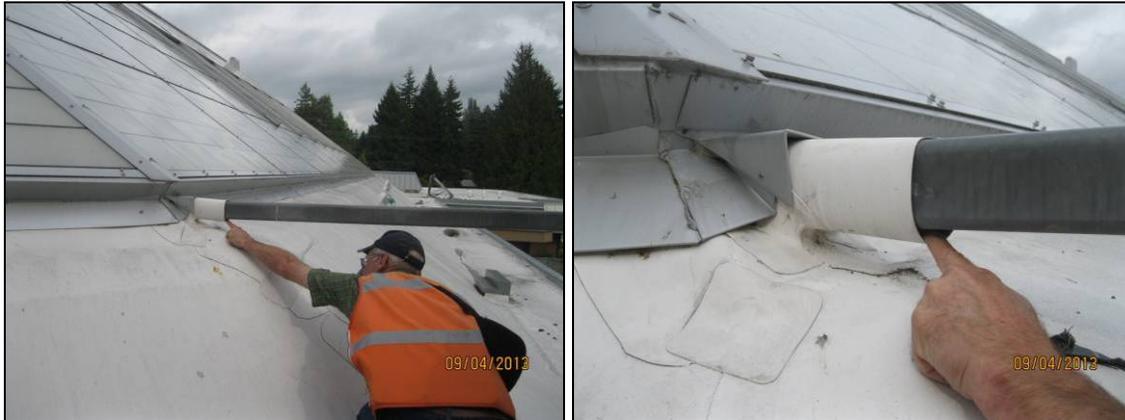
- Horizontal tube steel, of the sight screen bracing, penetrates the roofing near the bottom of the translucent panel skylight system over the south natatorium. These penetrations are installed with un-terminated membrane flashings. Typically, a band clamp with sealant is used to seal the open ends of the flashing. Because band clamps are missing, there is a potential for water to migrate laterally along the tube steel and enter the roofing system at these locations.

Context view of horizontal tube steel penetrations Close up showing lack of termination

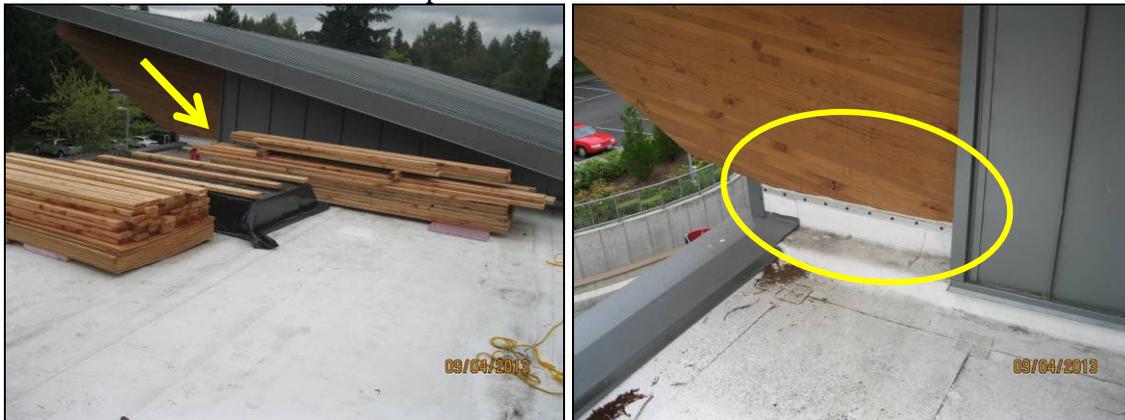
- Termination bar is left exposed where attached to the glulam beam near the north end of the west elevation above the staircase roof. This detail, while possibly warrantable by the manufacturer, requires routine maintenance to the sealant, which in most cases, is excluded in the warranty. Adjacent metal cladding system should have been extended to counterflash this termination point.

Context view of west elevation over staircase roof Exposed termination bar with sealant

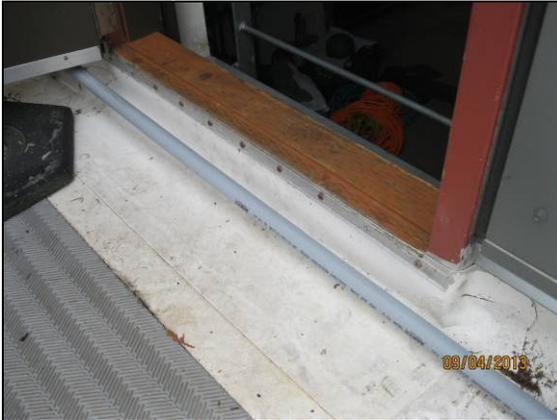
- At the access door on the south elevation of the storage room out onto the roof where new HVAC work is being performed, the termination bar for the flashing membrane is exposed at the sill. At the jambs, where the flashing membrane returns back towards the wall, the exposed top edge of the membrane is dependent on sealant which has adhesively failed.

Context view of access door sill

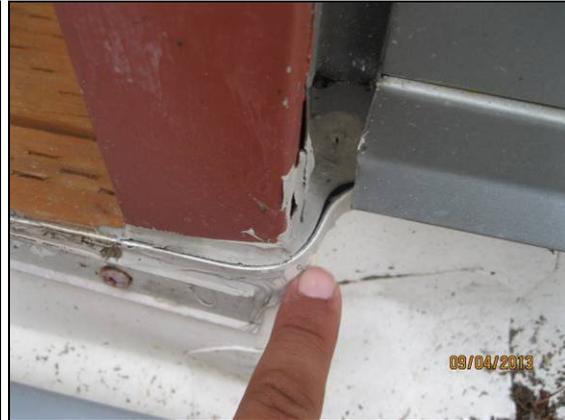
Wall flashing return showing exposed edge of membrane

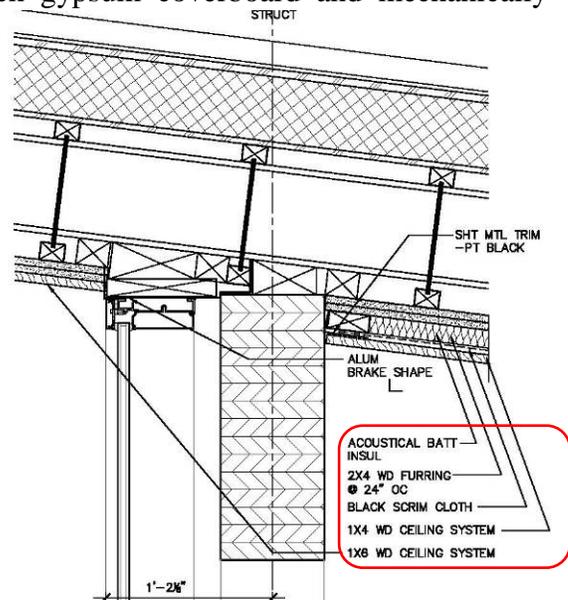
Detail 22/A5.4 from NAC architecture plans dated 12/11/2009 listing ceiling assembly under SIPs

In regards to anomaly location 1, further intrusive investigation is required to determine how the SIPs connections were installed and confirm if a vapor barrier exists under the SIPs. Per Detail 22/A5.4 shown on Page 4, a 'black scrim cloth' is called out which would not provide a vapor barrier. There is a potential for condensation to occur at the Carlisle WIPHT self adhering underlayment due to warm and humid interior air migrating through the SIPs joints.

Considering the pool environment below, a continuous vapor barrier under the SIPs panels must be in place or moisture diffusion through the panels may result in condensation at the impervious roof underlayment over the panels, trapping moisture in the assembly.

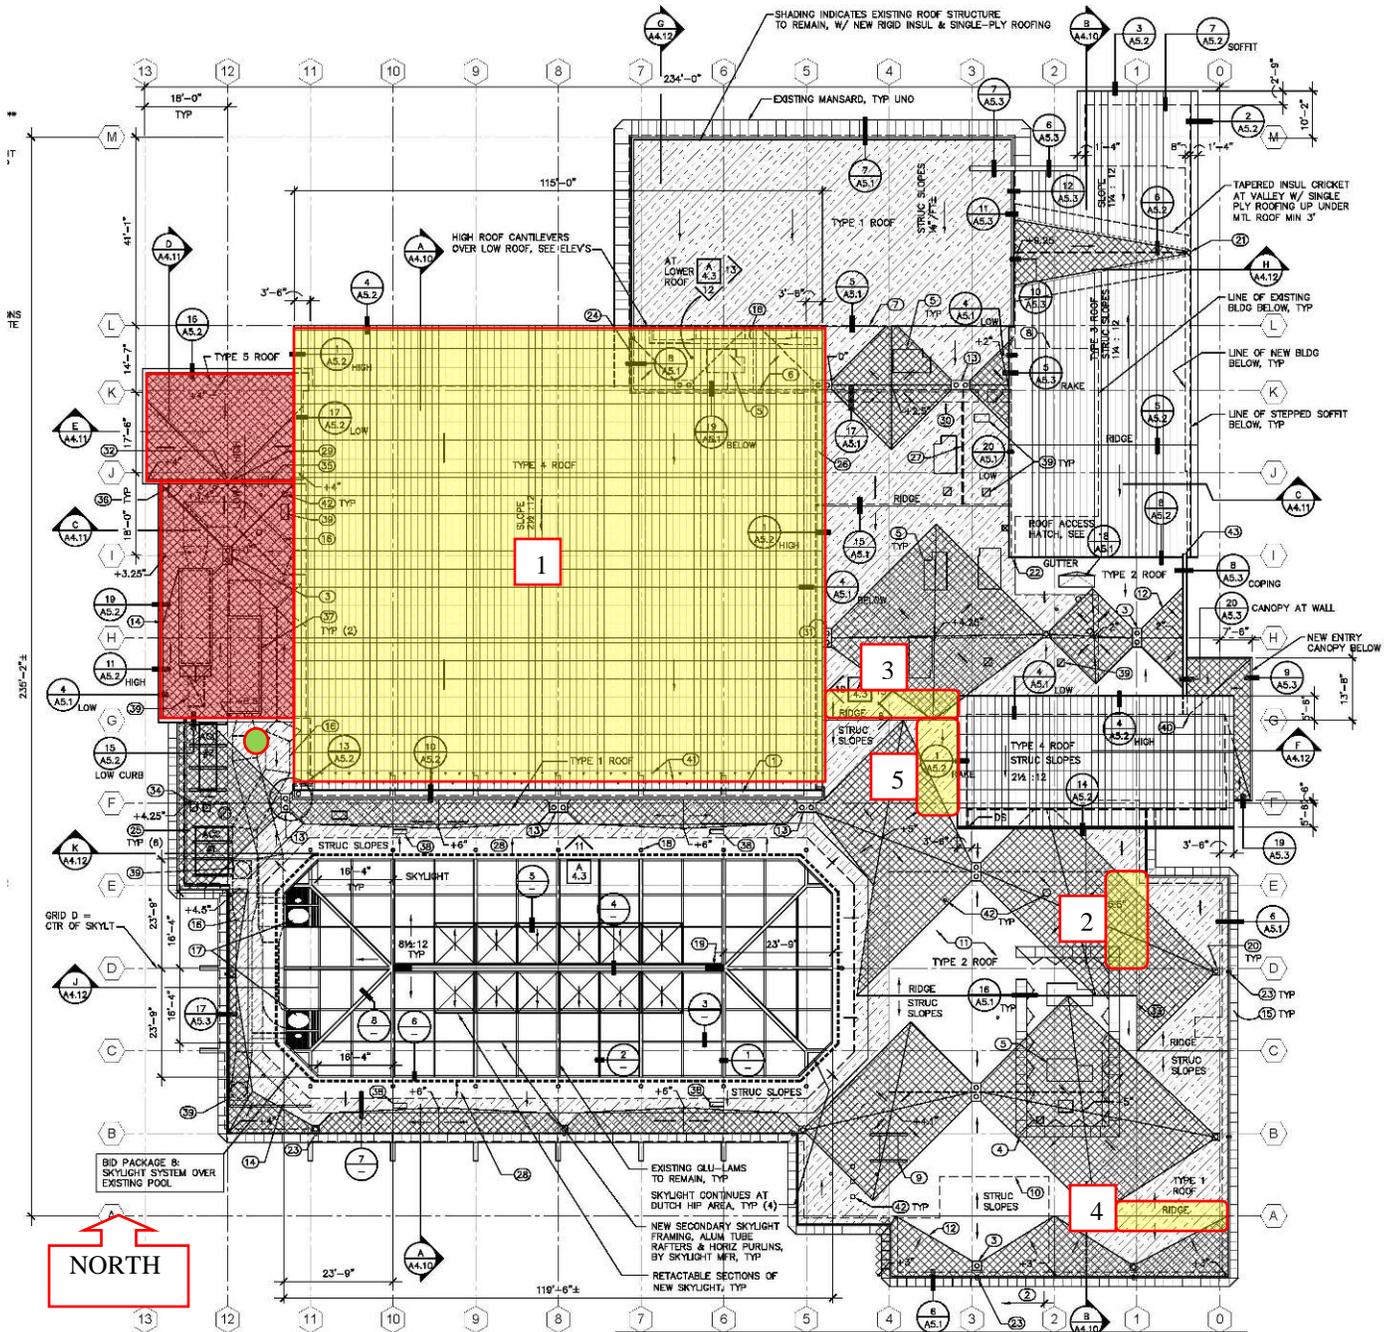
Moisture Survey Roof Plan

A roof plan denoting the approximate locations of the anomalies listed above is attached at the end of this report.

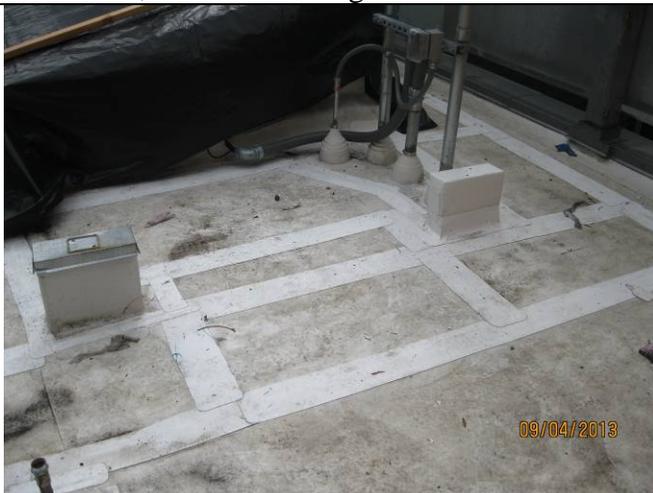
Photograph #3

Near northwest corner of roof referenced on previous photo where initial roof demo occurred and halted due to discovering moisture in cover board.

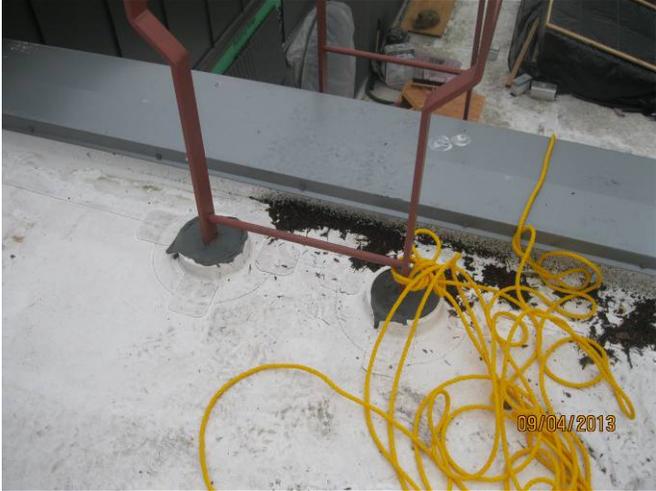
<p>Photograph #4</p> <p>Penetration pockets for ladder onto higher elevation northwest area roof. Note that this detail typically requires routine maintenance due to the exposed filler material.</p>

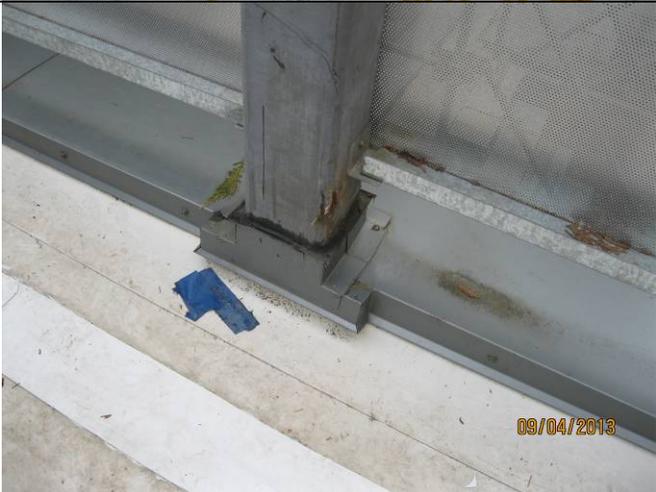
<p>Photograph #5</p> <p>View of sight screen post at base along west perimeter of roof area referenced on photo #2. Metal counterflash with sealant cup appears to be integrated with the coping metal.</p>

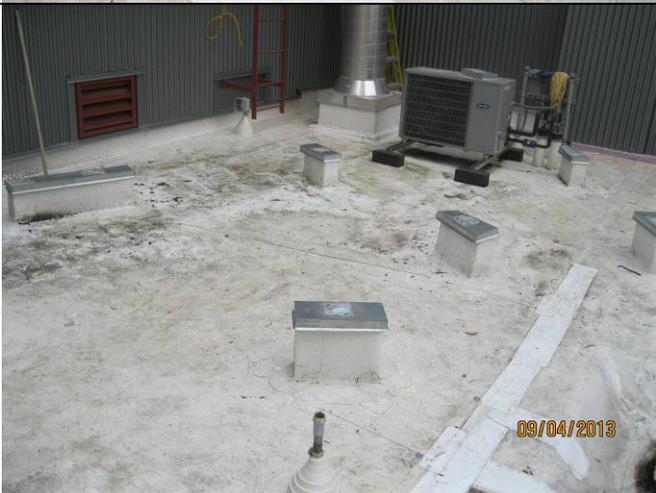
<p>Photograph #6</p> <p>Northeast corner of roof area referenced on photo #2 showing existing duct support curbs to remain from ductwork removal.</p>

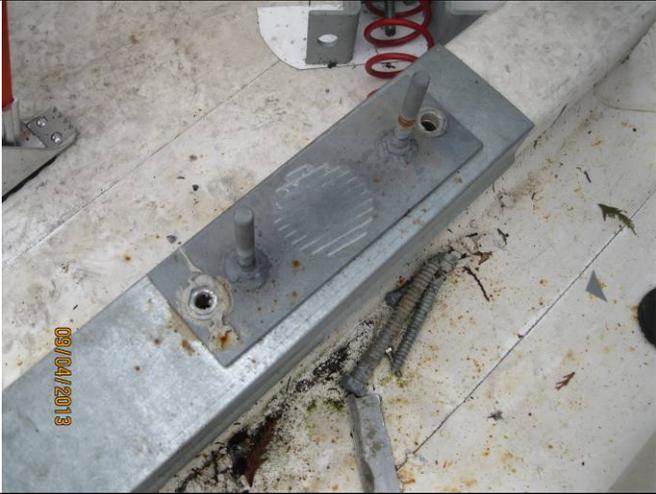
<p>Photograph #7</p> <p>Close up of remaining duct support curb/sleeper. Plate attached through metal cap on curb appears to have been applied with sealant around fasteners.</p>

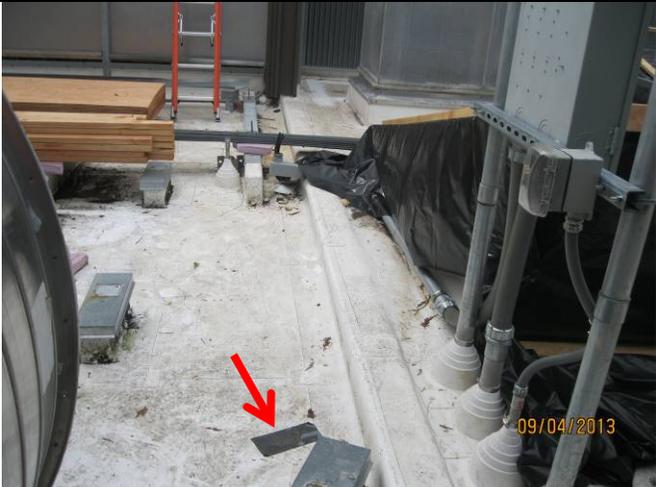
<p>Photograph #9</p> <p>View of curb that divides north roof area (concrete over steel deck) and south roof area (wood deck).</p> <p>Arrow points to self adhered membrane patch.</p>

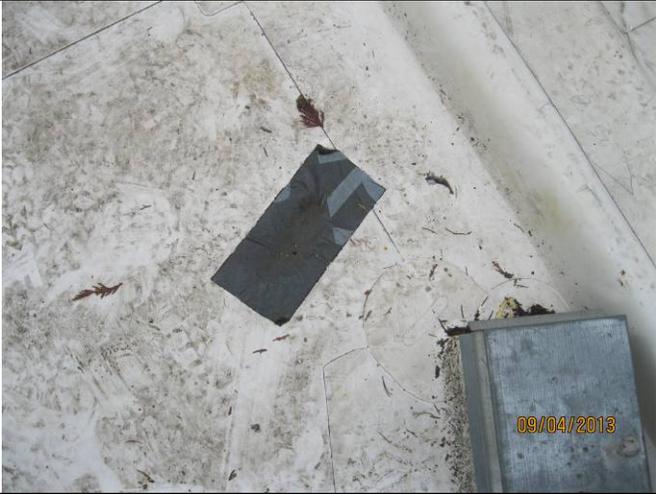
A close-up photograph of a roof surface showing a dark, rectangular self-adhered membrane patch. The patch is surrounded by a white, fibrous material, likely insulation or a substrate. A date stamp '09/04/2013' is visible in the bottom right corner of the image.	<p>Photograph #10</p> <p>Close-up of previous self adhered membrane patch, appears to be Grace product, installed over TPO membrane. Patch should be replaced with a hot air welded TPO membrane patch.</p>

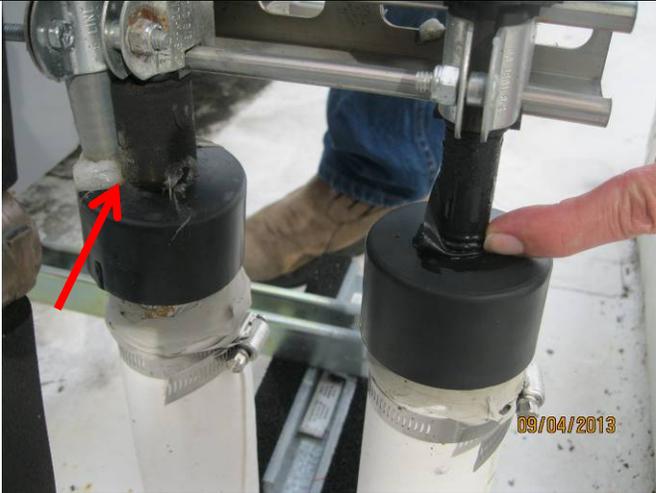
A close-up photograph of two HVAC penetrations on a roof. The penetrations are white pipes with black caps. A red arrow points to the left penetration. A date stamp '09/04/2013' is visible in the bottom right corner of the image.	<p>Photograph #11</p> <p>Penetrations adjacent to Carrier HVAC unit near the northeast corner of roof area referenced on photo #2. Caps over membrane flashing wraps appear to be dependent on tape or sealant to keep watertight. Note two penetrations through same pipe on left.</p>

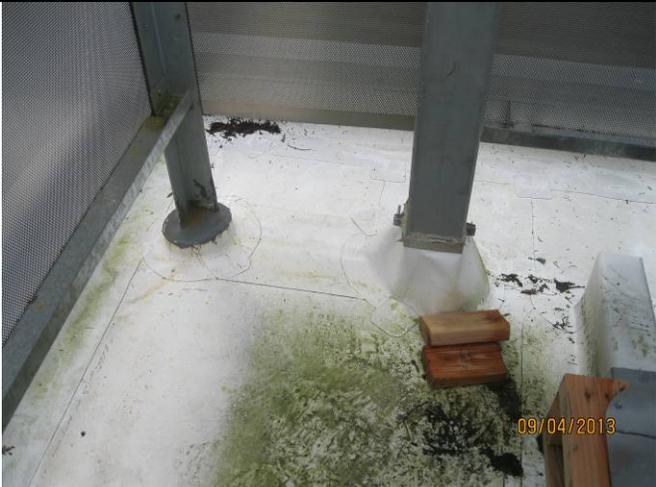
A photograph showing two sight screen posts on a roof. The posts are grey metal and are surrounded by a white sealant. The roof surface is white and shows some green algae or mold. A date stamp '09/04/2013' is visible in the bottom right corner of the image.	<p>Photograph #12</p> <p>Sight screen post penetrations at the southwest corner of roof adjacent to skylight over natatorium.</p> <p>Sealant in the penetrations should be considered maintenance items.</p>

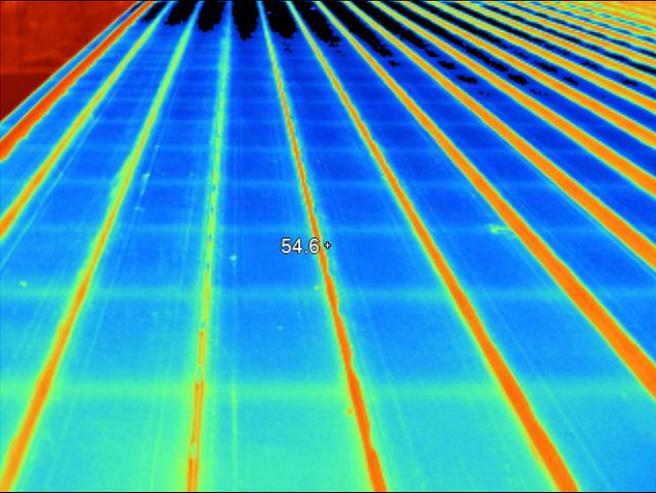
- At the steep slope metal roof over the natatorium, a higher heat signature was observed in lines running perpendicular

to the roof slope about 4 feet apart. It appears that this correlates with the edges of the SIPs panels which may indicate thermal bridging through the joints. Typically, SIPs connections are assembled with block or I-joist splines which are to be applied with continuous panel sealant on each side of the spline. In most cases, 6 inch SIP tape is specified on the (winter) warm side of the panel to prevent air and moisture infiltration into the assembly.

An infrared thermal image of a standing seam metal roof. The image shows a series of parallel lines representing the roof's structure. The color scale ranges from blue (cooler) to red (warmer). A temperature reading of '54.6°' is visible in the center of the image.	<p>Photograph #14</p> <p>Anomaly 1 - Infrared image of standing seam metal roof over natatorium, west rake area.</p> <p>Note higher heat signature in lines perpendicular to roof slope.</p>

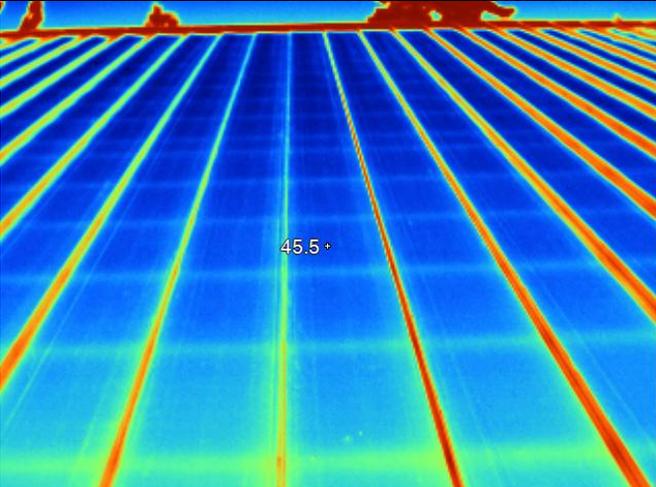
An infrared thermal image of a standing seam metal roof, similar to the previous one but showing a different area. It features the same parallel line pattern and color scale. A temperature reading of '45.5°' is visible in the center of the image.	<p>Photograph #15</p> <p>Anomaly 1 - Infrared image of standing seam metal roof over natatorium, field of roof.</p> <p>Note higher heat signature in lines perpendicular to roof slope.</p>

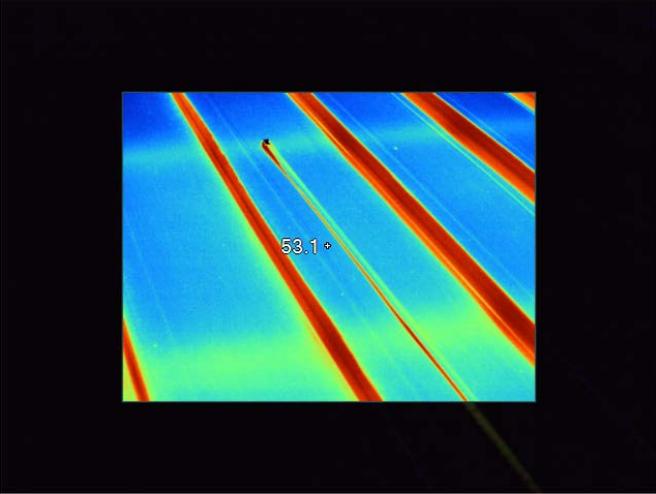
<p>Photograph #16</p> <p>Anomaly 1 - Picture-in picture infrared image of standing seam metal roof over natatorium, field of roof.</p> <p>Note higher heat signature in lines perpendicular to roof slope.</p> <p>Tape measure showed approximate 4-foot on center spacing.</p>

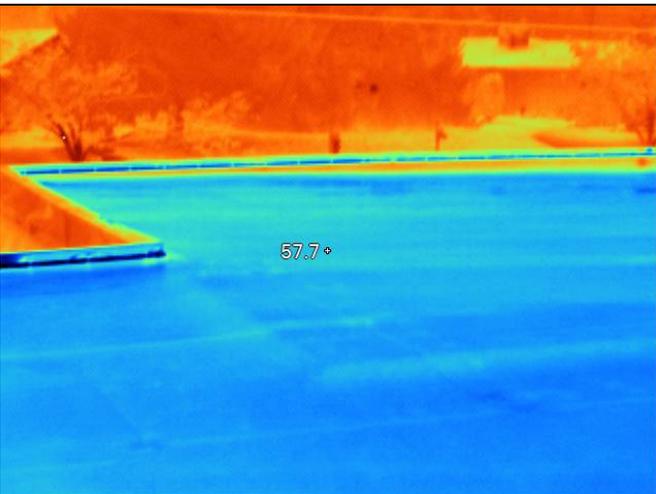
- 2) South of the clerestory wall of the Lobby roof, a higher heat signature was observed where bridging or unevenness of the coverboard appears to occur. No elevated moisture was detected with the Tramex RWS scanner.

<p>Photograph #17</p> <p>Anomaly 2 - Infrared image of change in plane in low slope roof, south of Lobby clerestory.</p> <p>Note higher heat signature at edge of what appears to be bridging coverboard.</p>

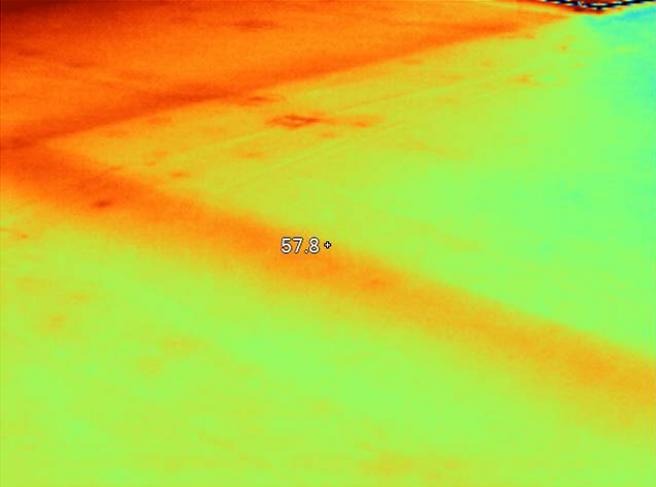
<p>Photograph #18</p> <p>Anomaly 2 - Infrared image of change in plane in low slope roof, south of Lobby clerestory.</p> <p>Note higher heat signature at edge of what appears to be bridging coverboard.</p>

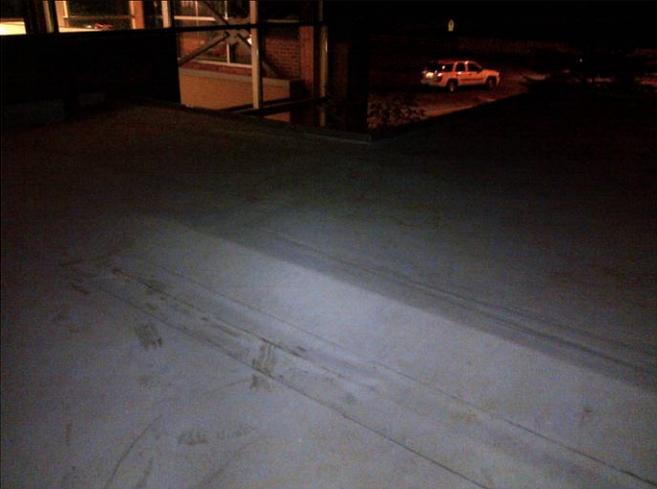
<p>Photograph #19</p> <p>Anomaly 2 – Digital photo of previous digital image, Photo #18.</p>

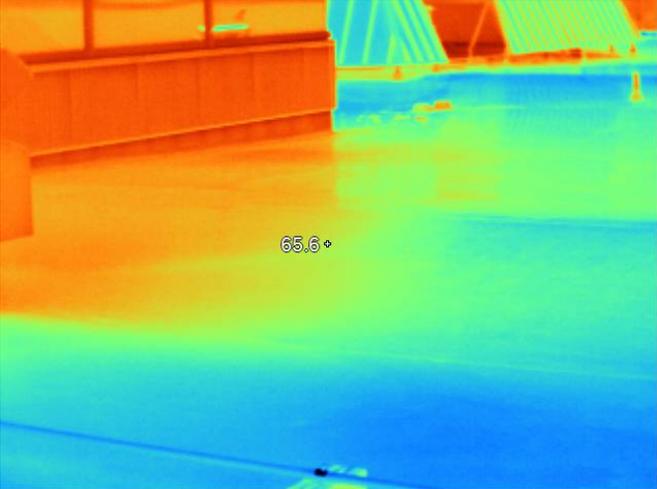
- 3) West of the northwest corner of the Lobby clerestory, a higher heat signature was observed where the single ply membrane has stretched and is bridging over a change in the plane of the roof assembly. No elevated moisture was detected with the Tramex RWS scanner.

<p>Photograph #20</p> <p>Anomaly 3 - Infrared image of change in plane in low slope roof where single ply membrane is stretched, west of northwest corner of Lobby clerestory.</p>

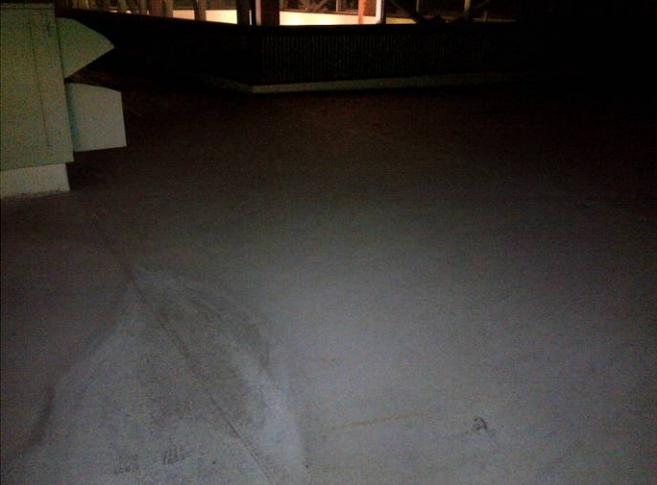
<p>Photograph #21</p> <p>Anomaly 3 – Digital photo of previous digital image, Photo #20.</p>

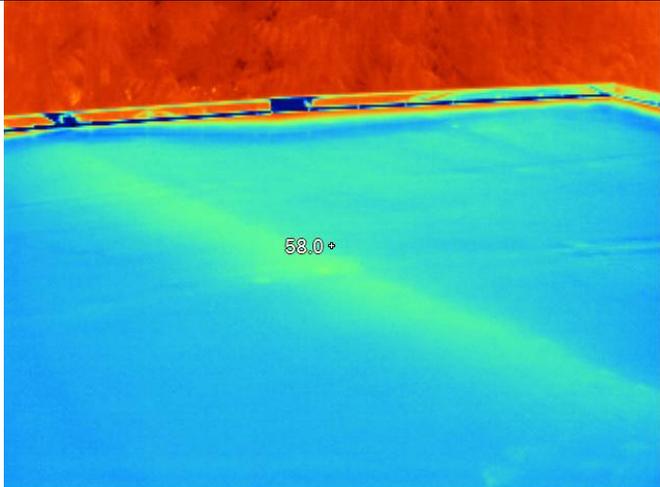
- 4) Near the southeast corner of the main low slope roof area, what appears to be bridging or unevenness in the coverboard at perimeter edges resulted in a higher heat signature. No elevated moisture was detected with the Tramex RWS scanner.

<p>Photograph #22</p> <p>Anomaly 4 - Infrared image of change in plane in low slope roof, southeast corner.</p> <p>Note higher heat signature at edge of what appears to be bridging coverboard.</p>

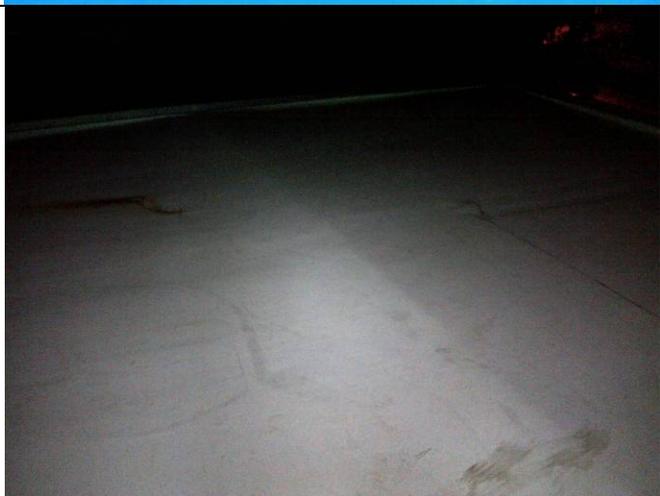
<p>Photograph #23</p> <p>Anomaly 4 – Digital photo of previous digital image, Photo #22.</p>

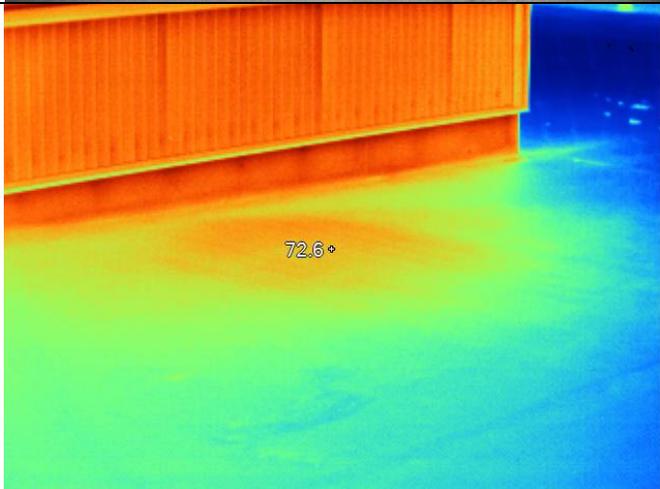
- 5) Adjacent to the west elevation of the Lobby clerestory, a higher heat signature was observed with the IR camera. Tramex RWS detected elevated moisture at this location. It appears that moisture intrusion may be present within this area. Destructive testing to confirm is recommended.

<p>Photograph #24</p> <p>Anomaly 5 - Infrared image west of Lobby clerestory.</p> <p>Note higher heat signature which may be an indication of moisture entrapment.</p>

Based on the IR survey and spot checks with the Tramex RWS scanner, it appears that anomaly location 5 listed above may be the result of moisture infiltration. Test cut(s) by a manufacturers approved installer should be performed to confirm the presence of moisture in the roofing assembly and further investigate potential leak sources if confirmed.

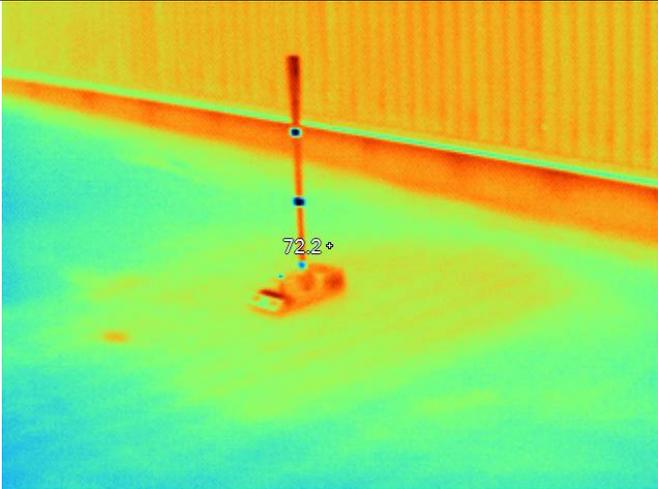
<p>Photograph #25</p> <p>Anomaly 5 - Infrared image west of Lobby clerestory, looking in a northeast direction.</p> <p>Tramex RWS scanner placed over area where anomaly was detected with IR camera.</p>

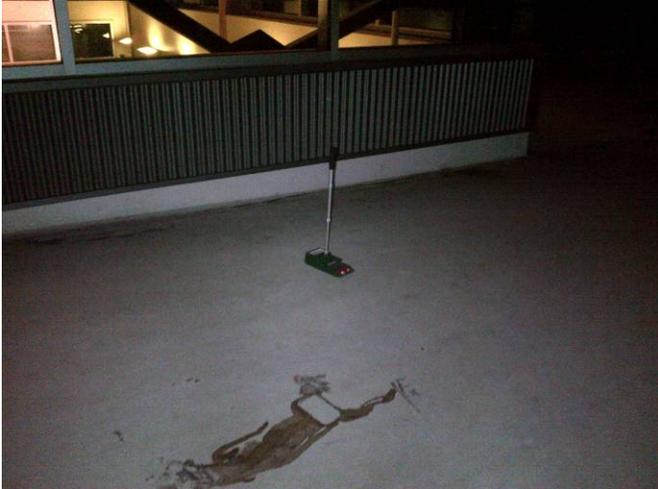
<p>Photograph #26</p> <p>Anomaly 5 – Digital photo of previous infrared image looking in a southeast direction.</p> <p>Tramex RWS scanner placed over area where anomaly was detected with IR camera.</p>

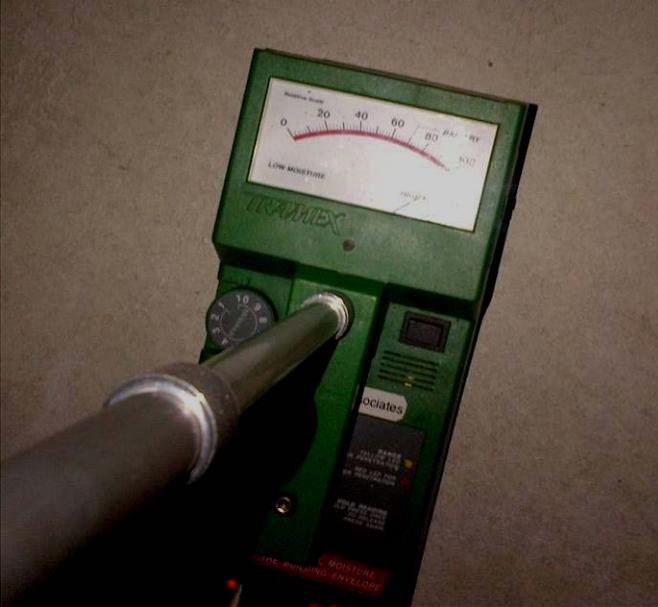
<p>Photograph #27</p> <p>Anomaly 5 – View of Tramex RWS analog display indicating high moisture content.</p> <p>Test cut should be performed and repaired by manufacturer’s approved installer to confirm readings.</p>
