LYNNWOOD INFILTRATION AND INFLOW STUDY

G&O #08624
February 2011

CITY OF LYNNWOOD

INFILTRATION AND INFLOW STUDY

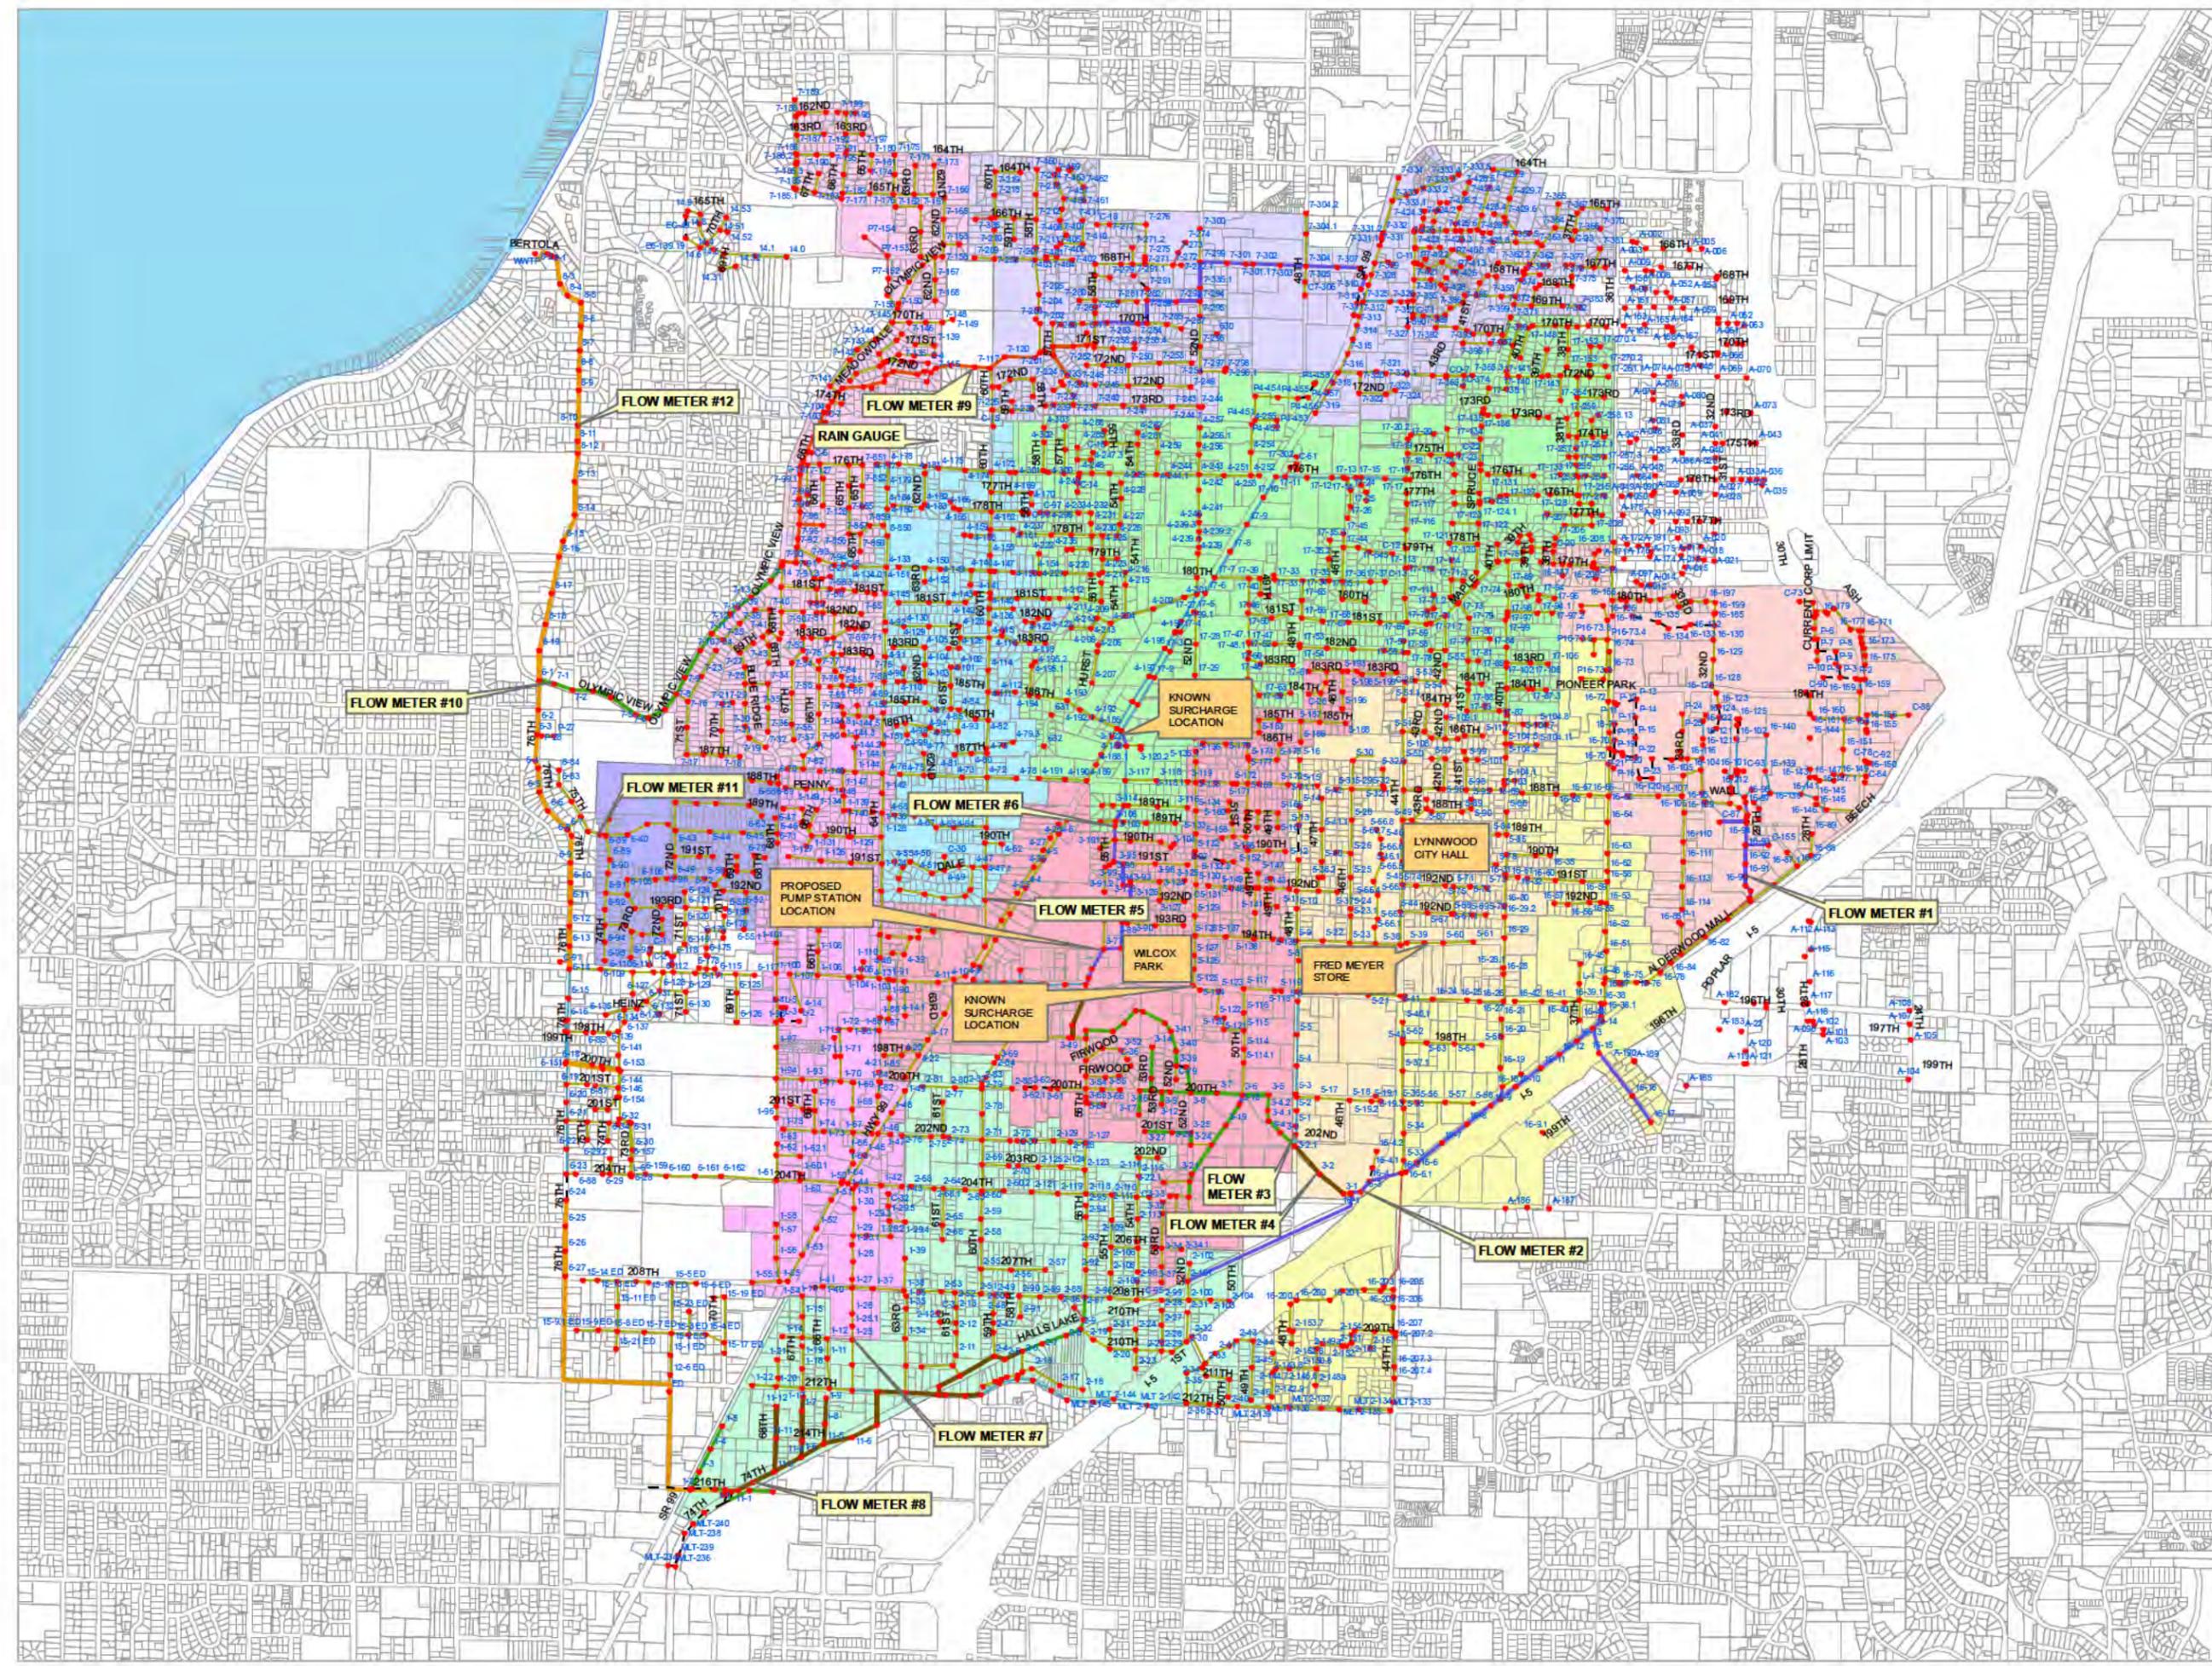
FIGURE 1
FLOWMETER LOCATIONS
WASTEWATER COLLECTION SYSTEM

The results shown in Table 1 are not unexpected. The older areas of the City’s sewer system with more concrete sewer pipe are shown to have more infiltration and inflow. The areas which drain to Lift Station No. 10 and Lift Station No. 12, both at or near capacity are also shown to have more infiltration and inflow. The Flow Meter Basin No. 3 is shown to be the worst basin with respect to both infiltration and inflow. We expect that Flow Meter Basin No. 4 also has high I/I since it is a known problem area, but did not capture sufficient data for this basin. Flow Meter Basin No. 8 is shown to have a high rate of infiltration and we expect the results would show a high rate of inflow if the January 7th storm event was captured. Flow Meter Basin No. 5 is shown to have a moderate rate of both infiltration and inflow. The remainder of the Flow Meter Basins all show moderate to low rates of I/I.

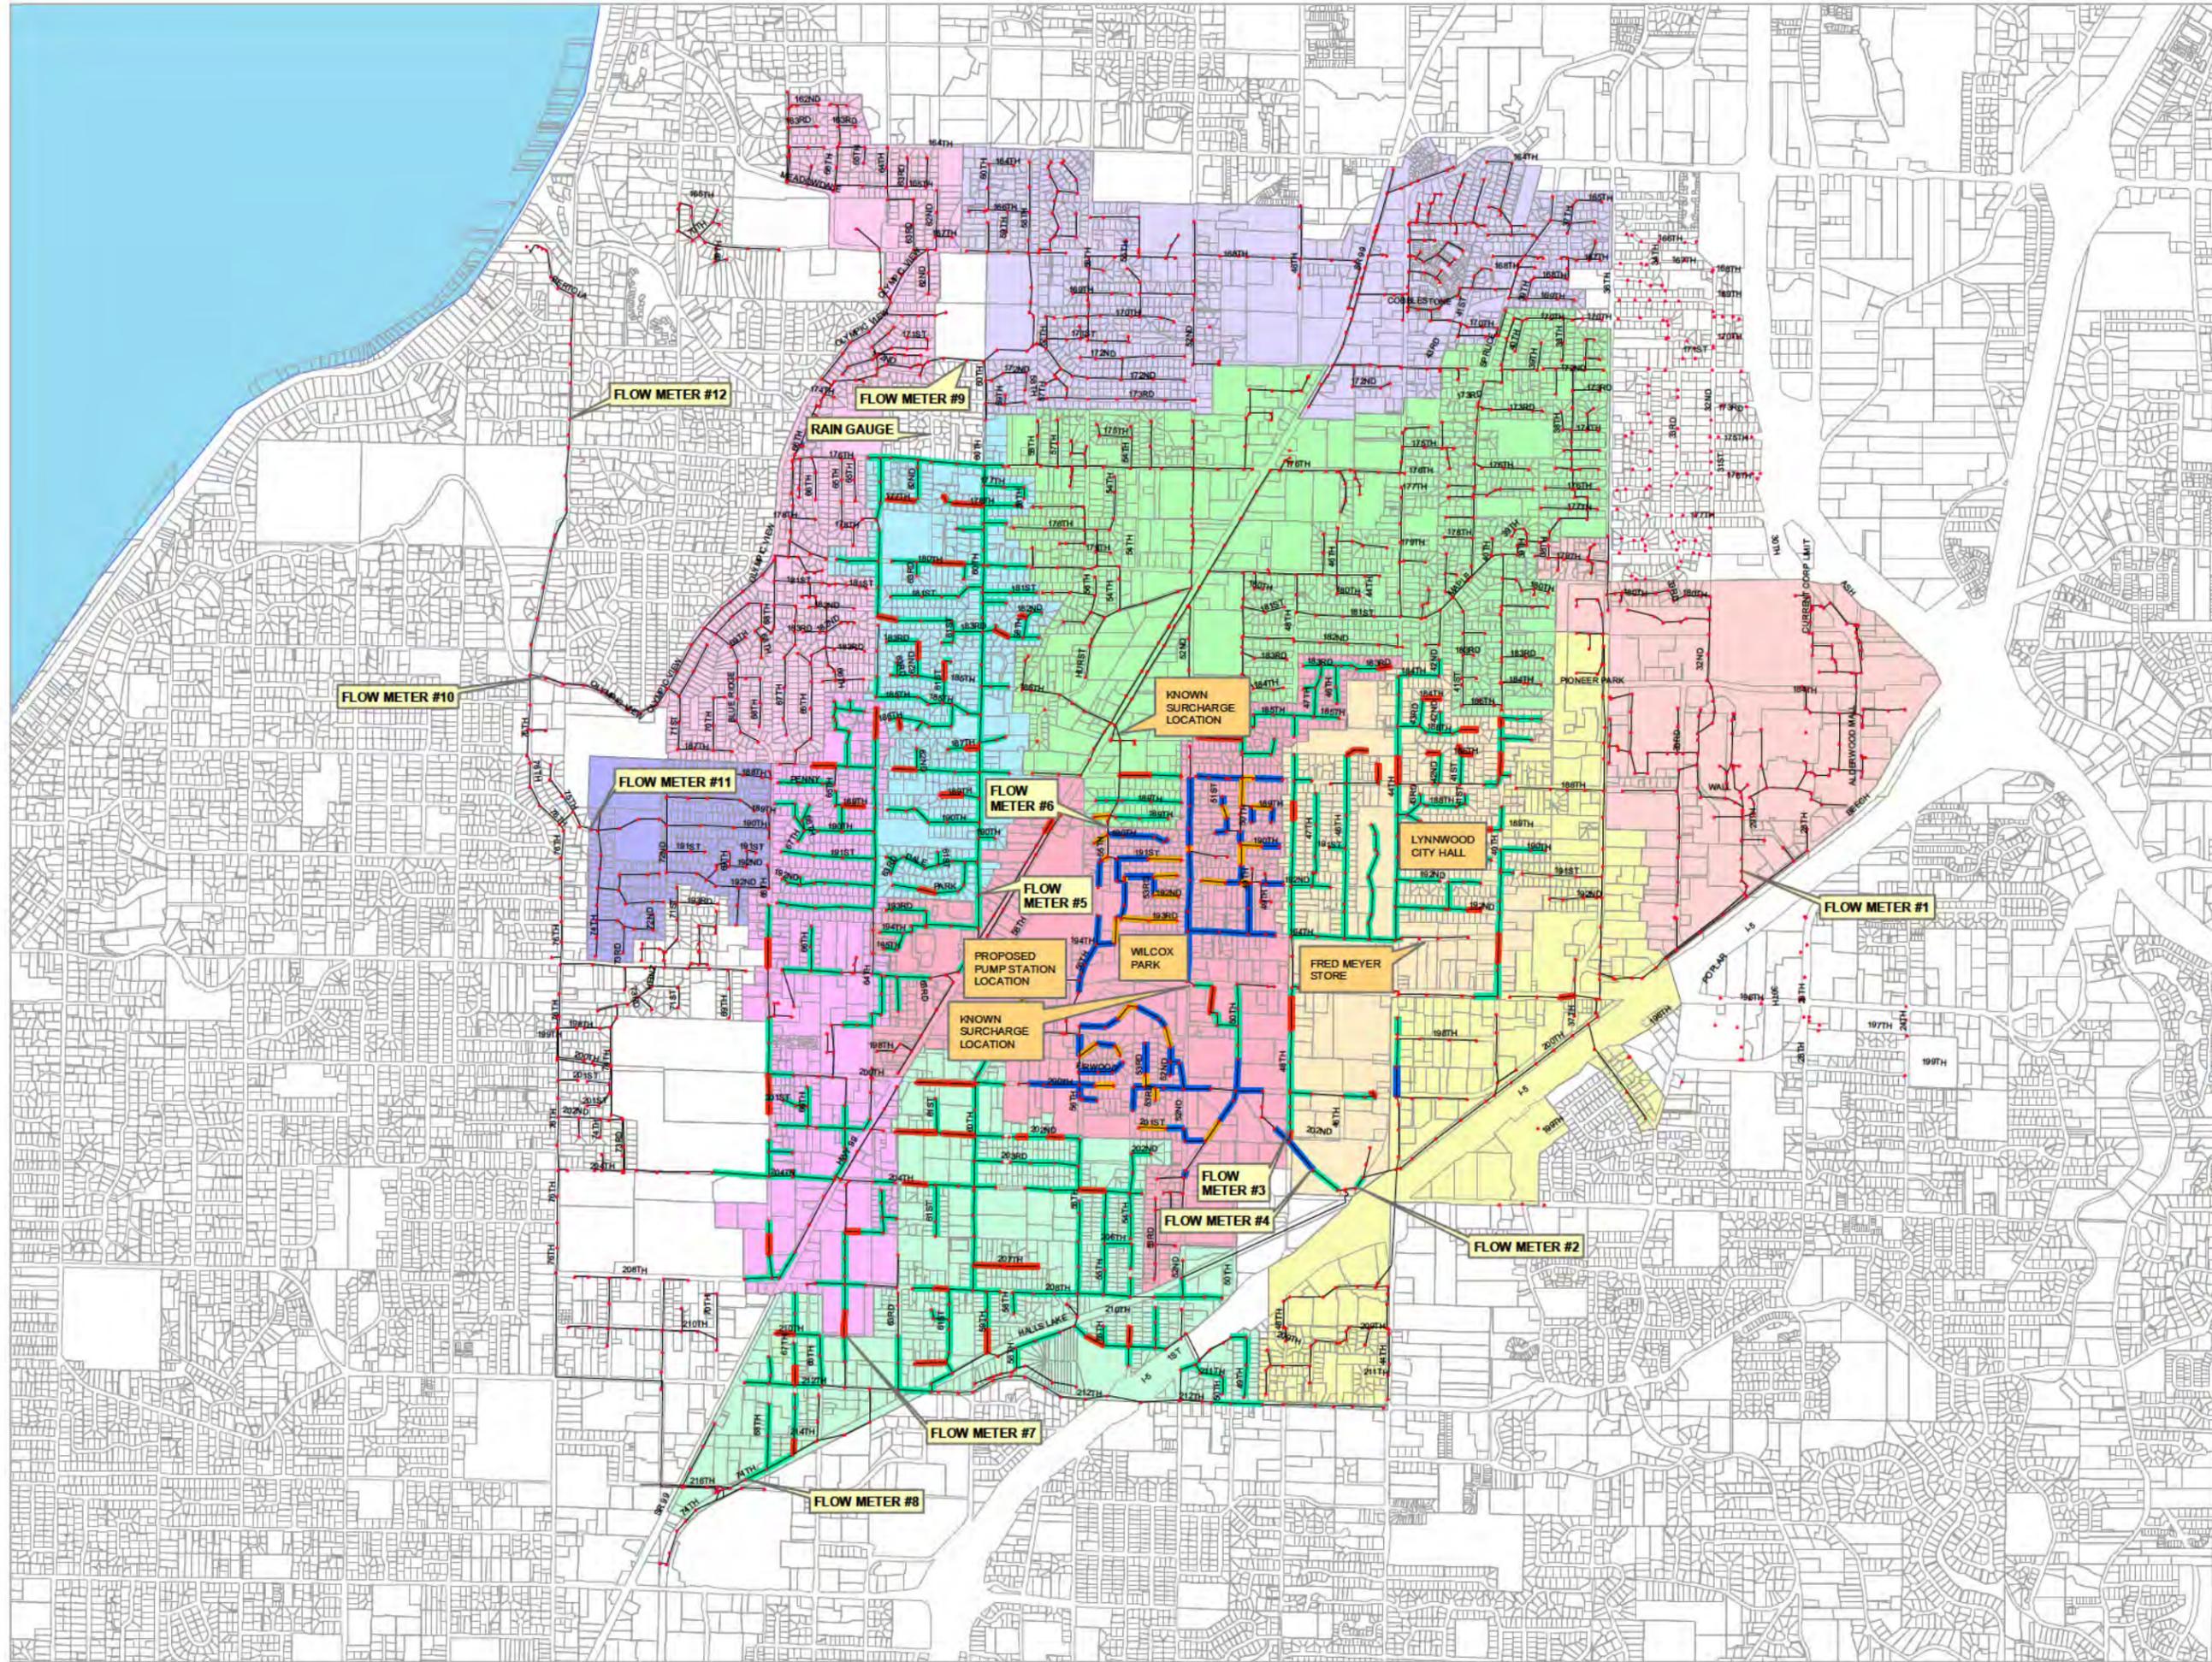
FIGURE 2
1992 & 2009 SMOKE TESTING RESULTS

A total of 98 problems were identified through the smoke testing results. A typical problem included smoke coming out of roof drains, leaky cleanout caps, or through the ground indicating leaking or broken sewer pipe. Each of the smoke testing problems were ranked by the severity of the problem. The severity of each problem was broken down into the following categories; Severe, Heavy, Medium, Light, Unknown, and None. The Unknown category included problems where the severity and the source of the problem is not known. An example of the Unknown category is smoke emanating from under a deck on private property and staff were unable to enter the site to determine the problem. The None category includes problems located in the field which were later determined to not be problems. An example of the None category is smoke coming

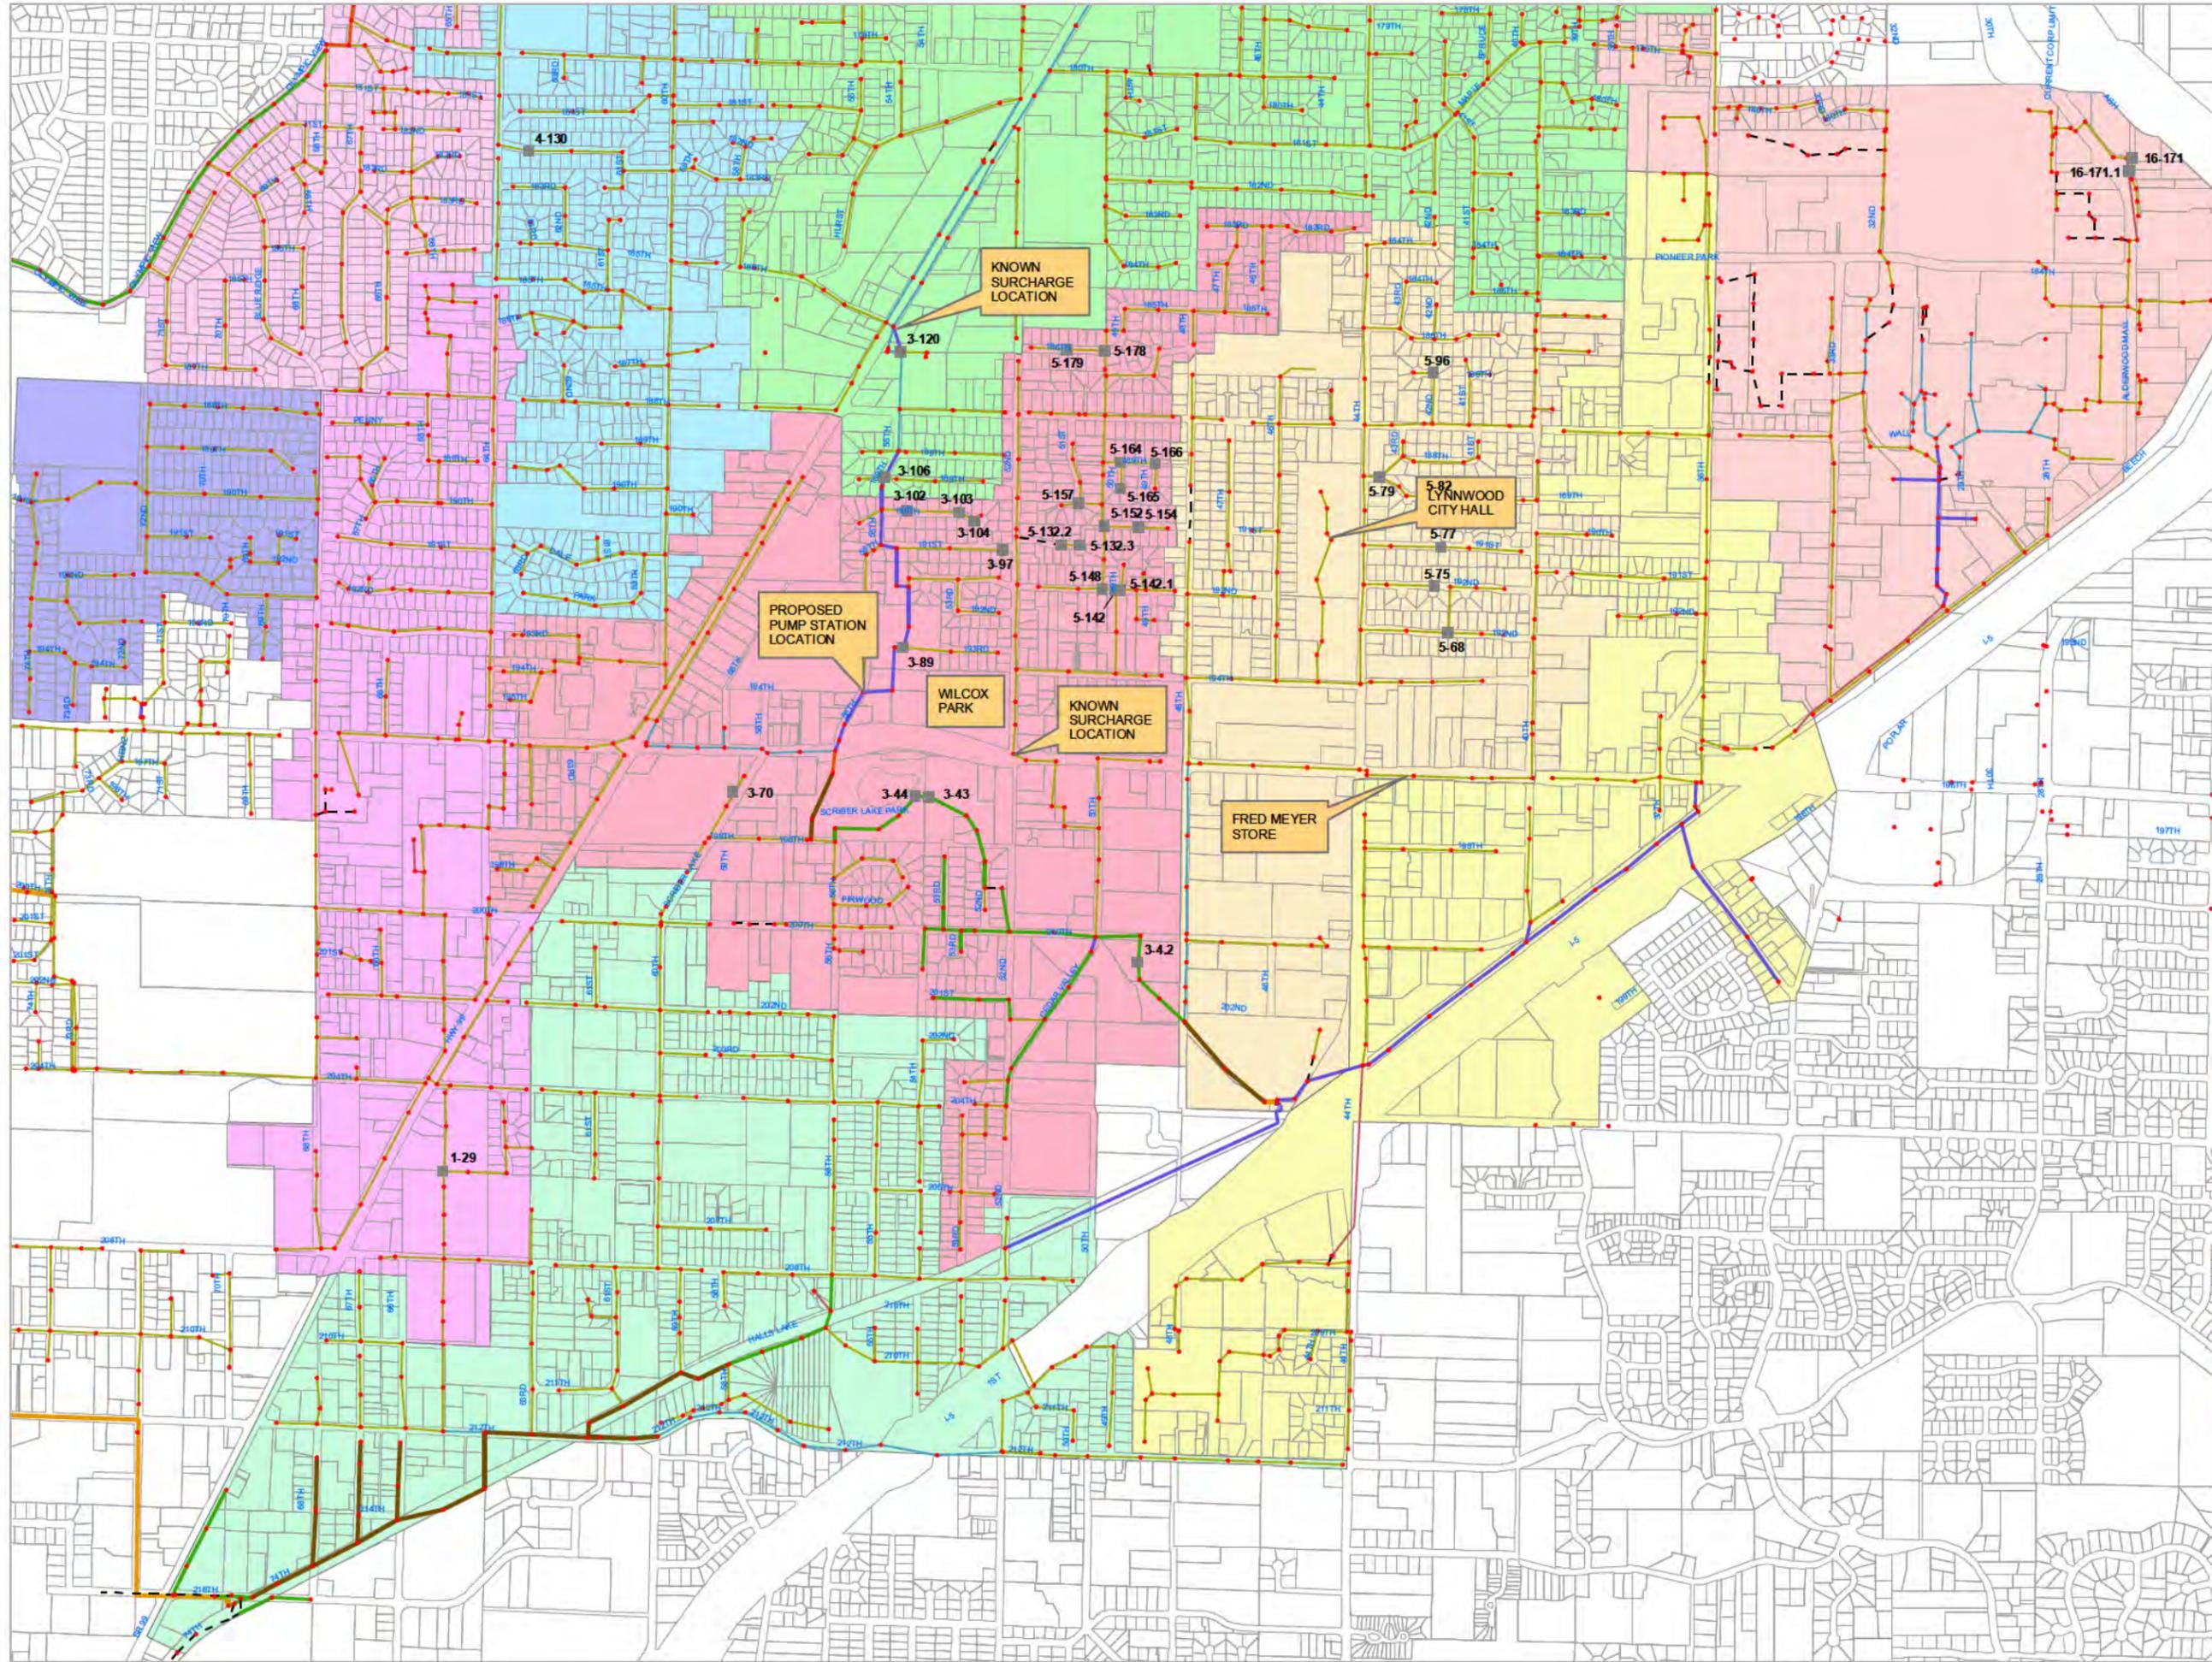
FIGURE 3
MANHOLE INSPECTION

A total of 34 problems were identified through manhole inspection. Typical problems included leaks in the manhole lid, adjustment rings or pipe penetrations with mineral deposits. Each of the manhole problems were ranked by the severity of the problem. The severity of each problem was broken down into the same categories used to define smoke testing problems. Most of the manholes inspected were in relatively good condition with 31 manholes having either light or no problems. However, three manholes were

identified with medium problems showing mineral deposits and visible infiltration into the manhole. Results are seen in Table 5.
