APPENDIX C
MANHOLE INSPECTION

Gray & Osborne, Inc. conducted manhole inspections in the City of Lynnwood on March 9th and 11th of 2010 by a crew of two people. No precipitation occurred on March 9th, however, there was steady rainfall during inspection on March 11th. In addition, the manhole inspection followed a significant period of wet weather, so the groundwater level was higher. Manhole inspections included a visual inspection of the area surrounding the manhole lid and removing the lid and conducting a visual inspection of the inside of the manhole.

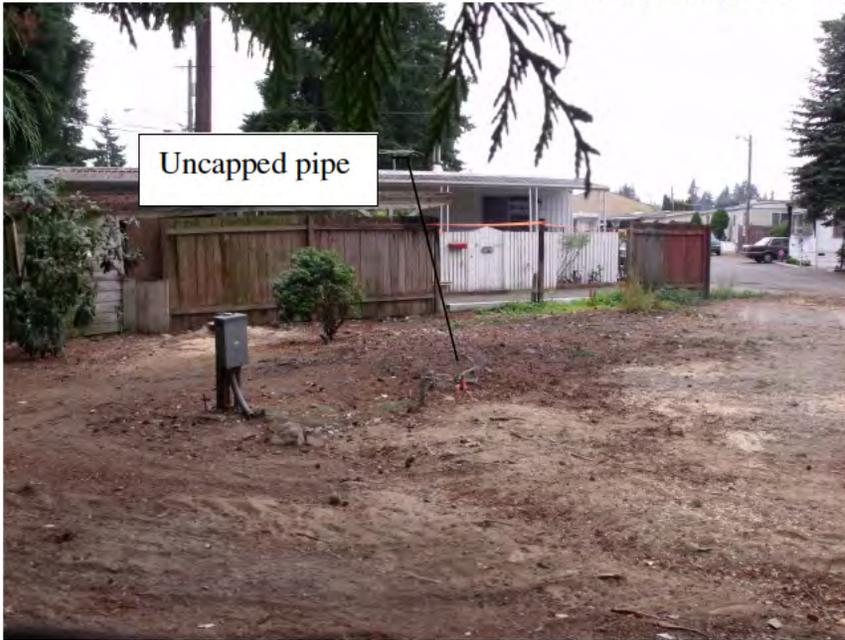
6208 202nd St. SW, Lynnwood, WA (S-82)

Area surrounding uncapped pipe.

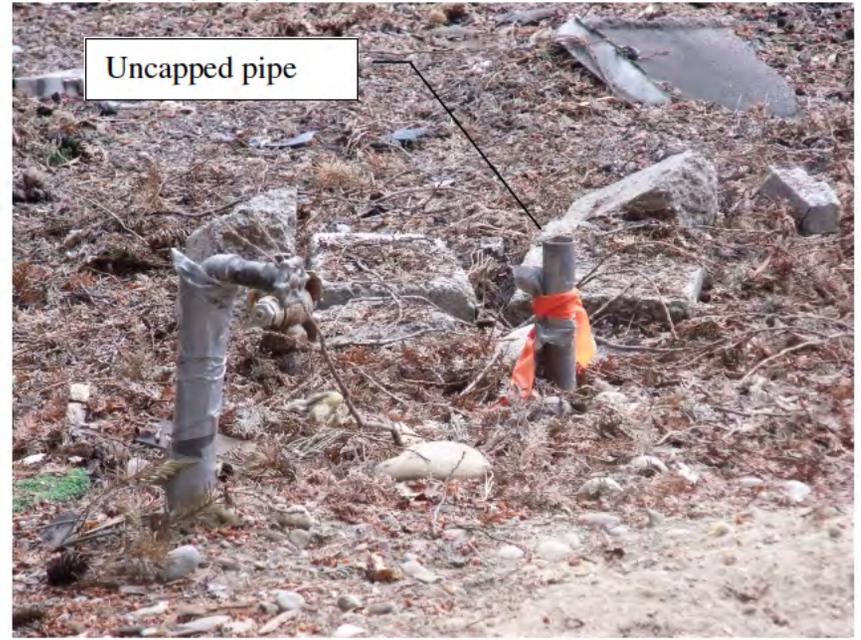
Smoke emanating from uncapped pipe.

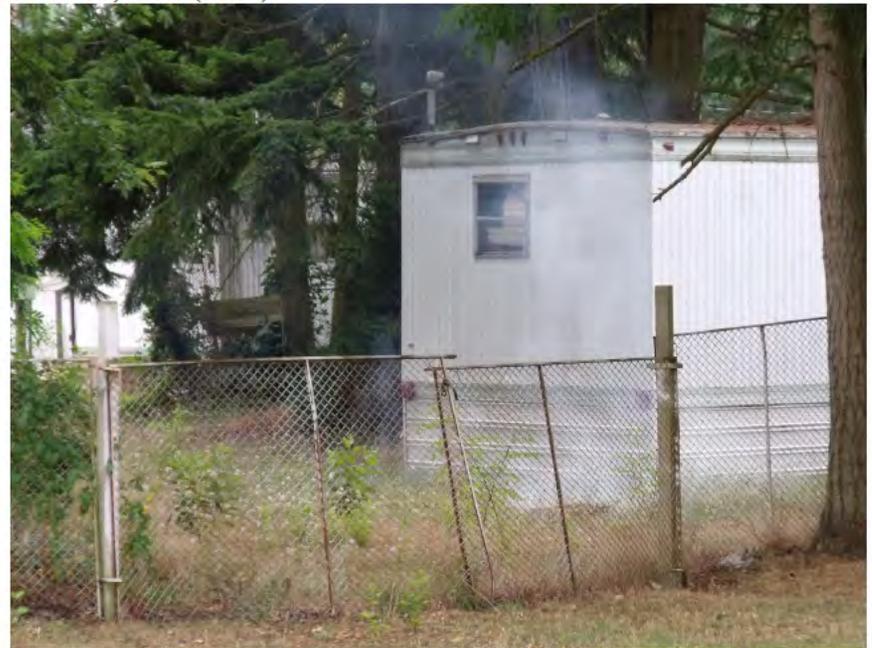
6208 202nd St. SW, Lynnwood, WA (S-83)

Smoke emanating from unknown source behind trailer.

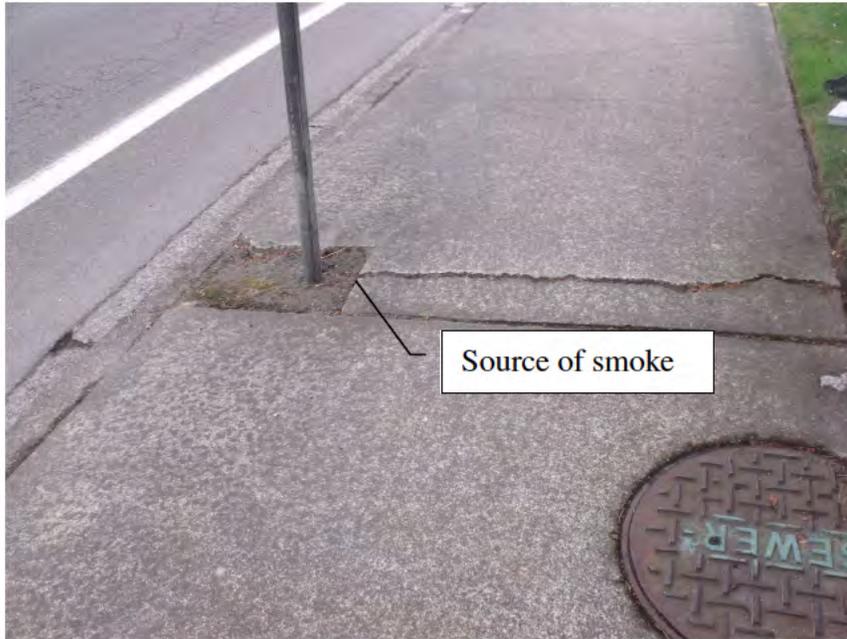
Near manhole #2-80 on 200th St. SW, Lynnwood, WA (S-84)

Smoke emanating from crack in sidewalk and base of street sign.

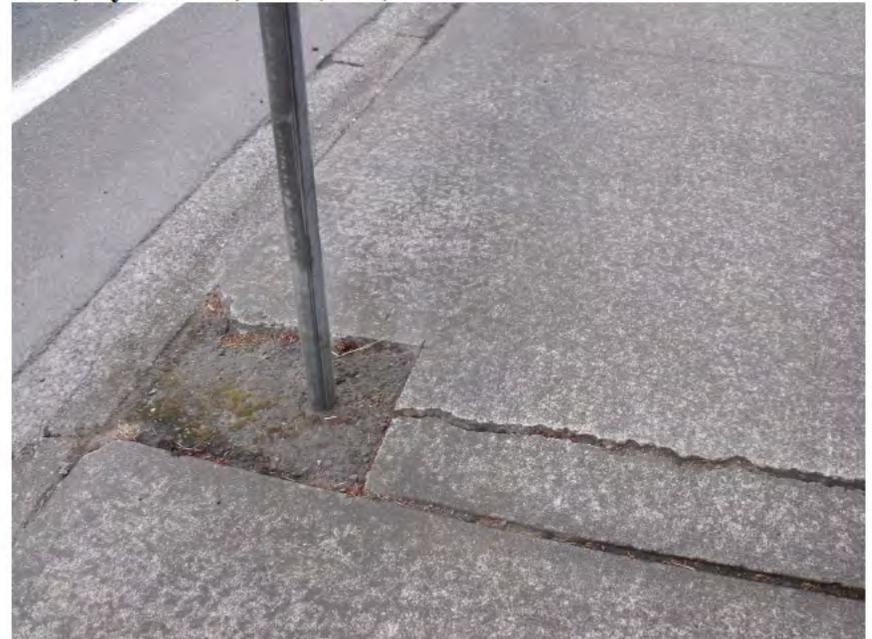
Crack in sidewalk and base of street sign.

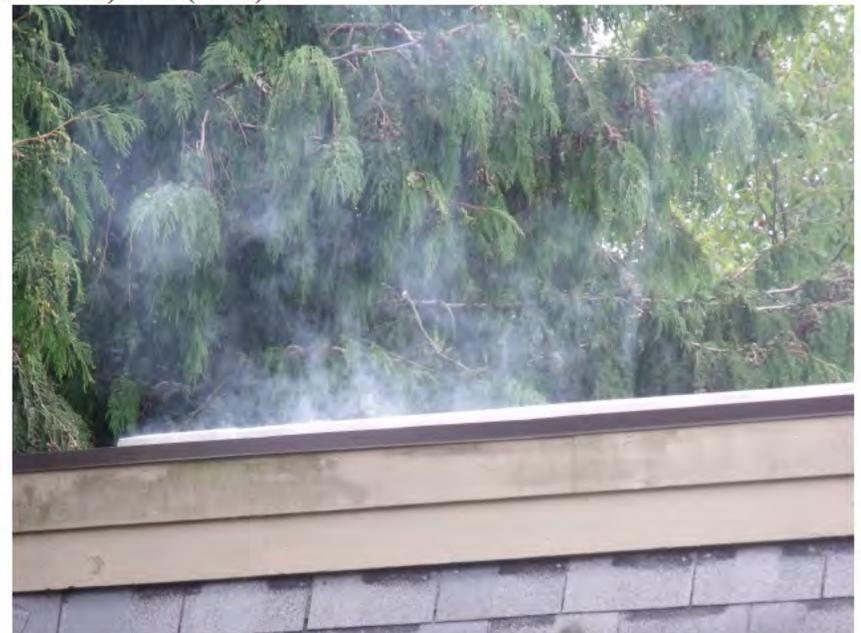
5703 202nd St. SW, Lynnwood, WA (S-85)

Smoke emanating from unknown source on roof top.

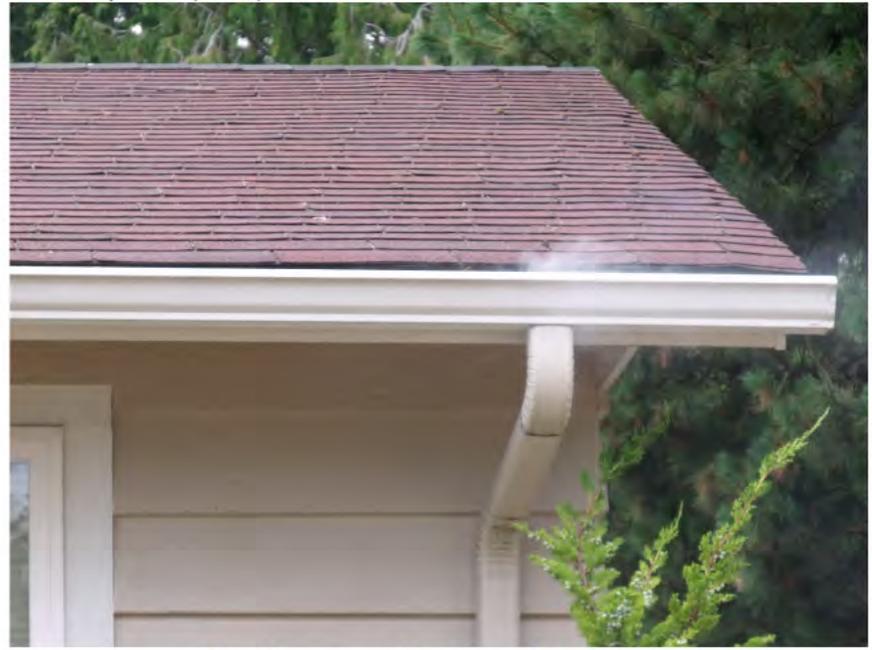
5523 204th St. SW, Lynnwood, WA (S-86)

Smoke emanating from downspout.

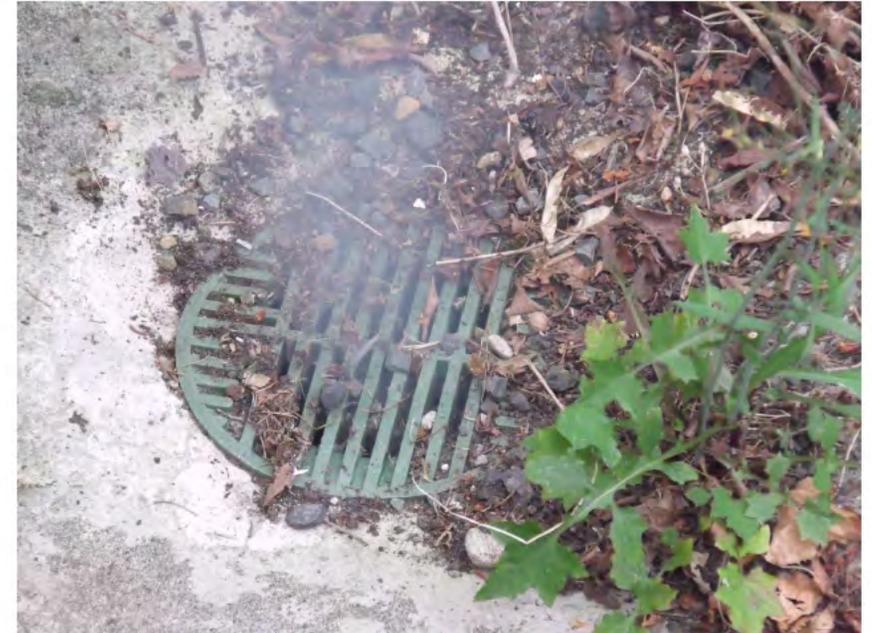
5910 207th Pl. SW, Lynnwood, WA (S-87)

Smoke emanating from drain at base of driveway.

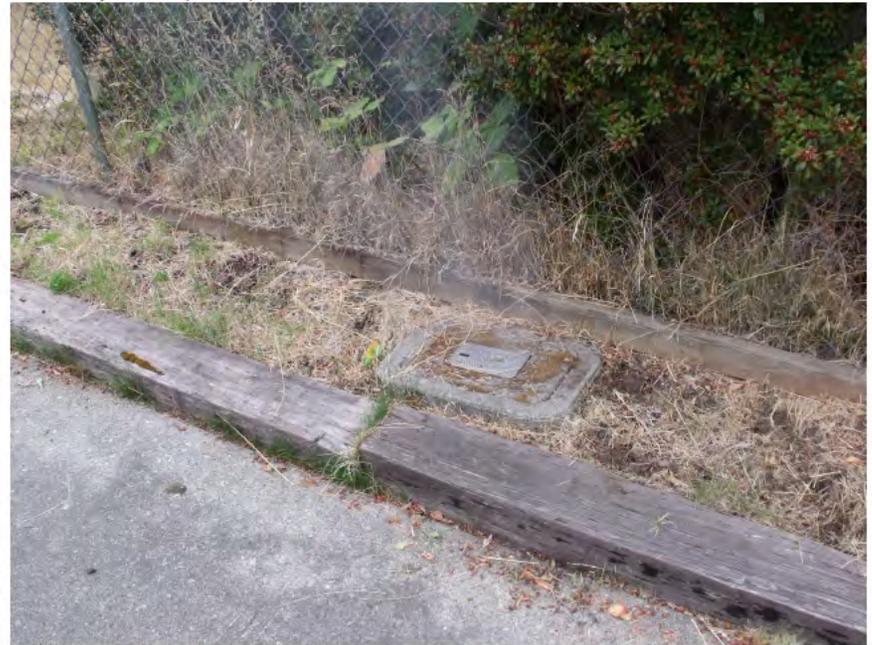
20923 59th Pl. W, Lynnwood, WA (S-88)

Smoke emanating from water meter box cover.

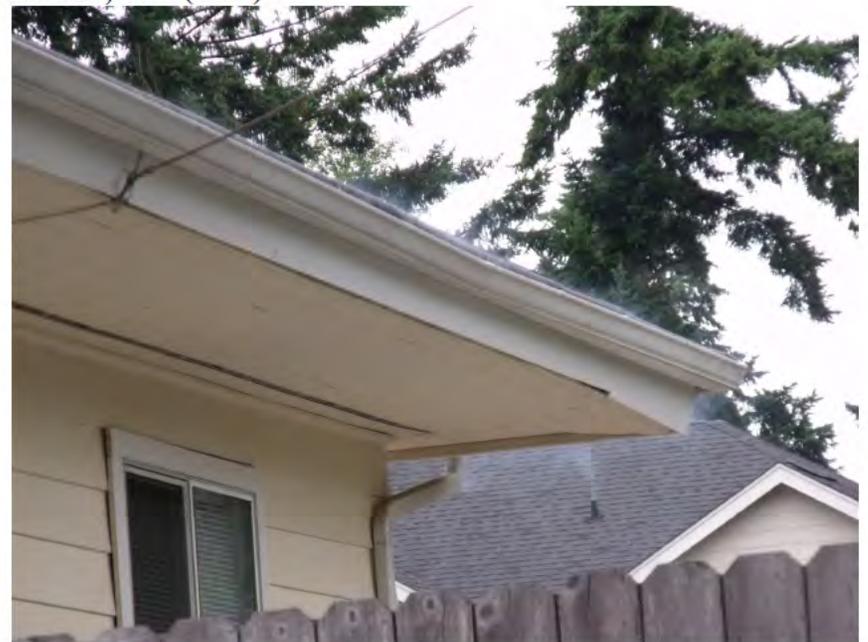
6207 211th St. SW, Lynnwood, WA (S-89)

Smoke emanating from rain gutter.

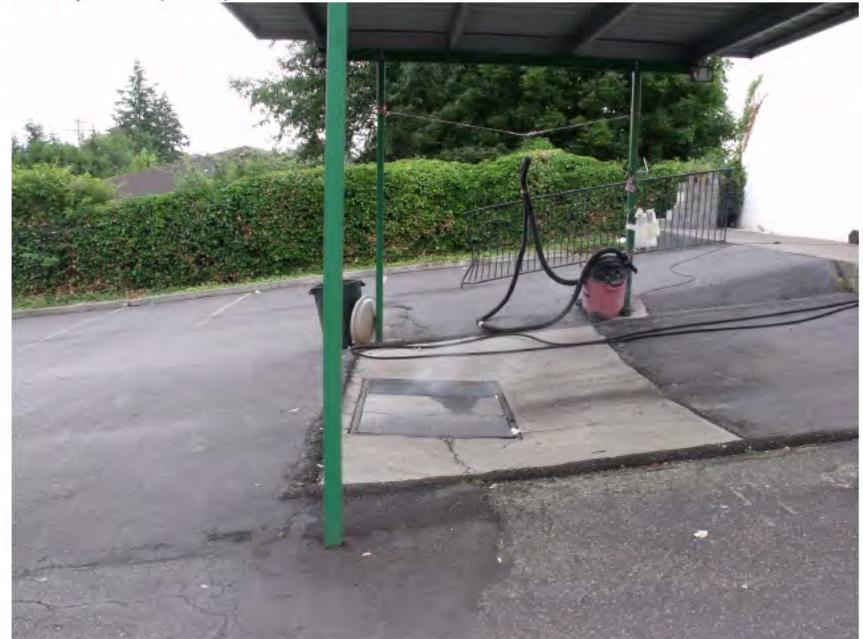
21101 Hwy 99, Lynnwood, WA (S-90)

Smoke emanating from grate under carport.

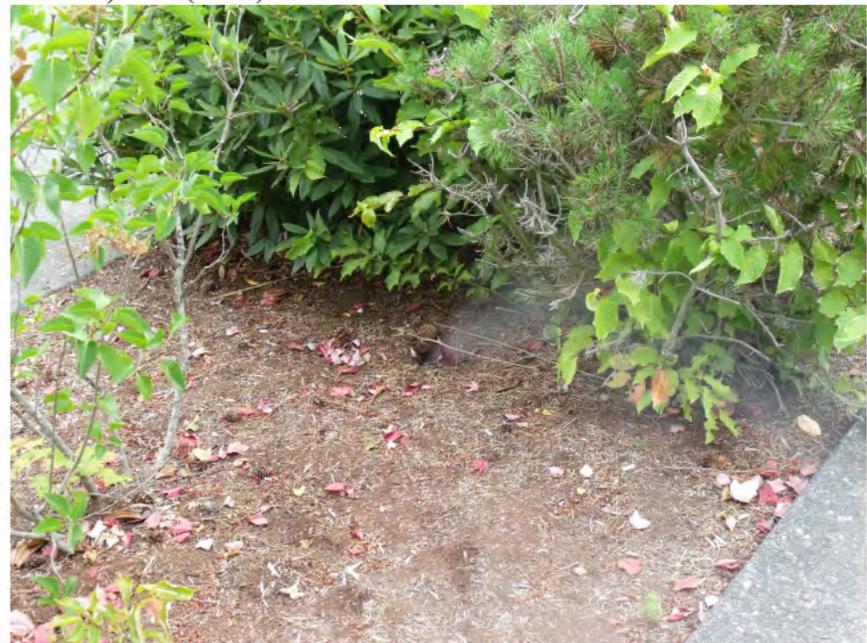
6125 202nd St. SW, Lynnwood, WA (S-91)

Smoke emanating from hole in ground.

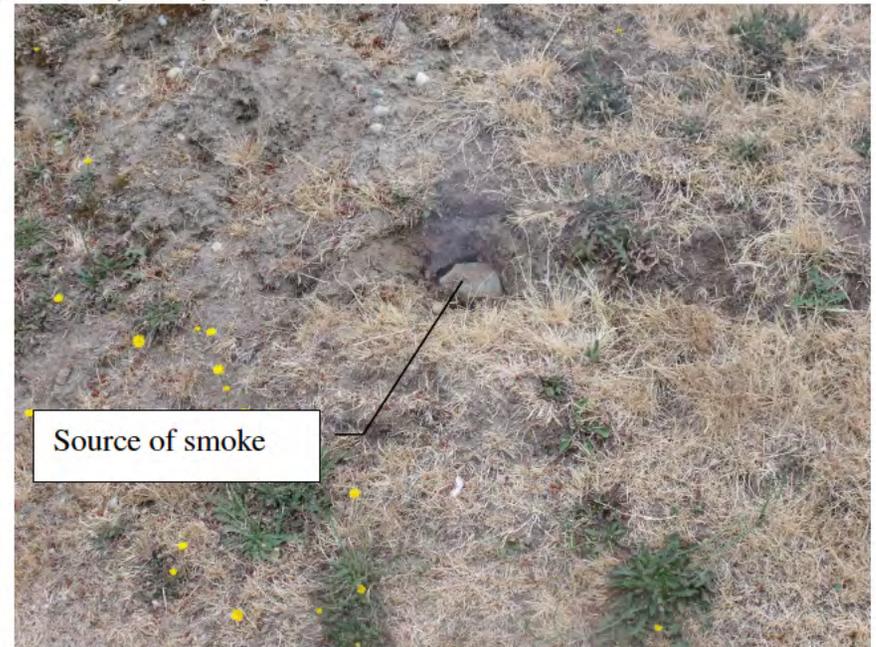
5823 202nd St. SW, Lynnwood, WA (S-92)

Smoke emanating from hole in ground on sideslope.

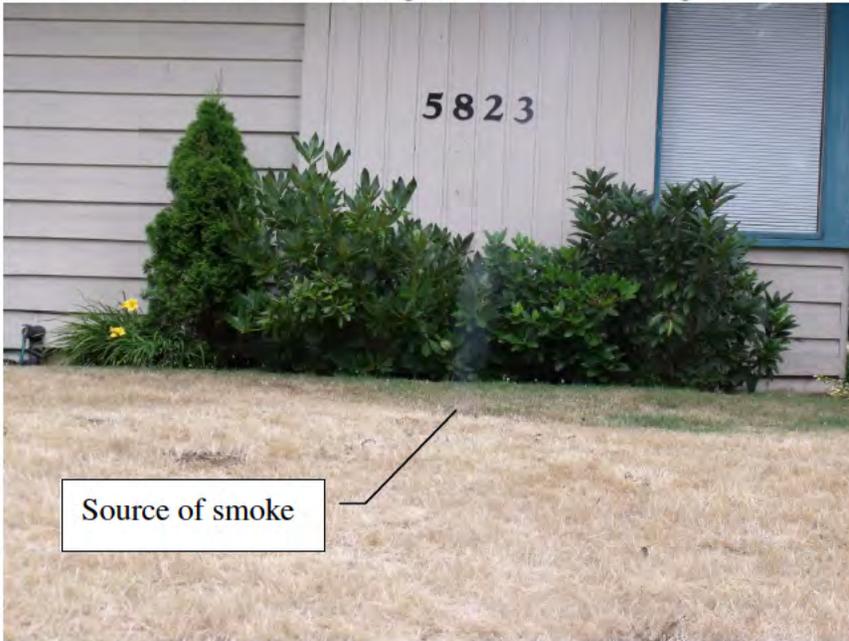
View of front of building and smoke emanating from hole in ground.

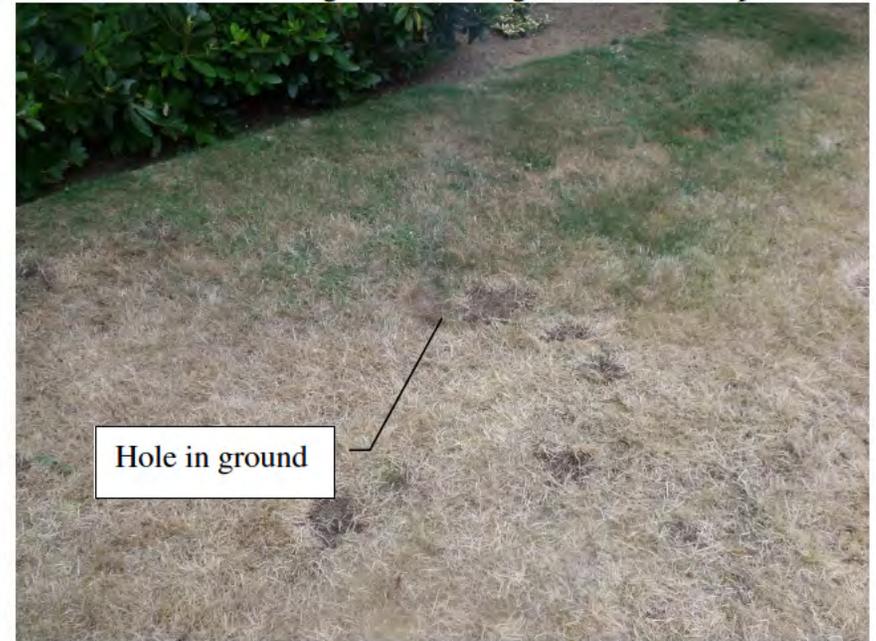
View from above of smoke emanating from hole in ground.

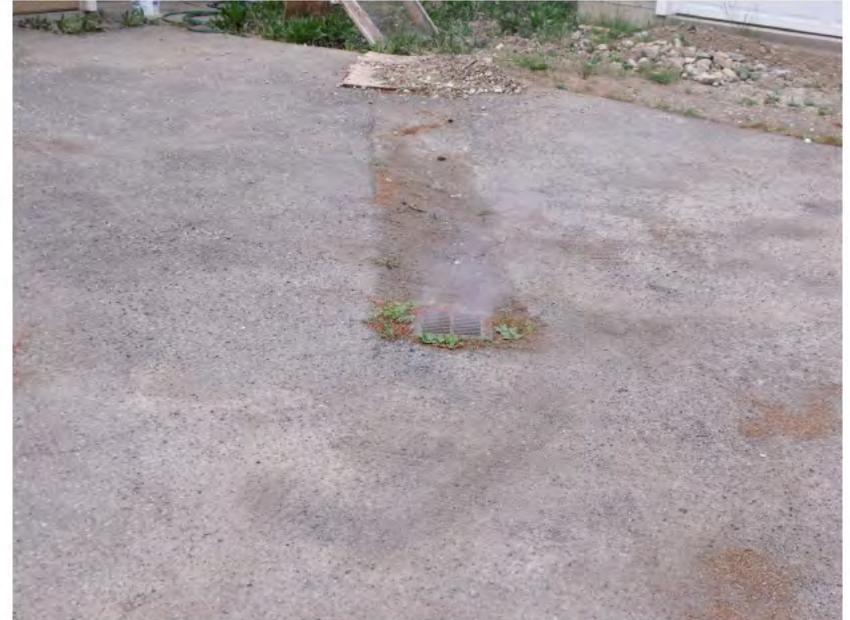
5827 207th Pl. SW, Lynnwood, WA (S-93)

Smoke emanating from drain in driveway.

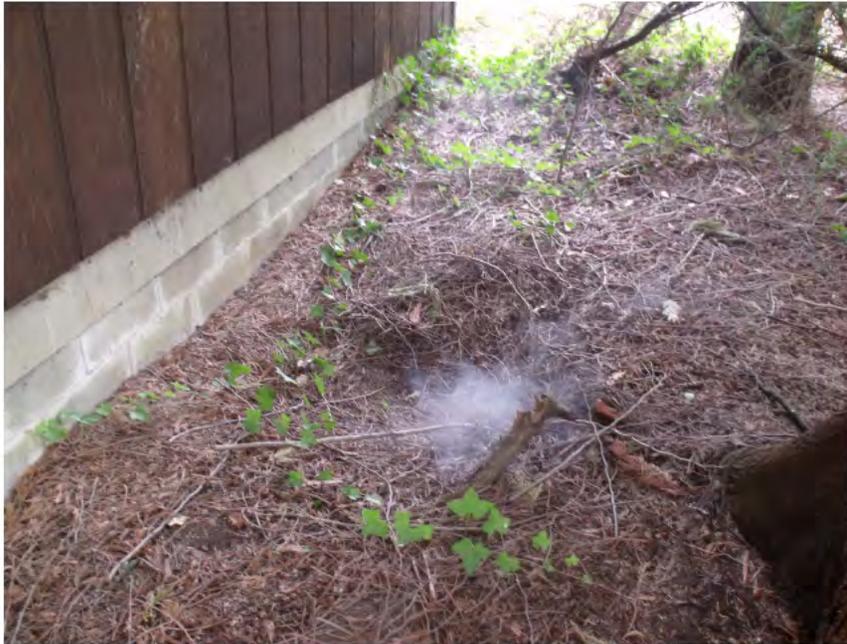
20920 (Near 55th Ave W and 210th St. SW), Lynnwood, WA (S-94)

Smoke emanating from depression in the ground.

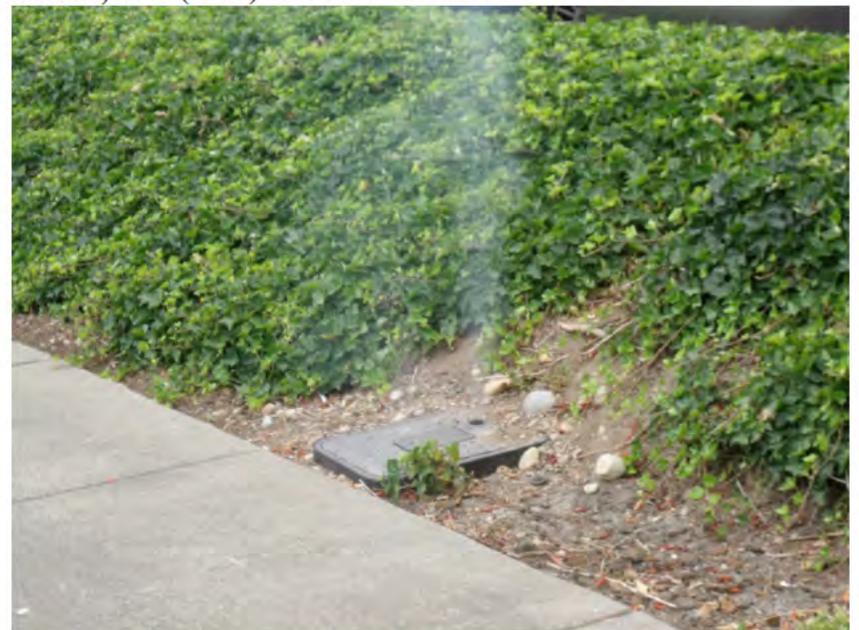
21116 67th Ave W, Lynnwood, WA (S-95)

Smoke emanating from hole in water meter box cover.

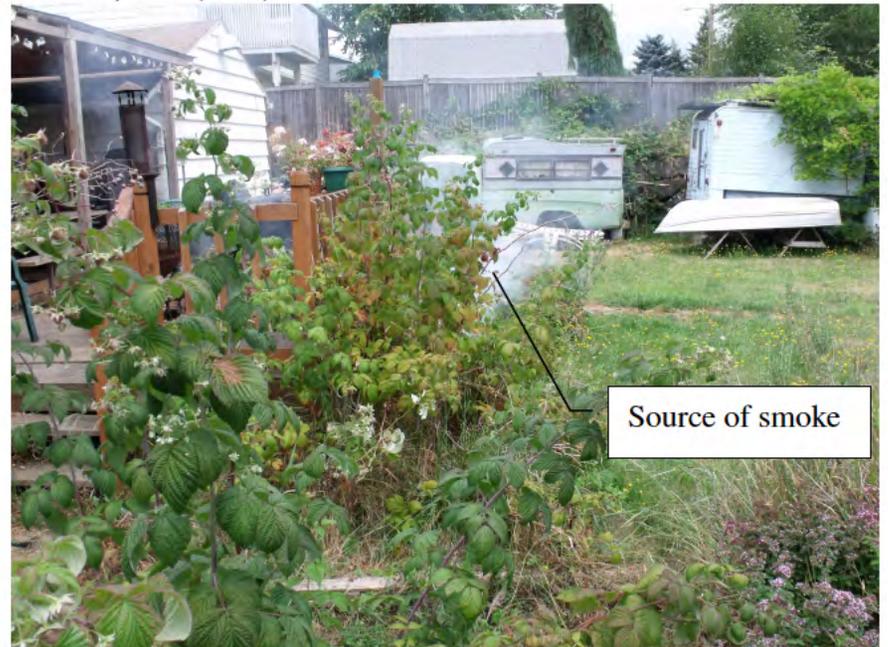
20903 54th Ave W, Lynnwood, WA (S-96)

Smoke emanating from under the deck.

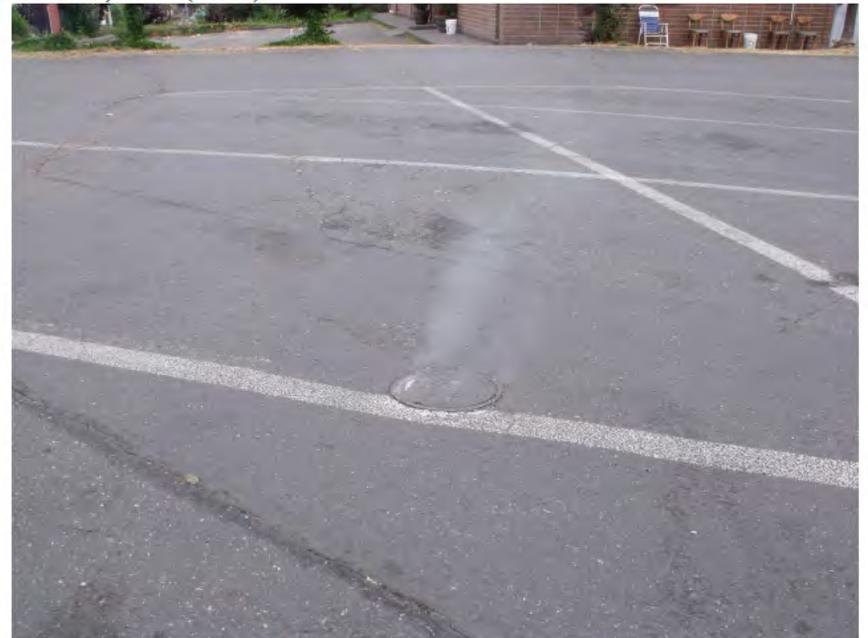
6210 200th St. SW, Lynnwood, WA (S-97)

Smoke emanating from cleanout cap.

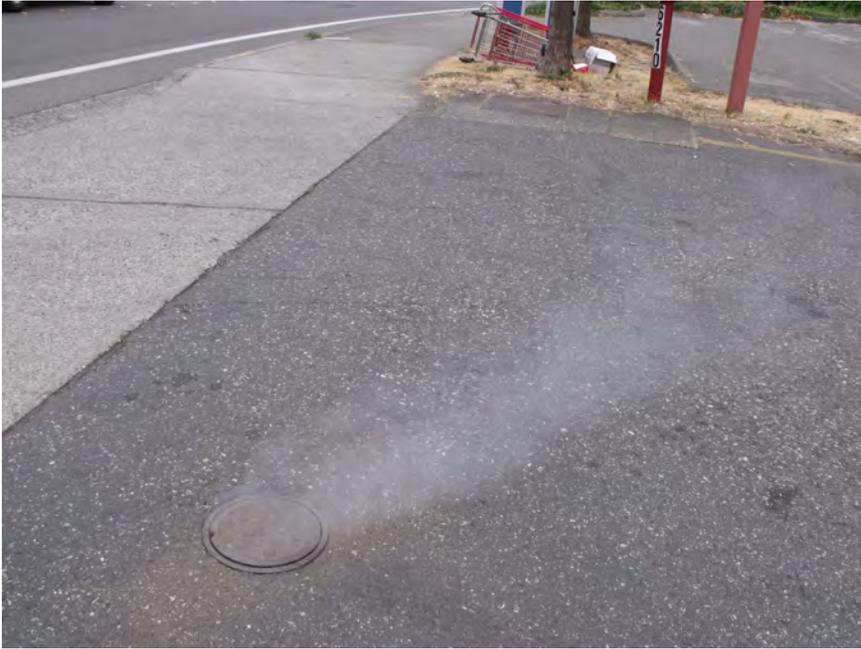
Smoke emanating from cleanout cap.

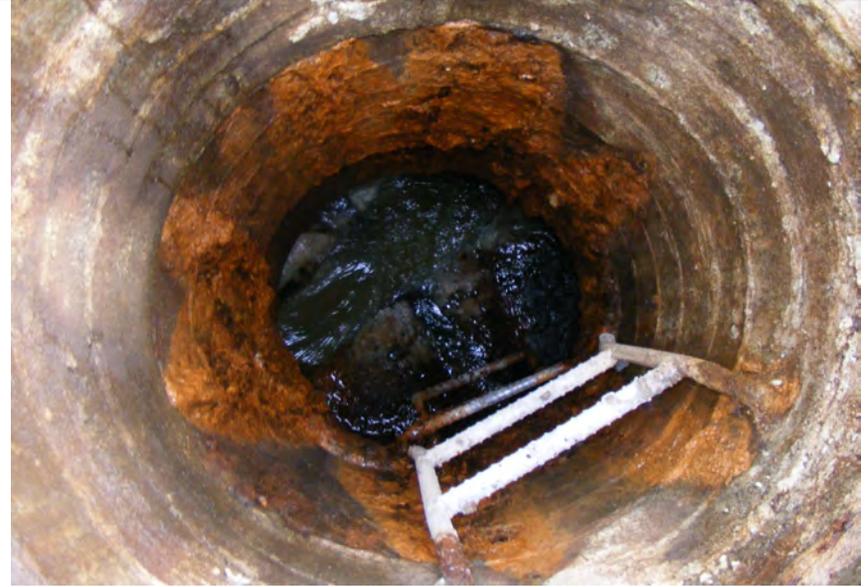
| Reference Number | Manhole | Problem Number | Location | Basin | Description | Potential Source of Flow | Severity | Year Tested |
|---|---|---|---|---|--|--|---|---|
| M-1 | 1-29 | 1-29-N/A | Near Hwy 99 and 186th PI SW | 7 | Heavy mineral deposits on riser section; visible infiltration; heavy mineral deposits on wet benches; heavy flows through manhole | Visible infiltration through manhole walls | Light | 2010 |

Visible infiltration and mineral deposits on interior manhole walls.

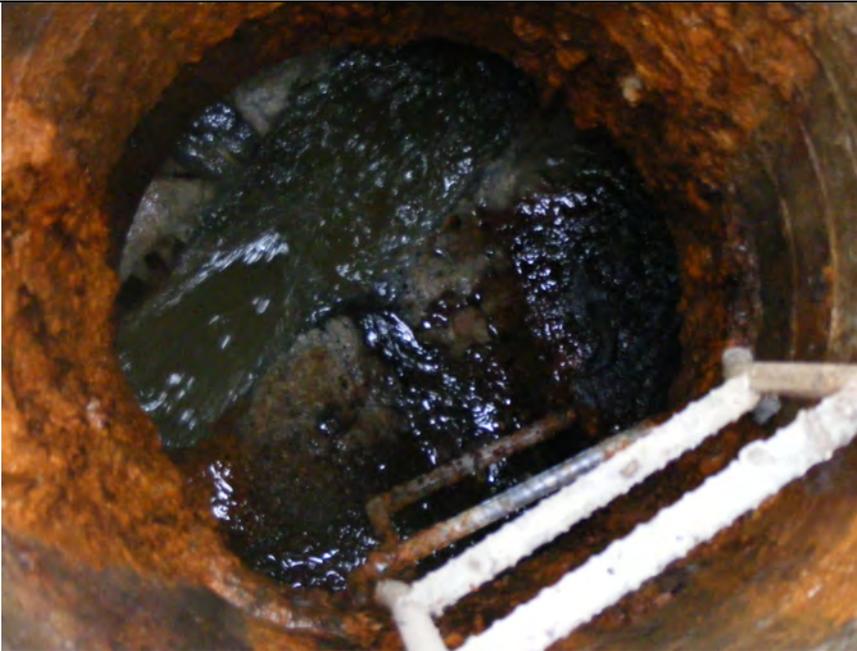
Benches are wet and inundated with mineral deposits.

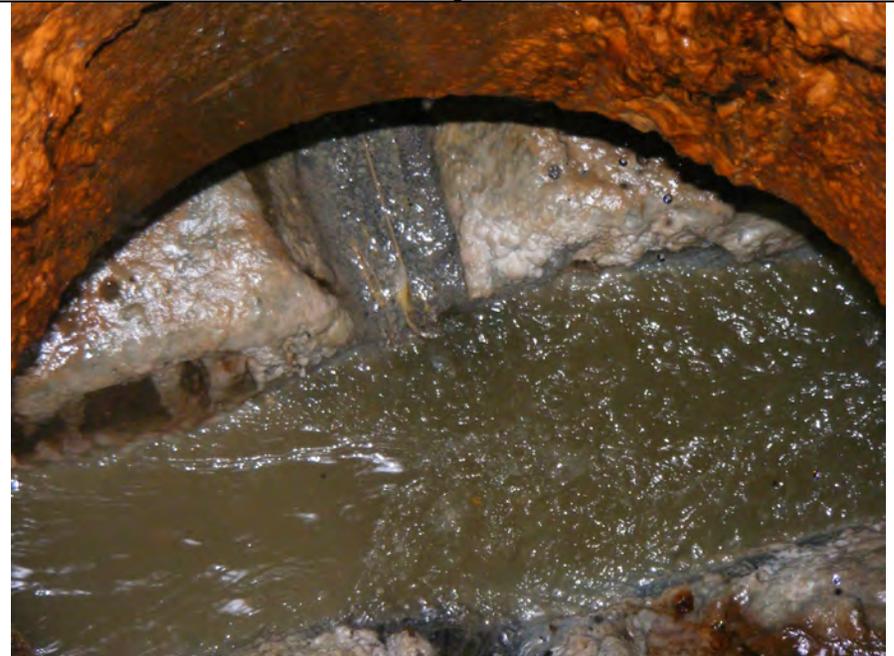
Heavy flows through manhole.

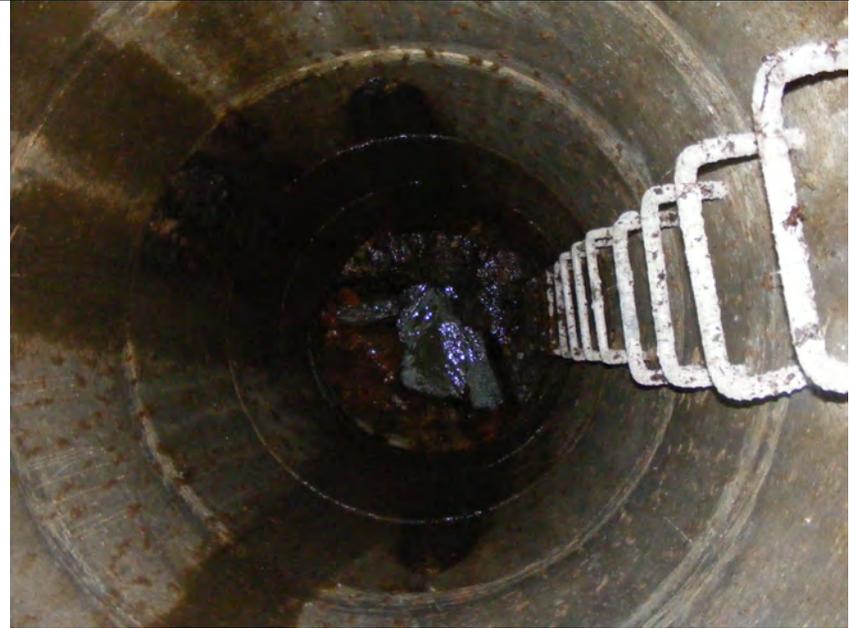
M-2

Infiltration streaks and stains on interior walls.

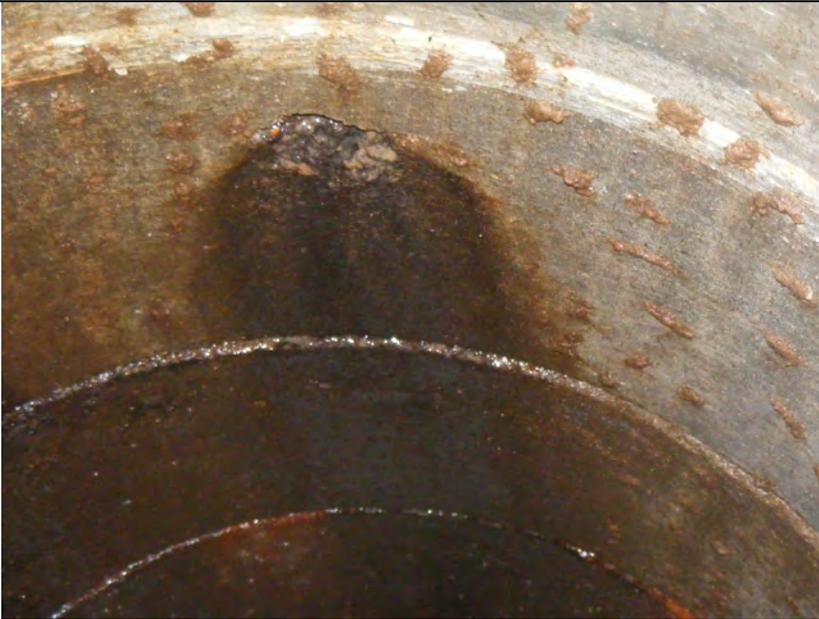
| Reference Number | Manhole | Problem Number | Location | Basin | Description | Potential Source of Flow | Severity | Year Tested |
|---|---|---|---|---|--|--|---|---|
| M-2 | 3-4.2 | 3-4.2-N/A | Near 48th Ave W & 200th St SW | 4 | Visible infiltration down south side wall- wall is broken up | Visible infiltration through spalled area on manhole wall | Light | 2010 |

Interior wall is spalling and visible infiltration through spalled area.

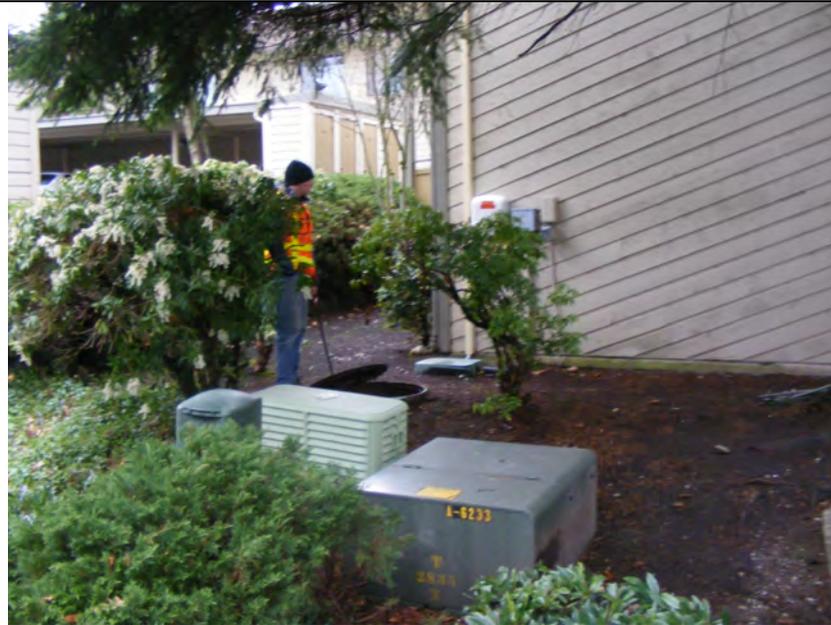
Manhole rim is at or above grade.

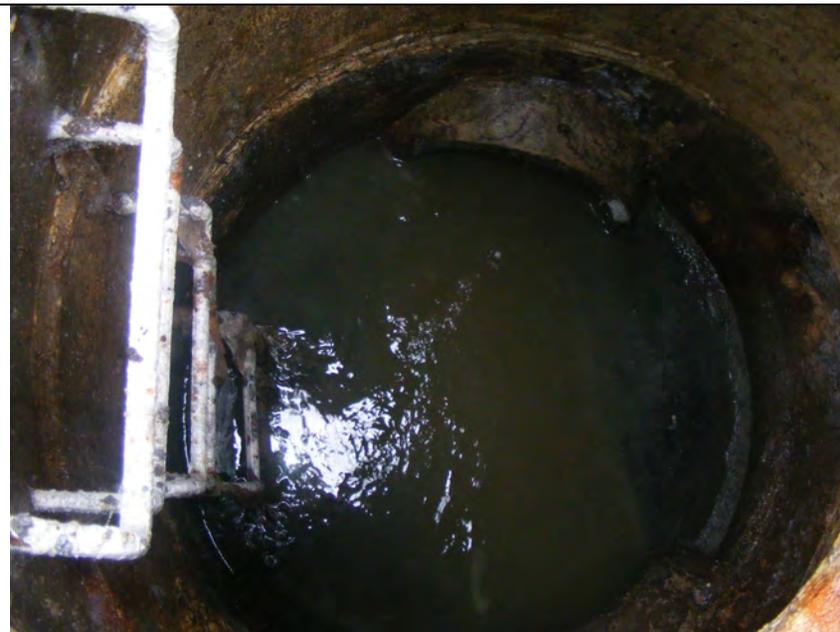
M-3, M-4

Flow on manhole benches

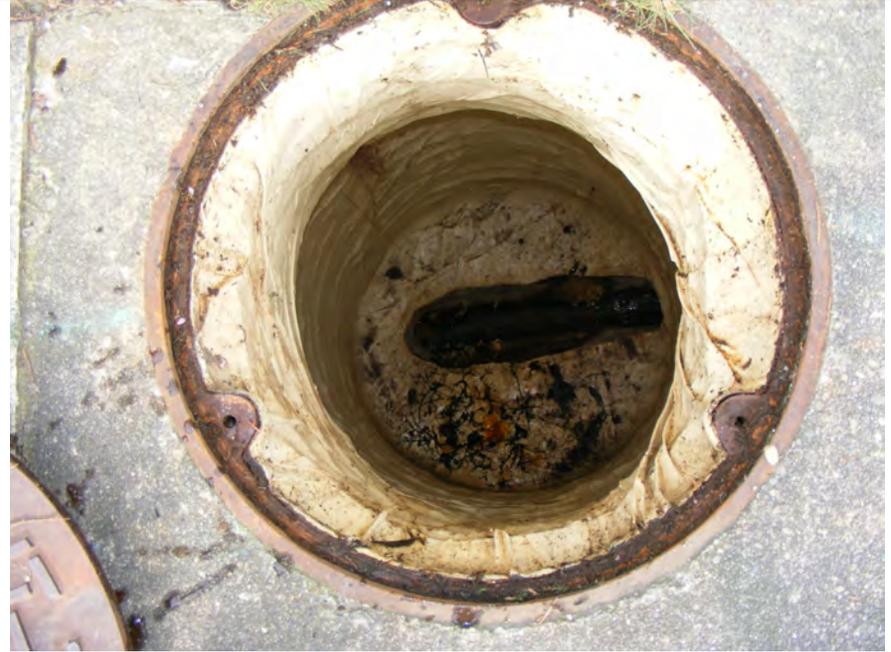
M-5

No ladder in manhole. Manhole rim flush with adjacent grade.

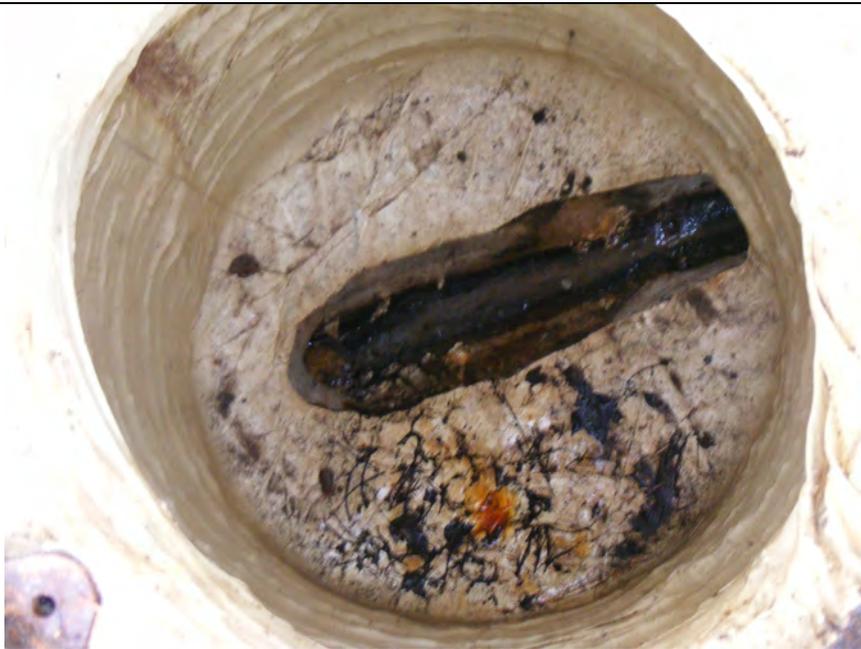
No current flows through manhole.

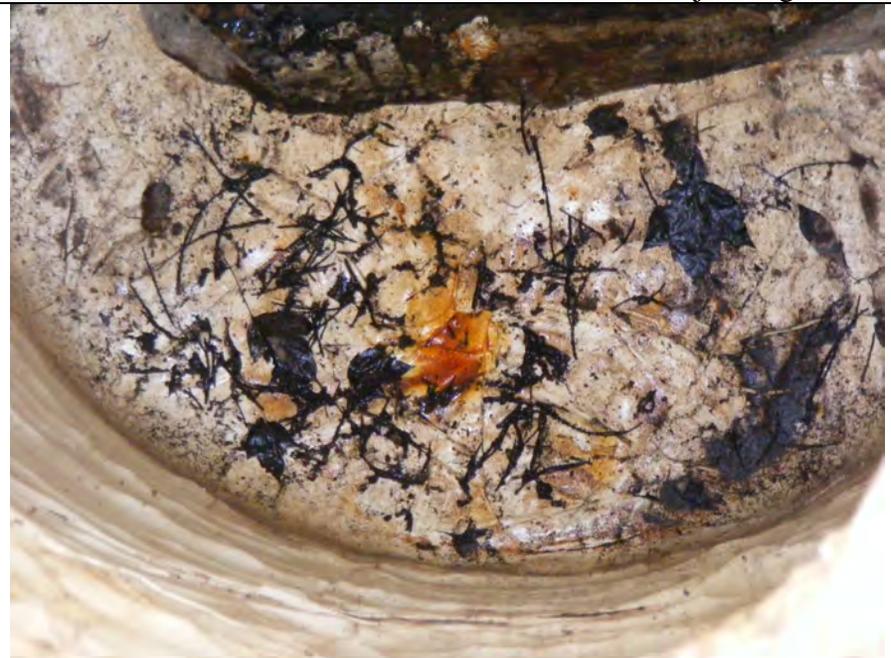
Debris on manhole bench.

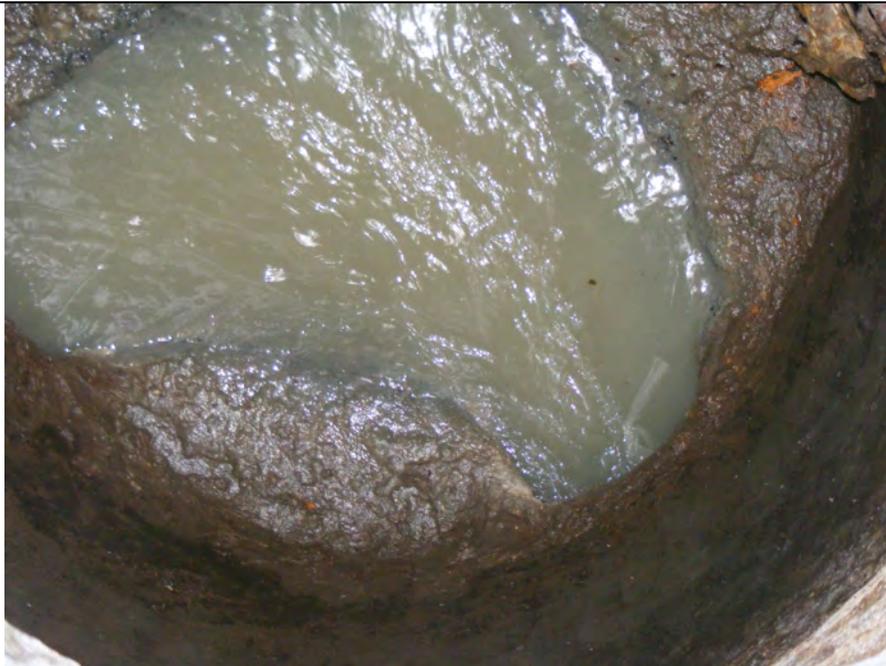
M-6

Heavy flows through manhole.

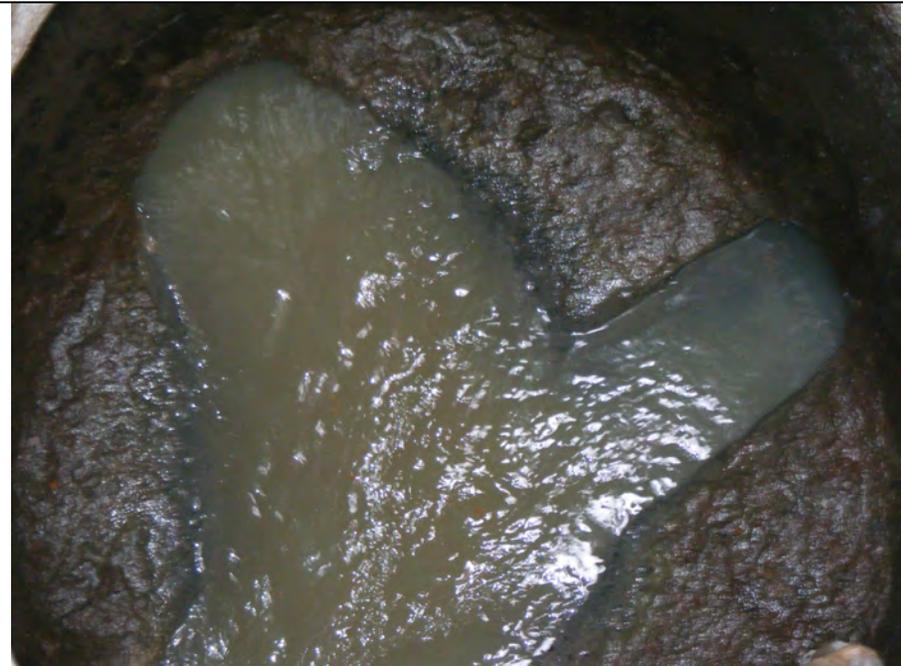
Benches are wet and have mineral deposits.

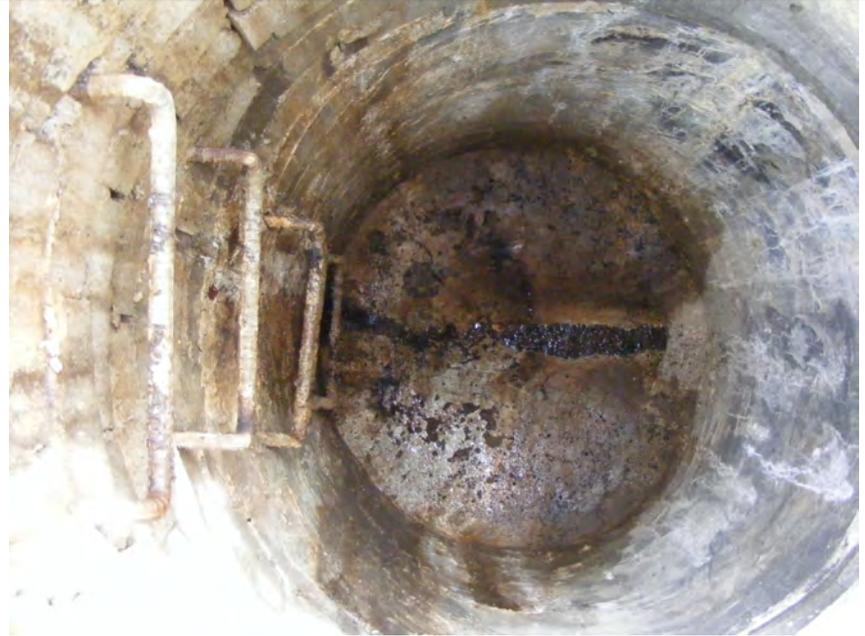
M-7

No existing flow through manhole but north side bench is visibly wet.

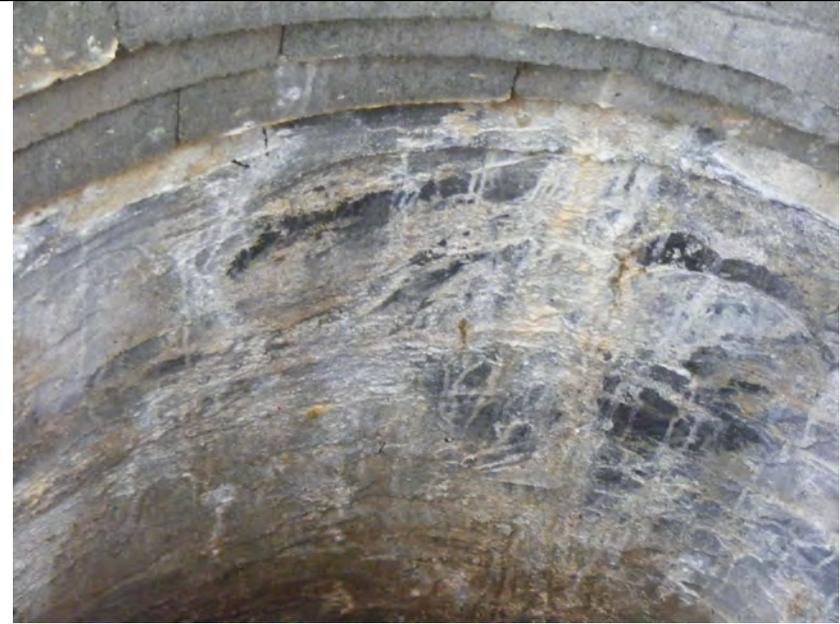
Infiltration streaks or stains on interior manhole wall.

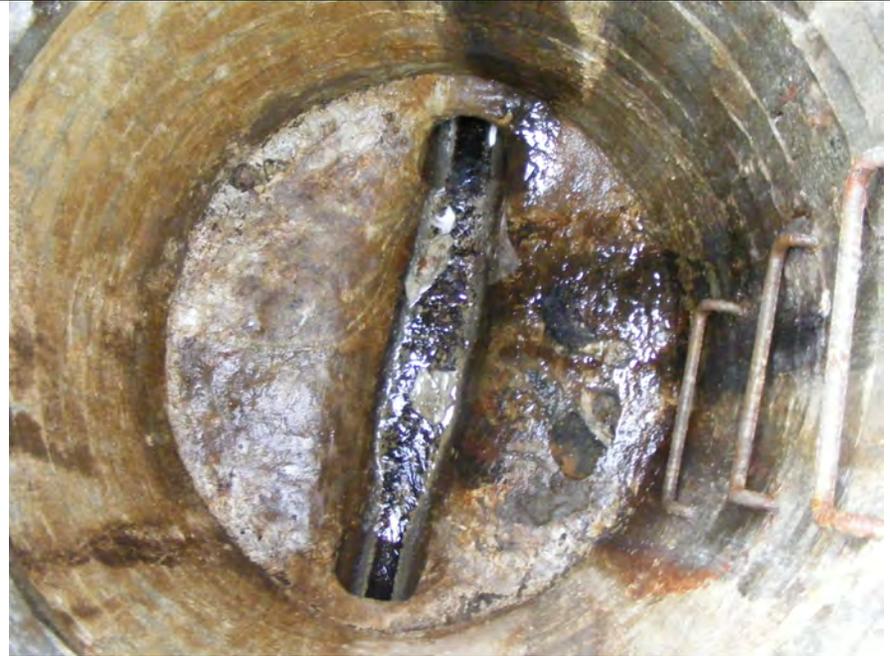
| Reference Number | Manhole | Problem Number | Location | Basin | Description | Potential Source of Flow | Severity | Year Tested |
|---|---|---|---|---|--|--|---|---|
| M-8 | 3-102 | 3-102-N/A | 190th St SW & 55th Ave W | 4 | Visible infiltration through interior manhole walls; north manhole bench is very wet; visible water dripping on south interior manhole wall | Visible infiltration through interior riser section walls, water dripping on south interior manhole wall | Light | 2010 |

Visible water dripping on south interior manhole wall.

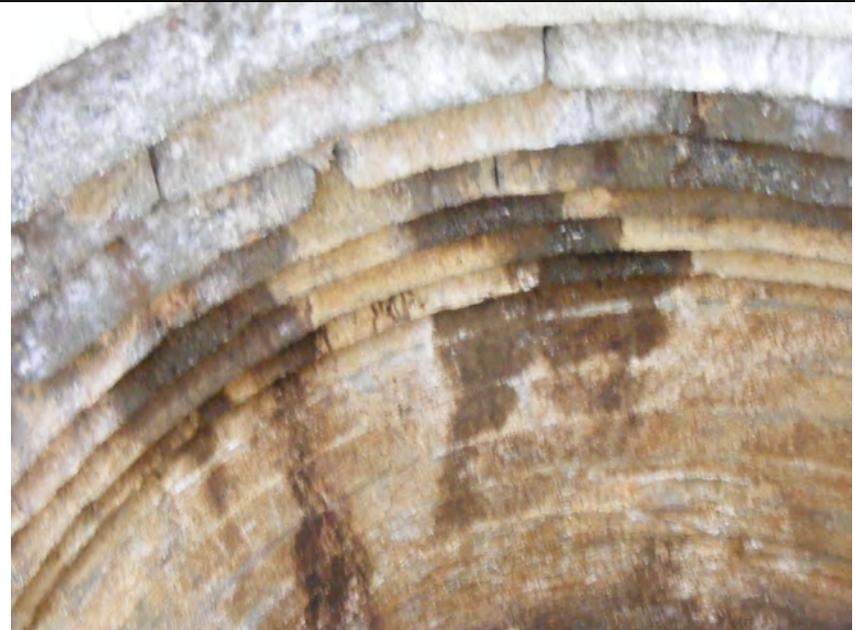
Visible infiltration through interior manhole walls.

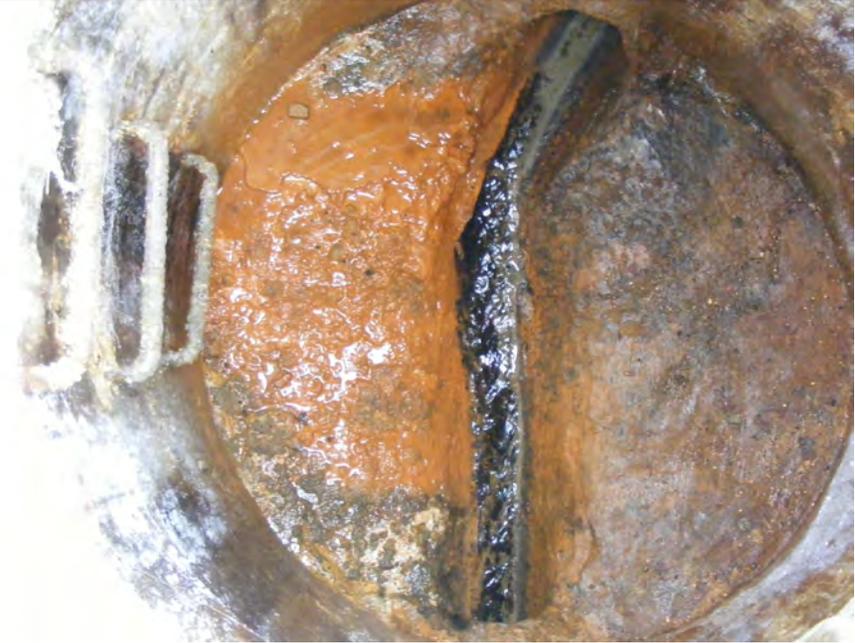
| Reference Number | Manhole | Problem Number | Location | Basin | Description | Potential Source of Flow | Severity | Year Tested |
|---|---|---|---|---|--|--|---|---|
| M-9 | 3-103 | 3-103-N/A | 190th St SW (near 55th Ave W) | 4 | Visible infiltration on interior manhole walls; numerous mineral deposits on manhole bench; infiltration through riser sections; both manhole benches are wet | Visible infiltration through interior riser section walls | Medium | 2010 |

Mineral deposits on manhole bench. Minimal flow through manhole.

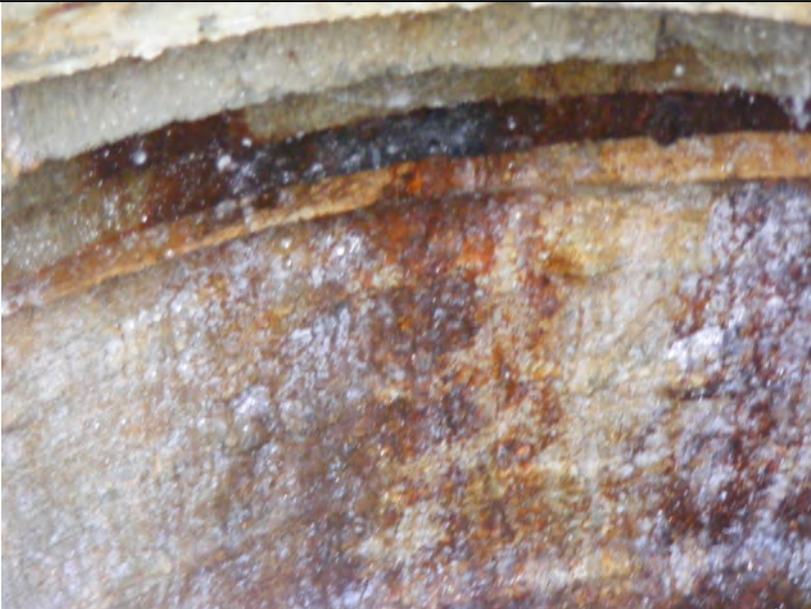
Visible infiltration on interior manhole walls.
