APPENDIX C
MANHOLE INSPECTION

Gray & Osborne, Inc. conducted manhole inspections in the City of Lynnwood on March 9th and 11th of 2010 by a crew of two people. No precipitation occurred on March 9th, however, there was steady rainfall during inspection on March 11th. In addition, the manhole inspection followed a significant period of wet weather, so the groundwater level was higher. Manhole inspections included a visual inspection of the area surrounding the manhole lid and removing the lid and conducting a visual inspection of the inside of the manhole.

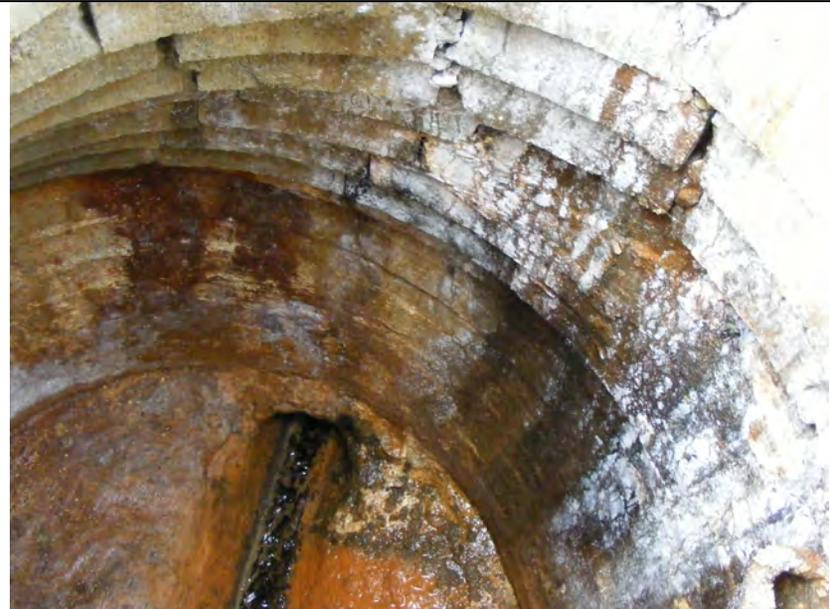
Infiltration through riser sections.

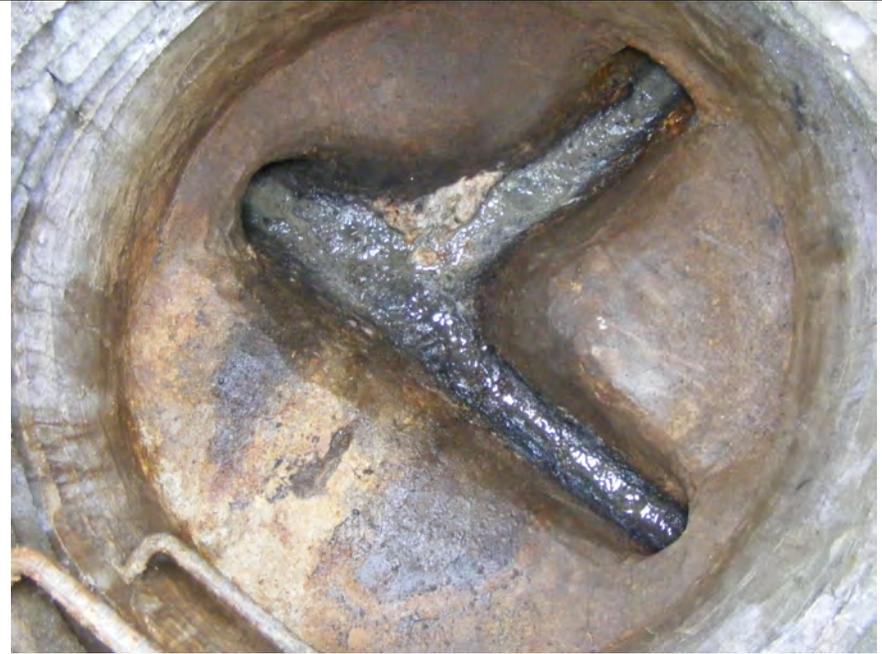
M-10

Minimal flow from southeast.

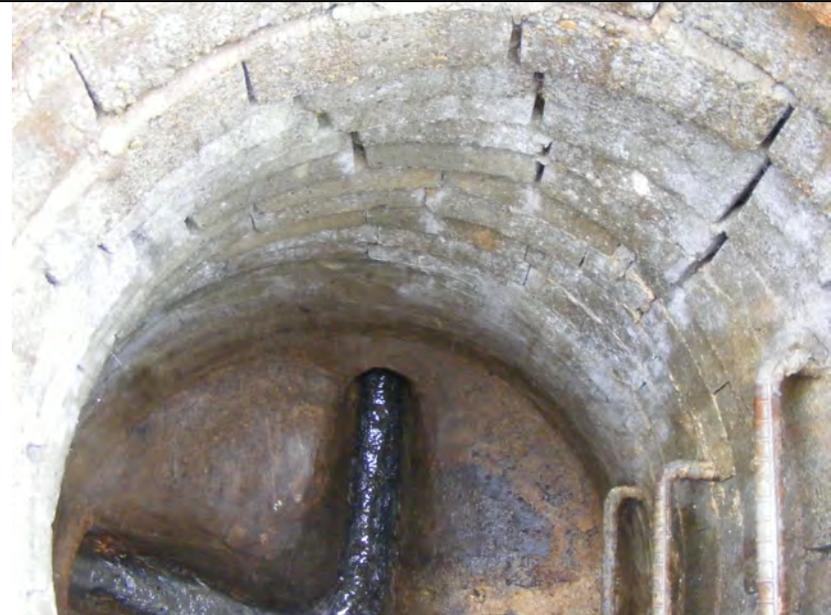
No visible infiltration.

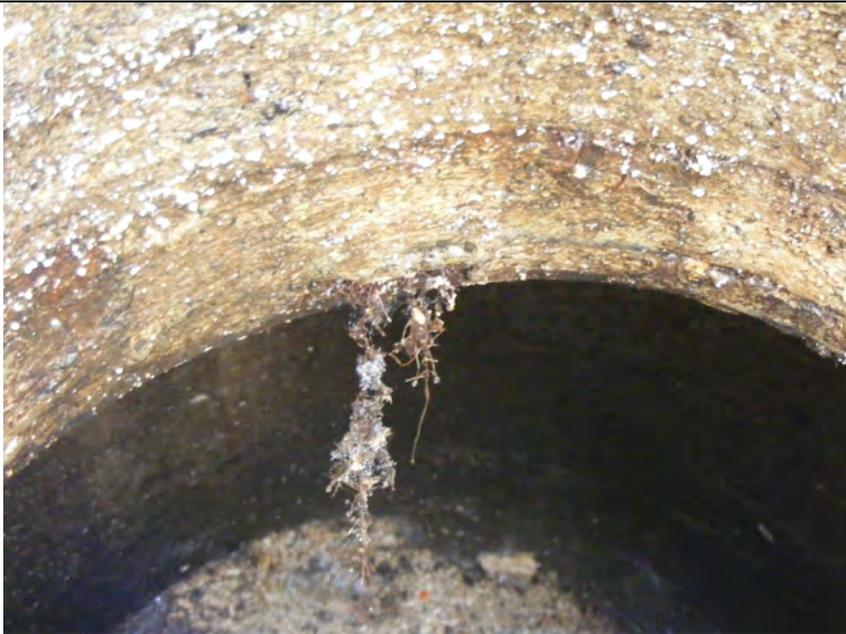
M-11

Roots pushing through between riser sections (minor).

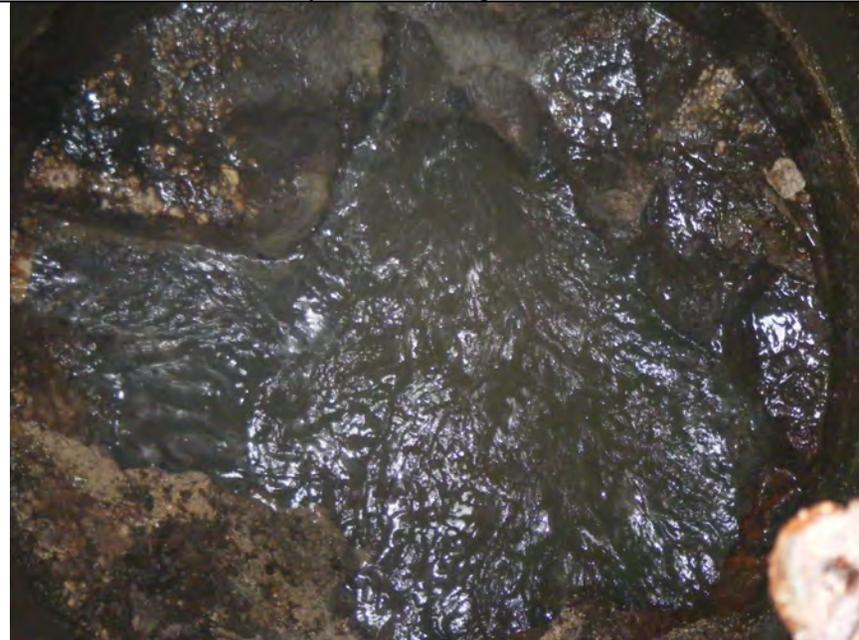
Manhole is surcharging.

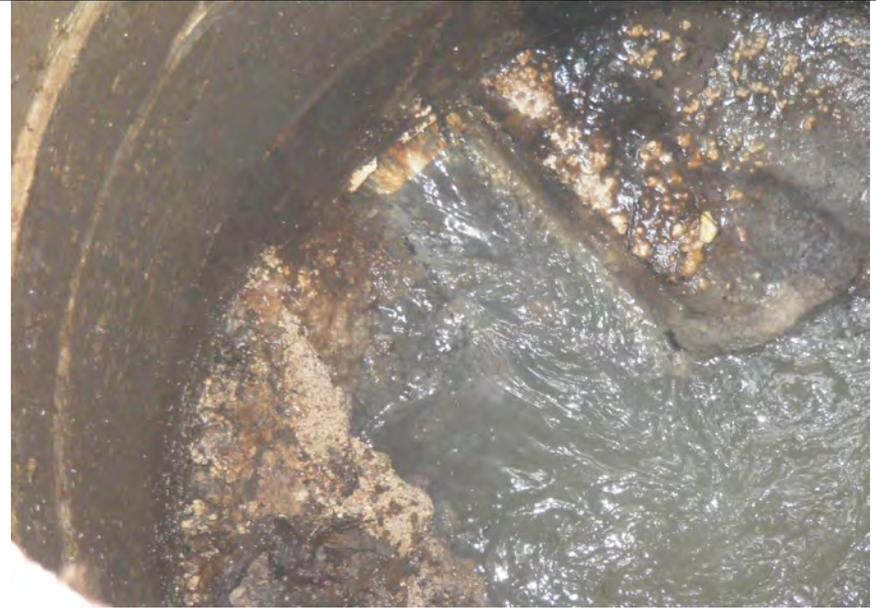
M-12

Heavy flows through manhole.

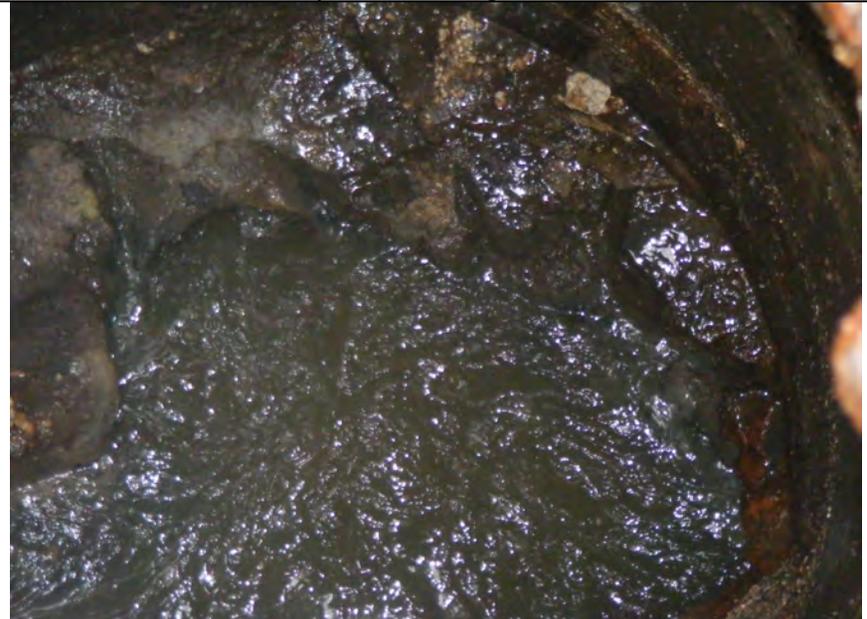
Flows on manhole benches.

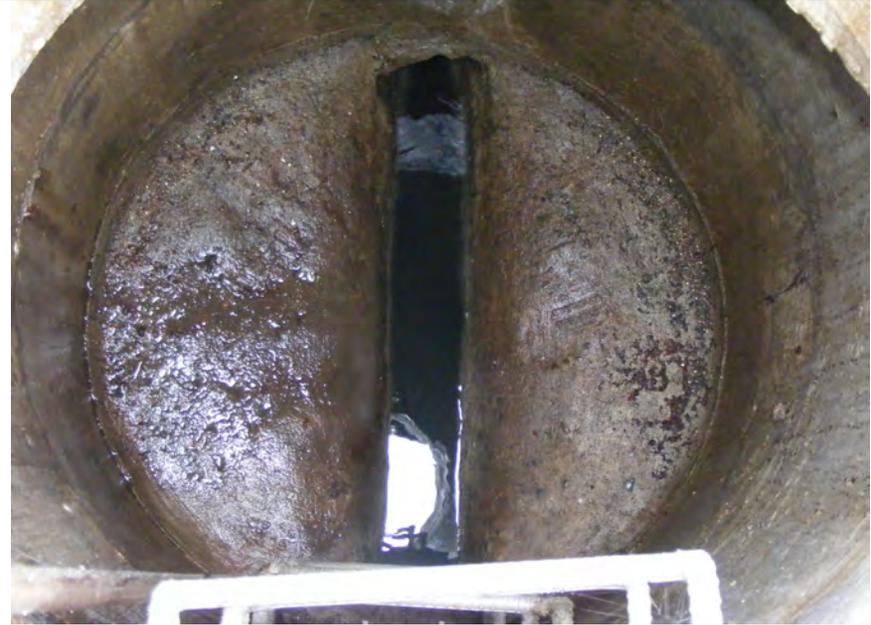
M-13

Minimal flow through manhole.

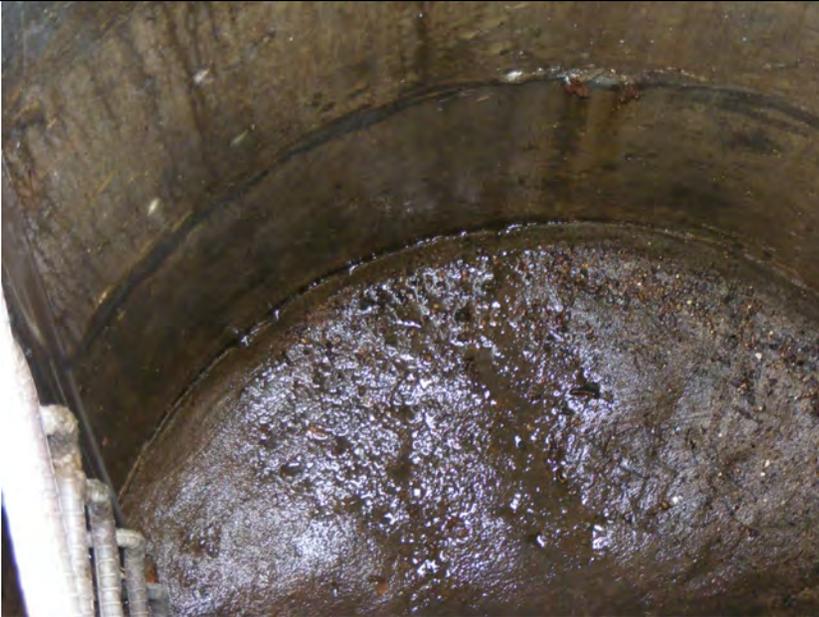
Wet on base of north side wall-appears to be a circular crack.

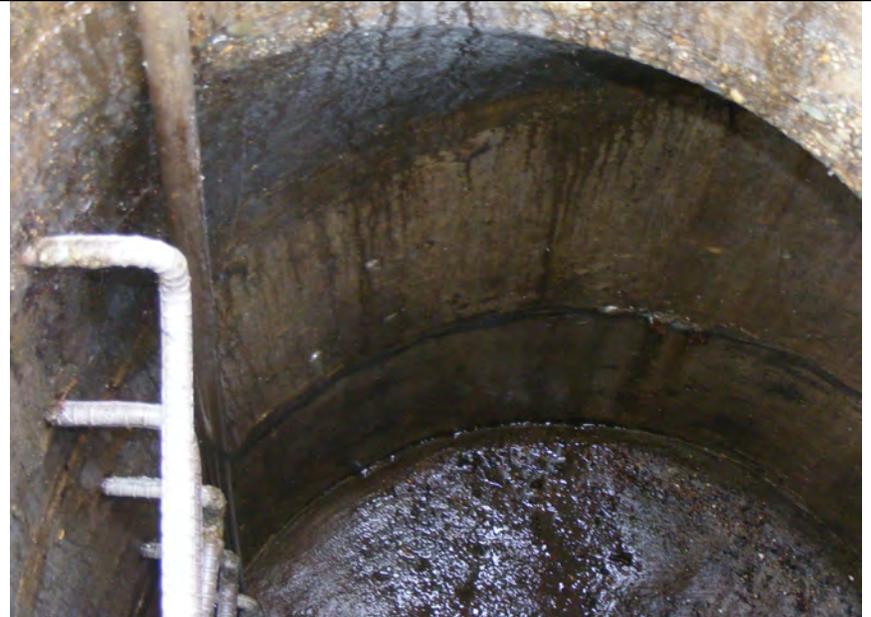
Infiltration stains on manhole interior wall.

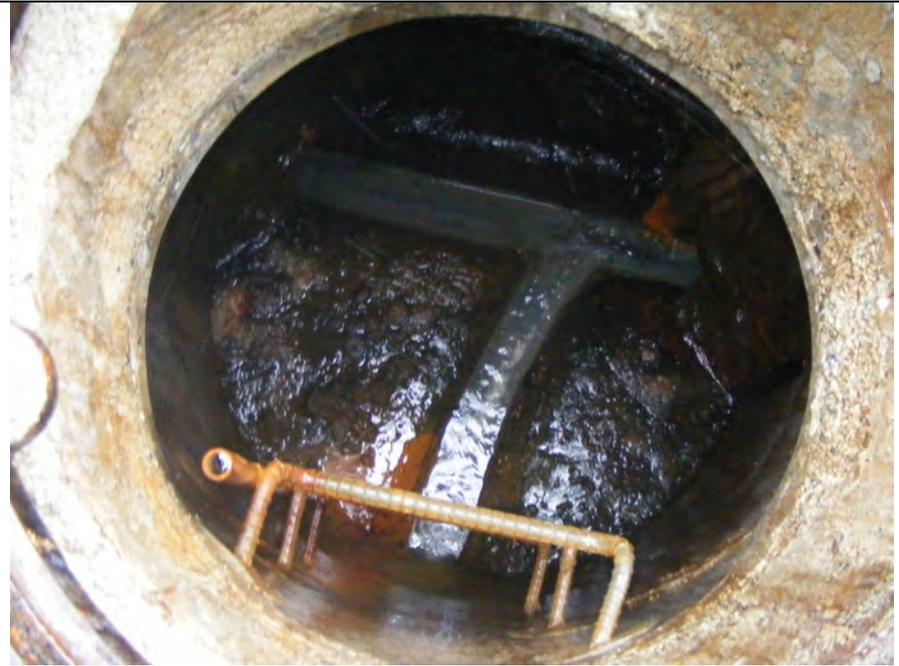
M-14

Steady flows through manhole.

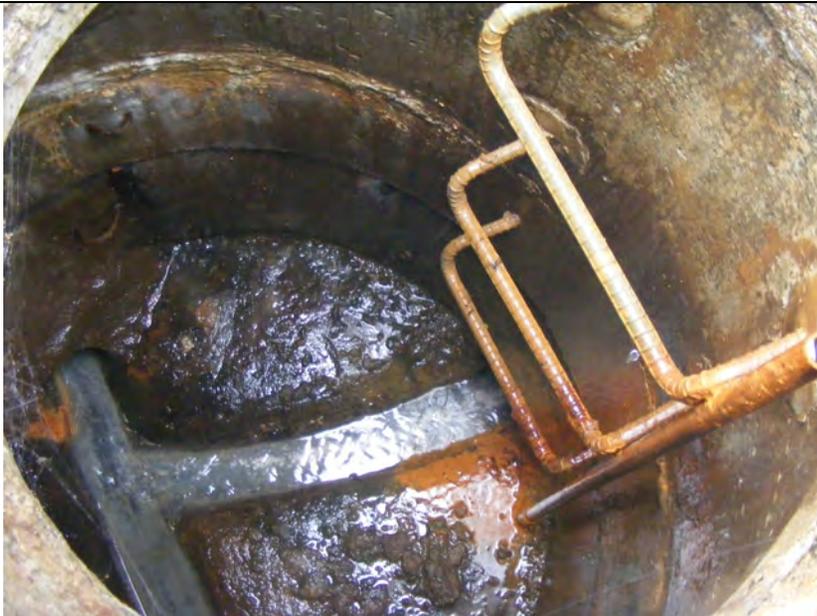
Infiltration stains on north interior wall.

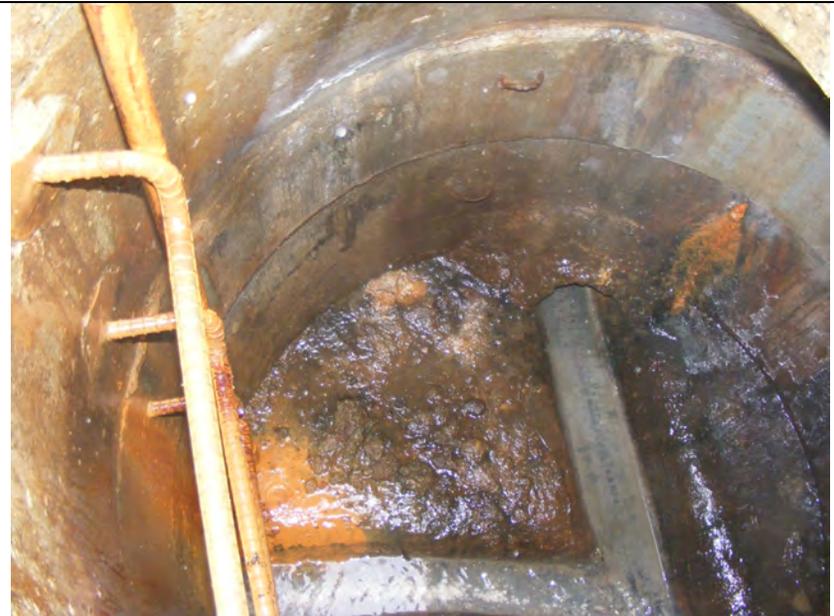
Mineral deposits around north and west pipes. Bench is covered with deposits.

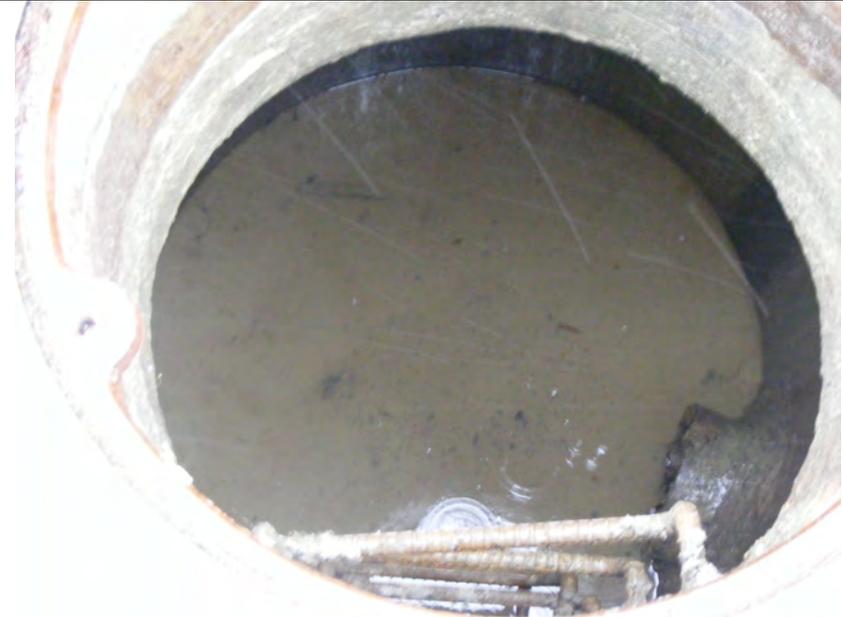
M-15

Appears to be a catch basin.

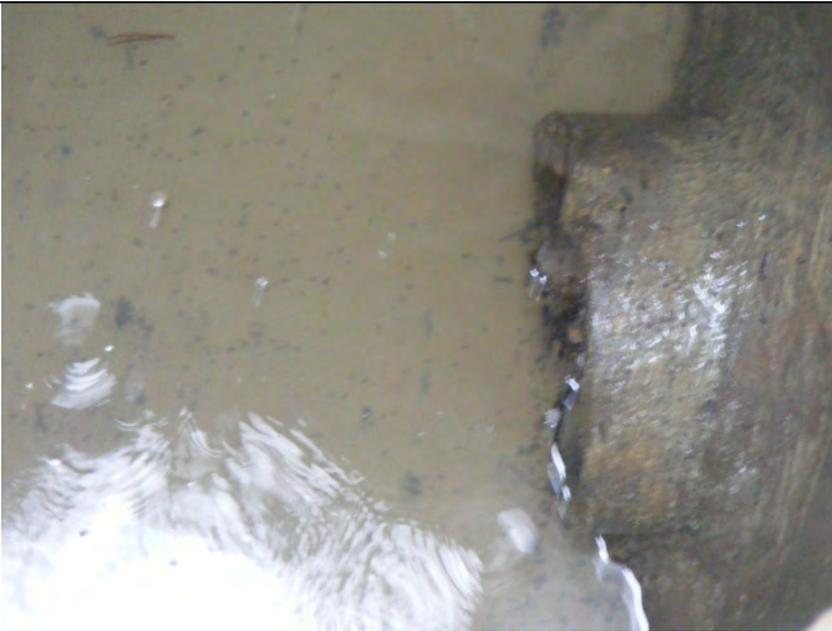
Concrete outlet to west.

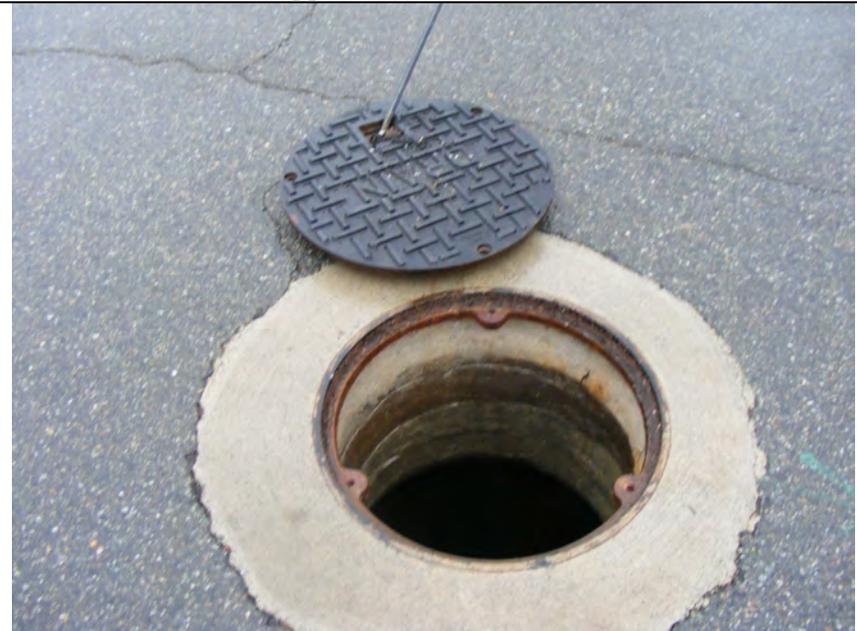
Manhole cover is labeled drain. Identified as manhole on basemap.
