APPENDIX D
TV INSPECTION

CITY OF LYNNWOOD
INFILTRATION & INFLOW STUDY
TV INSPECTION - JANUARY - APRIL 2010
DVD #1

**City of Lynnwood Infiltration & Inflow Study
Cleanout Cap Repair Cost Estimate**

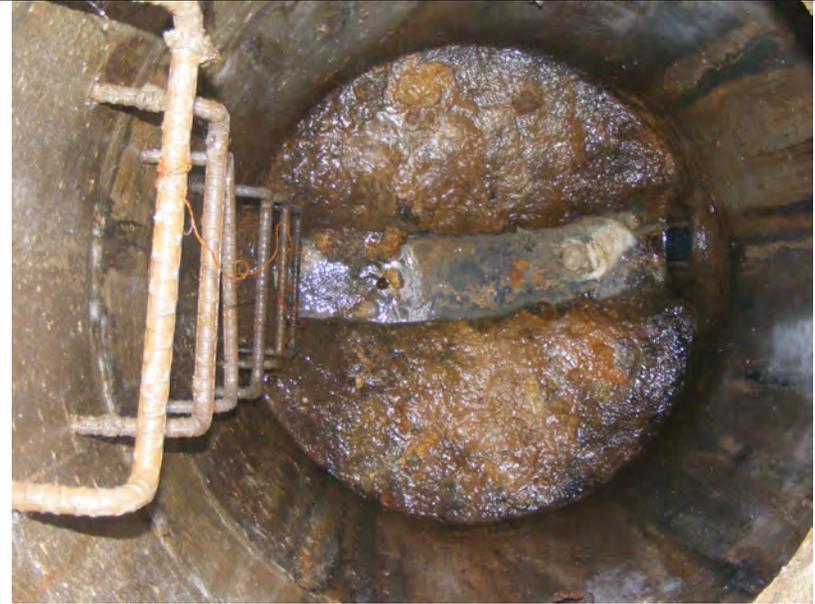
M-16

- Deposits (excrement, toilet paper, etc.) causing damming inside manhole
- Manhole channel may be in low spot
- Benches are full of deposits

Deposits are causing damming inside manhole channel.

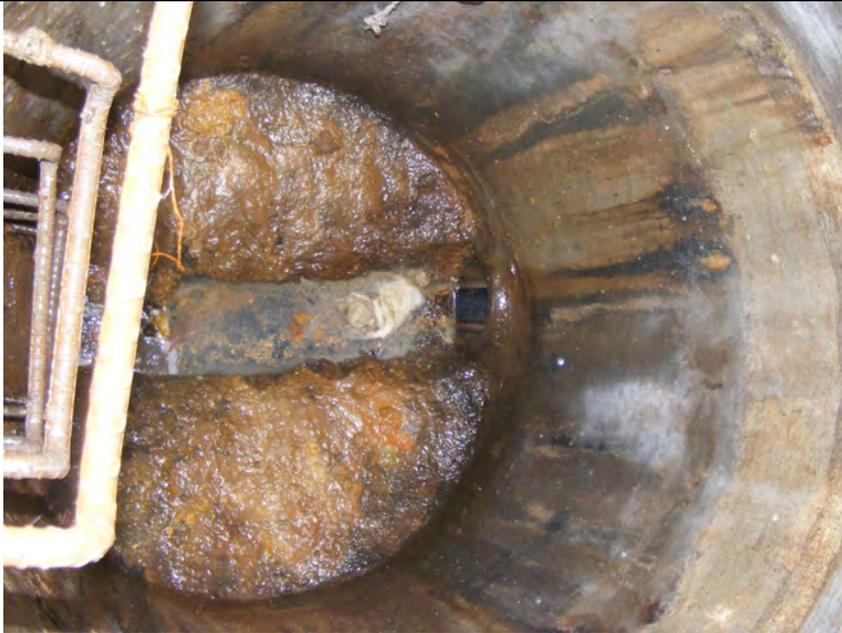
Manhole benches are full of deposits.

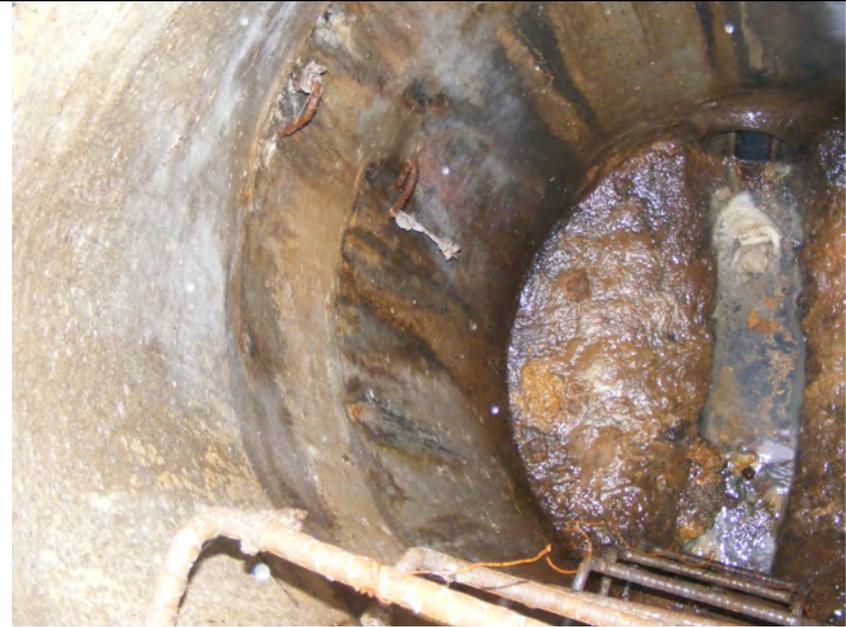
Infiltration stains on manhole interior walls.

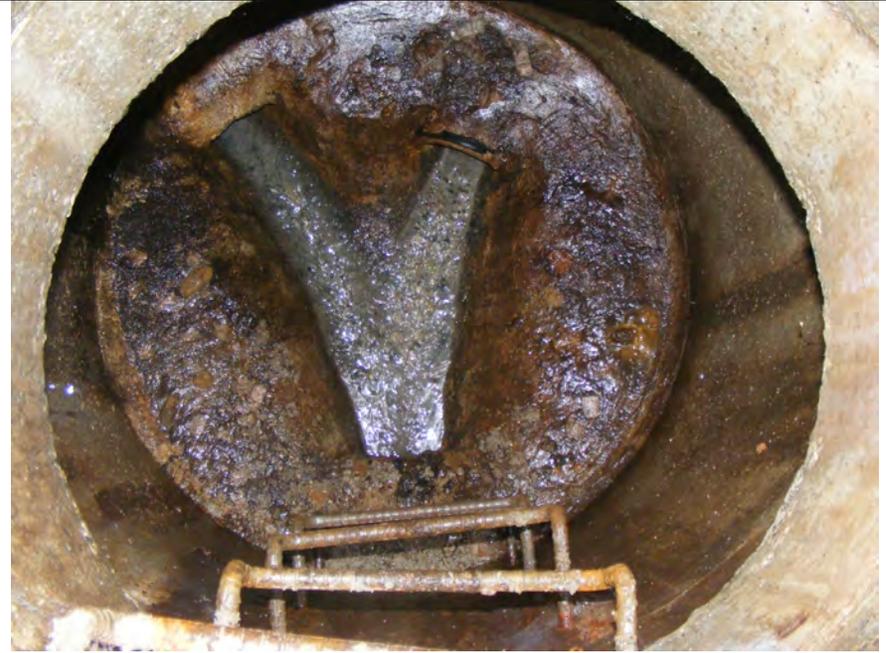
M-17

- Steady, clear flow through manhole
- Deposits on bench-may be from surcharge event
- Minimal ponding on manhole cover-concrete collar around manhole cover, looks relatively new

Steady, clear flow through manhole. Deposits on manhole benches.

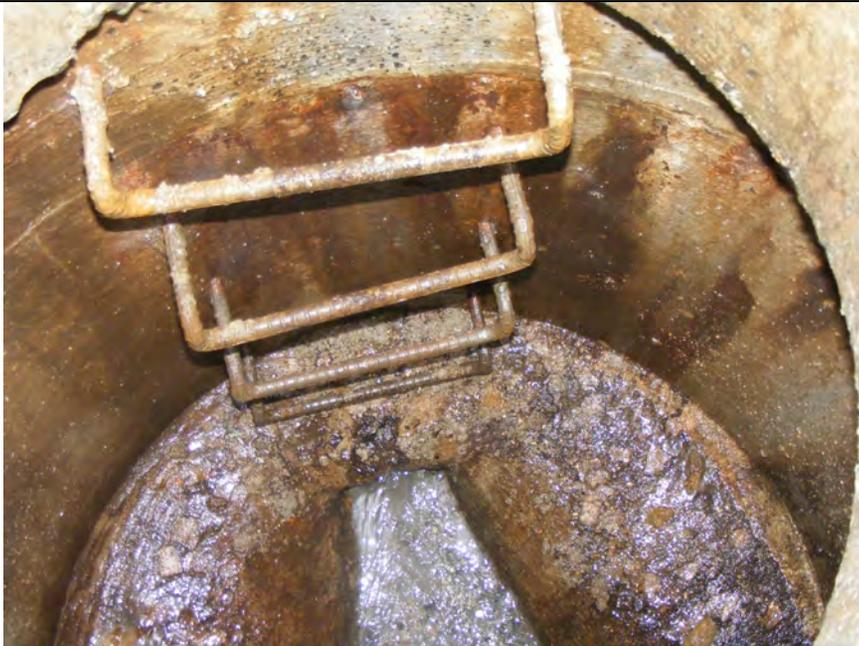
Infiltration stains on manhole interior walls.

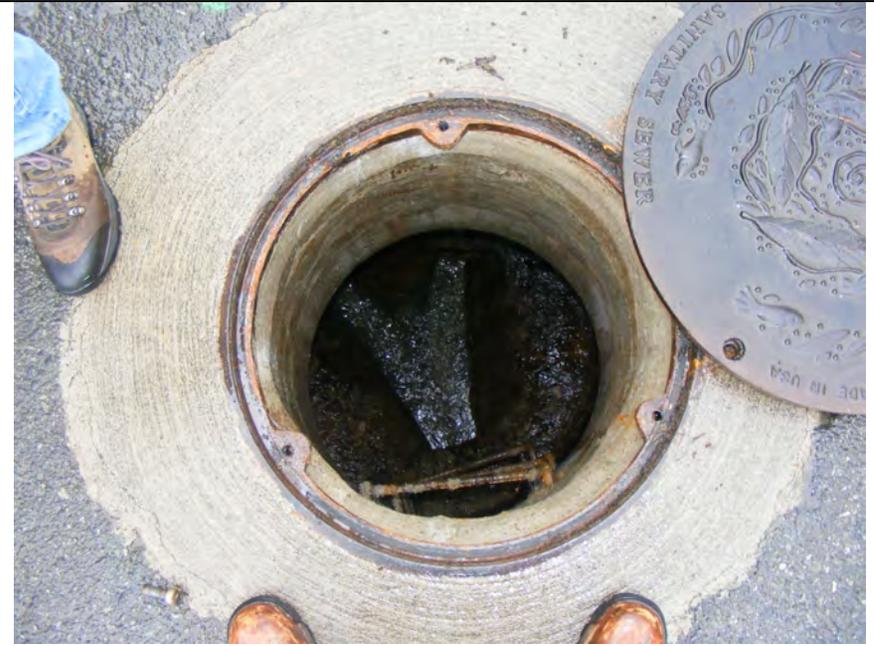
Concrete collar around manhole rim appears relatively new.

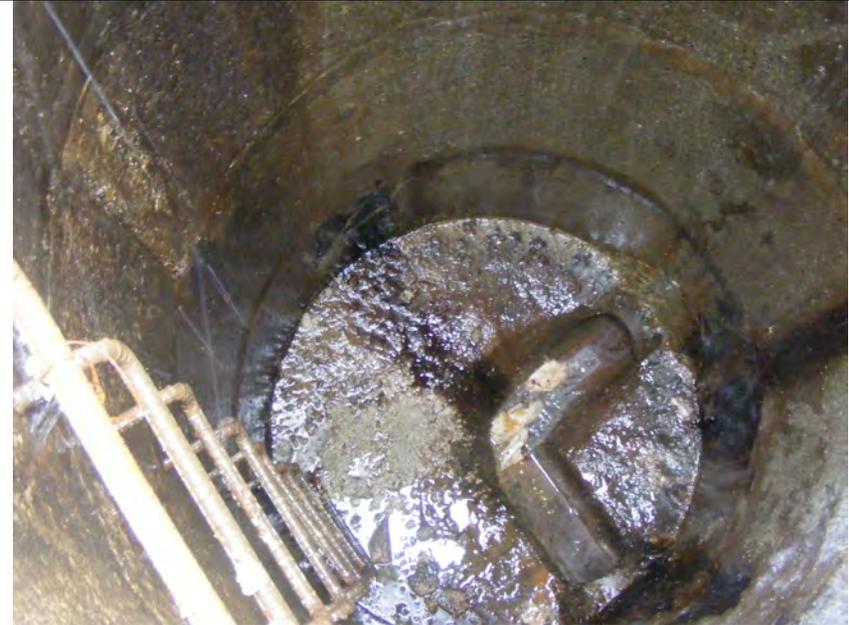
M-18

Minimal flow through pipe.

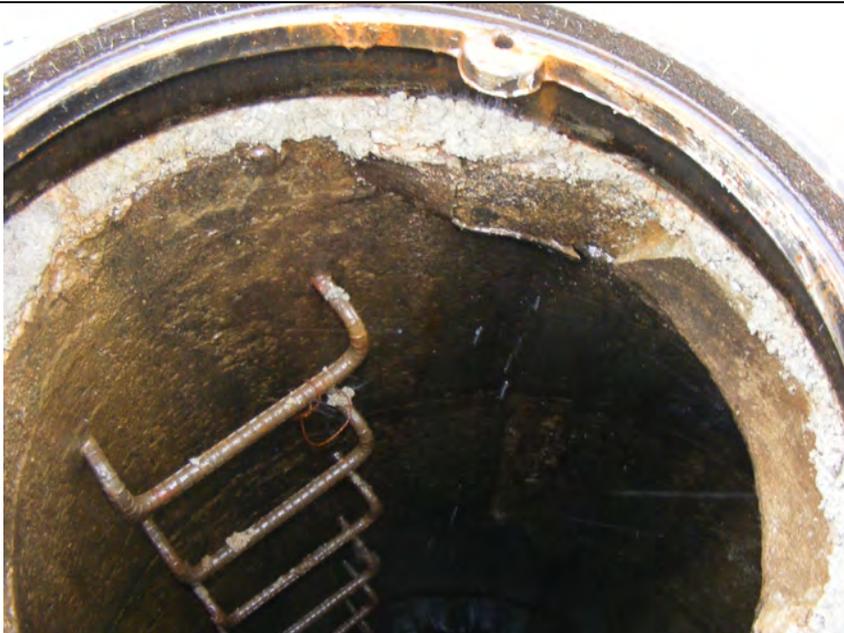
- Dripping water from leak in manhole riser section
- Interior walls are wet
- Mineral deposits on one riser section around entire section circumference- may be leak all around

Dripping water from leak in manhole riser section.

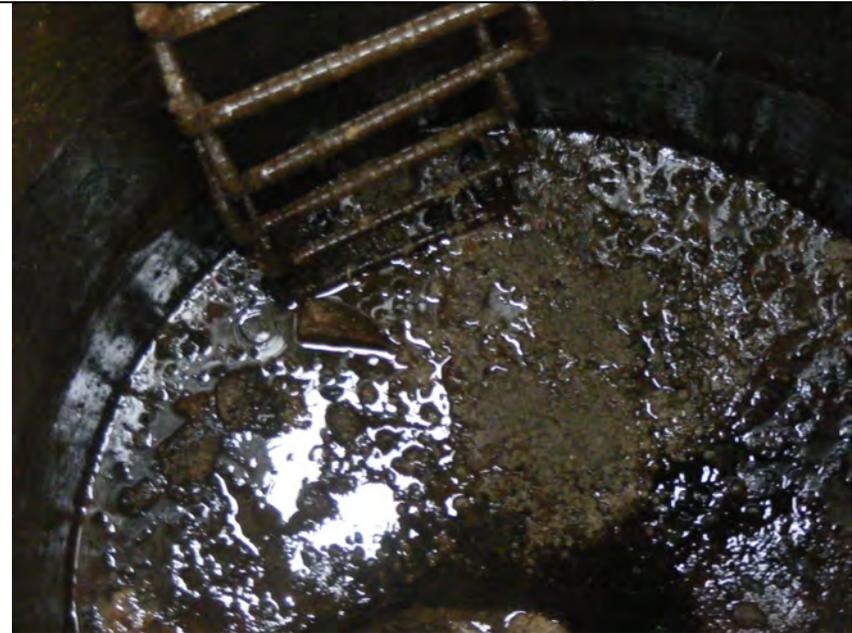
Manhole benches are wet.

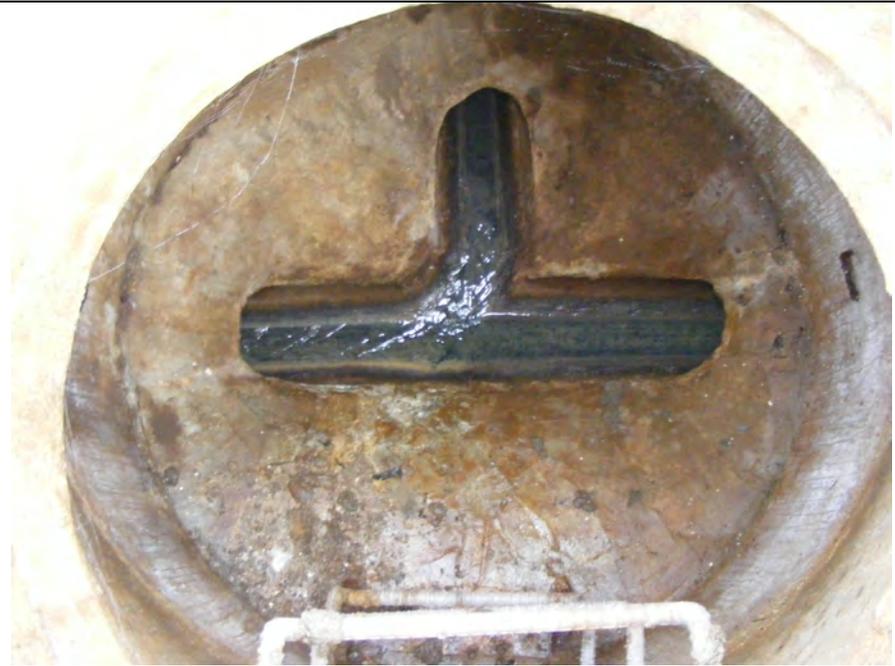
M-19

Minimal flow through pipe.

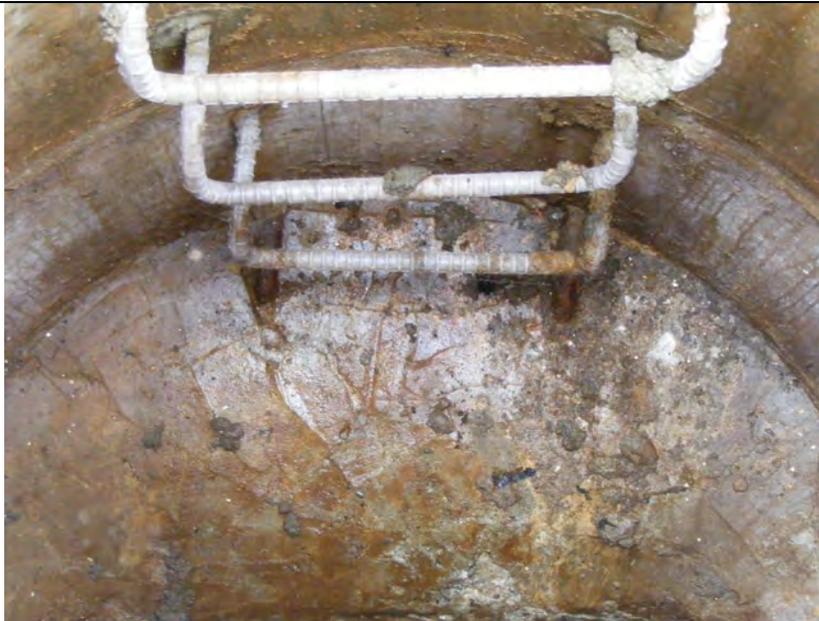
Mineral deposits on risers.

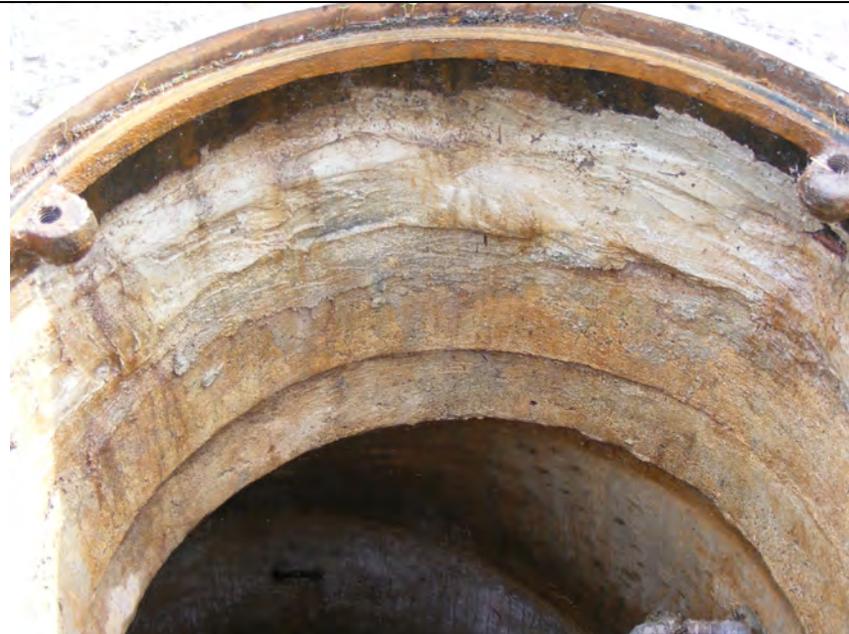
Manhole riser sections are wet.

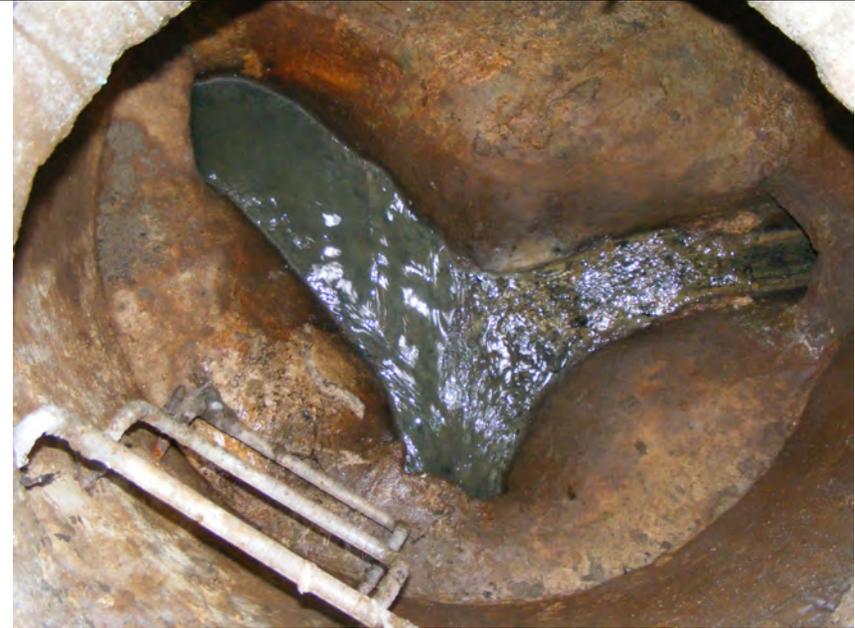
M-20

Significant flows from west.

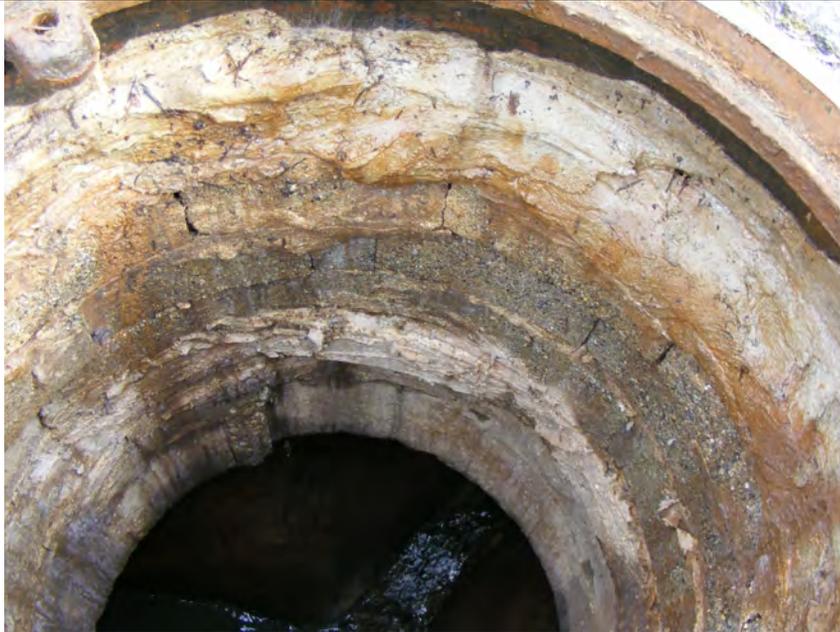
Infiltration stains on manhole risers.

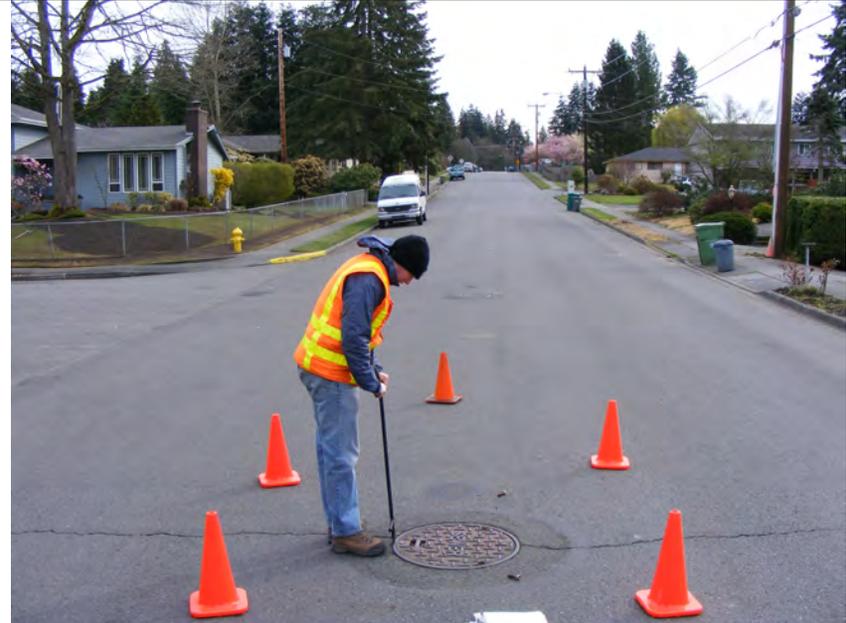
Lateral crack in pavement across entire roadway width jutting out laterally from manhole.

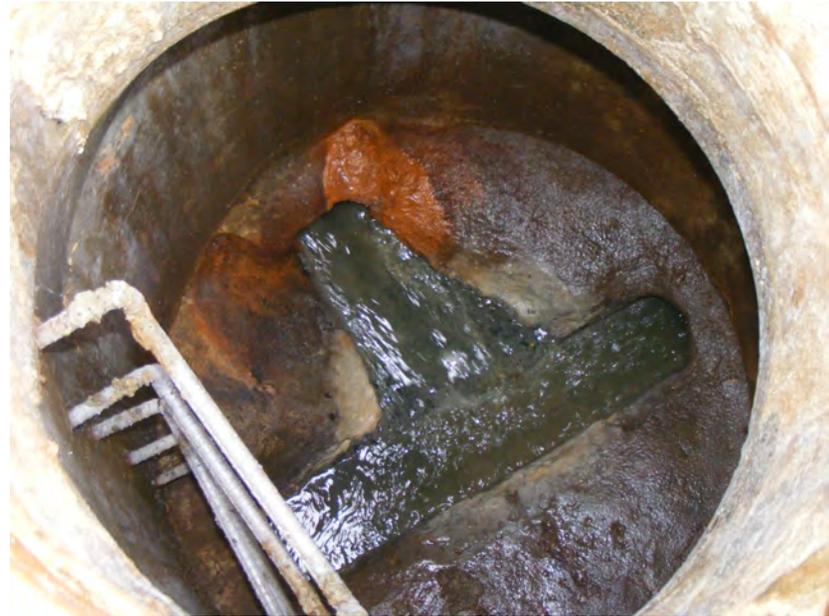
M-21	Basin: Flow Meter #4	MH #: 5-148
------	----------------------	-------------

- Bench is wet
 - Significant flow from north
 - Lateral crack in road from manhole to both edges of pavement
 - Pavement around manhole rim has been elevated
 - Mineral deposits around outside of north pipe invert
-
- No visible infiltration through manhole rim

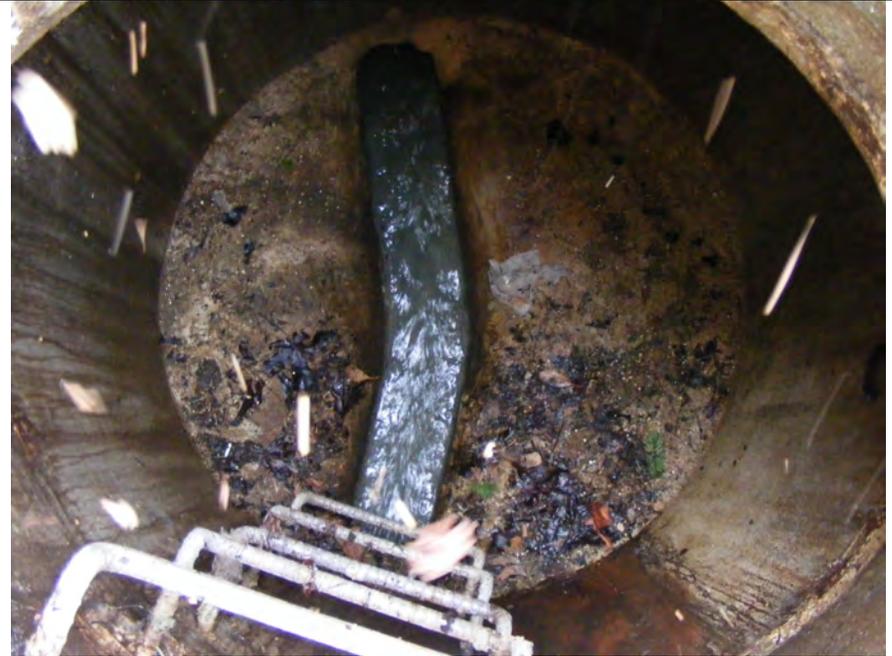
M-22

Steady flows through manhole. Debris on bench.

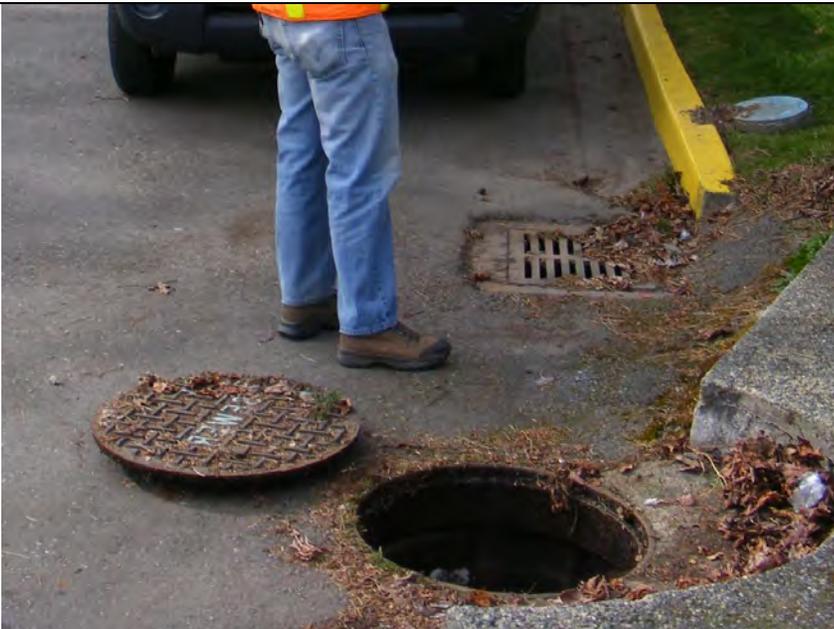
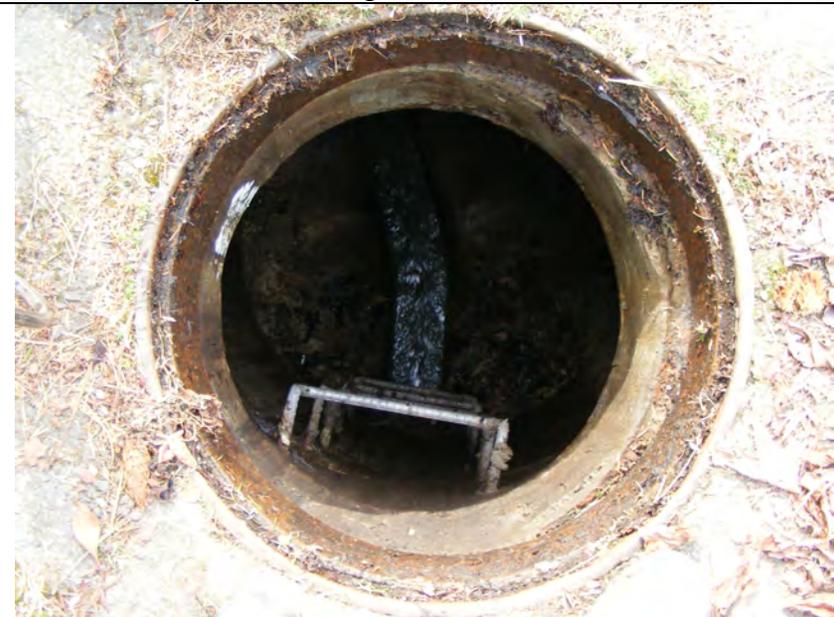
Manhole rim and cover have shifted.

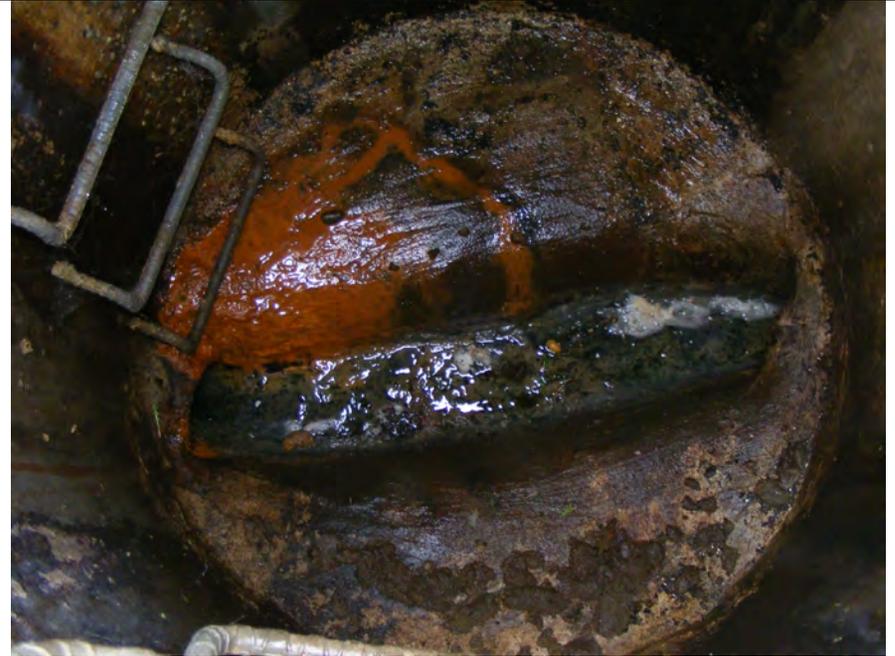
M-23

Mineral deposits on outside of east invert on south bench.

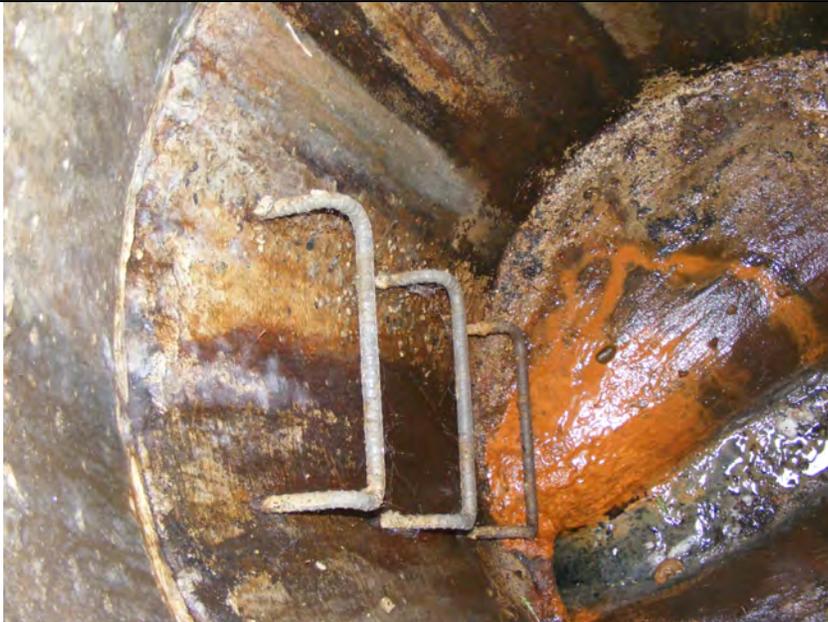
Streaks on interior manhole walls.

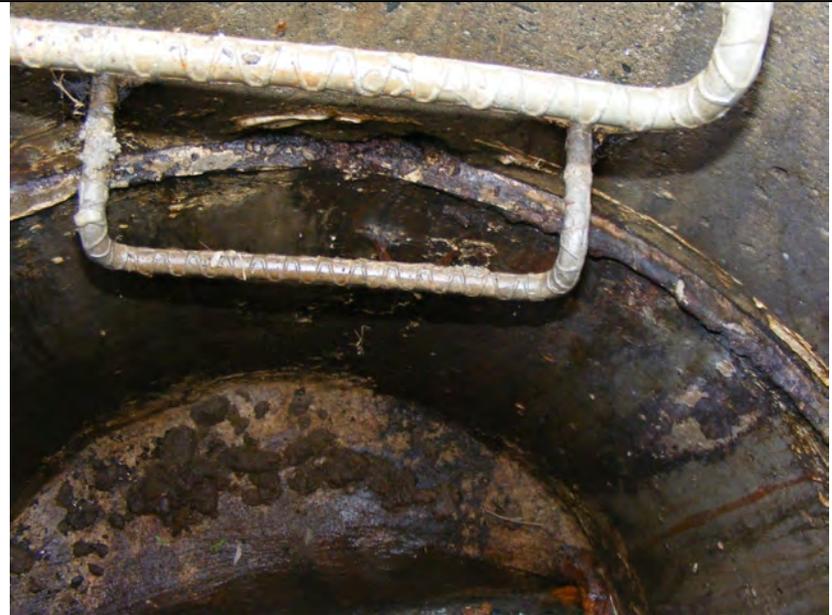
Deposits on north side bench.

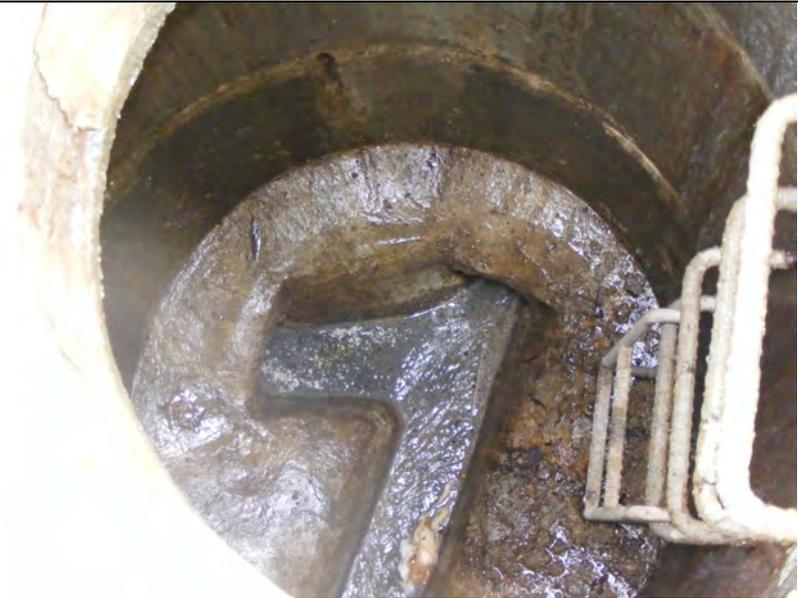
M-24

Minimal flow through manhole.

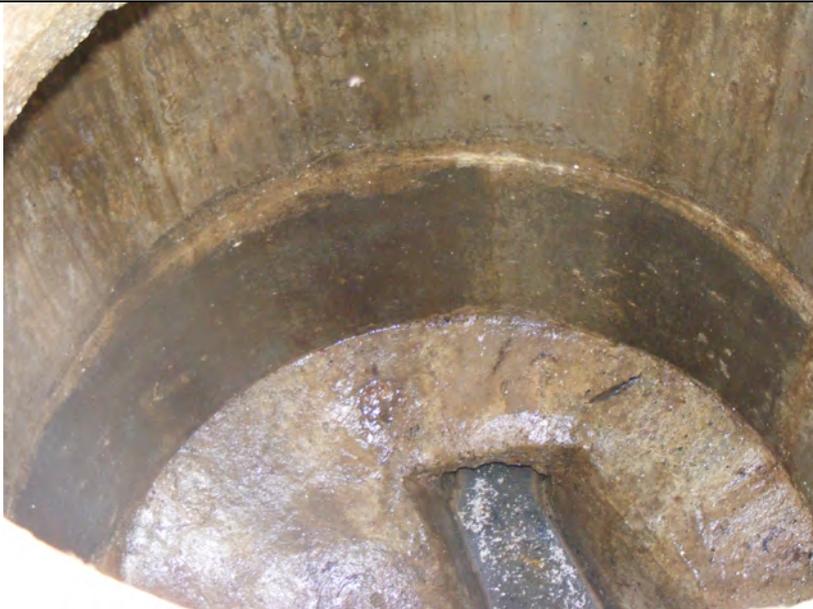
Seepage around edge from top of bench up to first riser section.

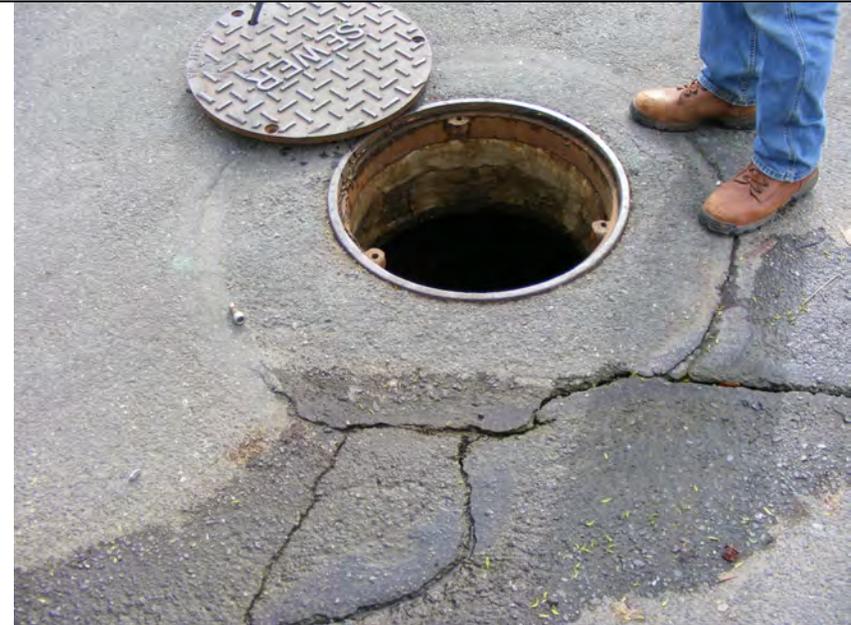
Rim slightly above grade of pavement. Pavement is cracked around manhole rim.

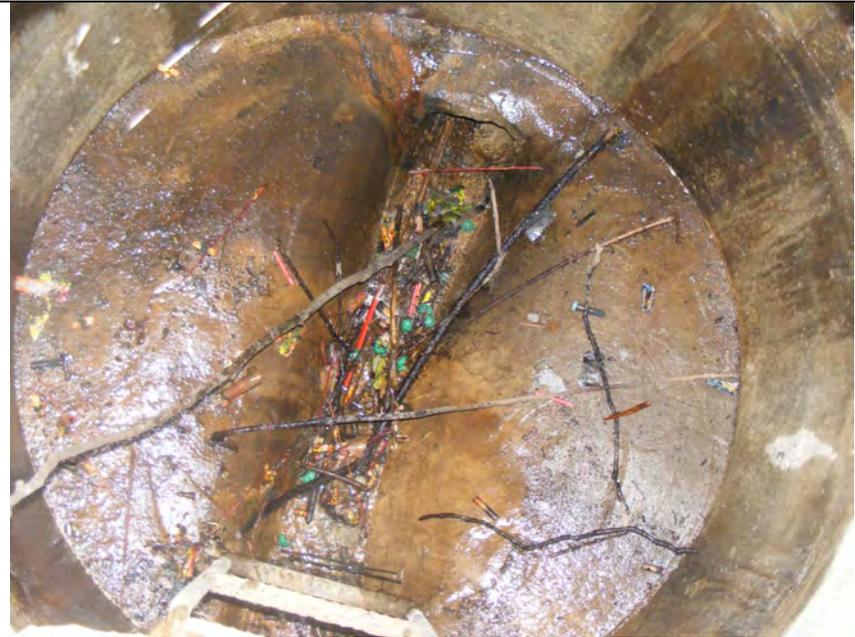
M-25

No flow through manhole.

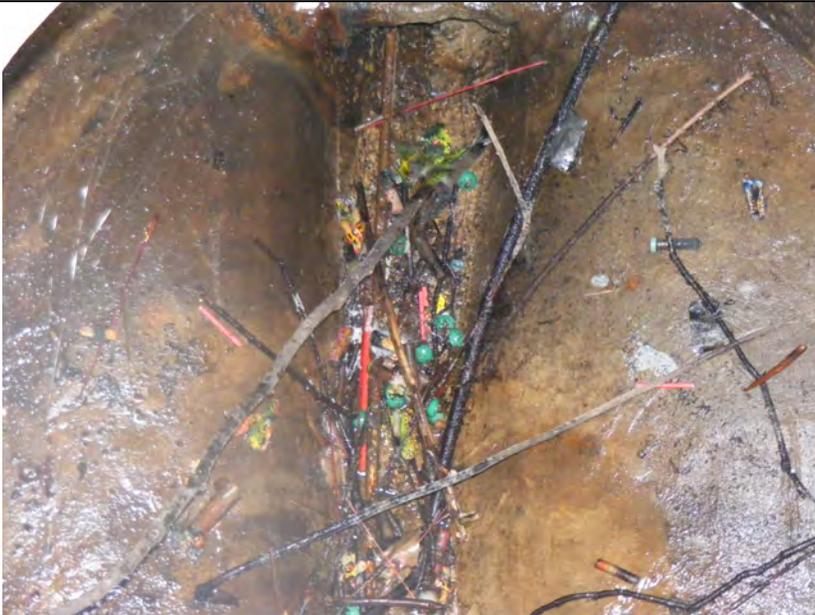
Sticks, debris and firecrackers inside.

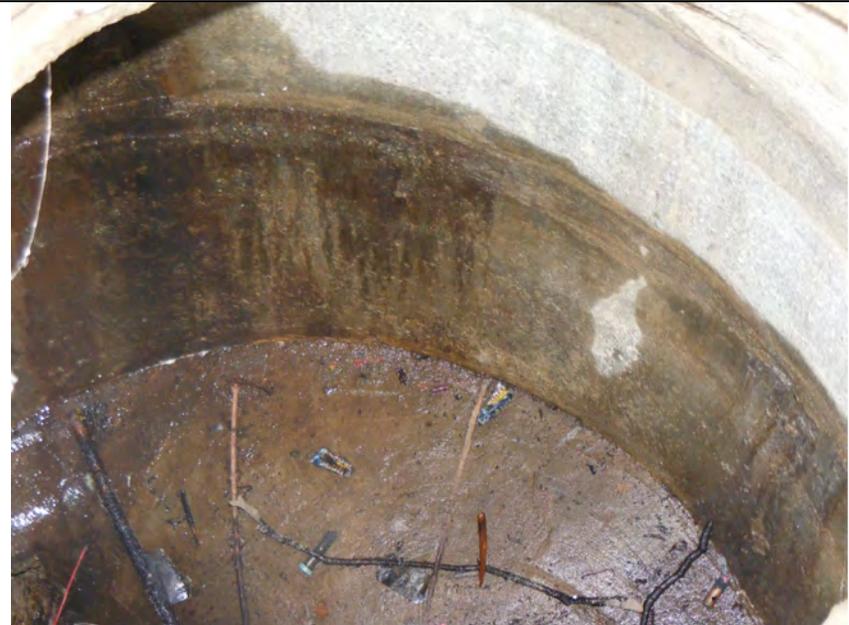
Stains on north side interior wall.

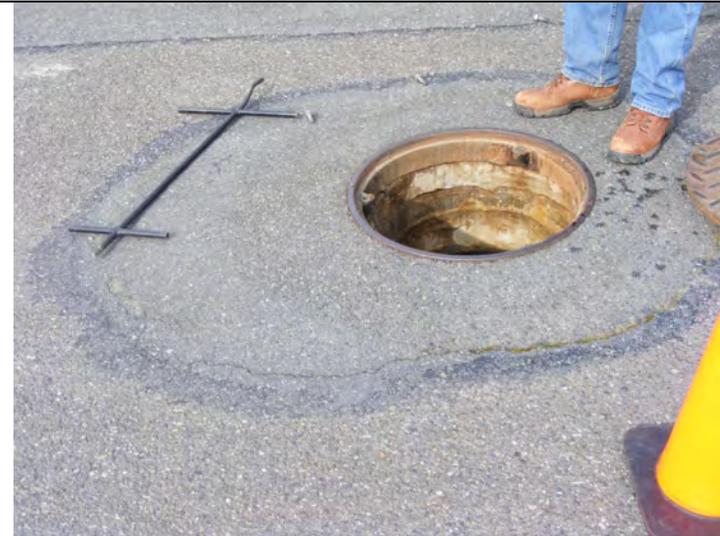
M-26

Manhole rim flush with adjacent grade.

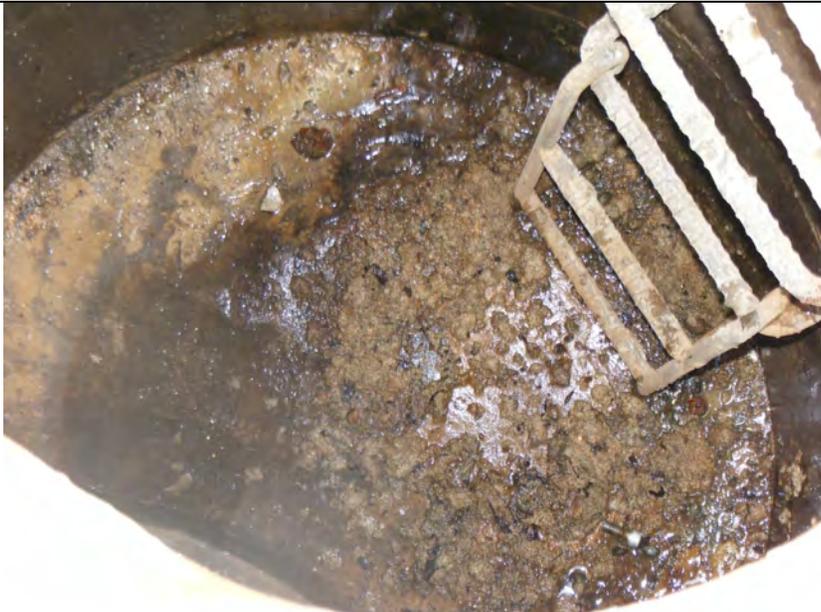
Benches are wet.

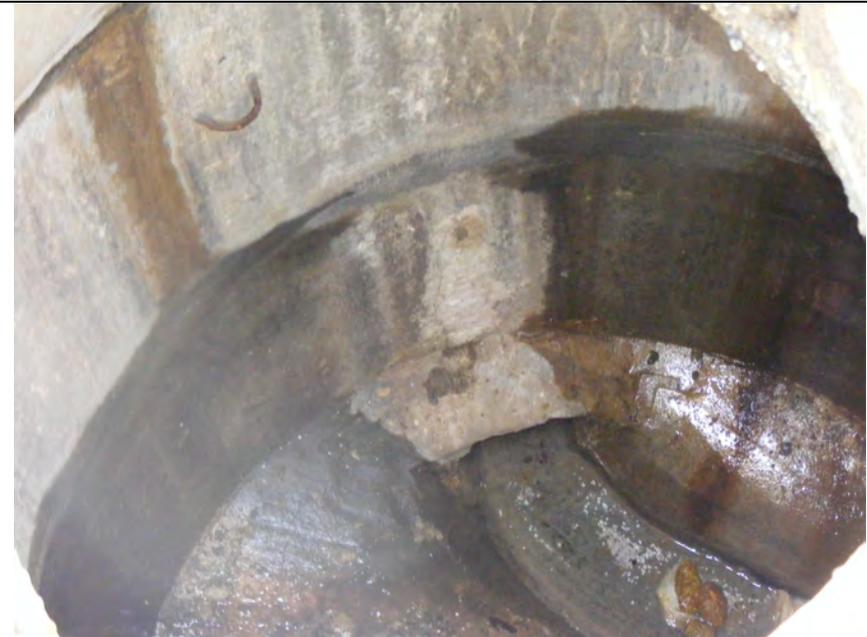
Interior walls are wet above manhole benches.

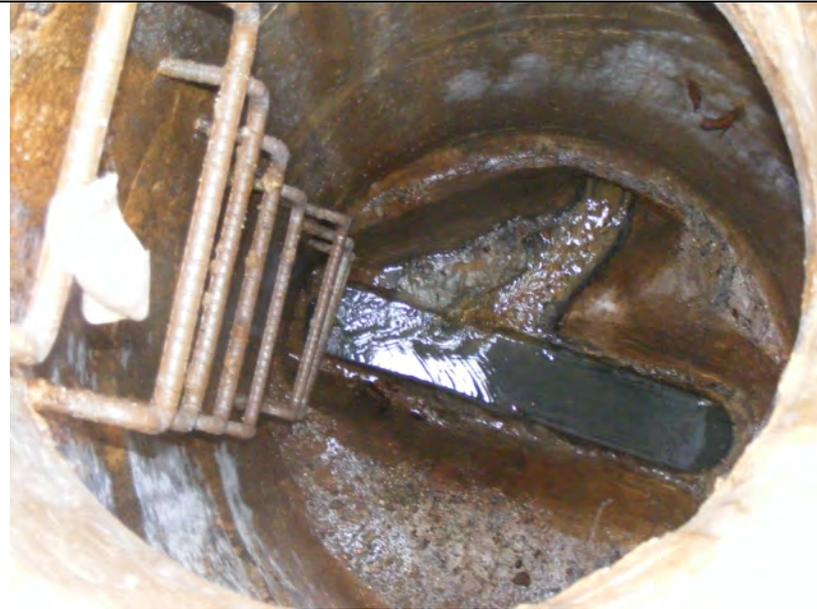
M-27

Steady flow from north. Minimal flow from west.

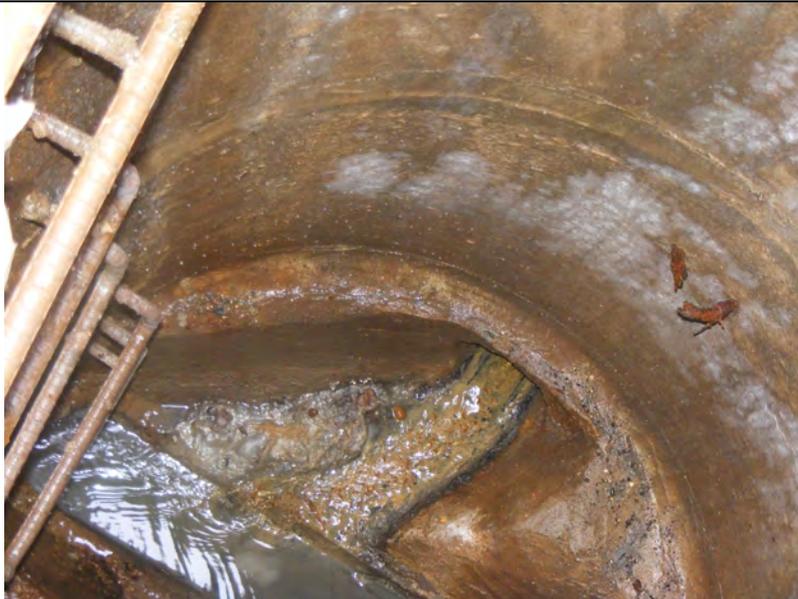
Mineral deposits on south riser section.

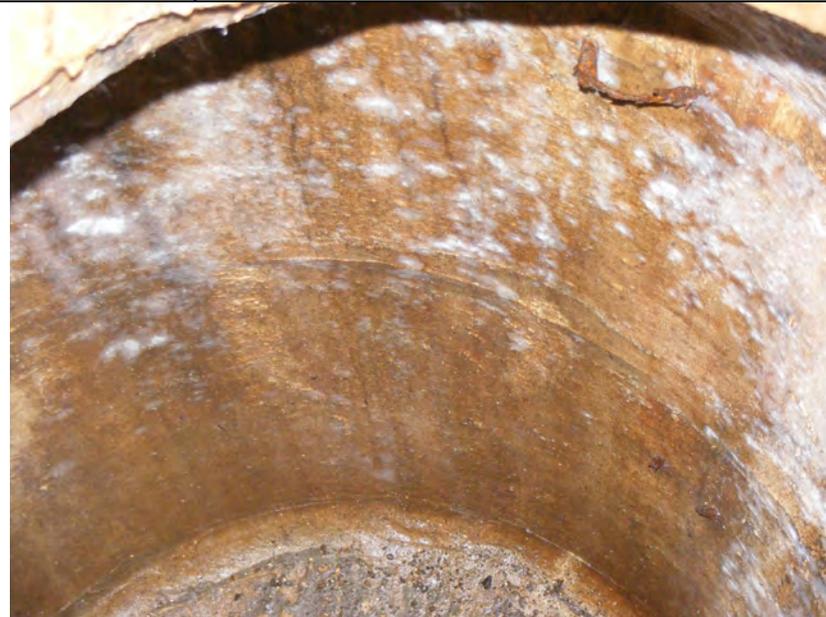
Stains on manhole interior wall.

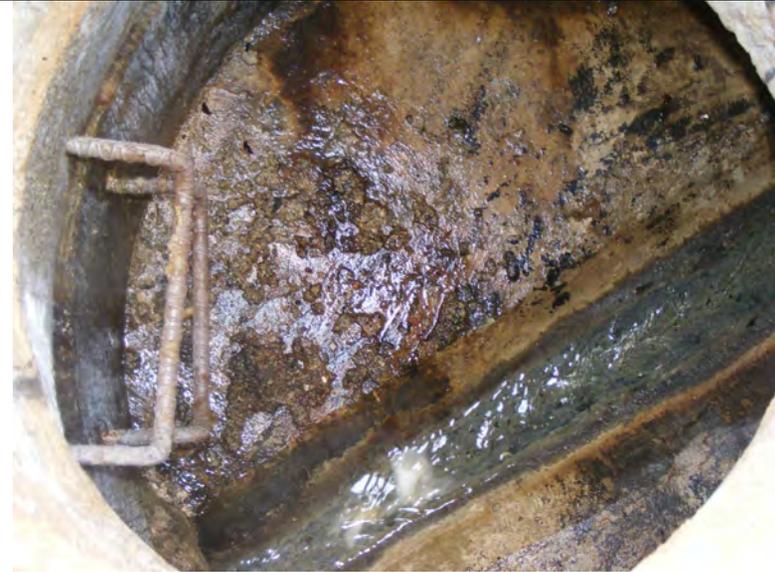
M-28

South bench is wet and has deposited solids.

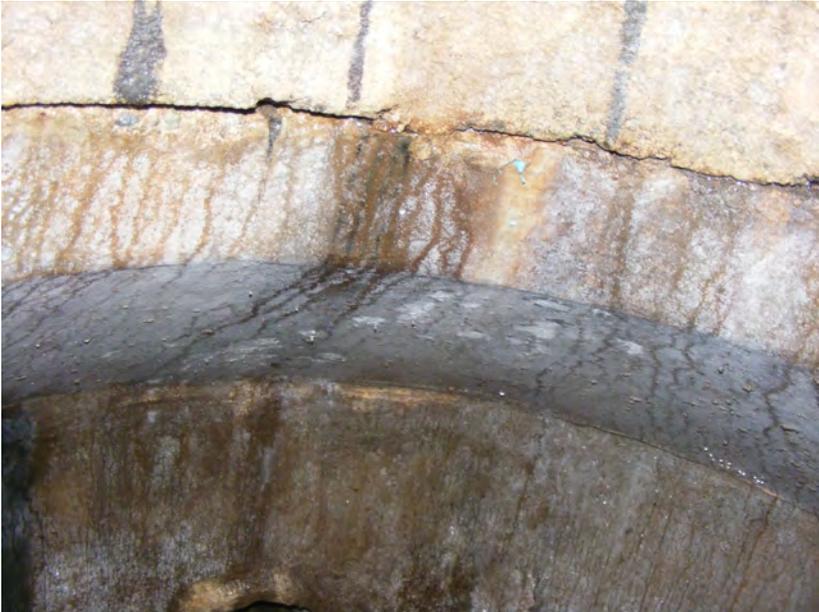
Infiltration stains.

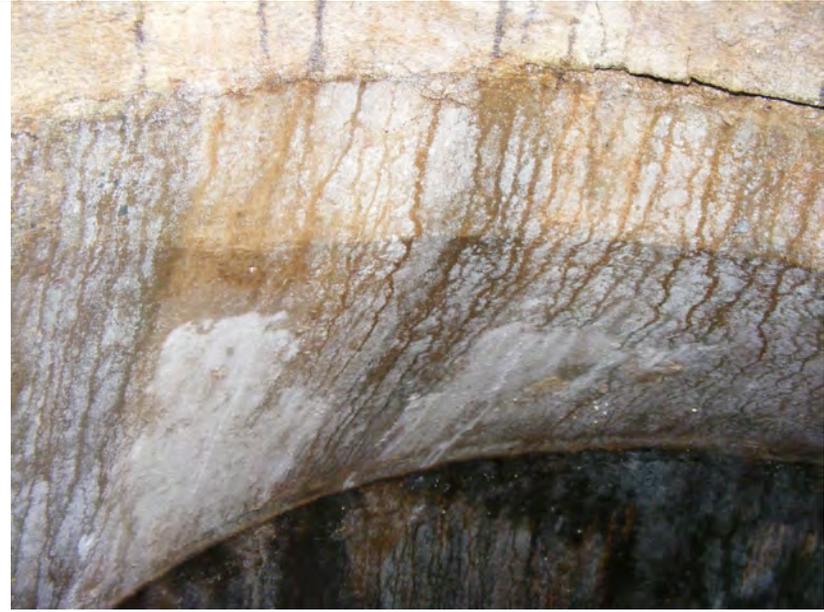
Visible infiltration on interior wall.

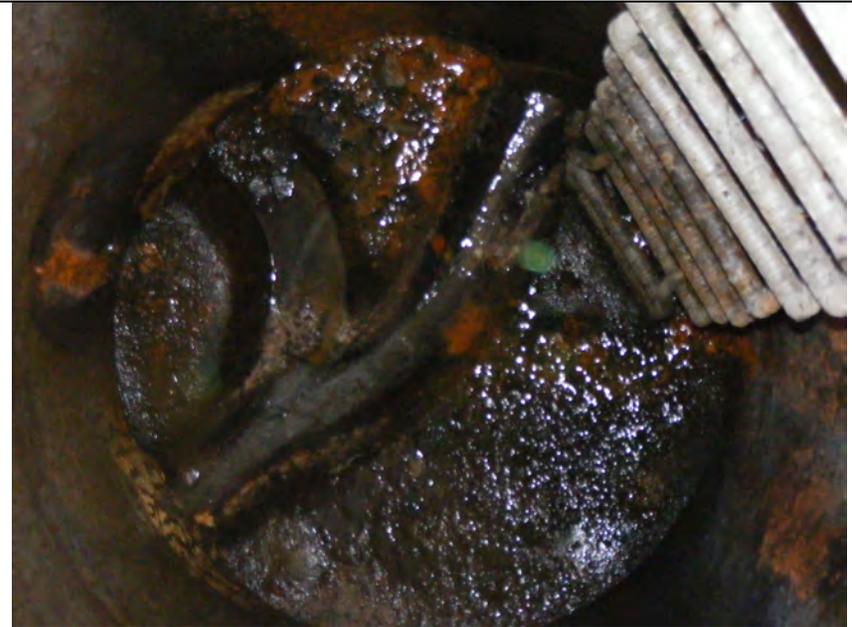
M-29

Minimal flow through manhole. Benches are wet.

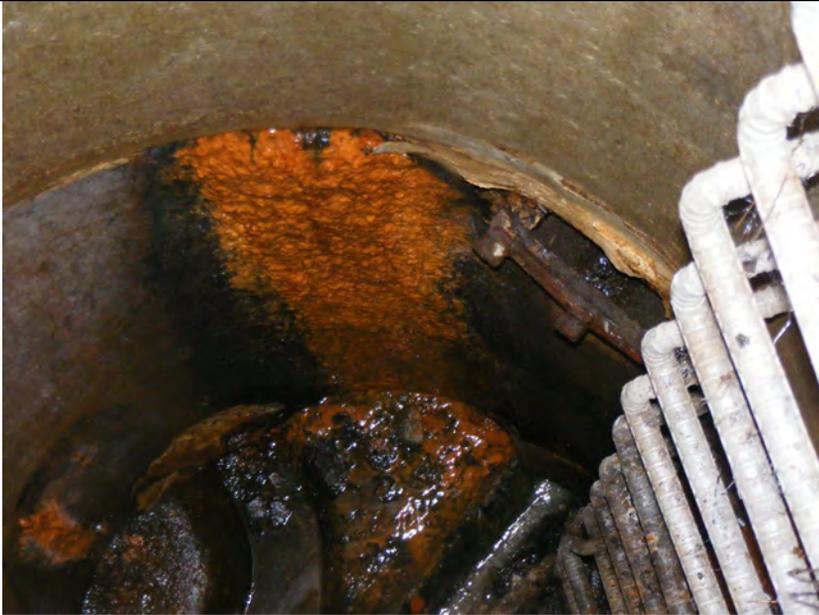
Heavy mineral deposits on interior wall.

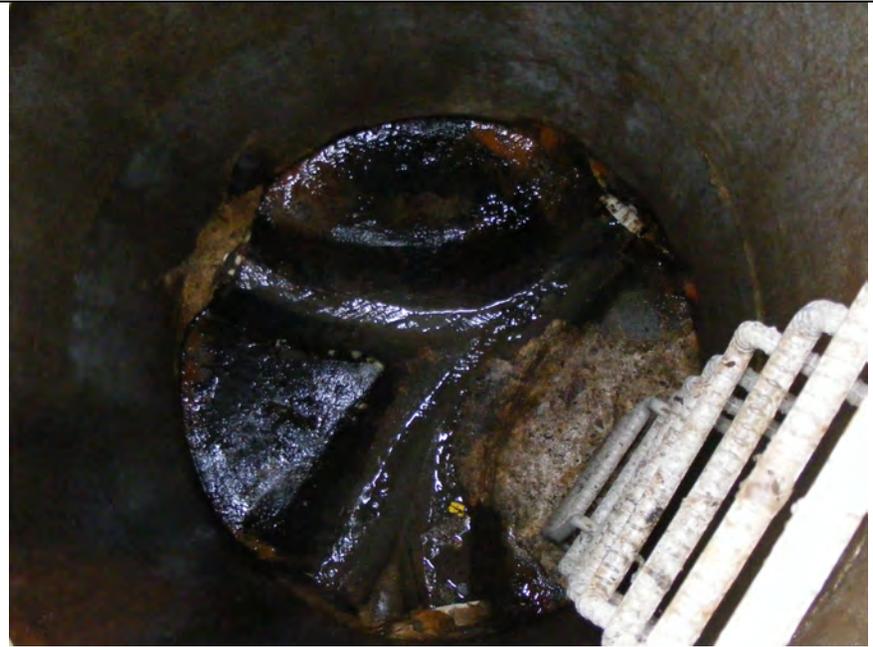
M-30

Deposits on benches.

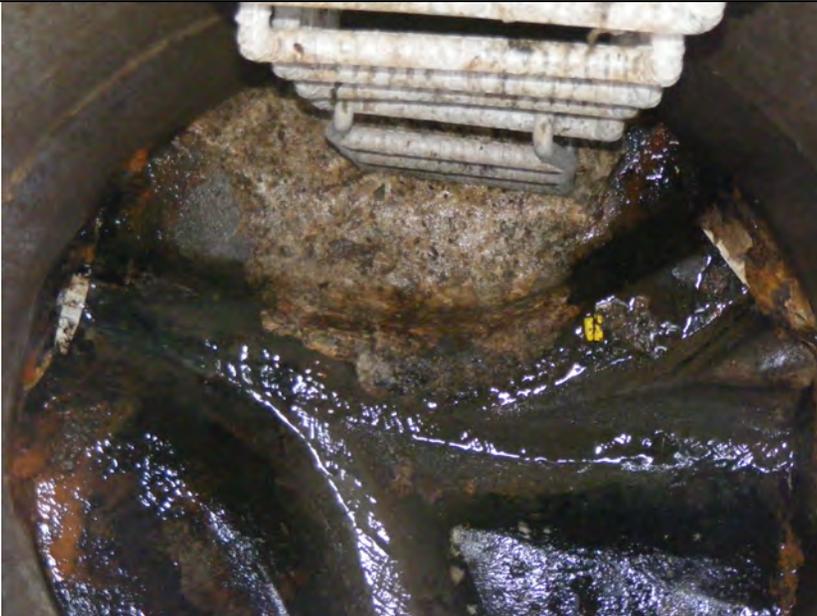
Minimal flow through manhole. Benches are wet.

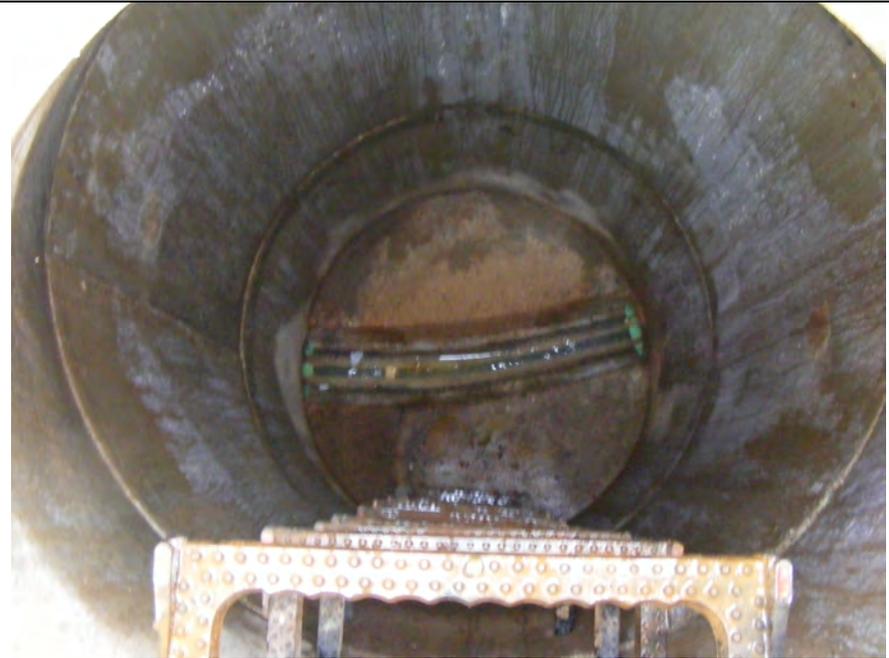
M-31

Minimal flow through manhole.

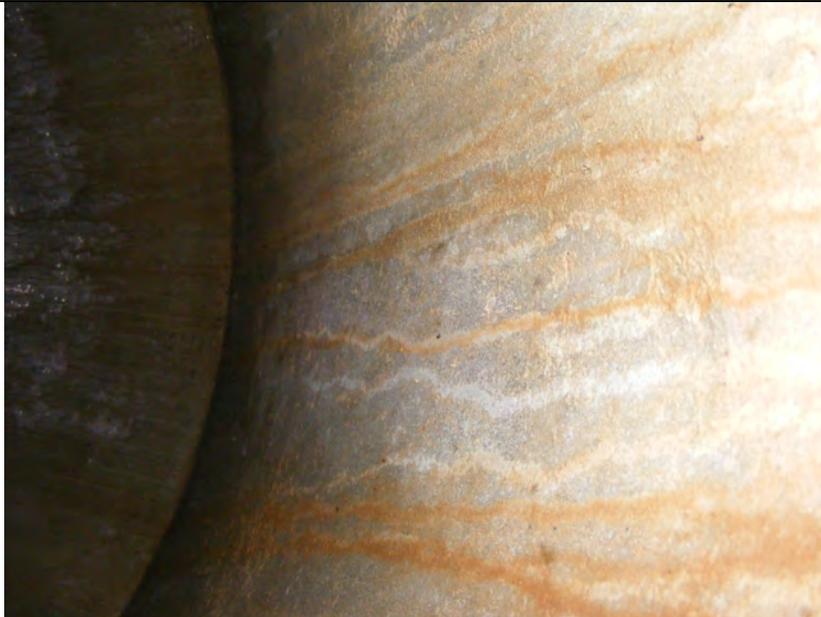
Appears to be infiltration at manhole wall joint.
