APPENDIX D
TV INSPECTION

CITY OF LYNNWOOD
INFILTRATION & INFLOW STUDY
TV INSPECTION - JANUARY - APRIL 2010
DVD #1

**City of Lynnwood Infiltration & Inflow Study
Cleanout Cap Repair Cost Estimate**

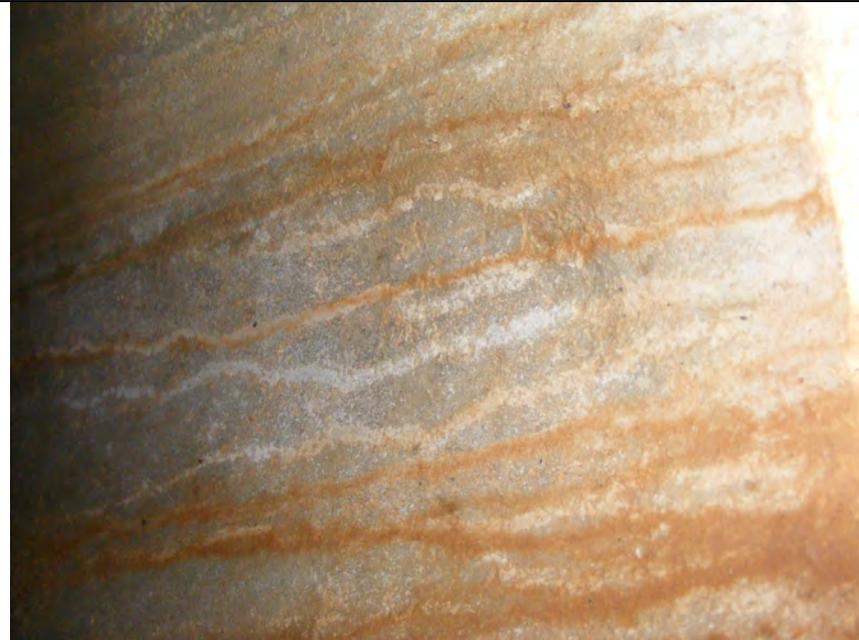
Infiltration stains on manhole interior walls.

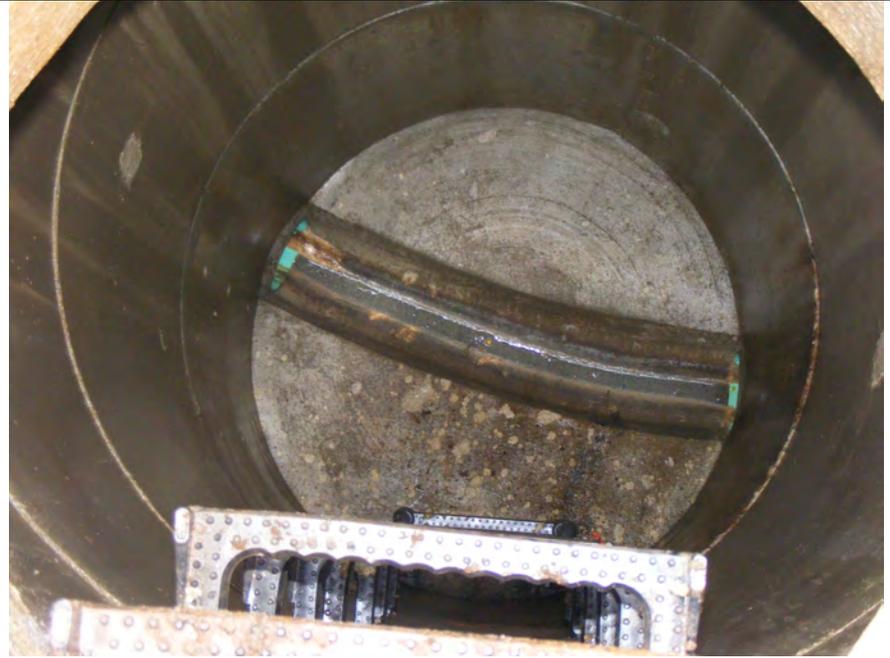
M-32

Minimal flow through manhole.

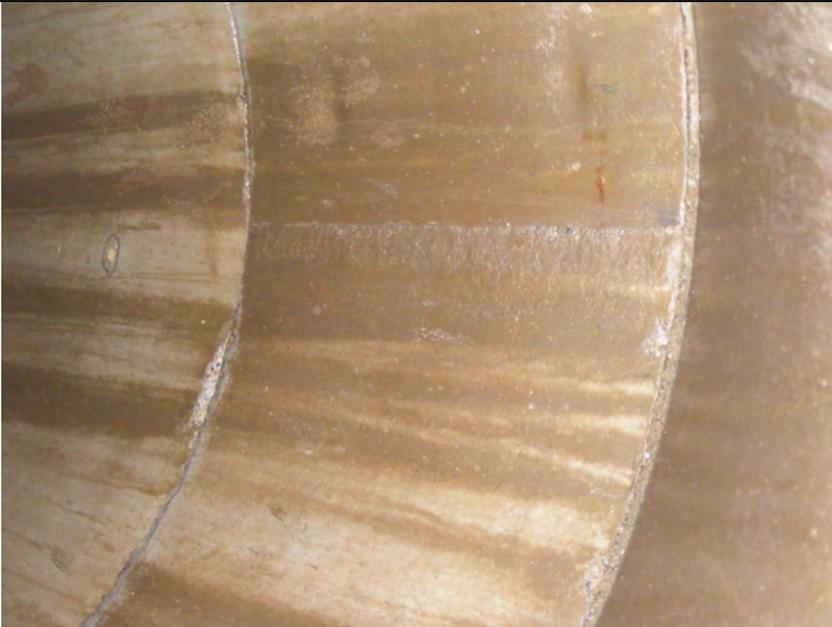
Light infiltration stains on manhole walls.

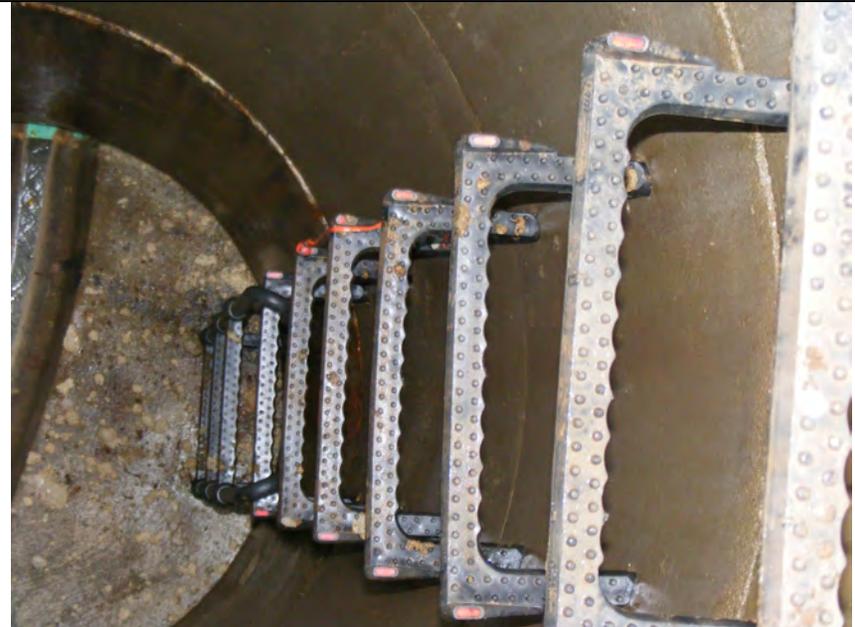
Manhole walls and ladder appear newer.

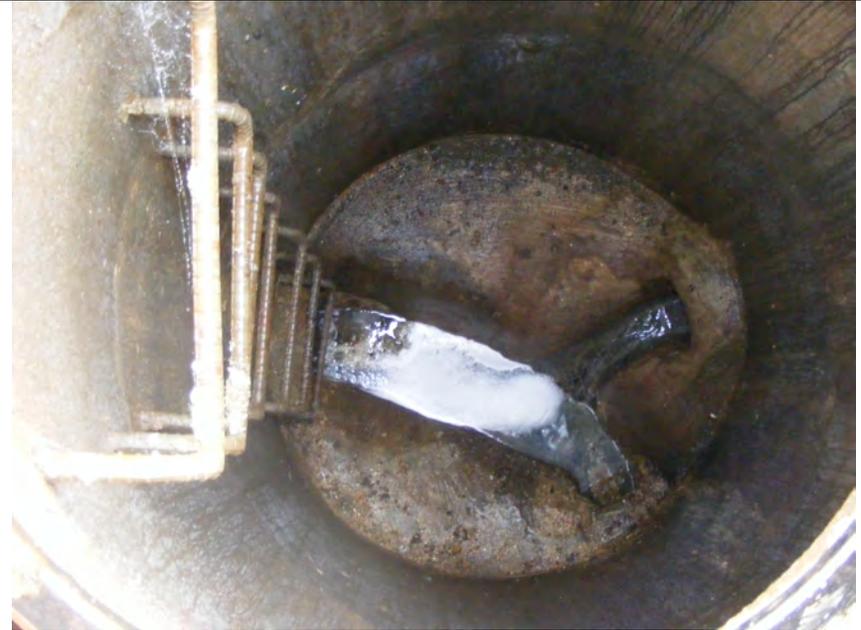
M-33

Steady flow from west.

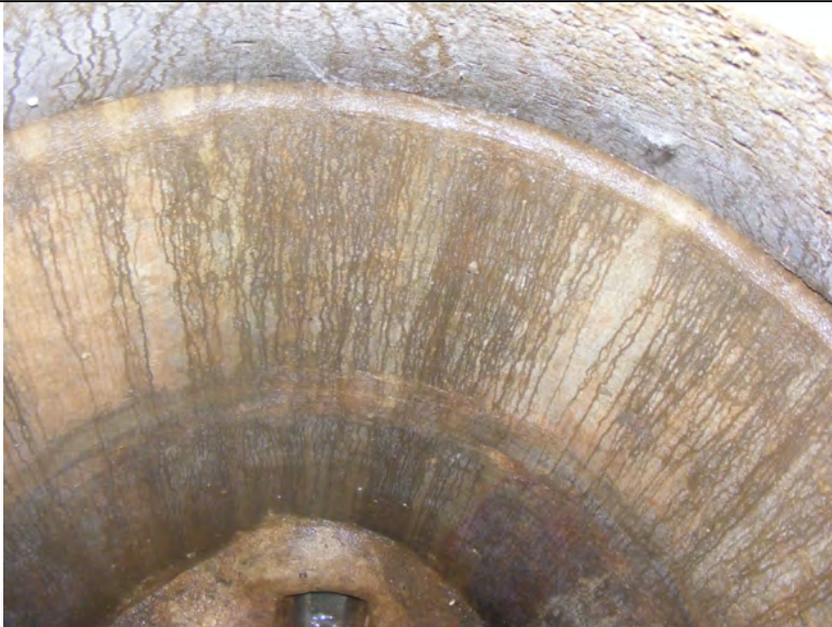
Light stains on interior manhole walls. No visible infiltration.

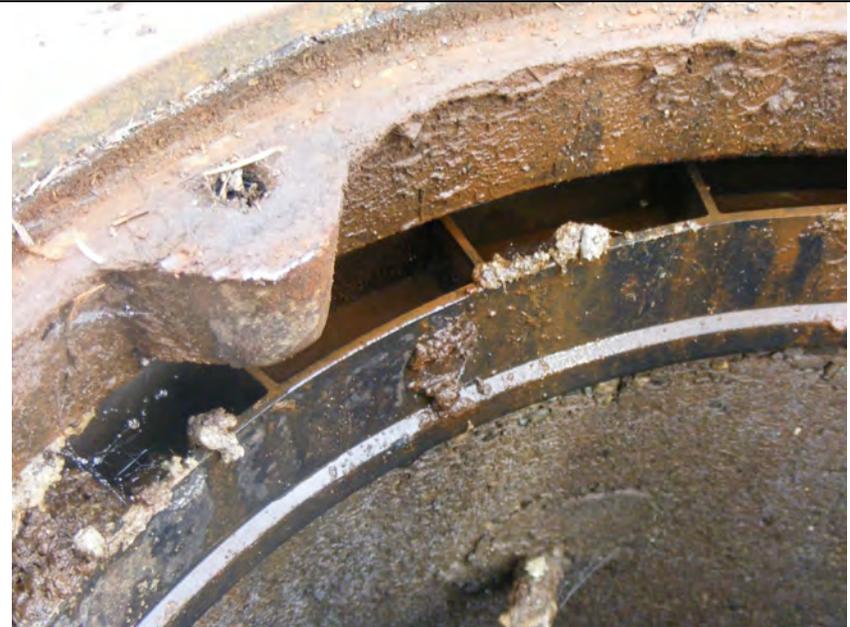
Standing water in manhole riser section.
