**Arborist Report
DRAFT**

Site: 200th Street Development
5710 - 5722 200th St SW, Lynnwood, WA 98036

Re: Tree Inventory and Assessment

Date: February 12, 2026

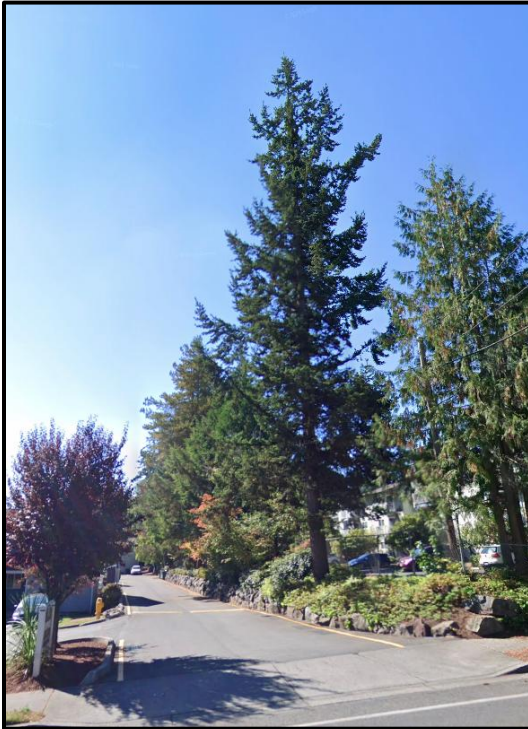
Photo 1. The grove of native conifer trees along the west property line. Many of these trees, although on the inside of the fence line, are on the neighboring property. Maintaining the rock wall should facilitate retention. Photo from google street view 2021.

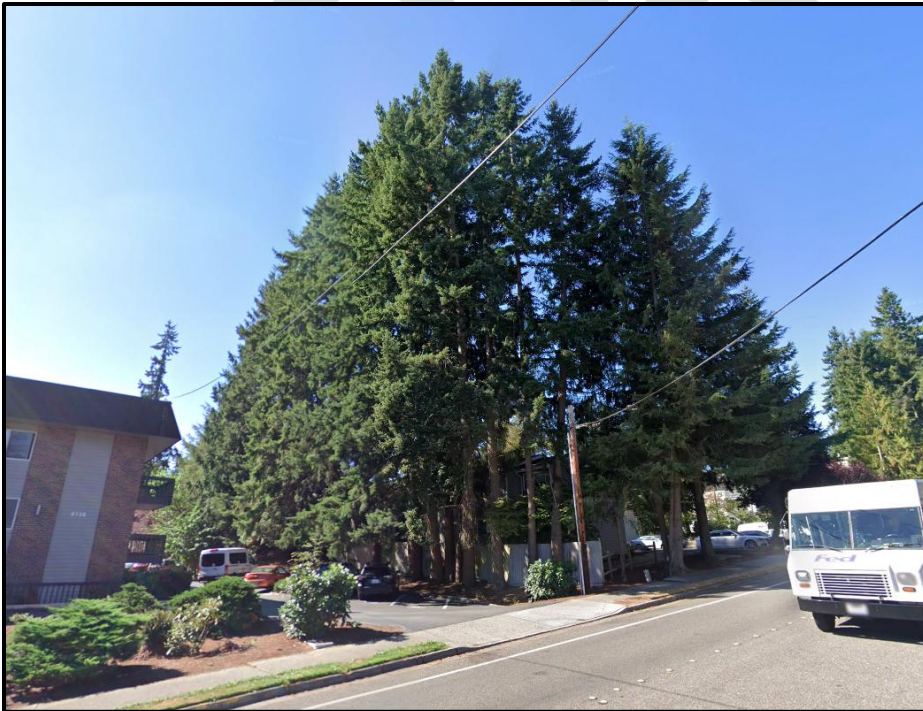
Photo 2. The central grove of trees was in good to excellent condition. The trees were growing on either side of a property line fence. Photo from google street view 2021.

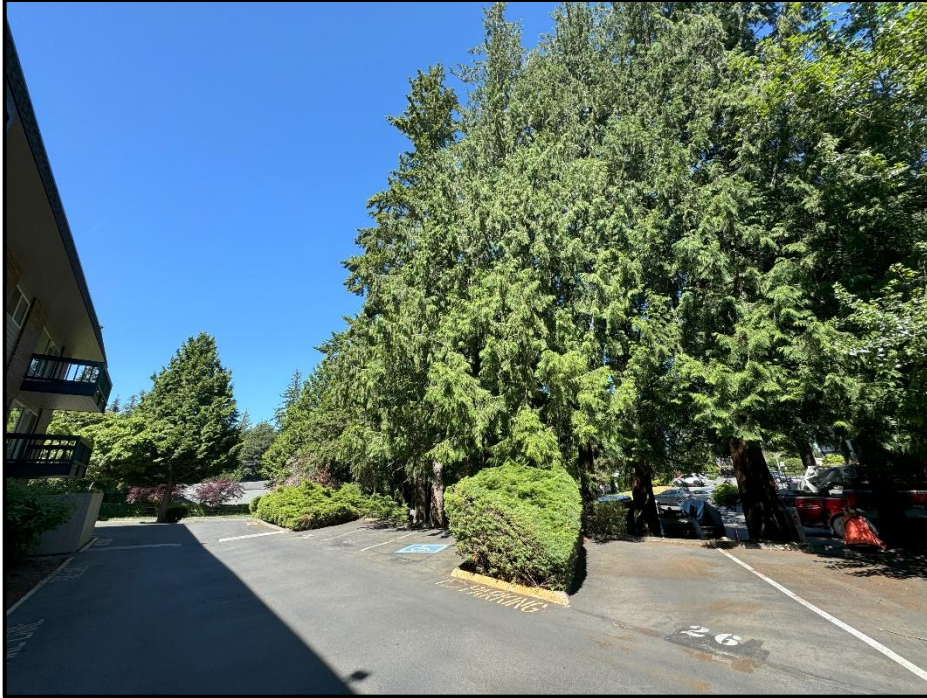
Photo 3. The grove of trees along the east property line. These trees are also shared between the subject site and the neighboring site. I recommend prioritizing these trees for retention.

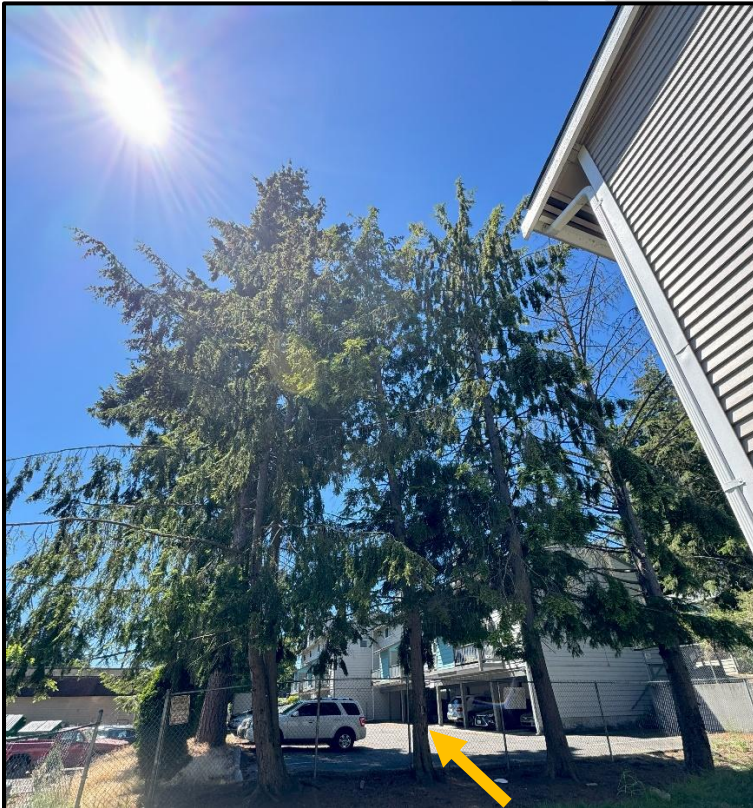
A western hemlock tagged 339 (Photo 4), was in declining condition with a weak crown and wounds on the stem. In addition, I rated the condition of the hemlocks tagged 338 and 340 on either side of tree 339 as fair as they also appear to be in decline. I recommend removing these trees as part of the development plans as they are not good candidates for retention near construction.

Photo 4. The grove of trees along the south property line. These trees are in decline, one of which has died, one of which has wounding on the stem with visible decay (orange arrow) and the other two which are beginning to thin.

339	<i>Tsuga heterophylla</i>	Western hemlock	12.5		Poor	Poor	1	10	10	Significant	2	Wounds twisting up stem, sparse crown, weeping from wounds, bacterial flux.	Remove	Parking, storm line, condition
340	<i>Tsuga heterophylla</i>	Western hemlock	15.6	11.4, 10.7	Fair	Poor	13	13	13	Significant	2	2025 Assessment: Someone hacked at the stem with a blade, likely during demolition	Remove	Parking, storm line, condition
341	<i>Tsuga heterophylla</i>	Western hemlock	13.9	9.3, 10.3	Good	Good	16	12	16	Significant	2		Unknown	Parking, utilities
342	<i>Tsuga heterophylla</i>	Western hemlock	12.3		Fair	Fair	15	10	15	Significant	2	Sparse, weeping wounds on trunk with decay visible.	Remove	Retaining walls, condition
343	<i>Tsuga heterophylla</i>	Western hemlock	11.8	9, 7.56	Fair	Fair	10	10	10	Significant	2	Suppressed form, not great overall.	Remove	Planter, paving, condition
344	<i>Tsuga heterophylla</i>	Western hemlock	18.5		Good	Good	18	15	18	Significant	3	2025 Assessment: Wounding on stem on all sides from a person with a blade and machine damage, reaction wood forming at wounds, roots to south torn and severed at 3 ft from trunk, pockets of decay at possible old branch scars along seam at 12 ft, remove	Remove	Condition

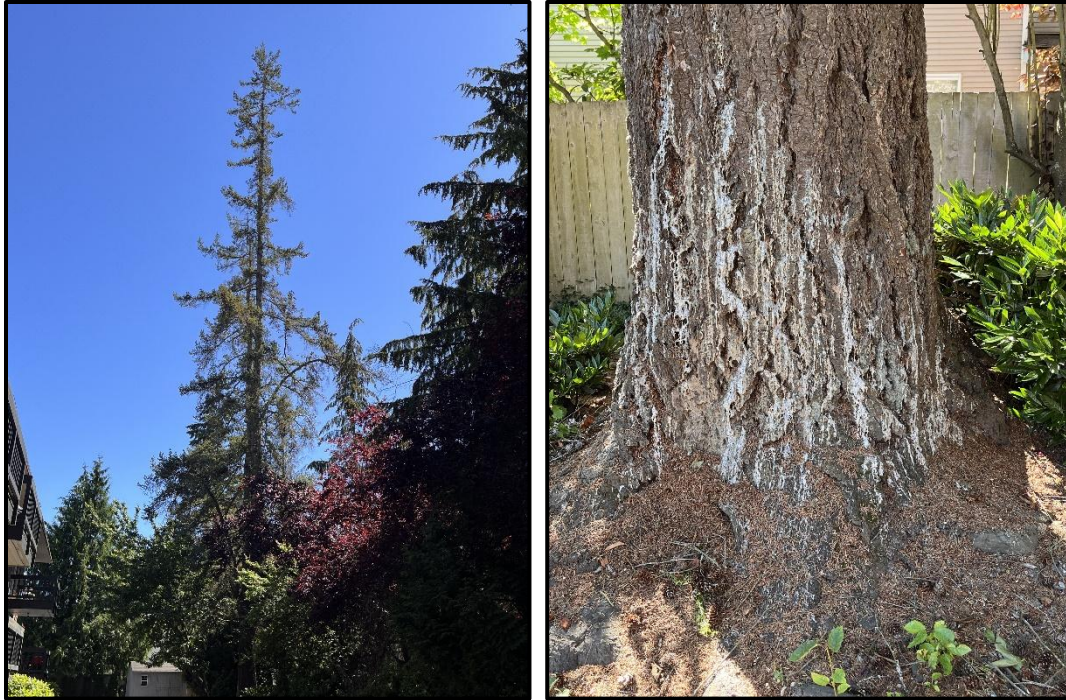
Two trees tagged 327 and 392 (Photo 5) have died since the initial inventory. They were noted in poor condition at the initial inventory and were expected to die in a relatively short time frame.

Photo 5. Tree 392 is a large Douglas-fir tree in decline. Based on the symptoms, I believe this tree has a fungal decay called honey mushroom (*Armillaria* sp.). The photo on the left shows thinning and the photo on the right shows heavy sap flow around the base that are characteristic of this disease.

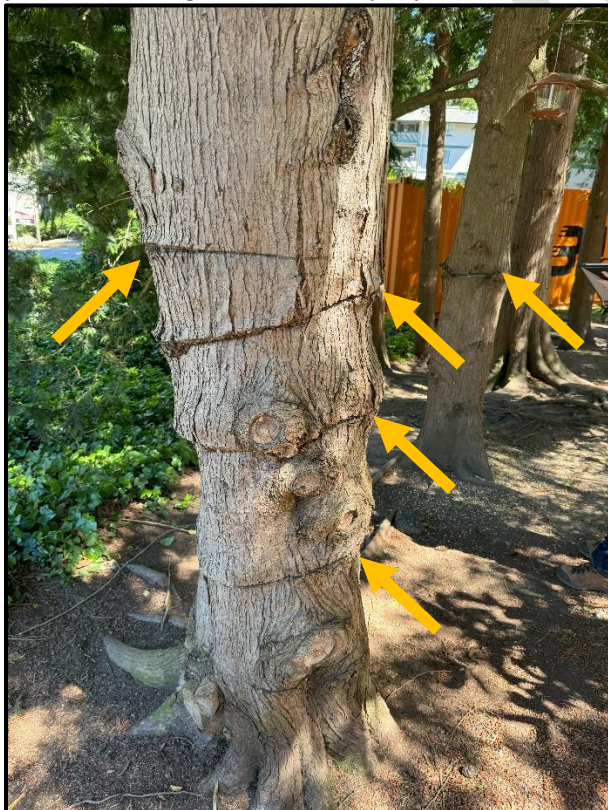
There were two western redcedar trees tagged 424 and 425 that had been girdled by lines wrapped around the trunks (Photo 6). The lines were almost completely enveloped and the canopies of the trees remained in good condition. The lines will leave an internal defect in the trunk that may cause stress over time or make the trees less windfirm in weather events.

Photo 6. Two western redcedar trees tagged 424 and 425 have been girdled by lines wrapped around their trunks. The lines are mostly enveloped and the canopies are still in good condition. These trees should be retained and monitored if they are not in conflict with new infrastructure.

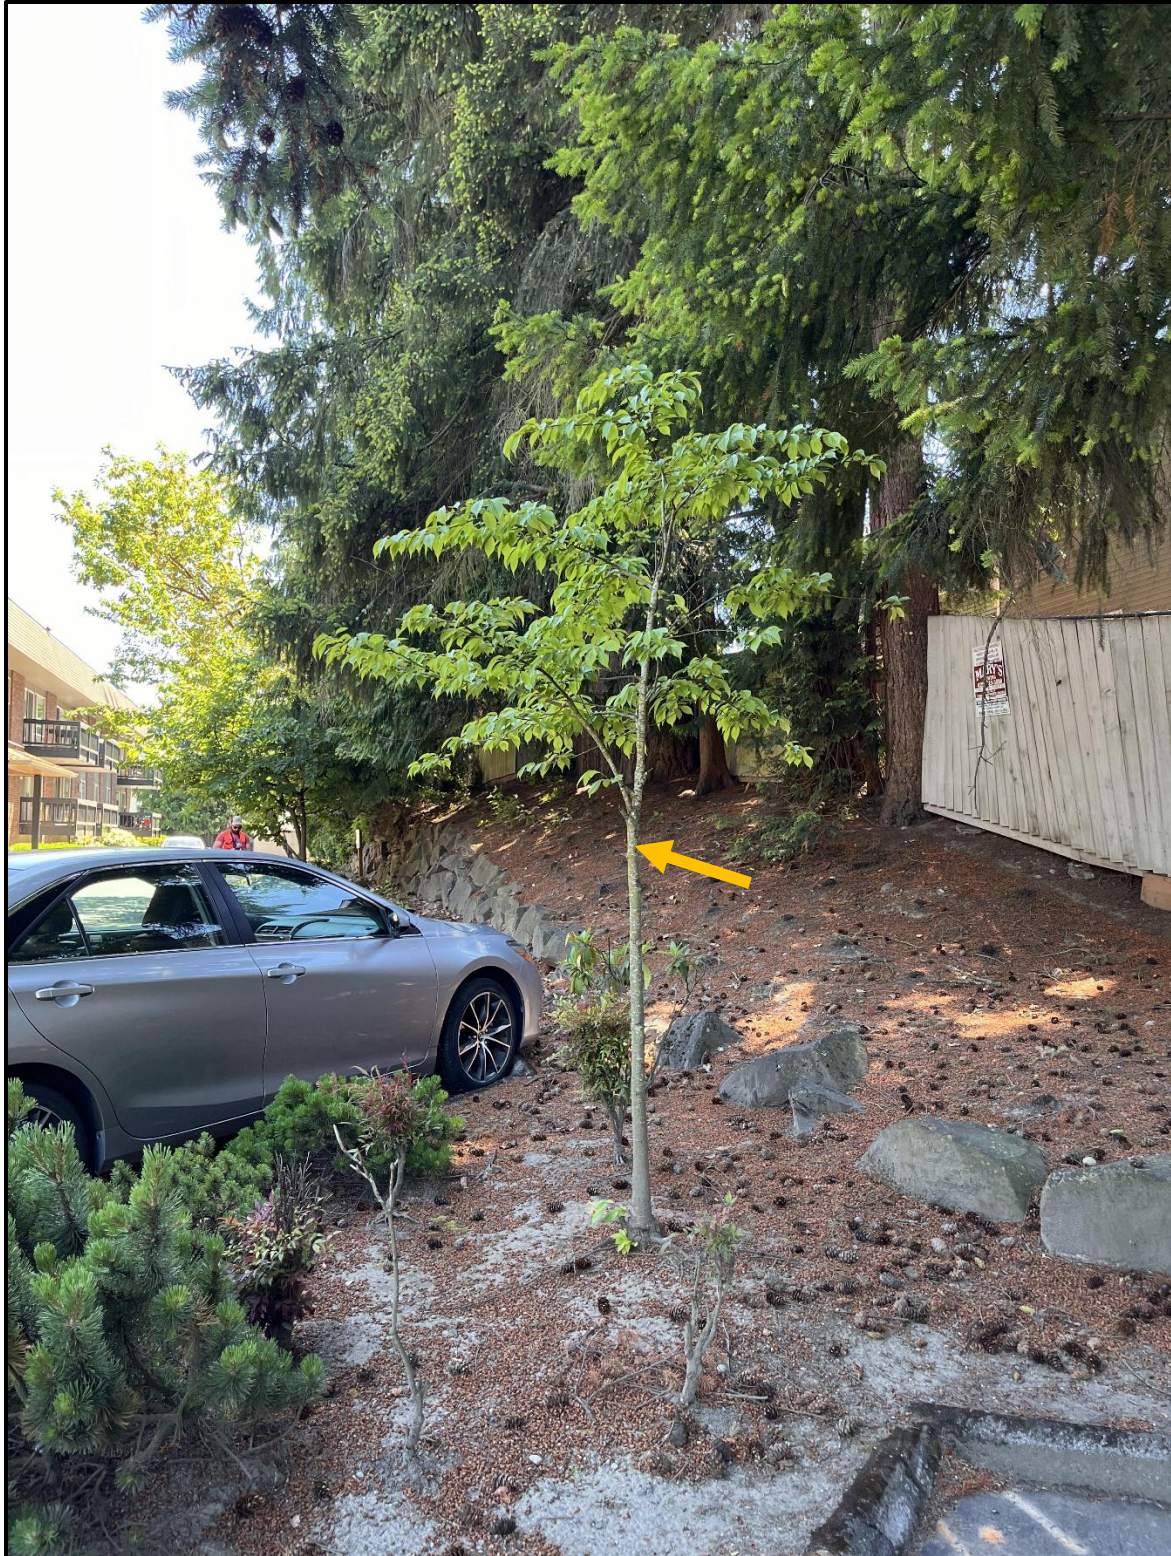
There was one cherry tree which measured 1.5 inches DSH that the site manager noted was planted by a resident and desired for transplant on the project site (Photo 7). It is in the northwest corner of the property in the parking area.

Photo 7. There is a small cherry tree that was recently planted by one of the residents. According to a HASCO site manager, this tree is desired for replanting to the new development.
