Project No. TS - 9391

## Arborist Report PRELIMINARY

Sarah Max, Housing Authority of Snohomish County (HASCO)
200 <sup>th</sup> Street Development 5710 - 5722 200 <sup>th</sup> St SW, Lynnwood, WA 98036
Tree Inventory and Assessment
February 13, 2025
Katherine Taylor ISA Certified Arborist #PN-8022A ISA Qualified Tree Risk Assessor
Shannon O'Bent ISA Certified Arborist #PN-8468A ISA Qualified Tree Risk Assessor
200 <sup>th</sup> St Schematic Design Plans (Environmental Works, 10/18/2024)
Table of Trees Tree Site Map

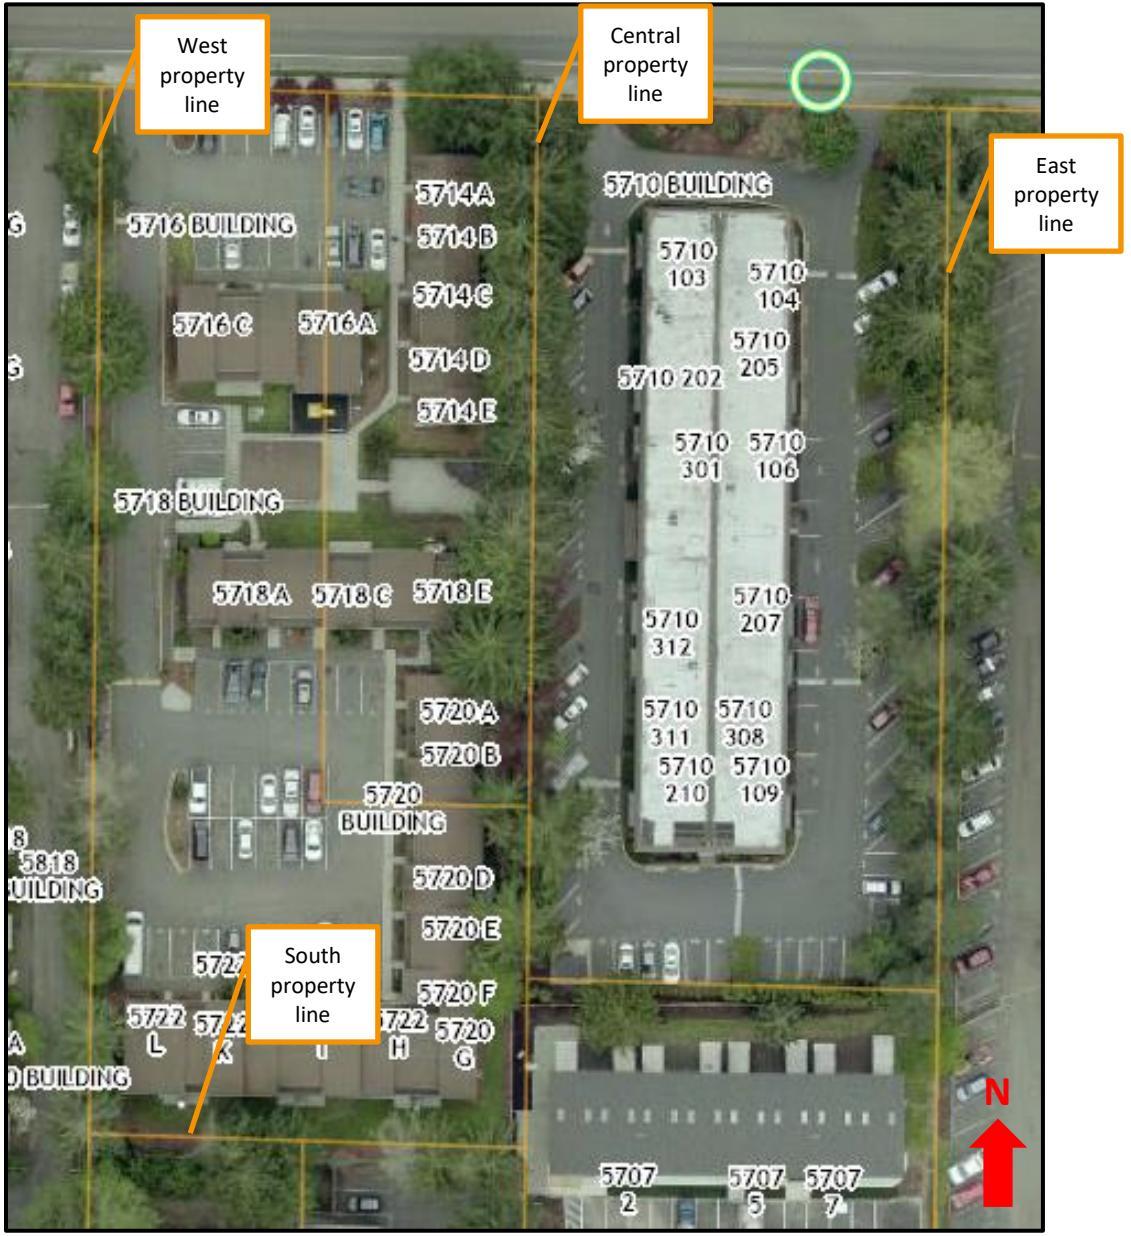
Figure 1. Site Map (PDS Map Portal, 2022 Aerial images). The tree groves along the west, central and east property lines are the most valuable onsite. Many of the trees on the west and east property lines are on the neighboring properties.
