2017 State of the Roadway Network in Lynnwood, WA

Stephen Smith, P.E., Project Principal
IMS Infrastructure Management Services

City of Lynnwood, WA
Network Valuation

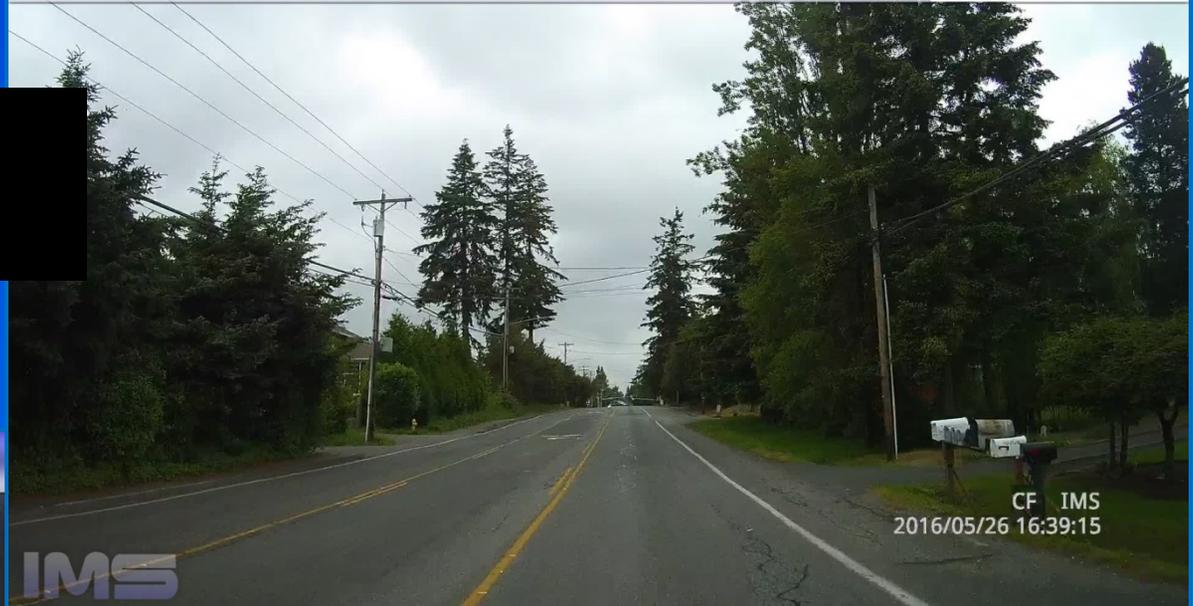
GISID: 1247
Image: LYNN003_000445_0002_CF.jpg

36th Ave W

**Base &/or Structural Failures
Rutting
Excessive Cracking**

**Past point of overlay based
rehabilitation and/or panel
replacements.**

**Rehabs often driven by citizen
complaints.**

**Safety becomes a concern at very
low PCI.**

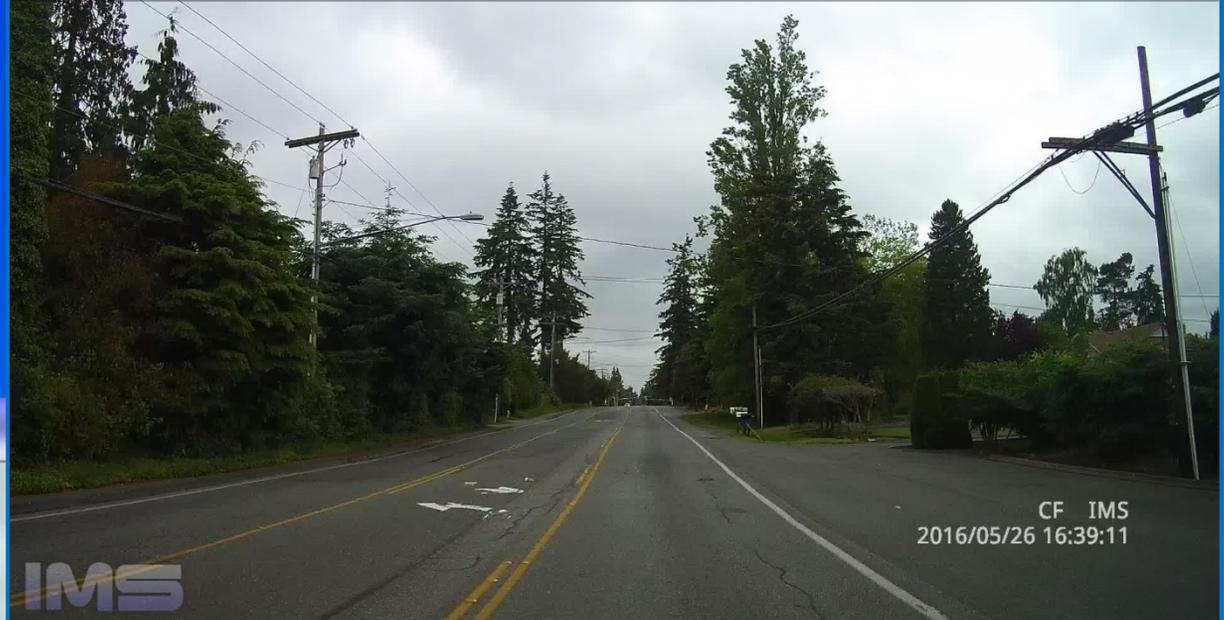
GISID: 148
Image: LYNN003_000444_0008_CF.jpg

36th Ave W

**Localized base failures
Rutting at intersections
Extensive cracking
Extensive patching**

Tired streets due for a thicker overlay, possibly a surface removal and replacement on ACP roads. Extensive joint, panel replacement, and grinding on PCC roads.

High priority to avoid reconstruction

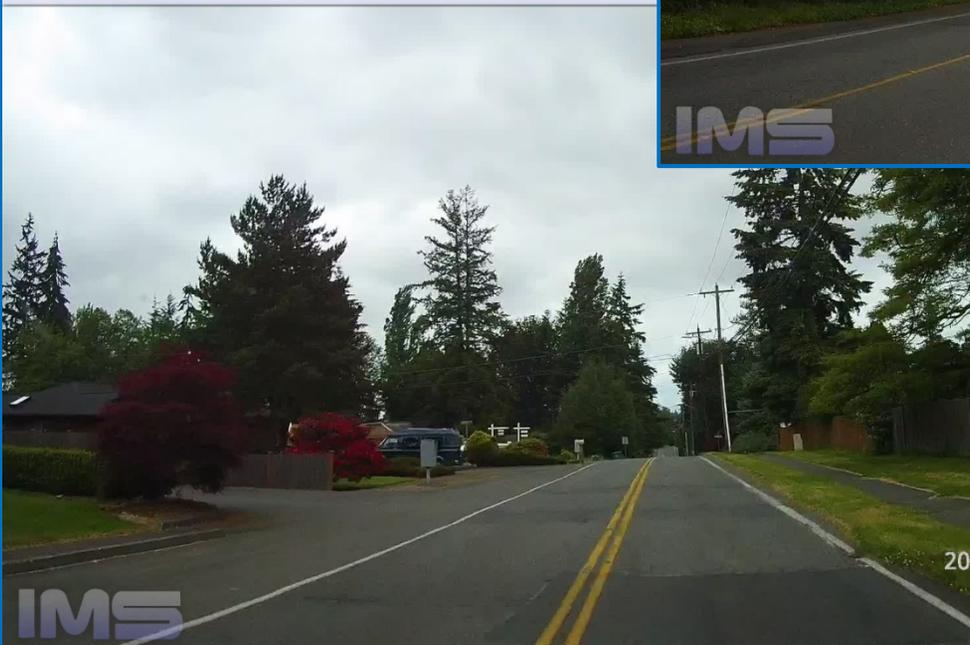
GISID: 243
Image: LYNN004_000670_0002_CF.jpg

172nd St SW

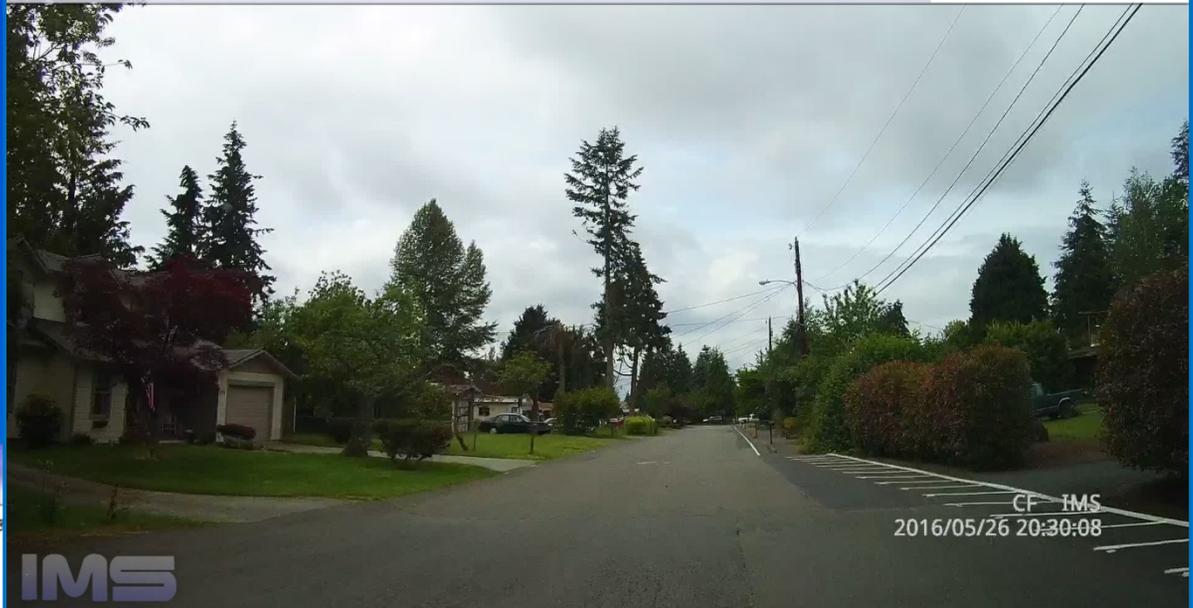
GISID: 214
Image: LYNN005_000788_0007_CF.jpg

Progressive cracking
Few base failures
Localized distresses

176th PI SW

Optimum timing for thin – moderate overlay or moderate panel replacement on PCC roads.

Many benefits to selecting these streets: early lower cost – greater return, less grinding, drainage

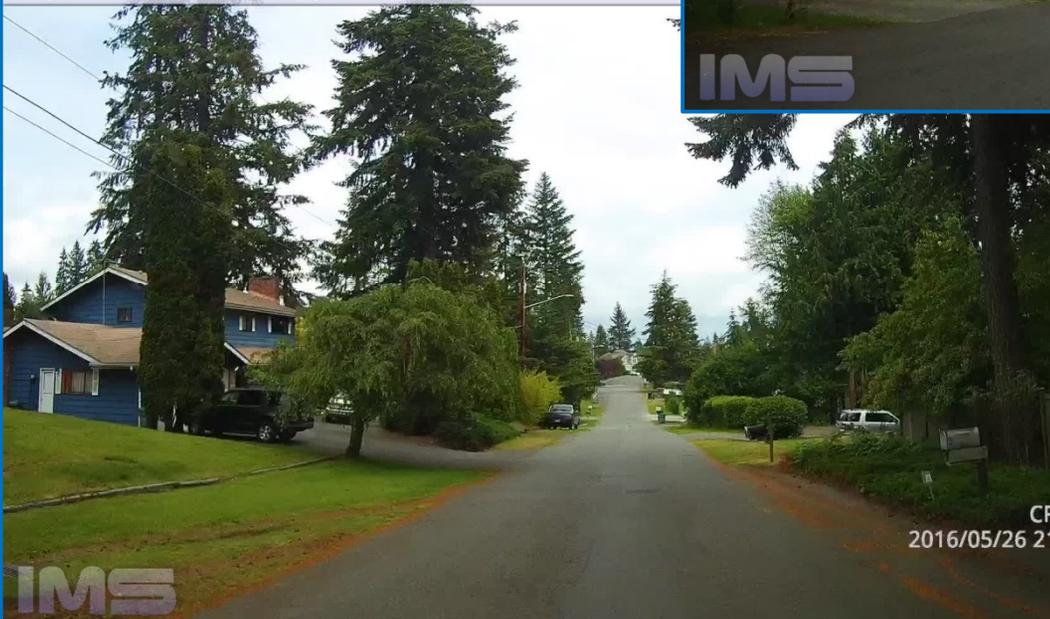
GISID: 239
Image: LYNN005_000839_0012_CF.jpg

177th PI SW

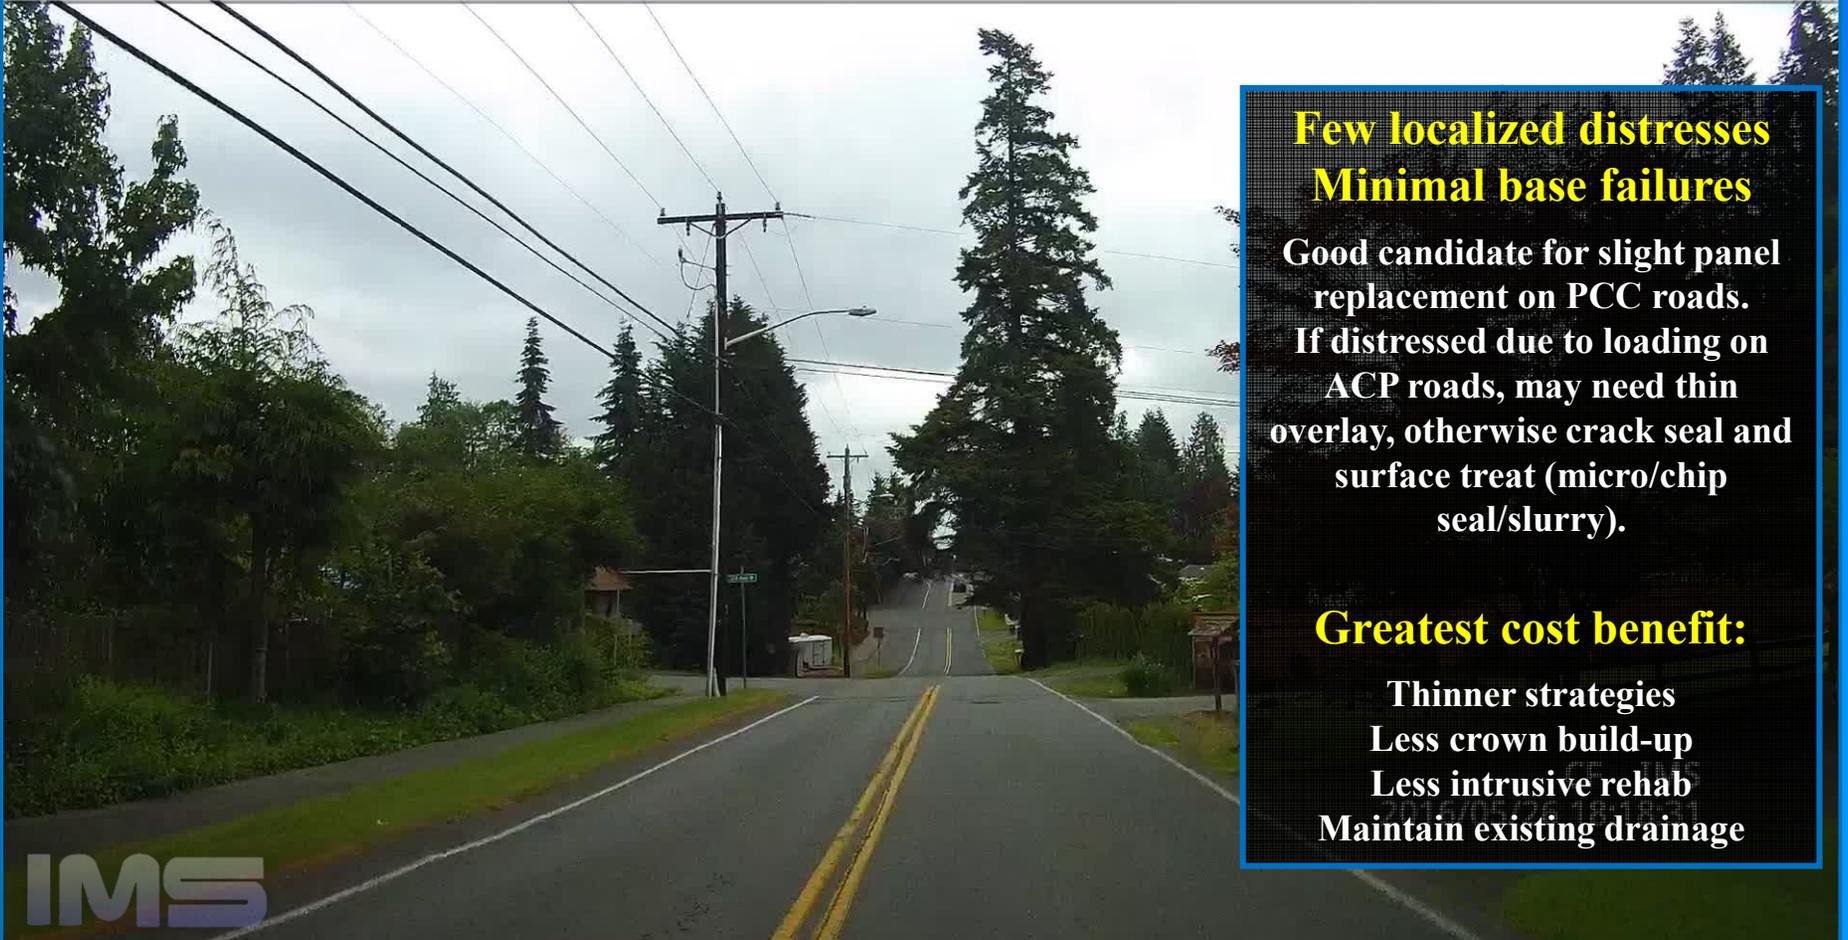
GISID: 164

172nd St SW

Few localized distresses
Minimal base failures

Good candidate for slight panel replacement on PCC roads.
If distressed due to loading on ACP roads, may need thin overlay, otherwise crack seal and surface treat (micro/chip seal/slurry).

Greatest cost benefit:

Thinner strategies
Less crown build-up
Less intrusive rehab
Maintain existing drainage

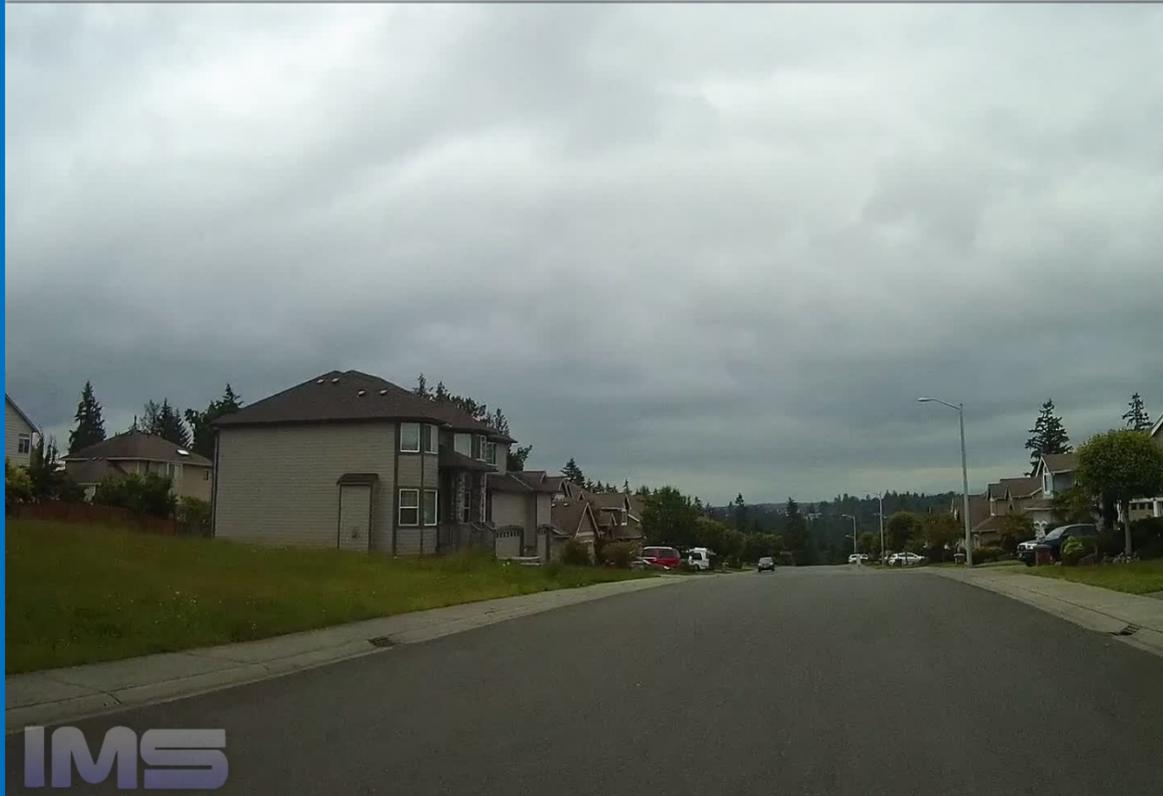
GISID: 1024

169th St SW

**Very few distresses
No rutting
No base failures**

**Crack seal with surface
treatment on asphalt roads.
Joint reseal and localized rehab
on concrete roads.**

**Maintains existing drainage.
Extends pavement life at lowest
cost**

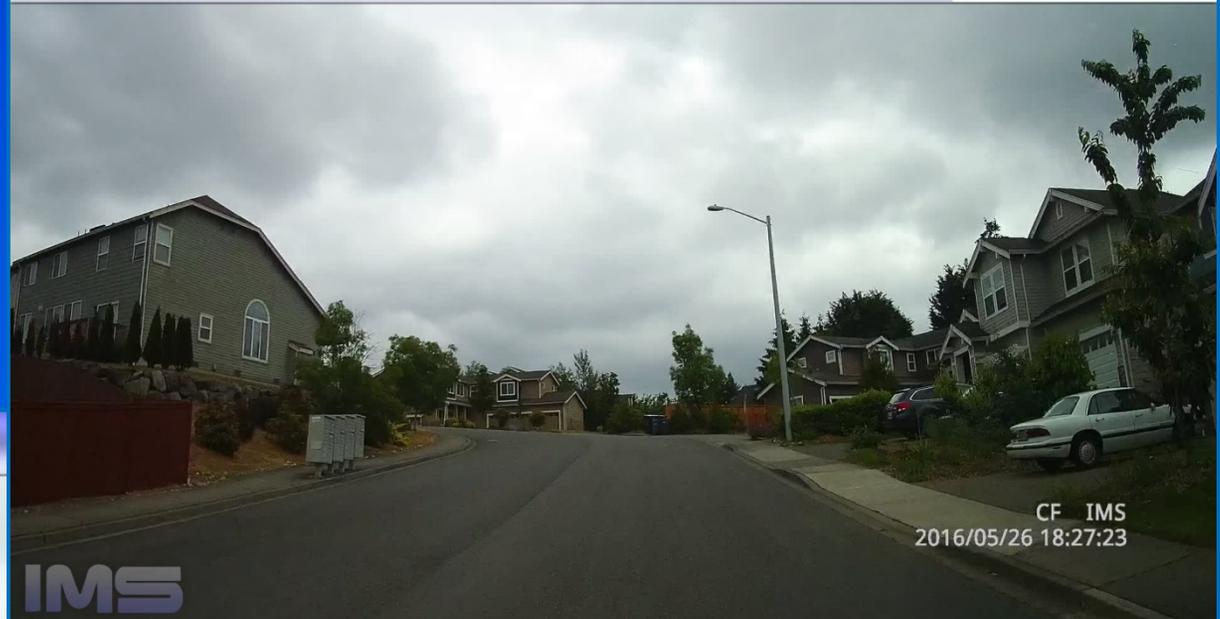
GISID: 1039
Image: LYNN004_000683_0008_CF.jpg

166th PI SW

Like new condition
Very few minor distresses
Smooth ride, good drainage

Should provide 5 to 10 years
prior to first rehabilitation
with routine maintenance

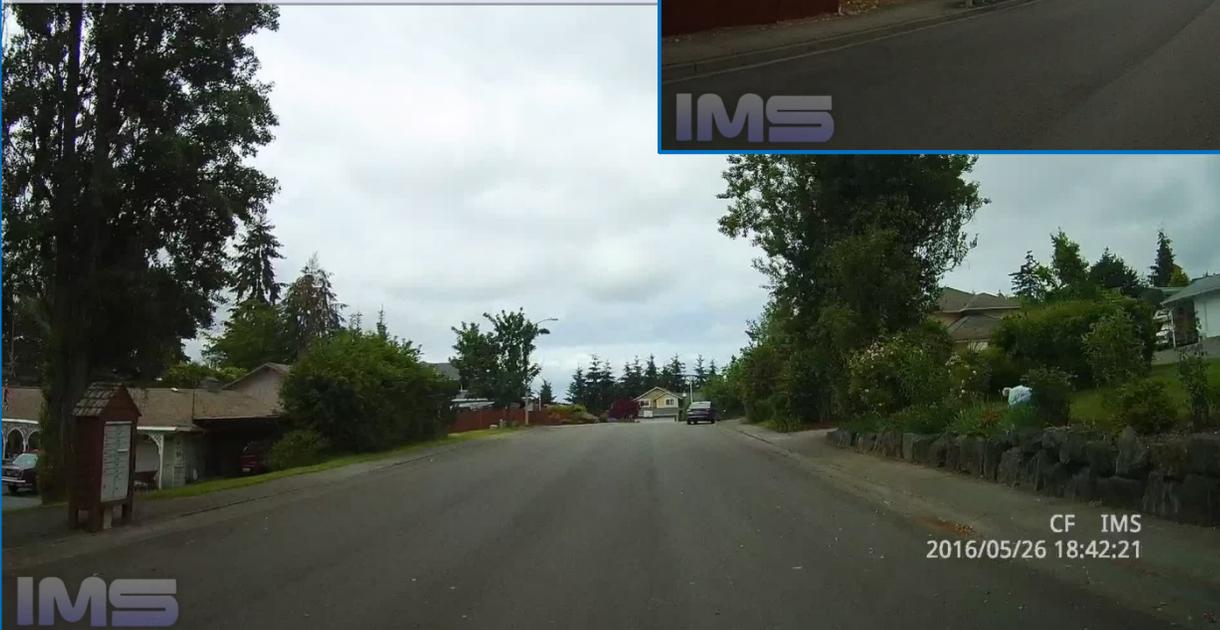
GISID: 1068
Image: LYNN004_000704_0007_CF.jpg

168th St SW

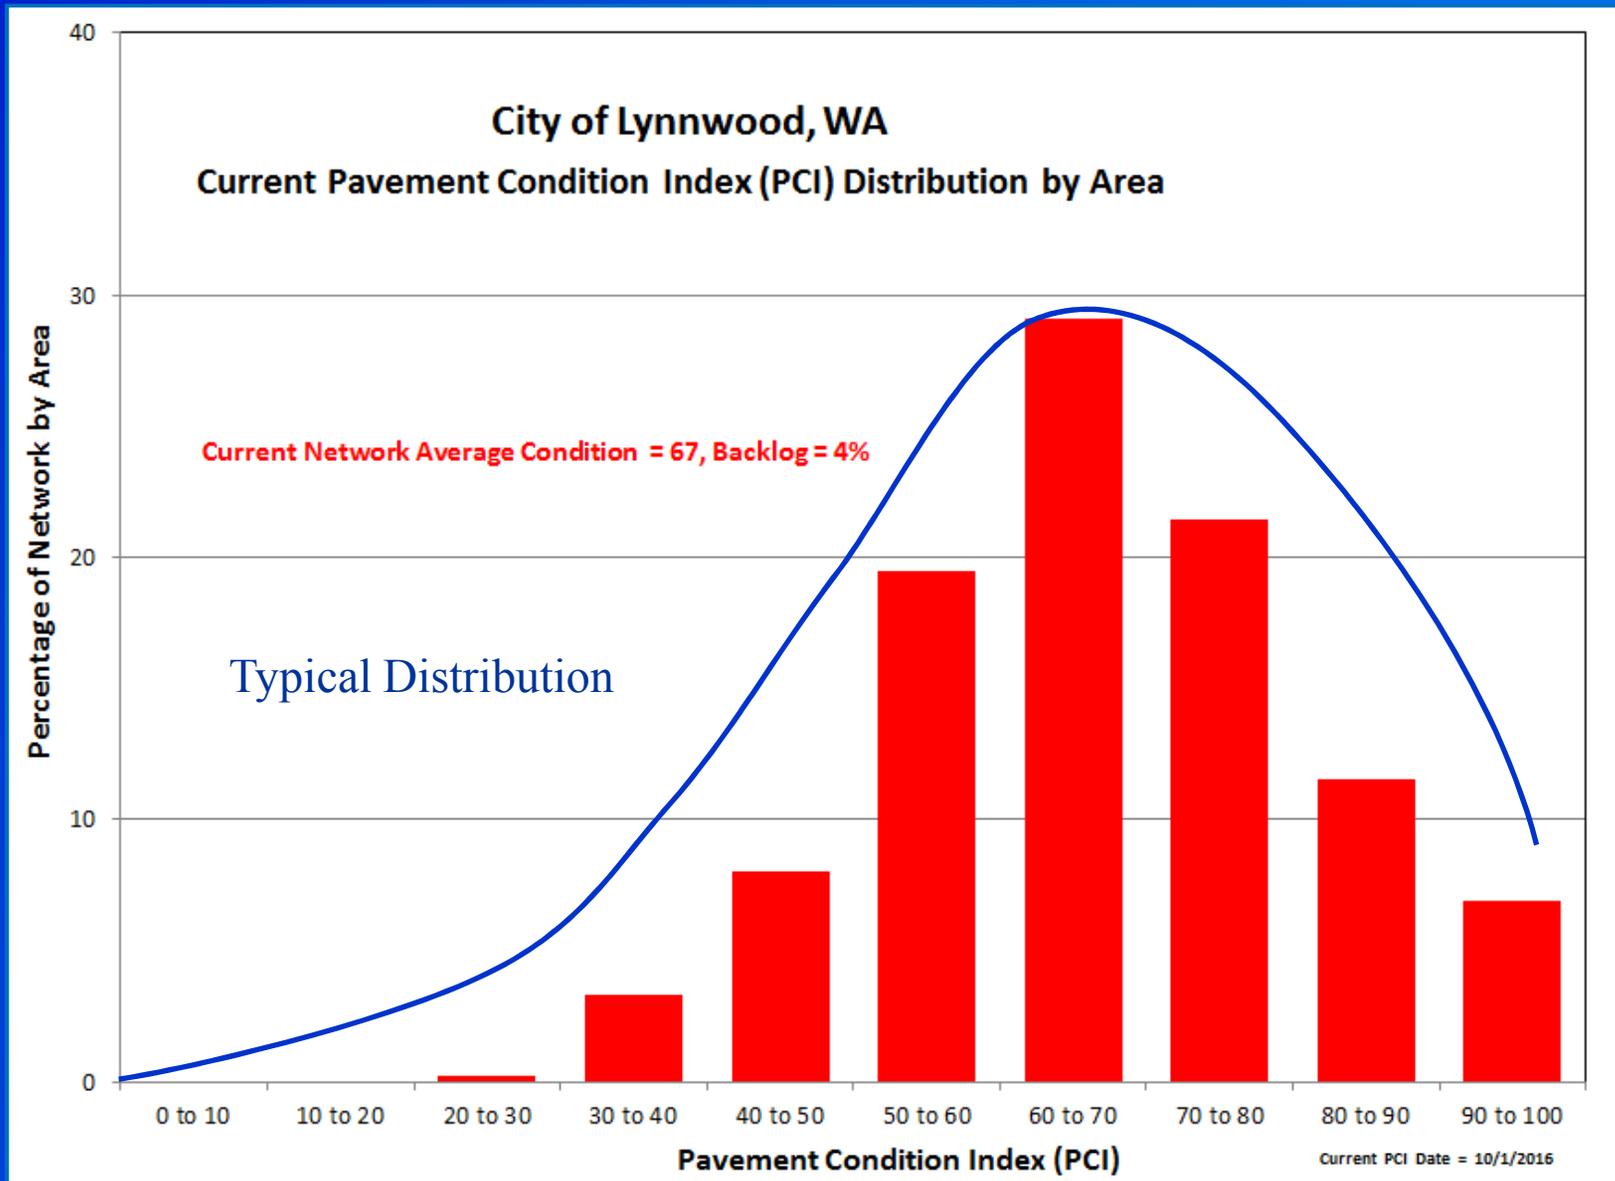
Lynnwood PCI Results for 2016....

Average Network PCI = 67
Backlog of reconstruction = 4%

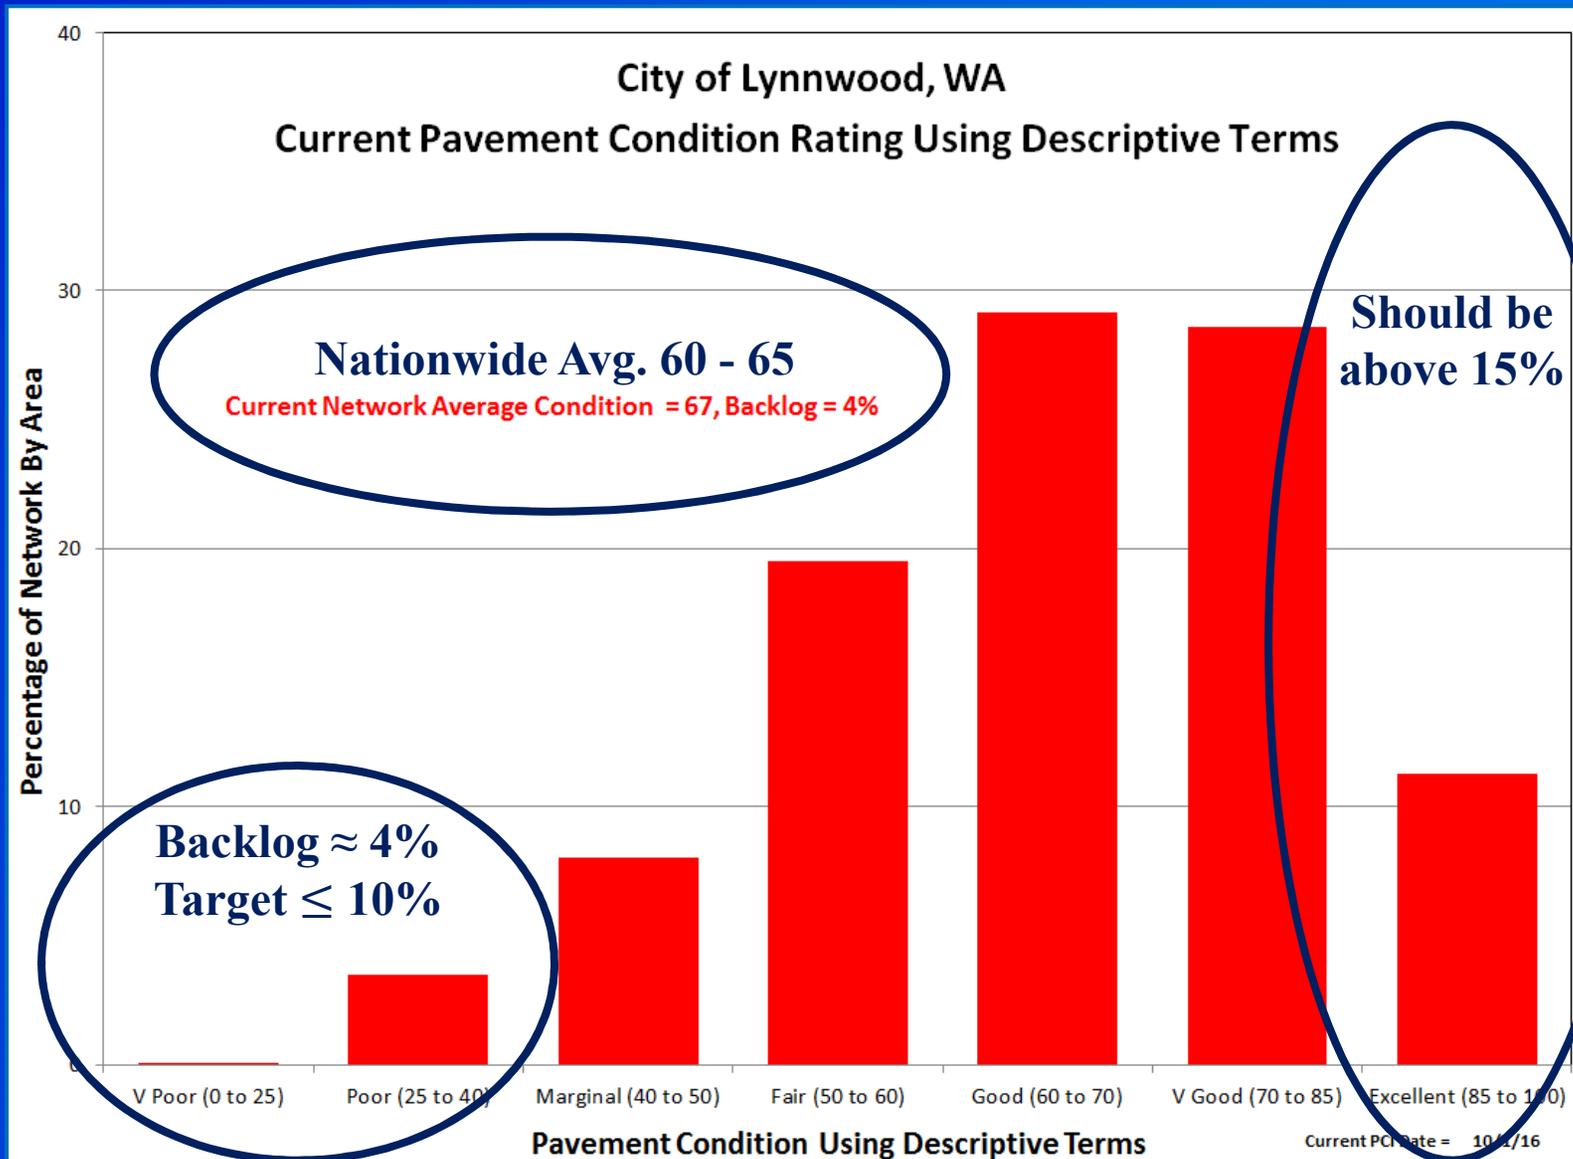
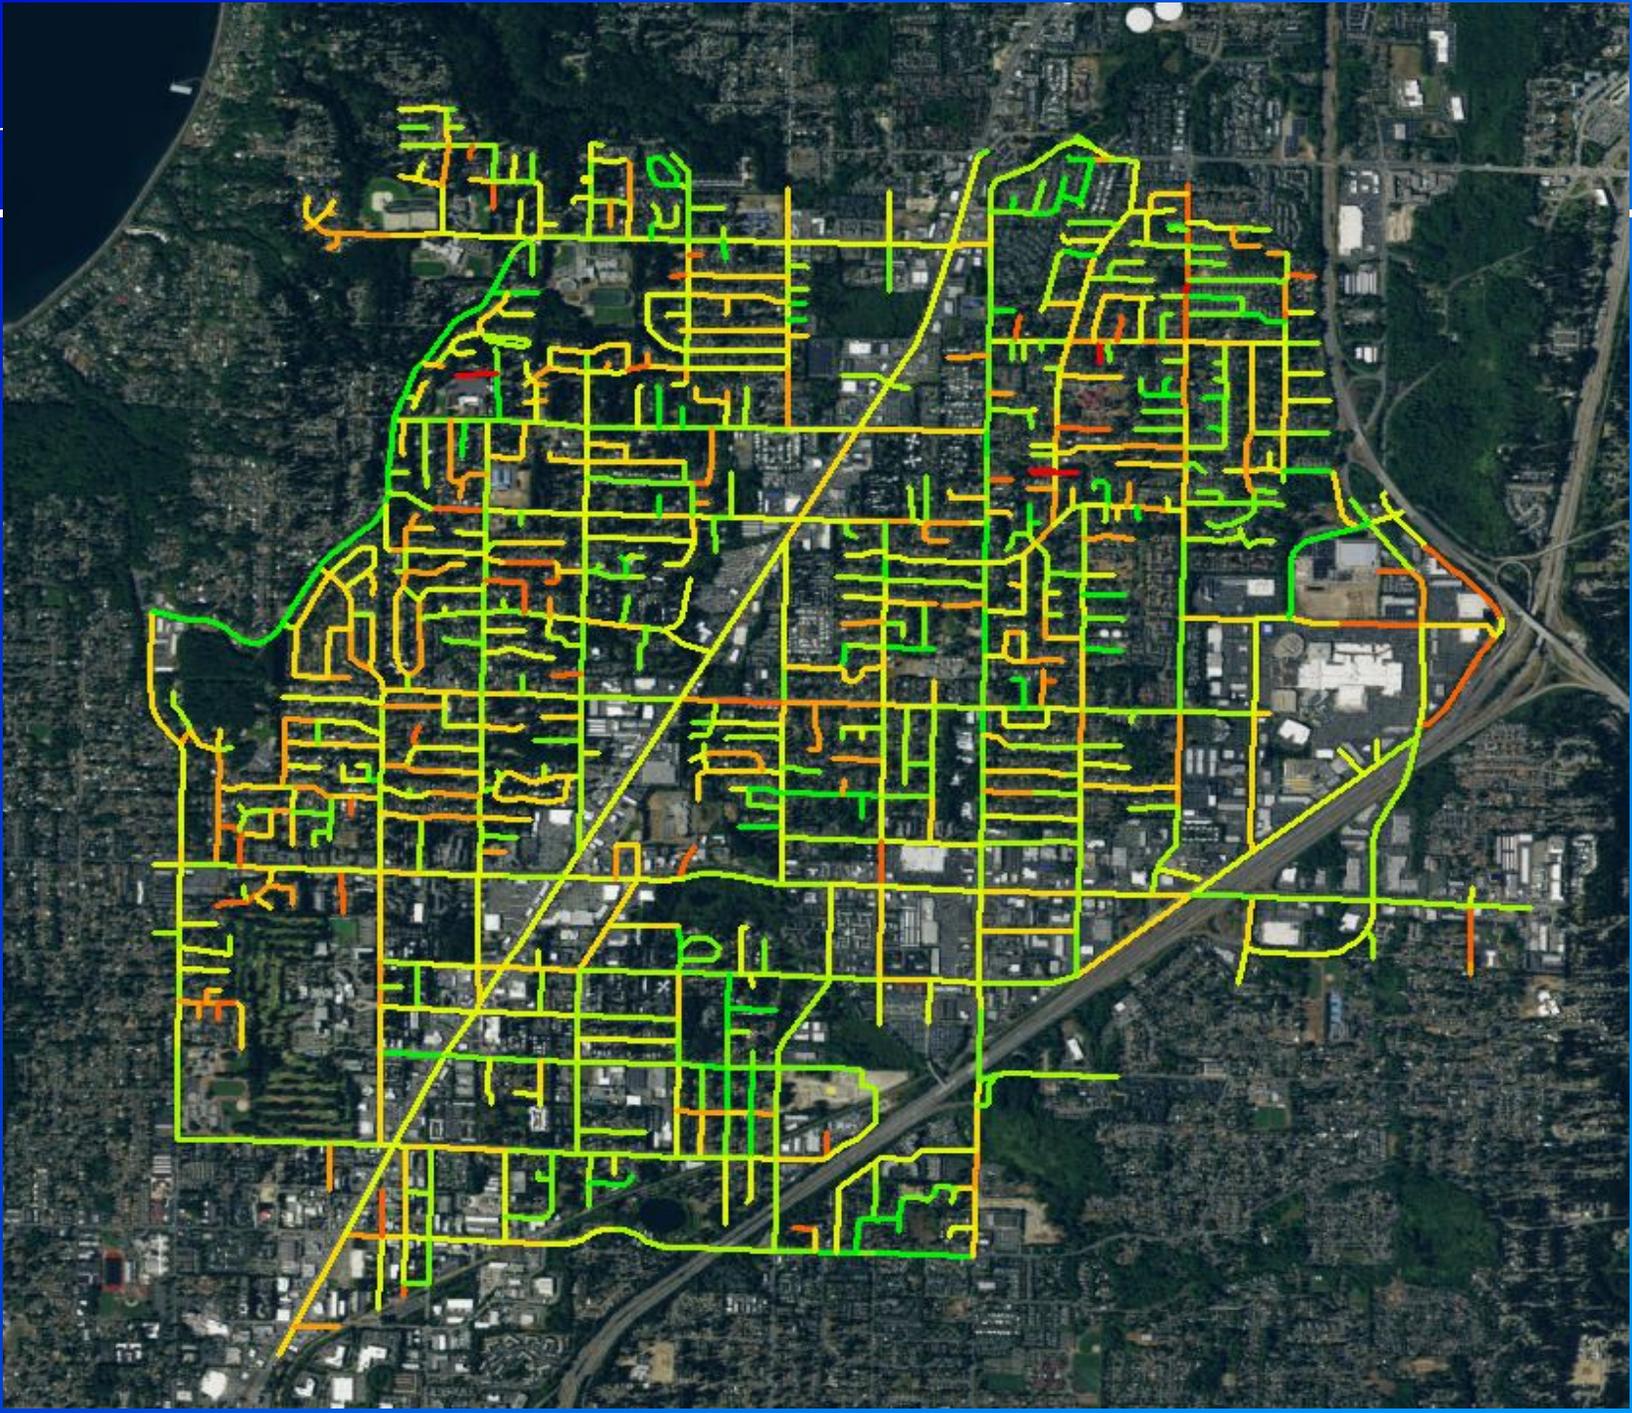
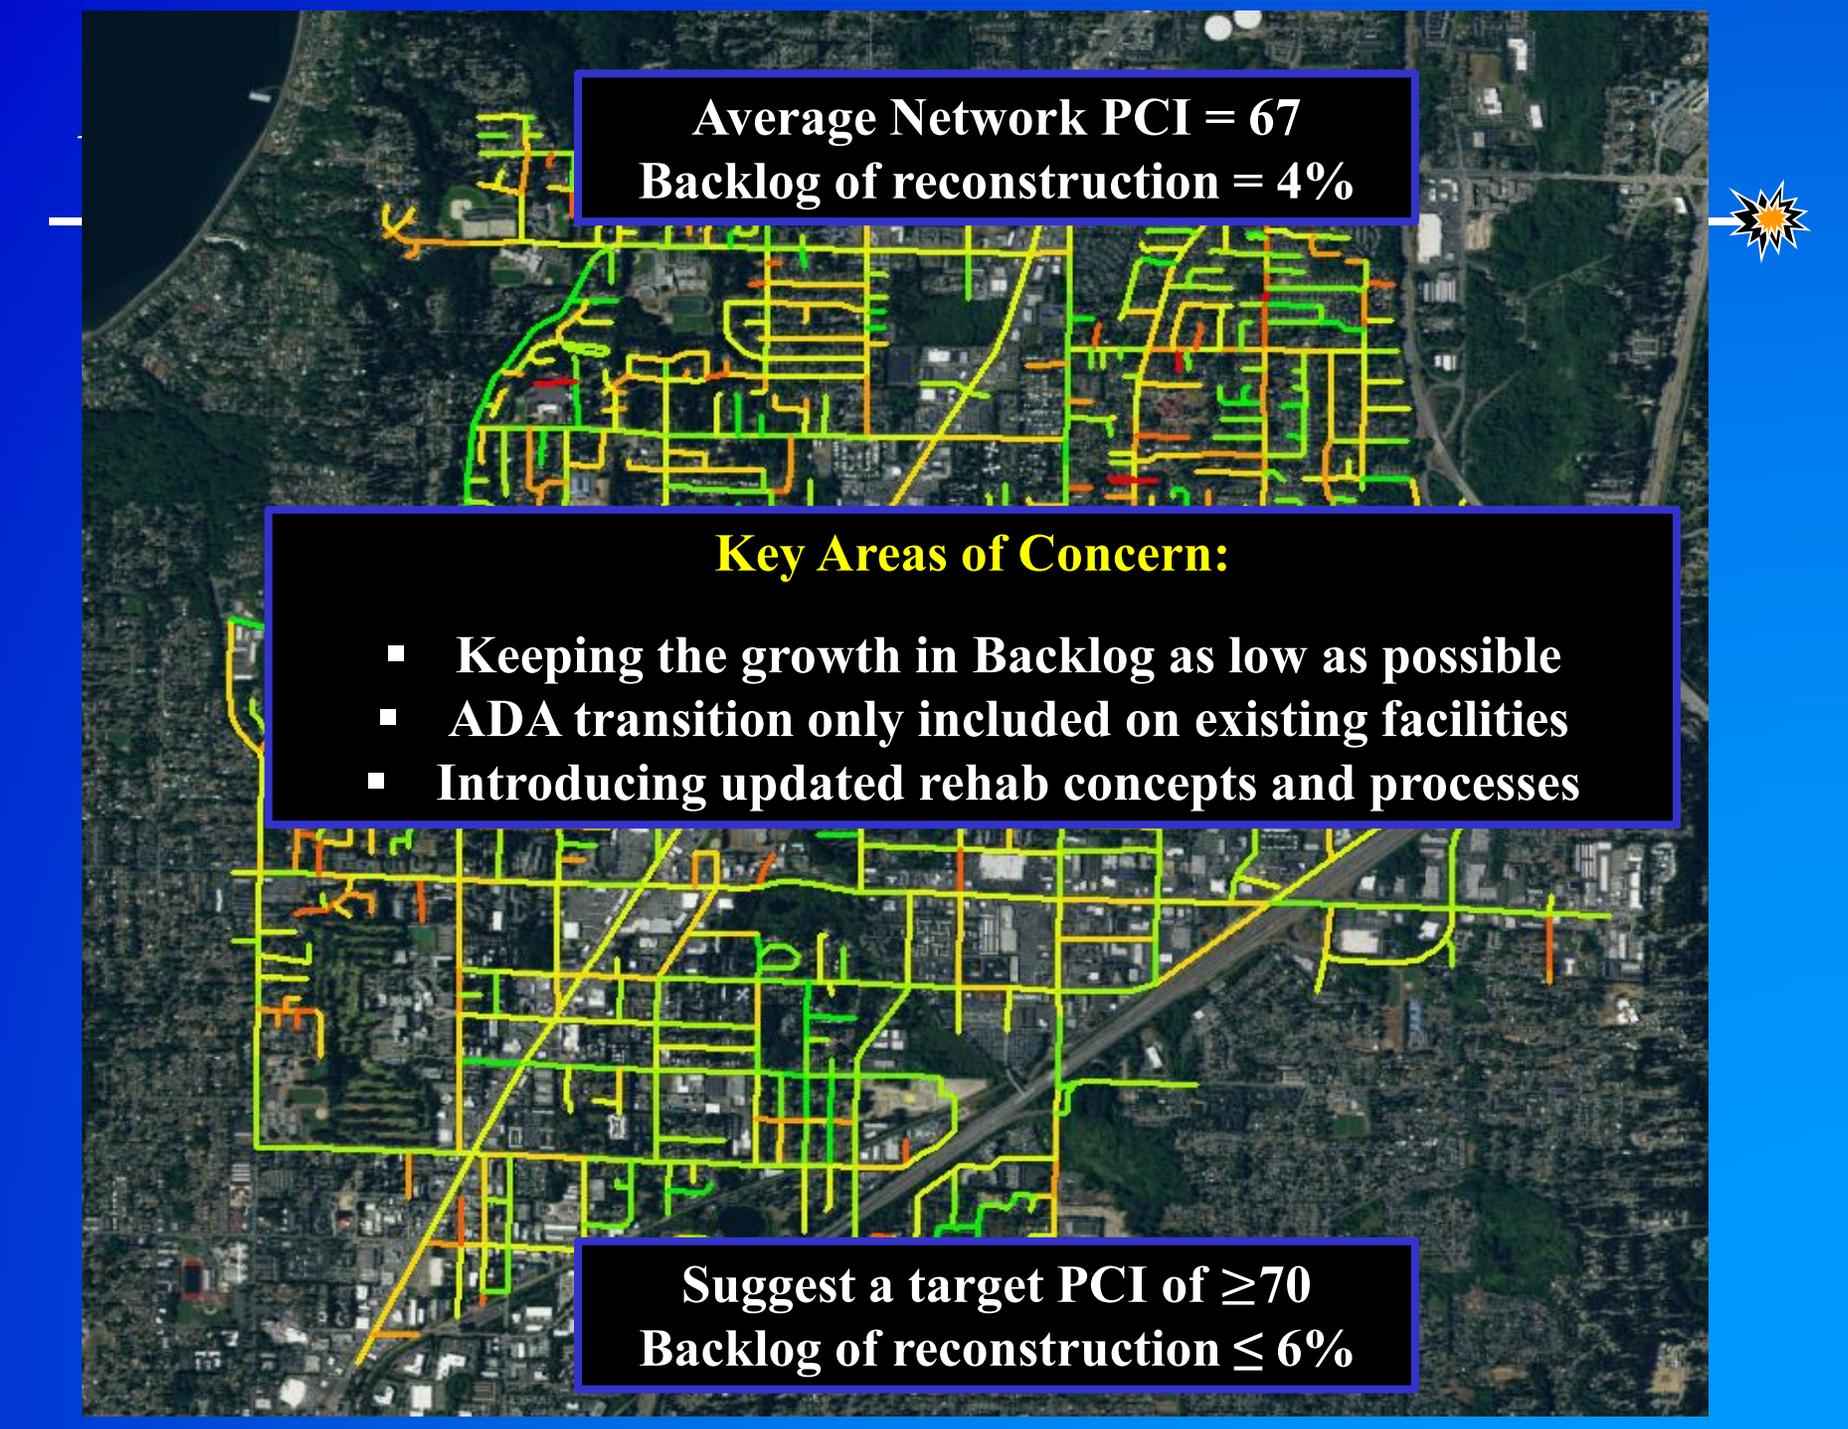
Lynnwood Results.... 3 metrics of health

- Keeping the growth in Backlog as low as possible
- ADA transition only included on existing facilities
- Introducing updated rehab concepts and processes

Suggest a target PCI of ≥ 70
Backlog of reconstruction $\leq 6\%$

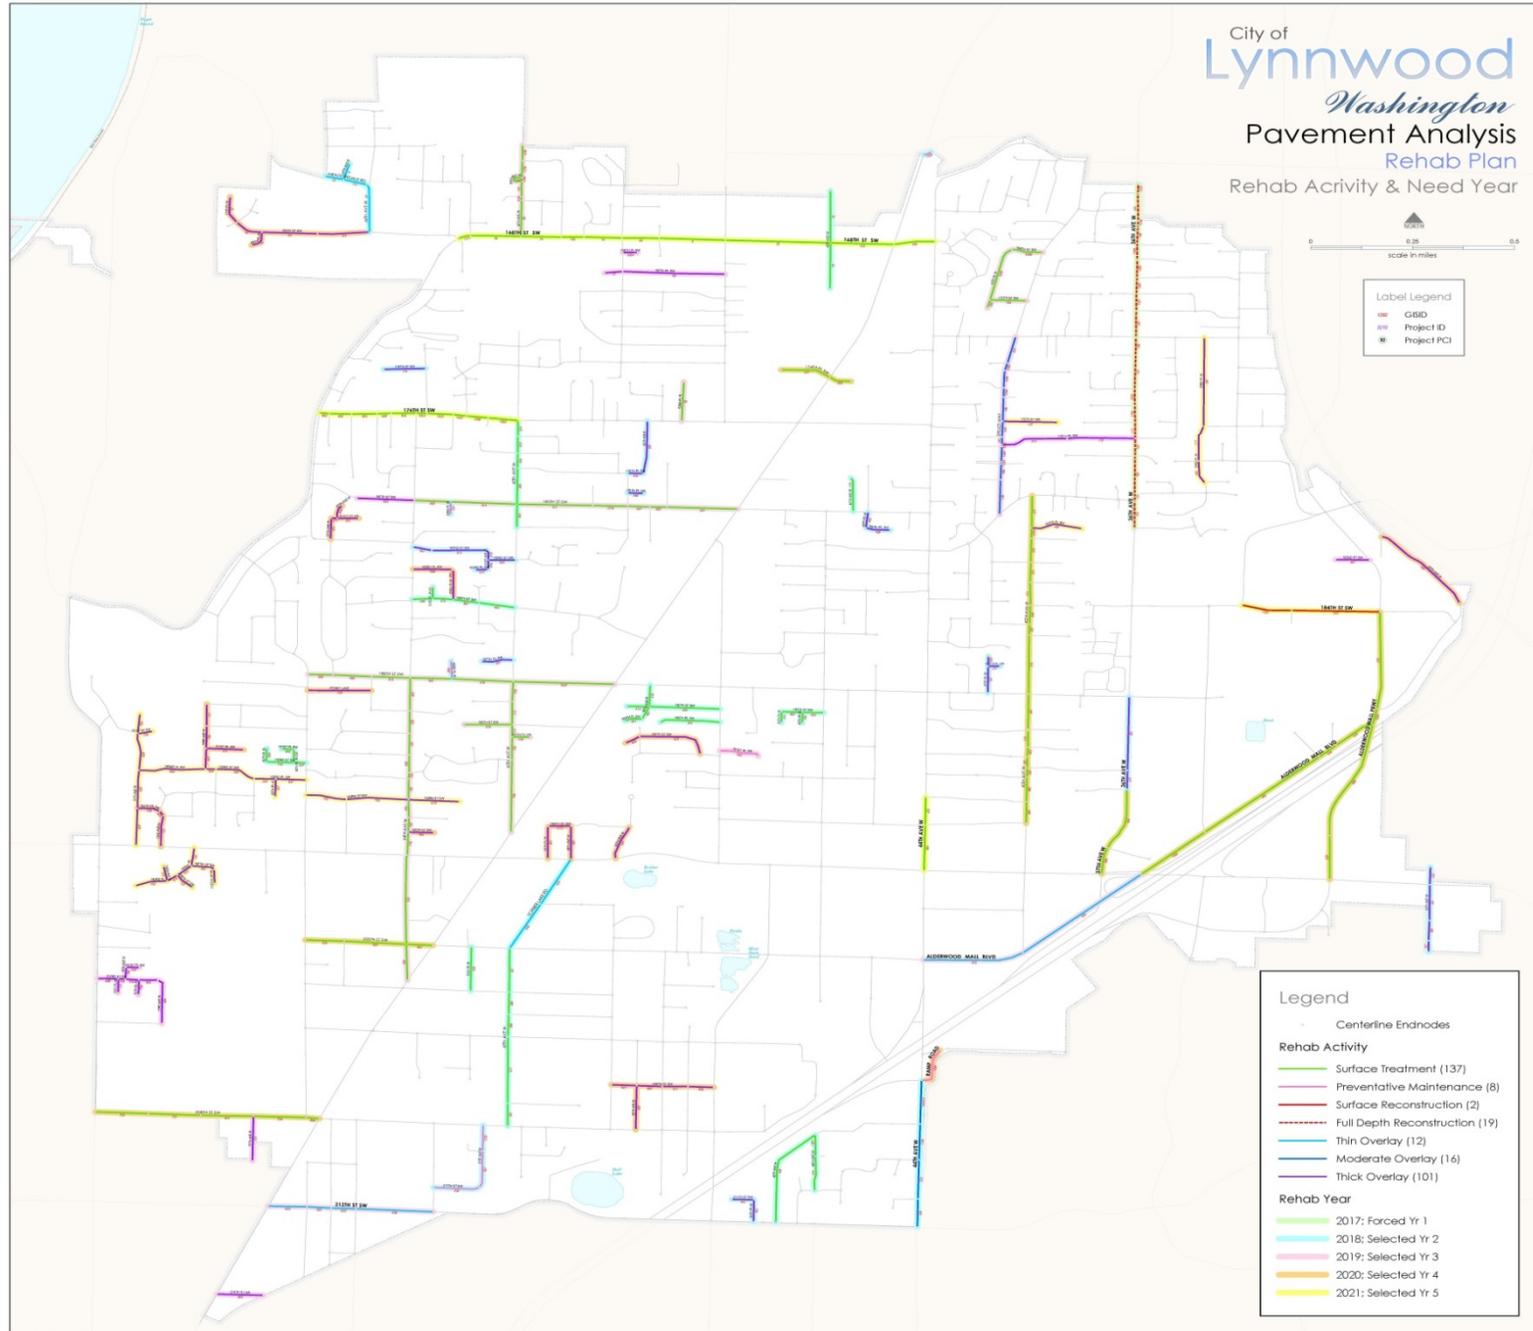
City of
Lynnwood
Washington
Pavement Analysis
Rehab Plan
 Rehab Activity & Need Year

- Surface Treatment (137)
- Preventative Maintenance (8)
- Surface Reconstruction (2)
- Full Depth Reconstruction (19)
- Thin Overlay (12)
- Moderate Overlay (16)
- Thick Overlay (101)

- 2017; Forced Yr 1
- 2018; Selected Yr 2
- 2019; Selected Yr 3
- 2020; Selected Yr 4
- 2021; Selected Yr 5
