Remedial Investigation Addendum

Alderwood Laundry and Dry Cleaner
3815 196th Street SW
Lynnwood, Washington
VCP NW3066

Lynnwood Public Facilities District

September 27, 2019

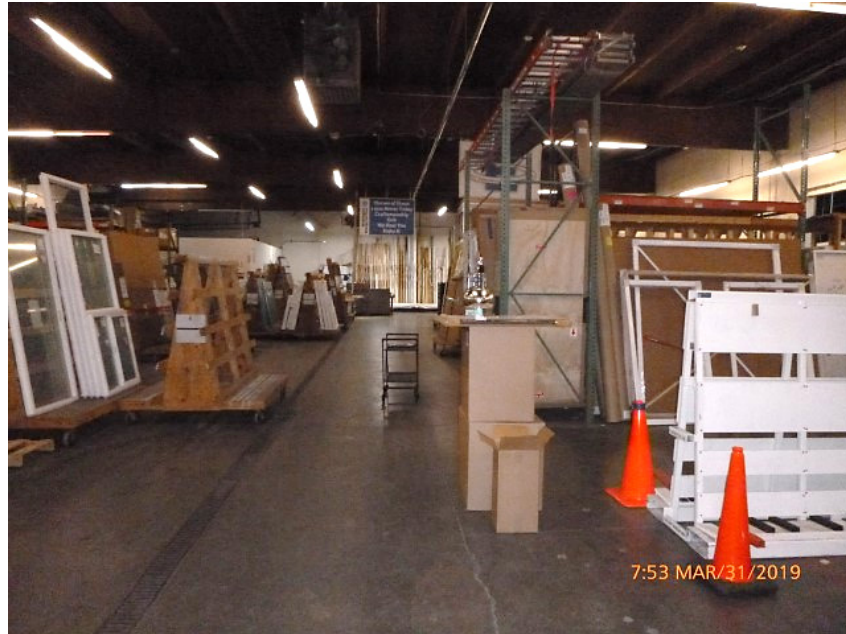
Photograph 1 – WES Building warehouse area looking south. Grated floor drain trench visible in photo left.

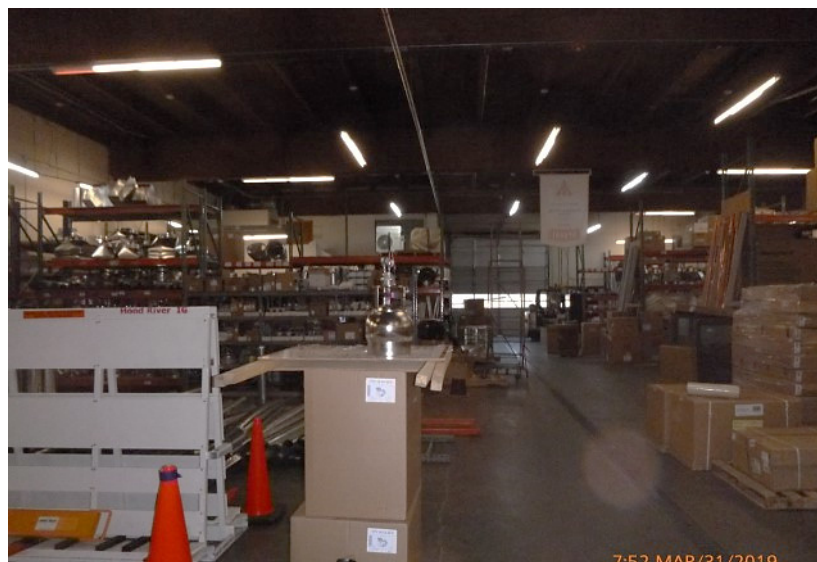
Photograph 2 – WES Building warehouse area looking north. Grated floor drain trench visible in photo right.

warehouse oriented north-south. The drain has a central drainage sump, which discharges into the storm drain line located outside the east side of the building (Figure 1). The interior drain was visibly dry during the survey.

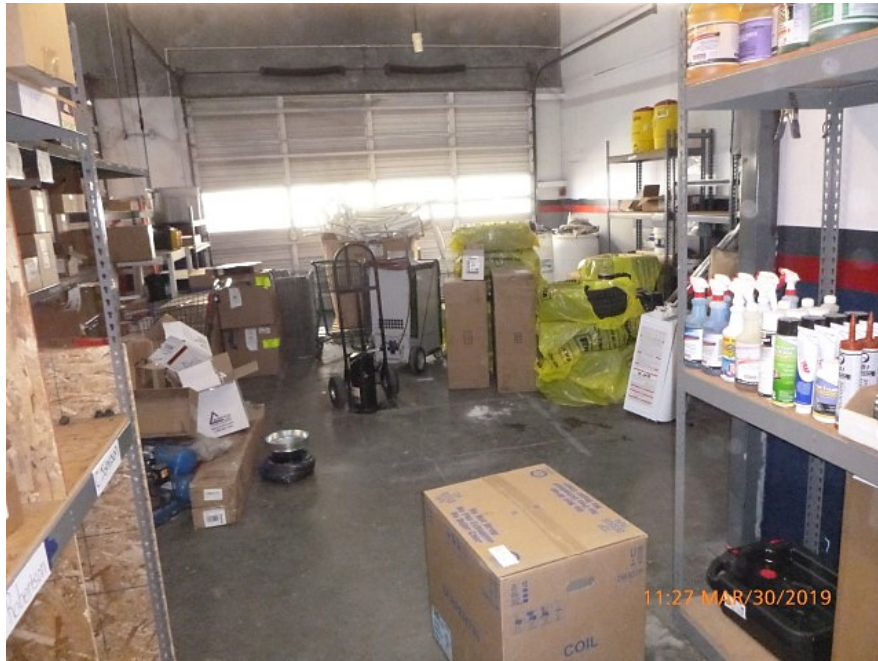
Miscellaneous chemicals, materials and equipment used by WES are stored in several locations of the warehouse. Items observed during the March 2019 survey included PVC primer, cleaning solvents, cleaning supplies, tires, and machinery (see Photo 3 below).

Photograph 3 – WES Building western storage room chemical storage including PVC primer, cleaning solvents and tires.

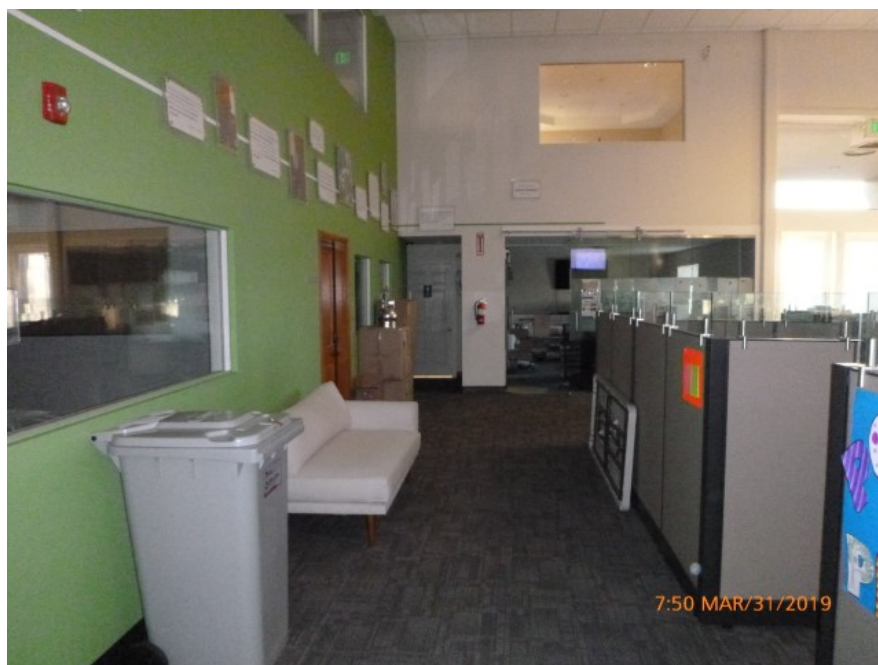
WES' main offices are situated in the southern end of the building. Concrete floors in the office areas are covered with finishes that include carpet and linoleum. A restroom and utility room are included within the eastern portion of the office areas. The utility room has an electric water heater, a floor sink and drain. Small quantities of typical cleaning products were observed stored in the bathroom areas.

Photograph 4 – WES office space looking east towards restroom.

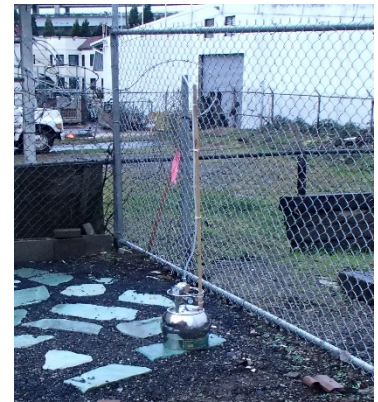
Photo 1. Summa Canister with Intake

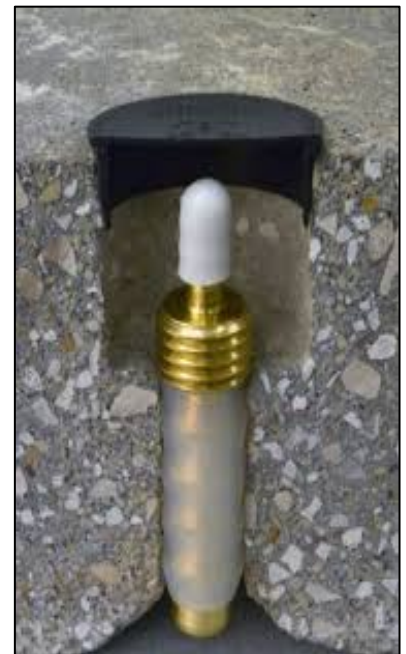
- The sub-slab samples will be collected using Vapor Pin™ sampling devices similar to the one shown on Photo 2. The Vapor Pin™ will be installed in general accordance with the manufacturers’ standard operating procedures (Appendix B), which involves drilling a hole through the concrete slab to insert the Vapor Pin™ and secure it in place with the silicone gasket.
- Pre-sampling quality control procedures (shut-in test, leak testing, and purging) and soil vapor sampling will not take place for at least 30 minutes hours following installation of the vapor pin.
- Sub-slab soil vapor samples will be collected using evacuated 1-liter Summa canisters.

Photo 2. Vapor Pin in Concrete Slab

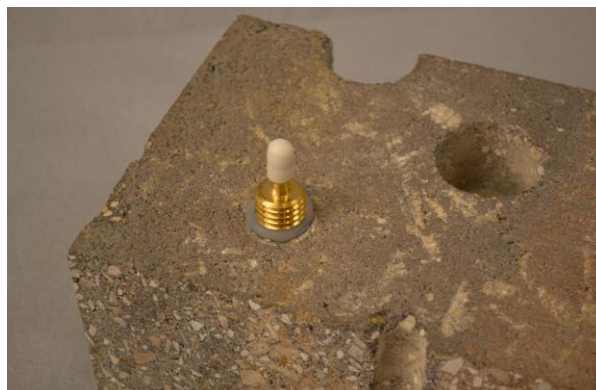
During installation, the silicone sleeve will form a slight bulge between the slab and the VAPOR PIN® shoulder. Place the protective cap on VAPOR PIN® to prevent vapor loss prior to sampling (Figure 3).

Figure 3. Installed VAPOR PIN®
