J-1225-01
30 November 2001

Subject: Phase I Environmental Site Assessment
Proposed Lynnwood Convention Center, "Task 2" Property
Lynnwood, Washington

APPENDIX A
J-1225-01
SITE AND VICINITY PHOTOGRAPHS

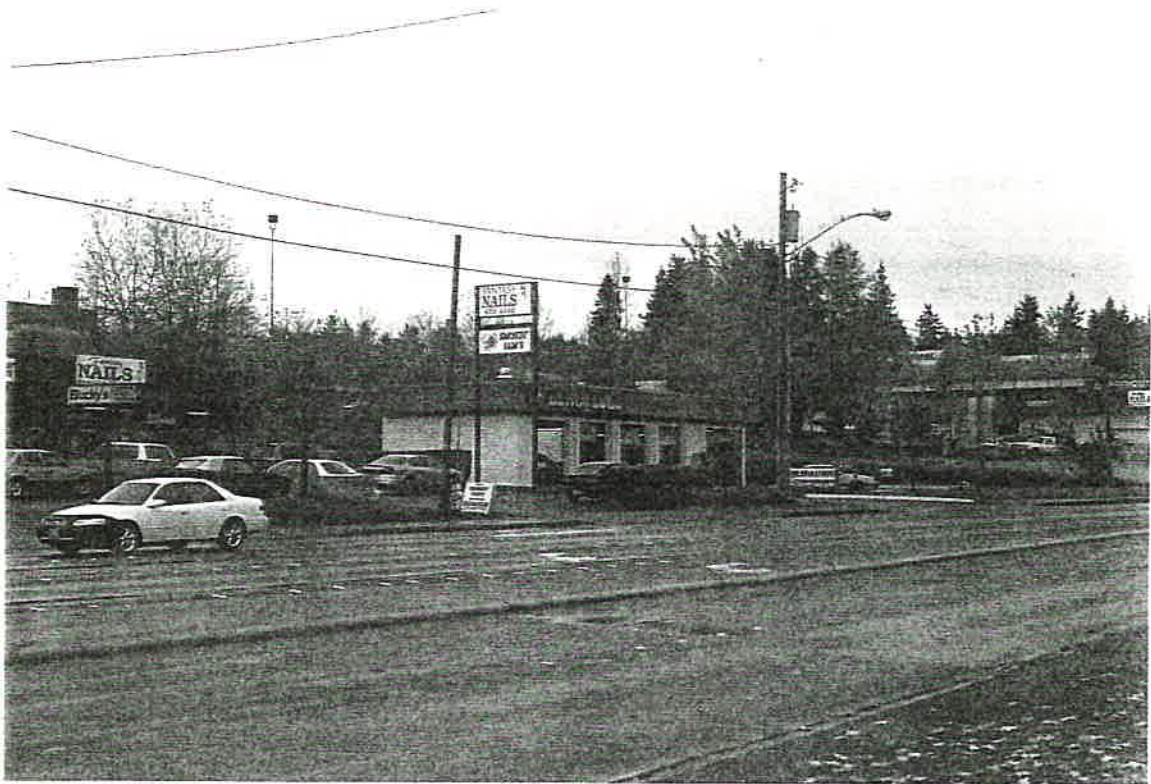
Photograph 1 View Northwest of the eastern portion of the site, showing Econo Lube and the property adjacent to the south of Econo Lube. The building in the right background is the Addicott Building.

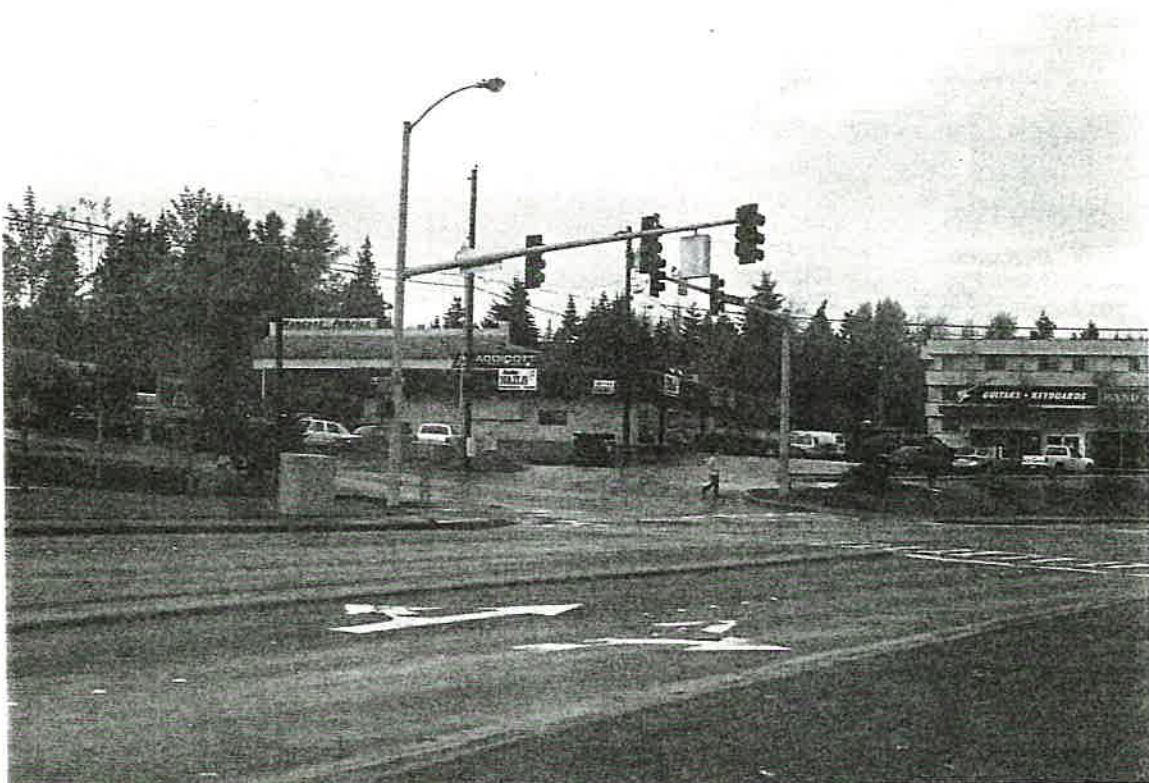
Photograph 2 View Northwest at the intersection of 195th Place and 37 Ave West. The sign for Hancock Fabric is seen above the Addicott Building. The Silver Cloud Motel, the gray building on the right, is north of Band Aid Music.

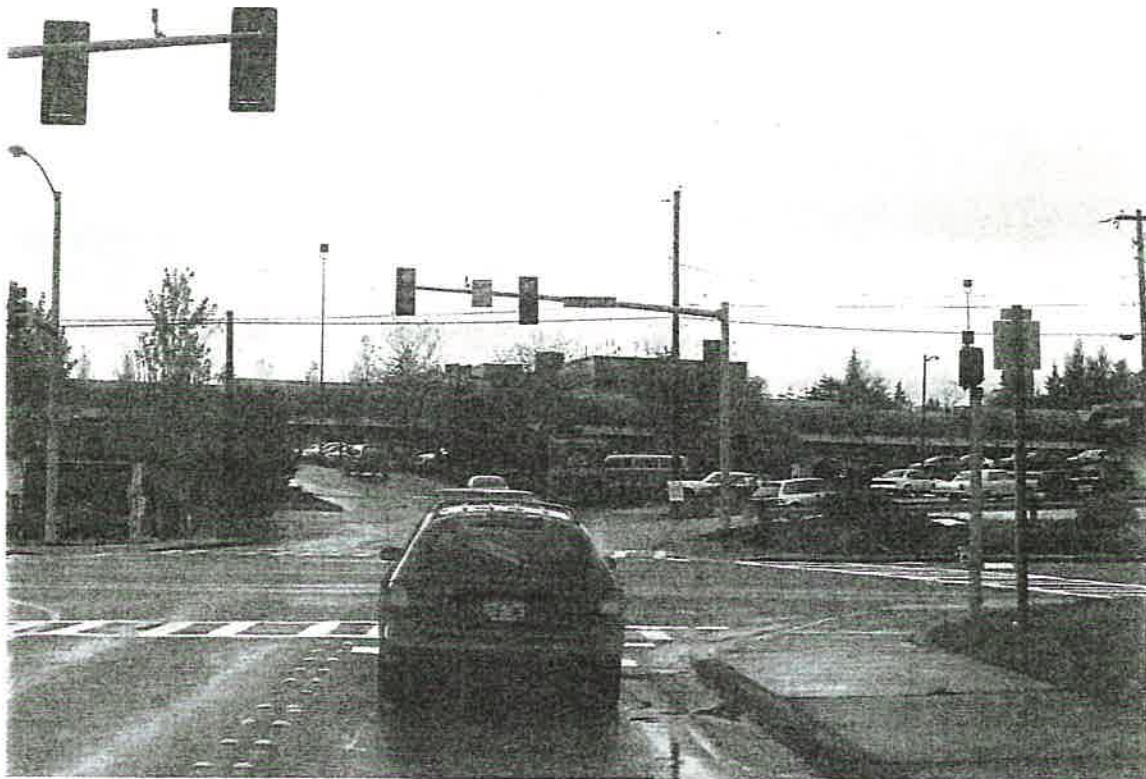
Photograph 4. View West. The subject site is the large building in the background. The photograph is taken from the intersection of 195th Place and 37 Avenue W. Manor Hardware is to the right, just out of the frame.

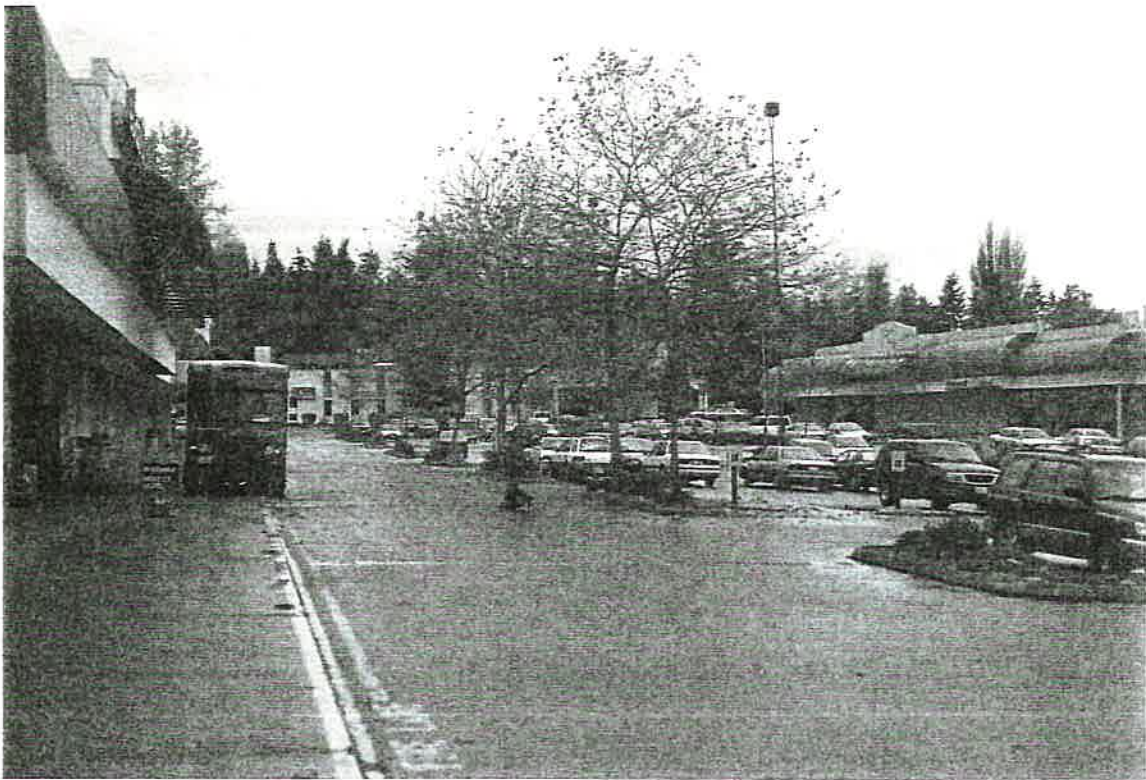
Photograph 5. View north across the subject site. Long Drugs is on the left, Hancock Fabric is in the building on the right.

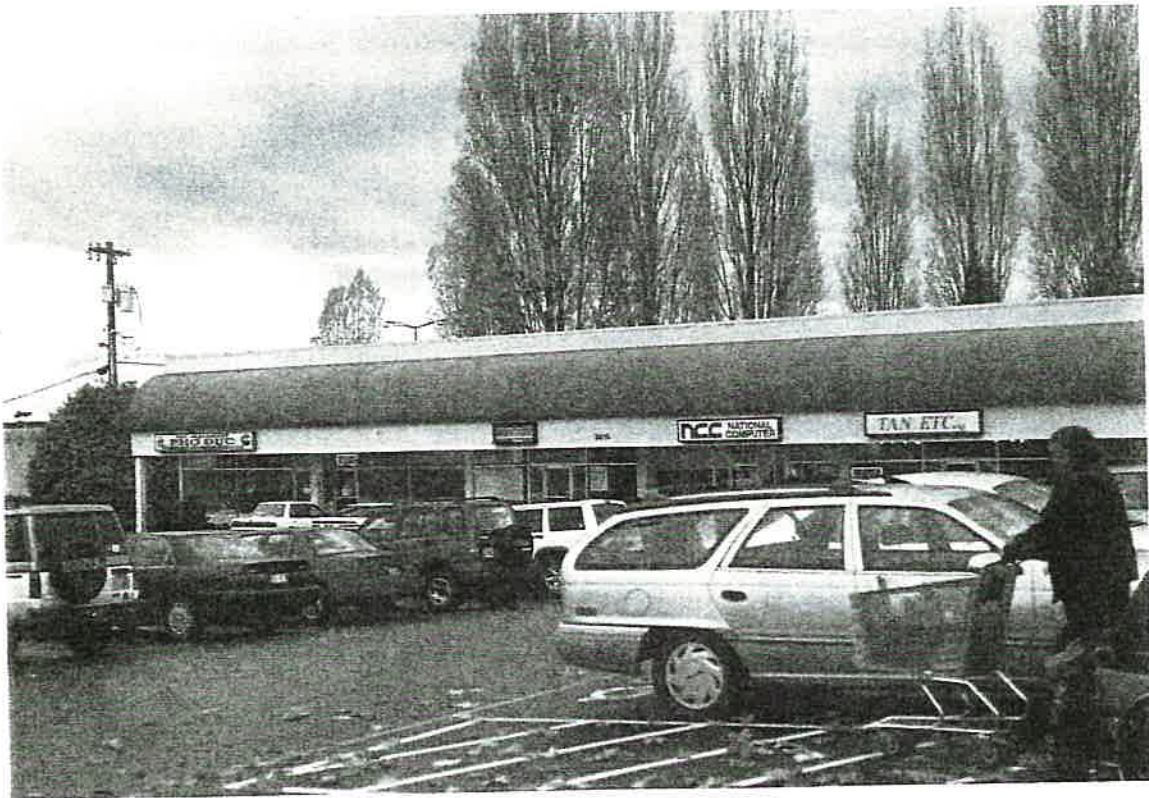
**Three sets of three pole-mounted transformers were observed on site. One set is adjacent to the northwest corner of *Cucina Presto*; one set is on the property boundary behind *Salon Veloce*, and the third set is located near the northwest corner of *Long's Drugs*. Neither ground staining nor distressed vegetation was observed at the base of these transformers. No stickers were observed that would indicate that the transformers had been tested or contain PCBs or not.

Photograph 6. View west of the north wing of Building D. The pole-mounted transformers on the left side of the photograph are at the northwest corner of Cucina Presto.

Asbestos surveys of the existing structures, and other surveys of surface improvements such as PCB and lead-based paint surveys, are also recommended. Environmental assessments of the tank and lifts at *Ultra Lube* are also recommended.

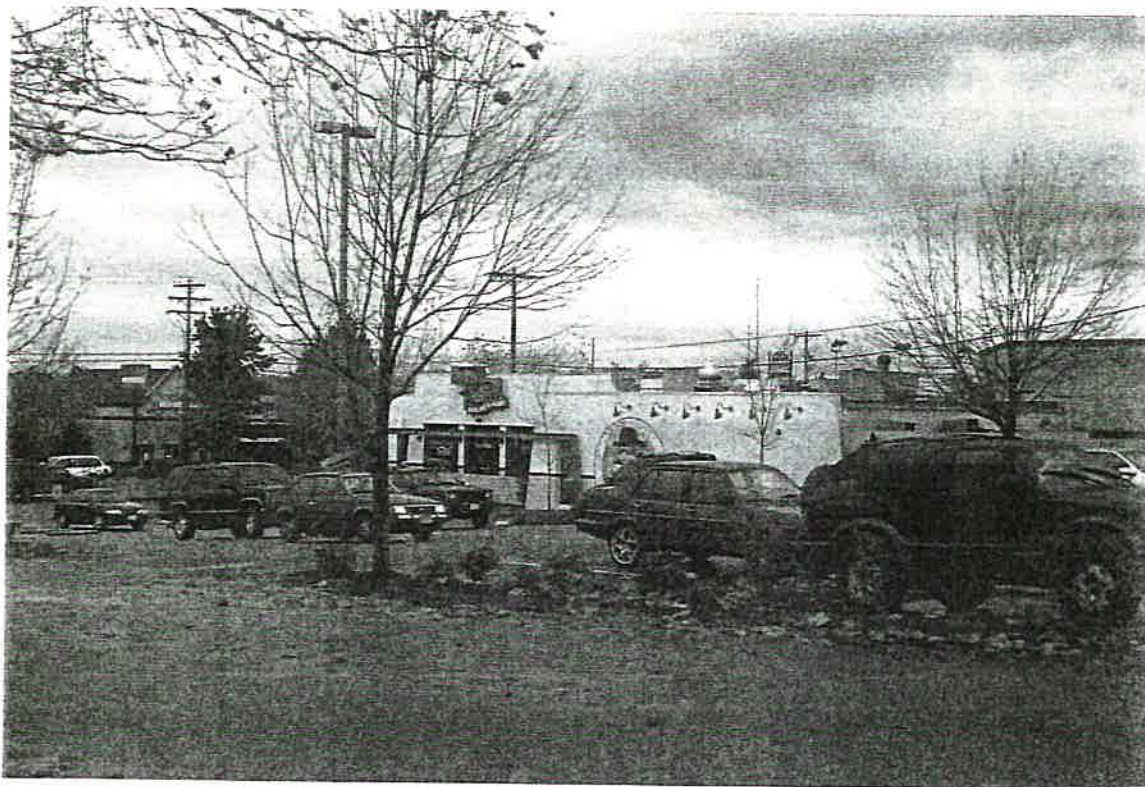
Photograph 7. View southwest of Cucina Presto, 3805 196th Street SW. The downwards site slope is most pronounced on this part of the property. The white car in the left background is heading east on 196th Street..

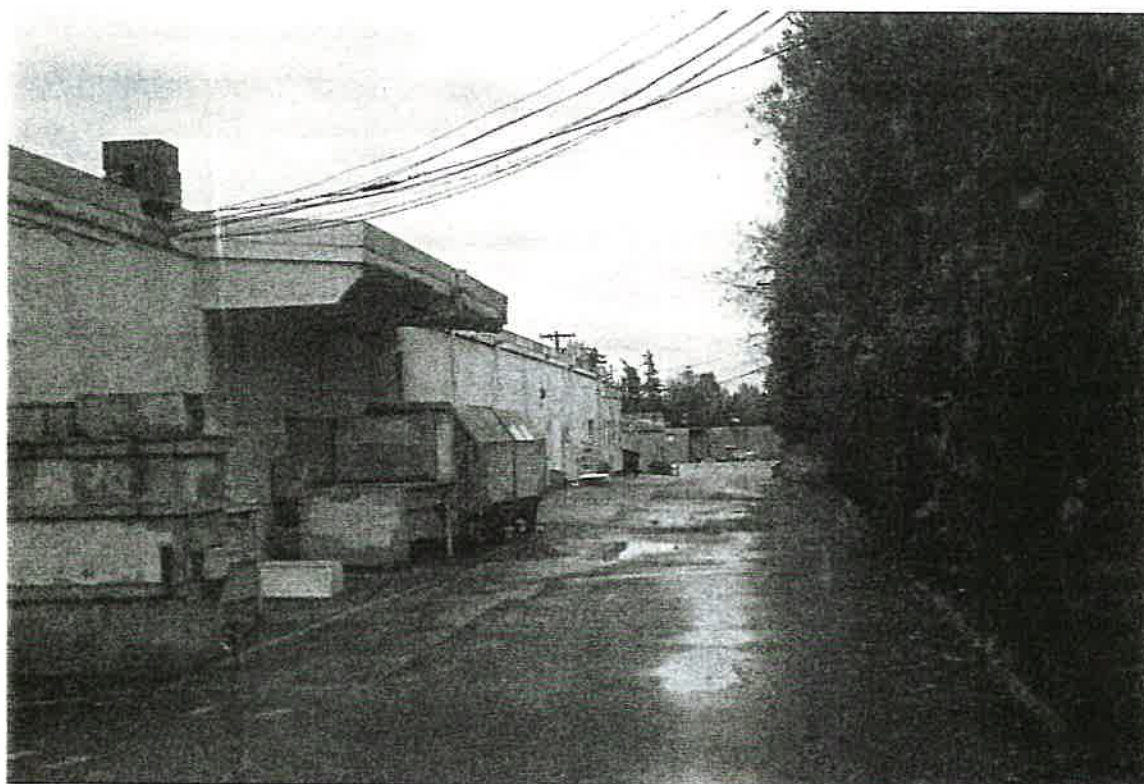
Photograph 8. View south along the western property boundary. The dumpster and paper compactors are behind Long Drug.

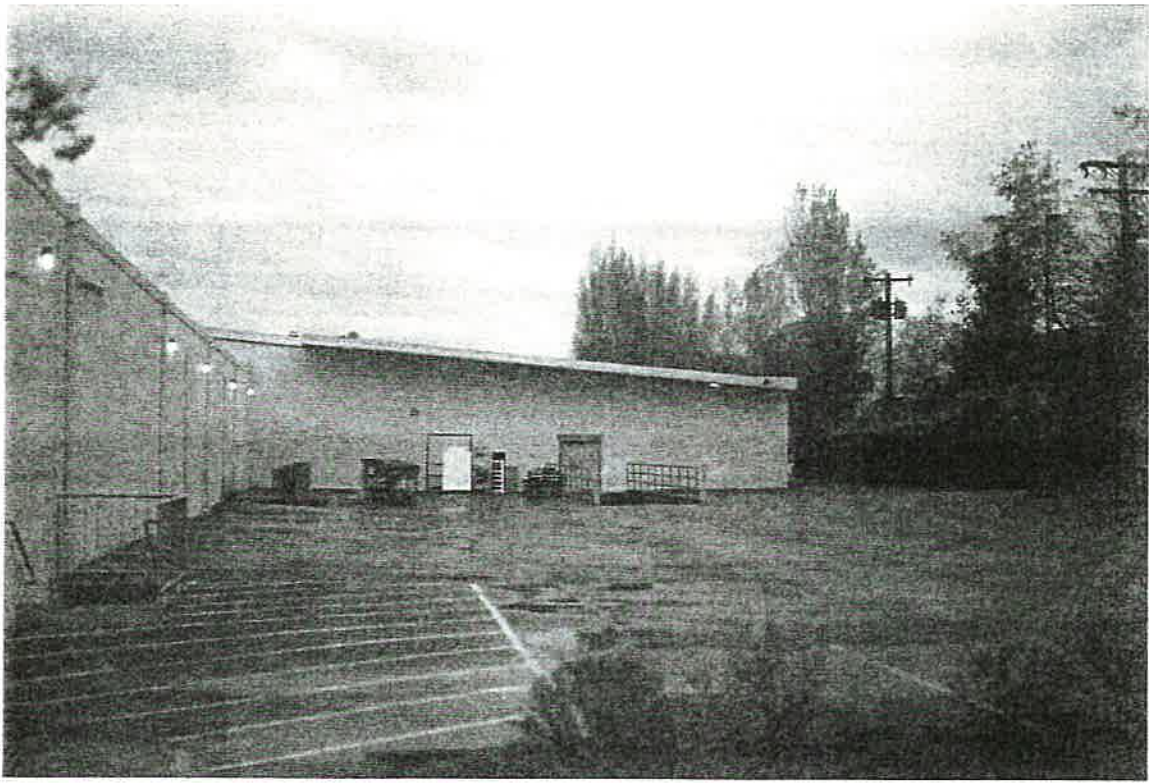
Photograph 9. View south from the northwest corner of the movie theater and beauty school. The wall on the left is the west side of the movie theaters. The building in the background is Long Drugs. Note the pole-mounted transformers on the right. Note how the land surface rises west of the site.
