REVISED CRITICAL AREAS REPORT
New Middle School
CITY OF LYNNWOOD, WASHINGTON

Subject: REVISED CRITICAL AREAS REPORT, NEW MIDDLE SCHOOL, CITY OF
LYNNWOOD, WASHINGTON

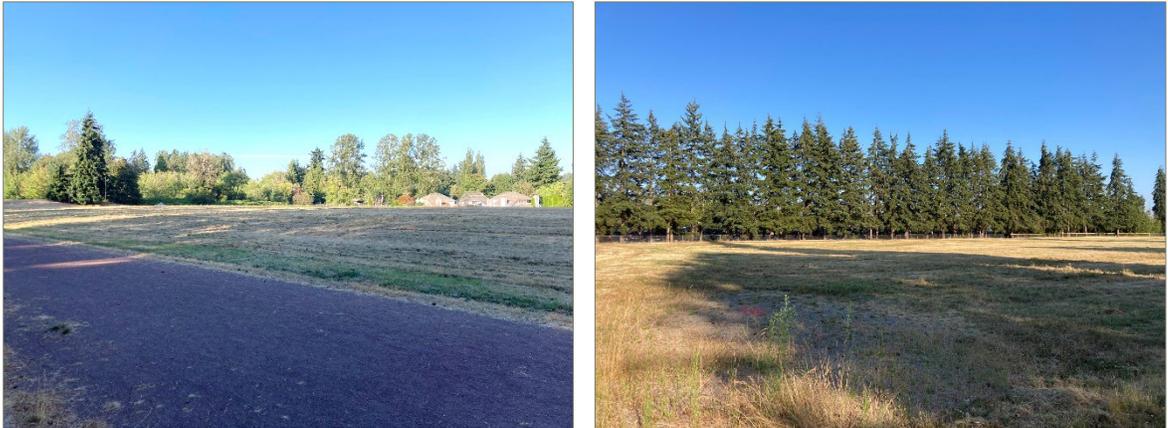
Exhibit 2-1: Track and Athletic Fields on Western Half of Project Site.

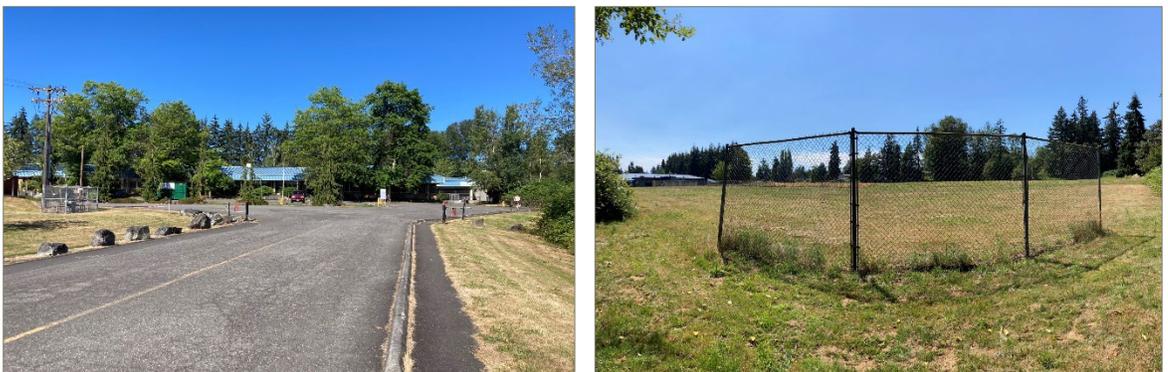
Exhibit 2-2: Existing School Entrance (Left) and Athletic Field in Northeast Corner of Project Site (Right).

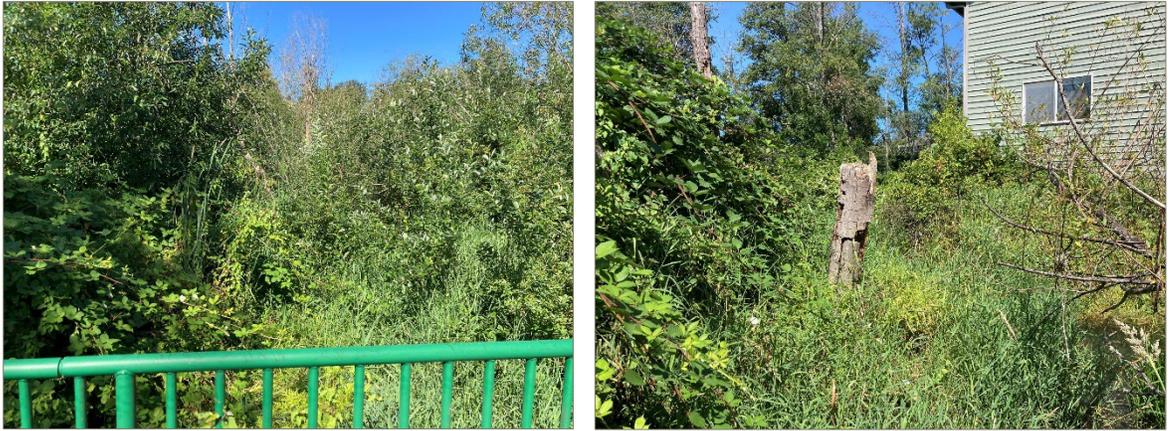
Exhibit 5-1: Example of Wetland A Vegetation Structure and Habitat Features.

Wetland A contains both riverine and depressional HGM components and, following Ecology’s guidance, was rated as a depressional wetland. The wetland’s rating unit is defined by the presence of a perched culvert under 199th Place SW at the wetland’s upstream end, and the wetland’s outlet culvert at its downstream extent. Flow through the wetland and culverts is unidirectional. The wetland was rated using Ecology’s *Washington State Wetland Rating System for Western Washington* (Hruby and Yahnke, 2023) and is a Category III wetland (Appendix C).

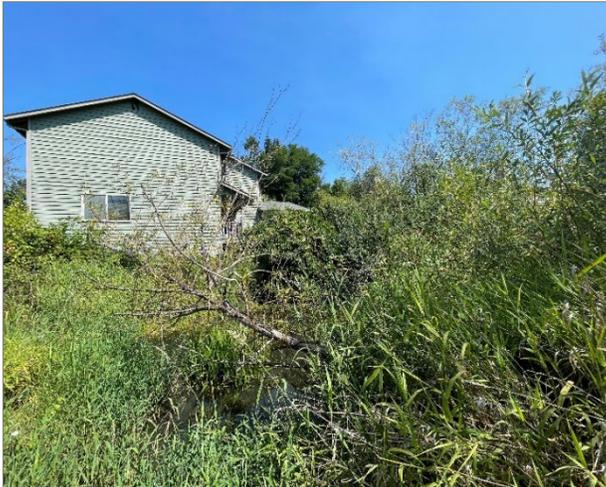
Exhibit 5-2: Wetland A Summary

Location Within Study Area	Central/Eastern Portion, North of School Entrance
	Standard Buffer Width	165 feet ^{1,2}
	Ecology Rating	Category III Water Quality Score: 7 Hydrologic Score: 6 Habitat score: 6
	Wetland Size	Approximately 0.45 acre, 0.25 acre on the Project site
	Cowardin Classification	Palustrine Forested, Scrub-Shrub, and Emergent
	HGM Classification	Depressional

Wetland A – Information Summary	
	Wetland Data Sheet(s) DP-1
Dominant Vegetation	Dominant trees include Pacific willow (<i>Salix lasiandra</i> , facultative wetland [FACW]), and dominant shrubs include Pacific willow and Himalayan blackberry (<i>Rubus armeniacus</i> , facultative [FAC]). Dominant herbaceous plants include creeping buttercup (<i>Ranunculus repens</i> , FAC), bird's foot trefoil (<i>Lotus corniculatus</i> , FAC), and reed canarygrass (<i>Phalaris arundinacea</i> , FACW).
Soils	The soil profile was examined to a depth of 26 inches below ground surface (bgs). The top layer was 6 inches of very dark brown (10YR 2/2) silty clay, underlain by a dark greenish gray (10Y 4/1) sandy clay loam extending to 26 inches bgs, with 7% strong brown (7.5YR4/6) redoximorphic concentrations in pore linings and the matrix from 6 to 12 inches bgs. Gravels were present in the lowest 10 inches of the soil pit. The Loamy Gleyed Matrix (F2) and Depleted Matrix (F3) hydric soil indicators were met.

Hydrology/Hydroperiods	The dominant hydrology sources appear to be Golde Creek and groundwater. Saturation was observed at 13 inches bgs and water was observed in the soil pit at 17 inches bgs. The Oxidized Rhizospheres along Living Roots (C3) hydrology indicator was met.
Buffer Conditions	The wetland is surrounded by a residential area, the school driveway and building, and mowed grass associated with the school facility dominated by bentgrass (<i>Agrostis</i> , FAC) and creeping buttercup. On the Project site, the southern portion of the buffer includes an area of mowed grass that is separated from and functionally disconnected from the wetland by the school's paved entrance.

Wetland A is associated with a segment of Golde Creek that crosses the Project site and study area near the school's entrance (Figure 2). The wetland flanks both sides of the stream along a narrow riparian corridor that starts south of 200th Street SW (Exhibit 5-1). Portions of the wetland extend upgradient from the Golde Creek's OHWL. The wetland is surrounded by the school and residential developments and receives multiple stormwater point discharges. A variety of habitat features were observed in the wetland, including standing snags, large, downed woody debris, and overhanging vegetation that replicates undercut banks (Exhibit 5-1). Wetland A outlets under 28th Avenue West through a 9.5-foot-wide, arched structural plate steel culvert (WDFW, 2025b).

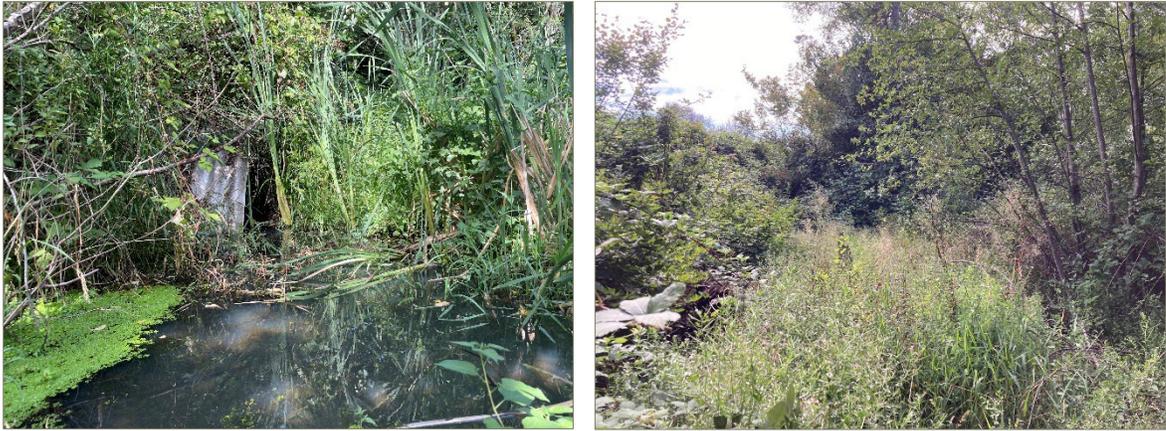
Exhibit 5-3: Wetland B Inlet Culvert (Left) and Backwater Feature (Right).

Wetland B is associated with the segment of Golde Creek immediately upstream from Wetland A. The wetland is located above and below the OHWM of Golde Creek. To the north, a 13-foot metal inlet culvert separates the wetland from the stream/wetland complex on the north side of Alderwood Mall Parkway (Exhibit 5-3, left). During the site visit, surface water flow through the wetland was slow. Wetland B includes a backwater feature that wraps around the north Project site boundary, west of the 13-foot inlet culvert (Exhibit 5-3, right).

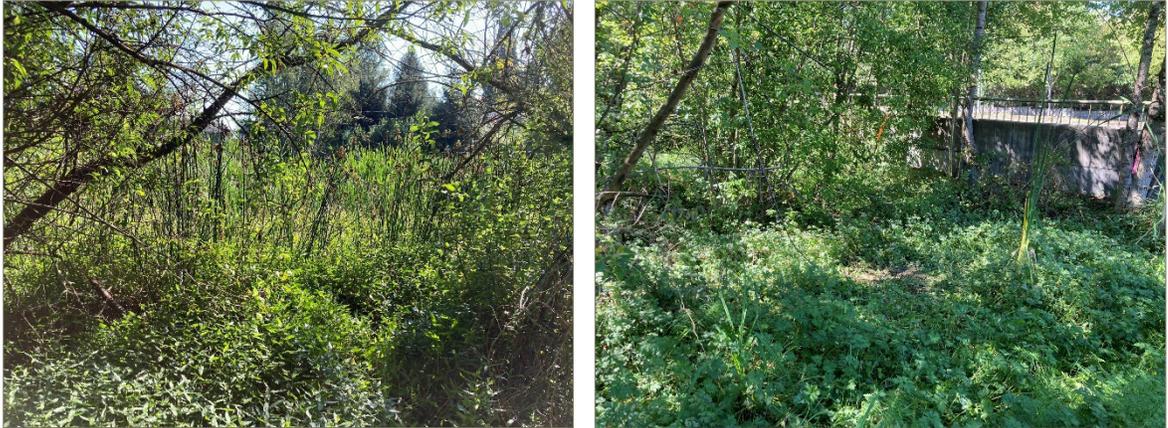
Exhibit 5-5: Diverse Vegetation Strata in Southern Portion of the Wetland (Left) and View of the Wall in the Northern Portion of the Wetland (Right).

depressions in the wetland. Surface water movement through the wetland generally flows from the southern end around to the north end of the 'C.' The northern boundary of the depressional wetland abuts a concrete wall that supports the fill associated with the Alderwood Mall Parkway road and sidewalk (see photo on right in Exhibit 5-5).

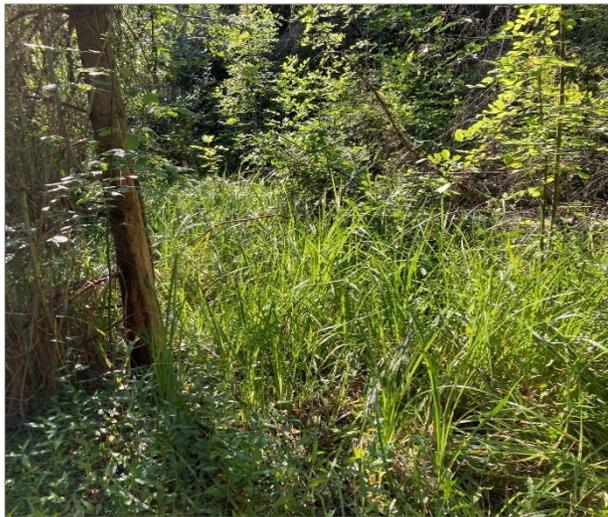
Exhibit 5-6: Depressional Wetland C Summary

Location Within Study Area	West of Project Site
Standard Buffer Width	105 feet ¹
Ecology Rating	Category III Water Quality Score: 7 Hydrologic Score: 7 Habitat score: 5
Depressional Wetland Size	Approximately 2.15 acres/ 0.02 acre on Project site
Cowardin Classification	Palustrine Forested, Scrub-Shrub, Emergent, Aquatic Bed
HGM Classification	Depressional
Wetland Data Sheet(s)	DP-8 and DP-11

Dominant Vegetation	Dominant trees include black cottonwood (<i>Populus balsamifera</i> ssp. <i>trichocarpa</i> , FAC) and Pacific willow. Dominant shrubs include willows (<i>Salix</i> sp., FAC) and Oregon ash (<i>Fraxinus latifolia</i> , FACW). Dominant herbaceous plants include creeping Jenny (<i>Lysimachia nummularia</i> , FACW), lady’s thumb (<i>Persicaria maculosa</i> , FACW), and creeping buttercup.
Soils	The soil generally exhibits an upper layer of black (10YR 2/1) to very dark brown (10YR 2/2) loam to silt loam with strong brown (7.5YR 4/6) concentrations in the matrix and pore lining, underlain by a dark gray (10YR 4/1) to dark grayish brown (10YR 4/2) silt loam with up to 15% strong brown (7.5YR 5/6) and yellowish red (5YR 4/6) redoximorphic concentrations in the matrix and pore linings. Gravels and cobbles were present below 5 inches bgs in the southern portion of the wetland. The Depleted Matrix (F3) and Redox Dark Surface (F6) hydric soil indicators were met.

Hydrology/Hydroperiods	The dominant hydrology sources in the depressional portion of the wetland are direct precipitation, seasonally high groundwater, and stormwater from the developed areas. The Oxidized Rhizospheres along Living Roots (C3) hydrology indicator was met.
Buffer Conditions	To the south, a narrow strip of upland mixed forest separates the wetland from residences. To the west is mowed lawn and patches of trees in Heritage Park. Alderwood Mall Parkway is to the north of Wetland C and the school’s athletic fields are to the east.

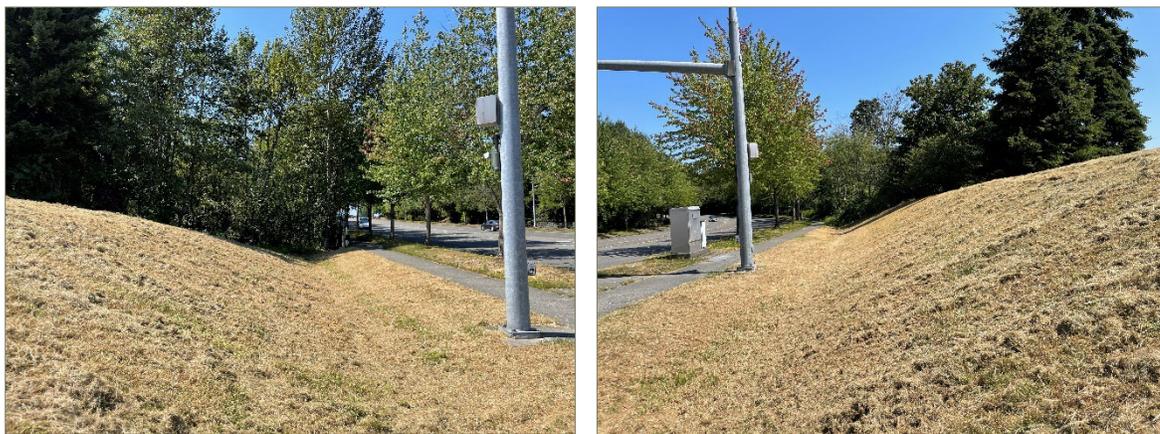
Exhibit 5-7: Grass Swale Connected to Wetland C, Viewing West (Left) and East (Right).

not exhibit indications of surface water movement, and the topography suggests that flow from Wetland C to the swale is occasional. The grass swale continues for just over 300 feet before turning into a riprap-lined swale. The riprap continues for approximately 100 feet before dropping into the depression where Wetland B and Golde Creek are located. The soil within the grass swale and the adjacent grass slope was observed to be extremely compacted.

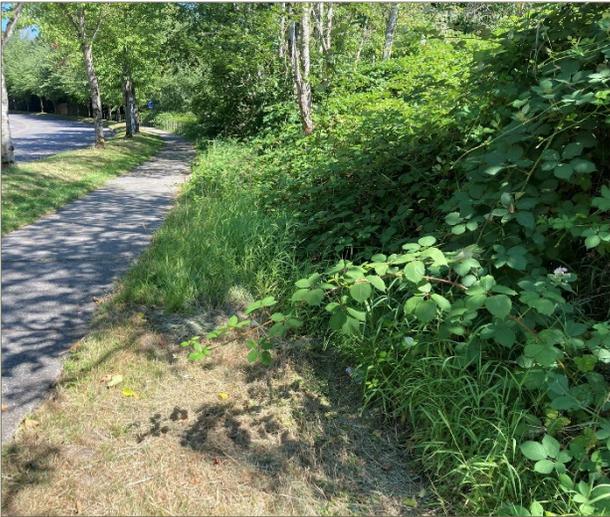
Exhibit 5-8: Constructed Swale Summary

Location Within Study Area	North of Project Site
	Swale Size	Approximately 1,900 sf/ 1,500 sf on Project site
	Cowardin Classification	Palustrine Emergent
	Wetland Data Sheet(s)	DP-7 and DP-9
	Dominant Vegetation	Swale vegetation is mainly limited to graminoids (mowed) and creeping buttercup, with trailing blackberry (<i>Rubus ursinus</i> , FACU), and Himalayan blackberry creeping into the swale at its eastern end.
Soils	<p>Soil is generally characterized as a very dark brown (10YR 2/2) silt loam with up to 5% strong brown (7.5YR 4/6) redoximorphic concentrations in the matrix and pore linings extending to approximately 10 inches. This is underlain by a lighter depleted layer, including a dark grayish brown (10YR 4/2) and very dark brown (10YR 2/2), and a greenish gray (10Y 5/1) matrix with 5 to 15% yellowish red (5YR 5/6) to strong brown (7.5YR 5/6) concentrations. Cobbles were observed starting at 3 inches and 10 inches bgs. The soil is very compacted.</p> <p>The Depleted Matrix (F3), Redox Dark Surface (F6), and Sandy Redox (S5) hydric soil indicators were met.</p>

Hydrology/Hydroperiods	<p>The swale receives occasional surface water discharge from Wetland C, along with surface water runoff from the Alderwood Mall Parkway sidewalk fill slope and the fill slope to the south.</p> <p>The Oxidized Rhizospheres along Living Roots (C3) hydrology indicator was met.</p>

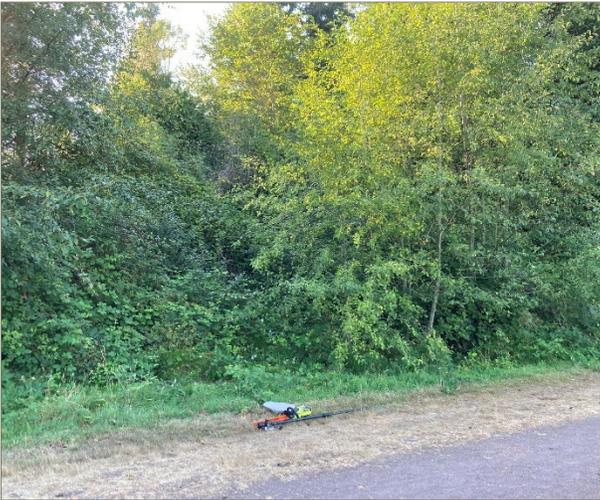
Exhibit 5-9: Wetland D Summary

Location Within Study Area	On Project Site, West of Track
	Standard Buffer Width ¹	60 feet
	Ecology Rating	Category III Water Quality Score: 6 Hydrologic Score: 6 Habitat score: 4
	Wetland Size	Approximately 0.05 acre
	Cowardin Classification	Palustrine Forested, Scrub-Shrub, Emergent
	HGM Classification	Depressional
	Wetland Data Sheet(s)	DP-13
	Dominant Vegetation	Dominant trees include red alder. Dominant shrubs include Himalayan blackberry and red-osier dogwood (<i>Cornus sericea</i> , FACW). Dominant herbaceous plants include field horsetail and soft rush (<i>Juncus effusus</i> , FACW).
Soils	The soil profile was examined to a depth of 16 inches. The top layer was 8 inches of very dark grayish brown (10YR 3/2) silt loam with 5% strong brown (7.5YR 4/6) redoximorphic concentrations in the matrix and pore linings. The layer below from 8 to 16 inches was a dark greenish gray (10Y 4/2) sandy loam with 7% strong brown (7.5YR 4/6) concentrations in the matrix. The Depleted Matrix (F3) and Redox Dark Surface (F6) hydric soil indicators were met.

Hydrology/Hydroperiods	Water was not observed in the soil pit. The Oxidized Rhizospheres along Living Roots (C3) hydrology indicator was observed in the field.	
Buffer Conditions	The track flanks the wetland to the east, mowed grass is to the south, and a forested area dominated by western red cedar (<i>Thuja plicata</i> , FAC) and black cottonwood, with shrubs including Himalayan blackberry and English laurel (<i>Prunus laurocerasus</i>) to the west.

Wetland D is within the Project site, west of the track. The wetland is on a slope and has a shallow ditch at its bottom. The slope portion of the wetland is mainly supported by groundwater and the wetland’s ditch collects surface runoff from the slope and the adjacent track. No hydrologic outlet was observed in the field. Wetland D was rated using Ecology’s *Washington State Wetland Rating System for Western Washington* (Hruby and Yahnke, 2023) and is a Category III wetland (Appendix C). A summary of the wetland data is provided in Exhibit 5-8.

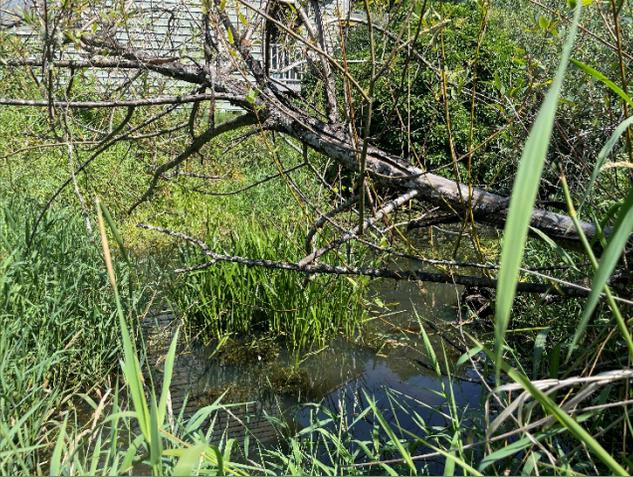
Exhibit 5-10: Golde Creek Information Summary

Location Within Study Area Northeast corner of study area and on the Project site near the existing access drive
	Water Type F
	Buffer Width 100 feet
	Connectivity Receives water from wetlands and streams 1,800 feet upstream. Connects to Scriber Creek, then Swamp Creek, then joins Lake Washington approximately 5.9 miles from the study area.
Fish Habitat	Within the Project site, Golde Creek has the potential to provide habitat (gradient accessible) to coho, Chinook, and sockeye salmon, and steelhead trout. Salmonid presence is not documented.
Flow Characteristics	Perennial

Golde Creek flows from the north to the south through the study area. We delineated the right bank of the stream in the Project site and in City ROW where the stream's buffer would project onto the Project site. Indicators observed during the OHWM delineation include water stains and marks, top of bank, and deposition/erosion features.

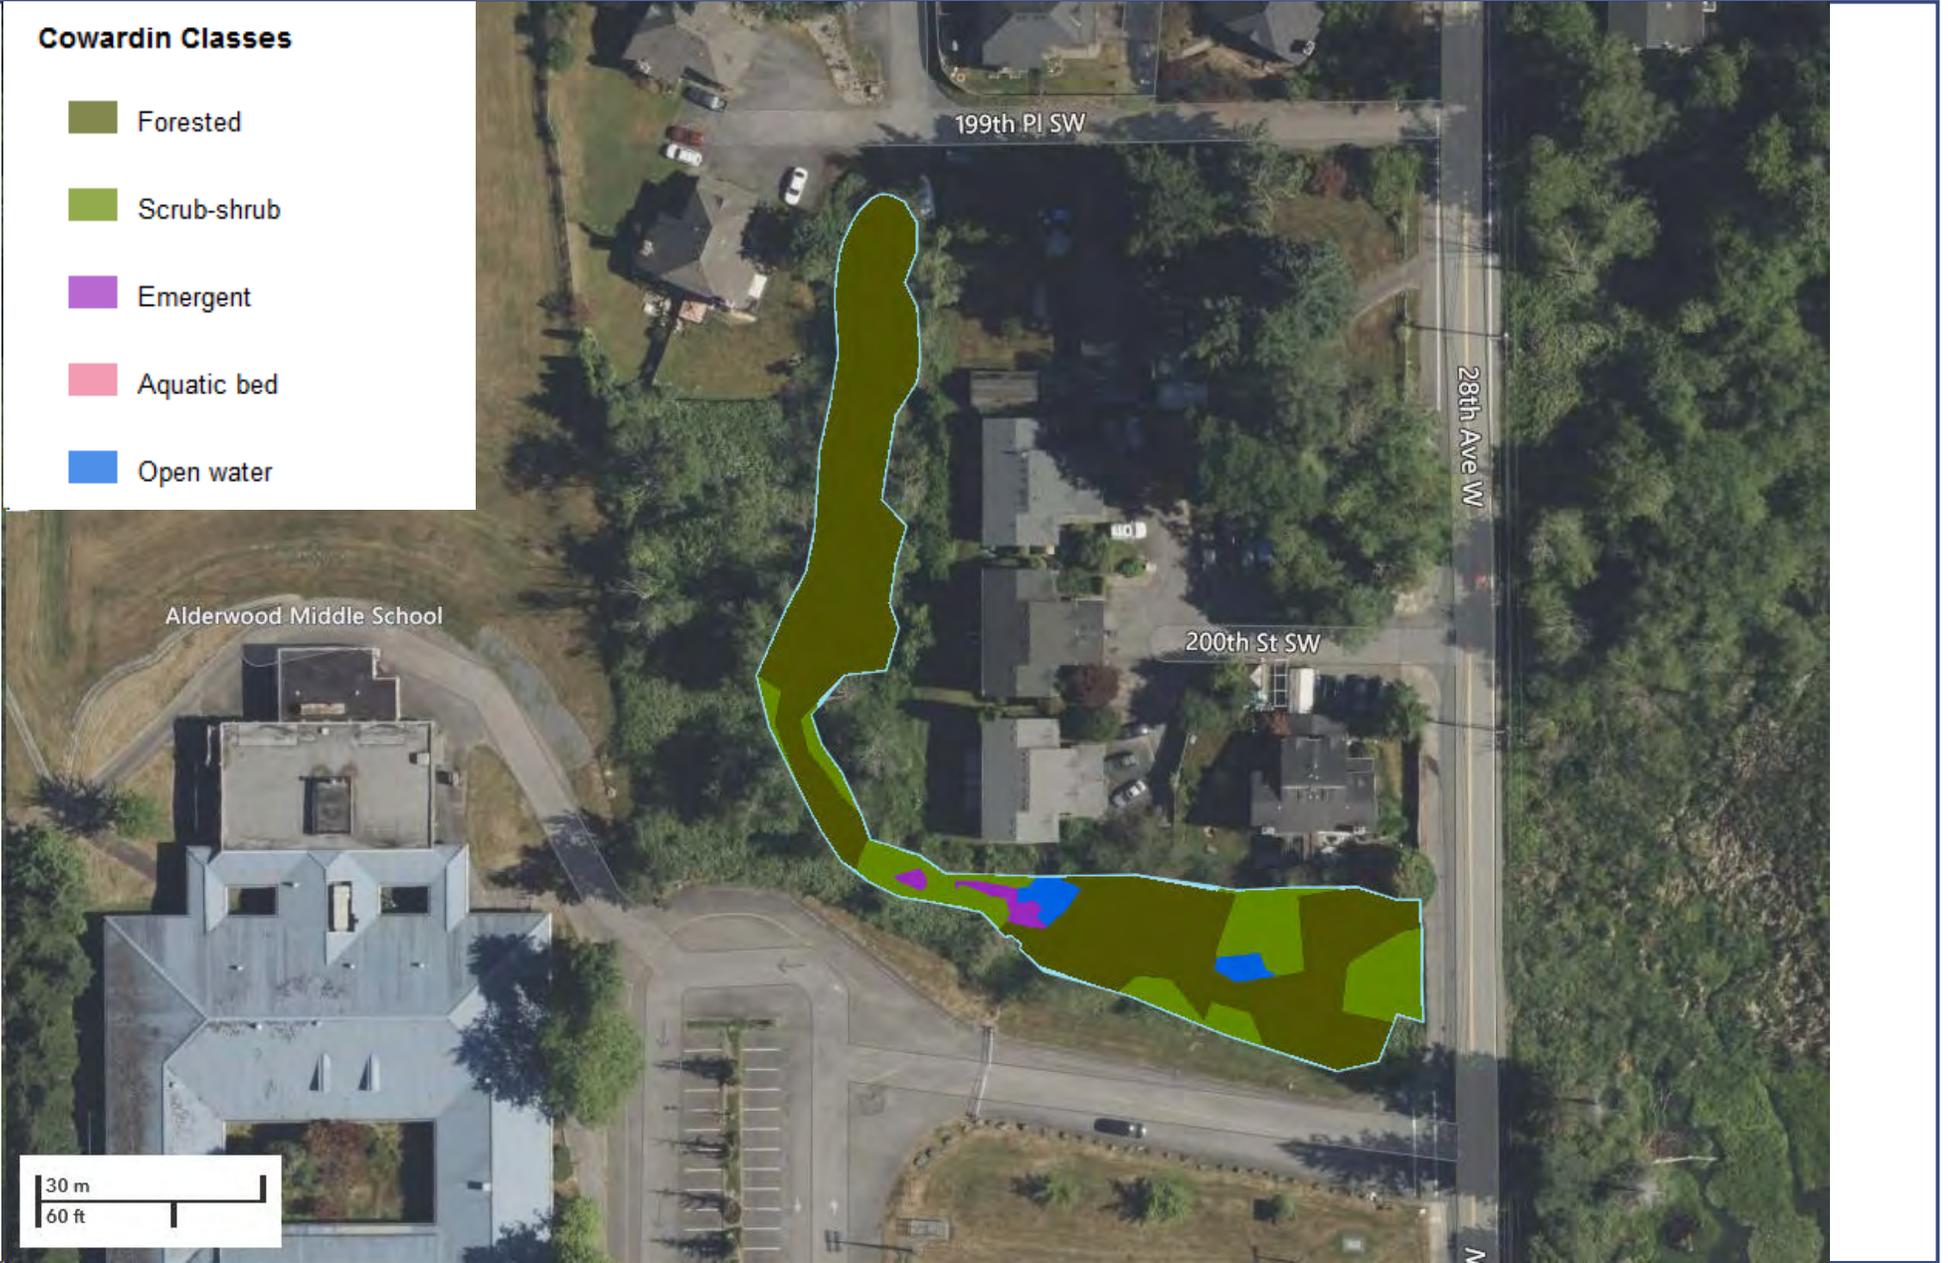
Rating Figure A-1
Cowardin Classes

These figures were generated using the Washington State Department of Ecology "Washington Tool for Online Rating (WATOR)" web tool.

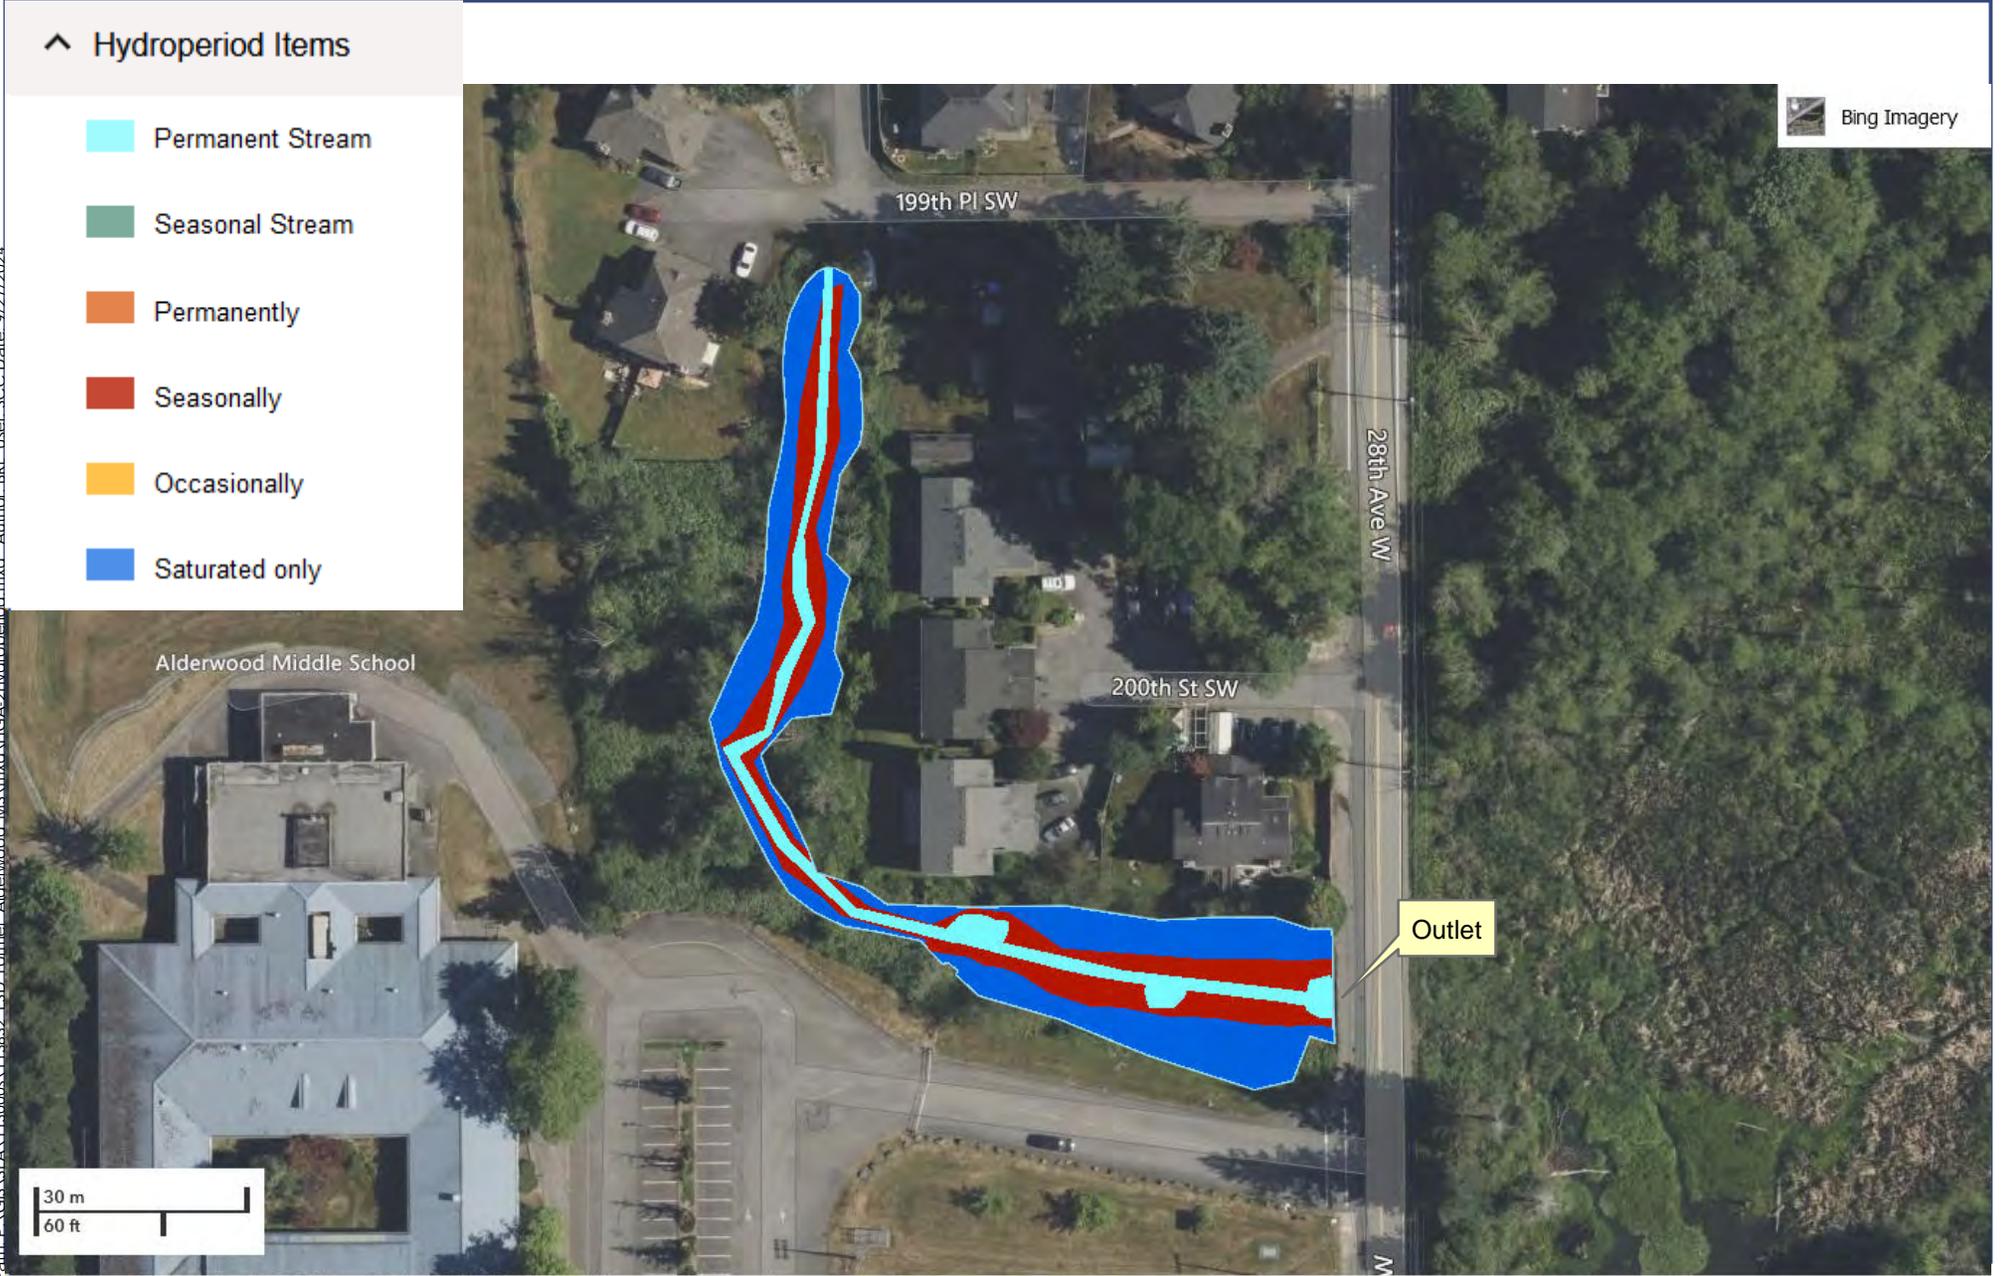
Rating Figure A-2
Hydroperiods

These figures were generated using the Washington State Department of Ecology "Washington Tool for Online Rating (WATOR)" web tool.

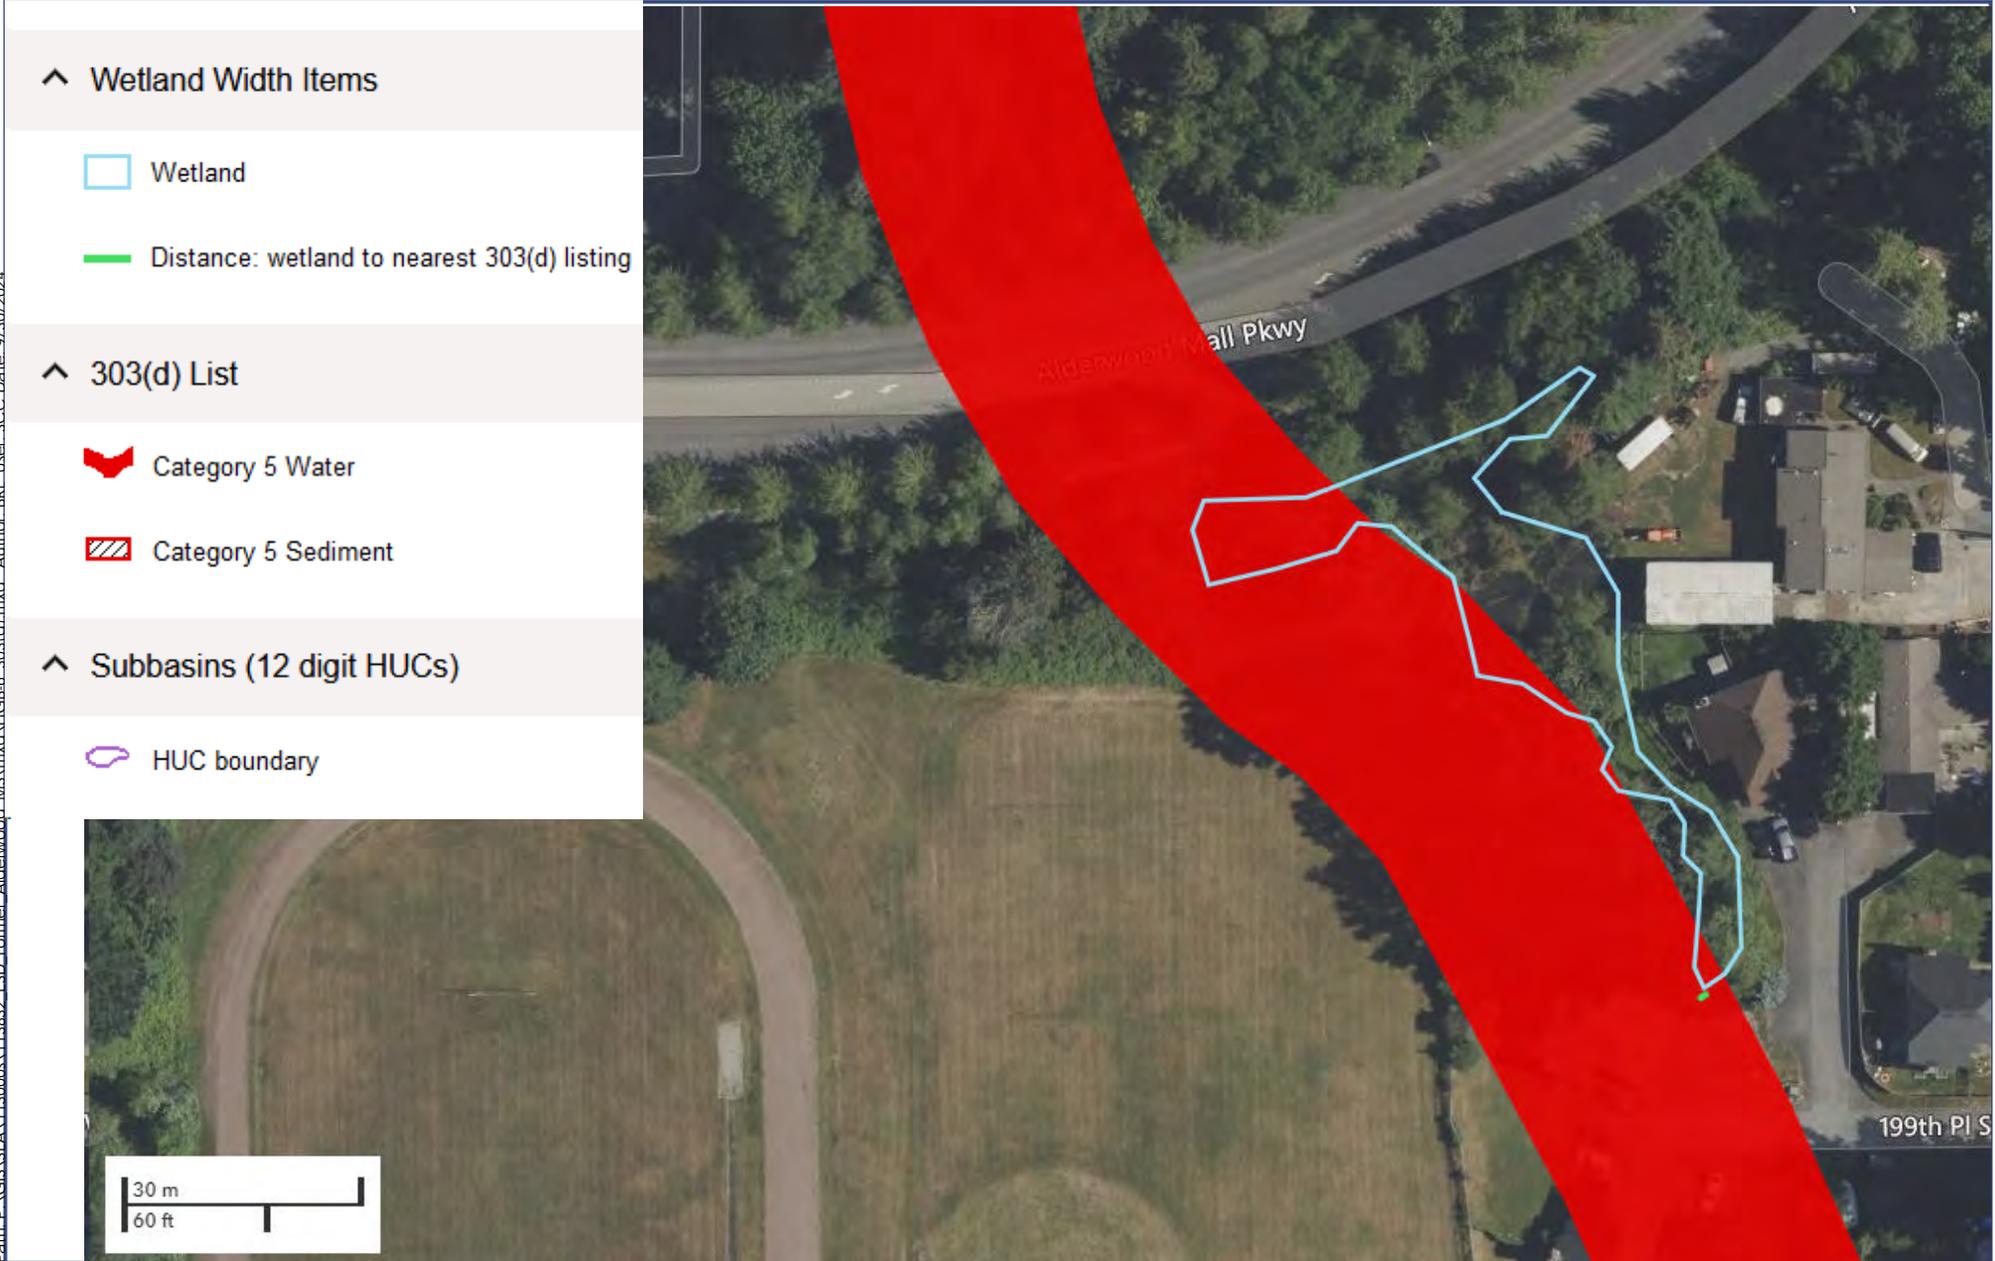
Rating Figure B-6
303(d) Impaired Waters

These figures were generated using the Washington State Department of Ecology "Washington Tool for Online Rating (WATOR)" web tool.

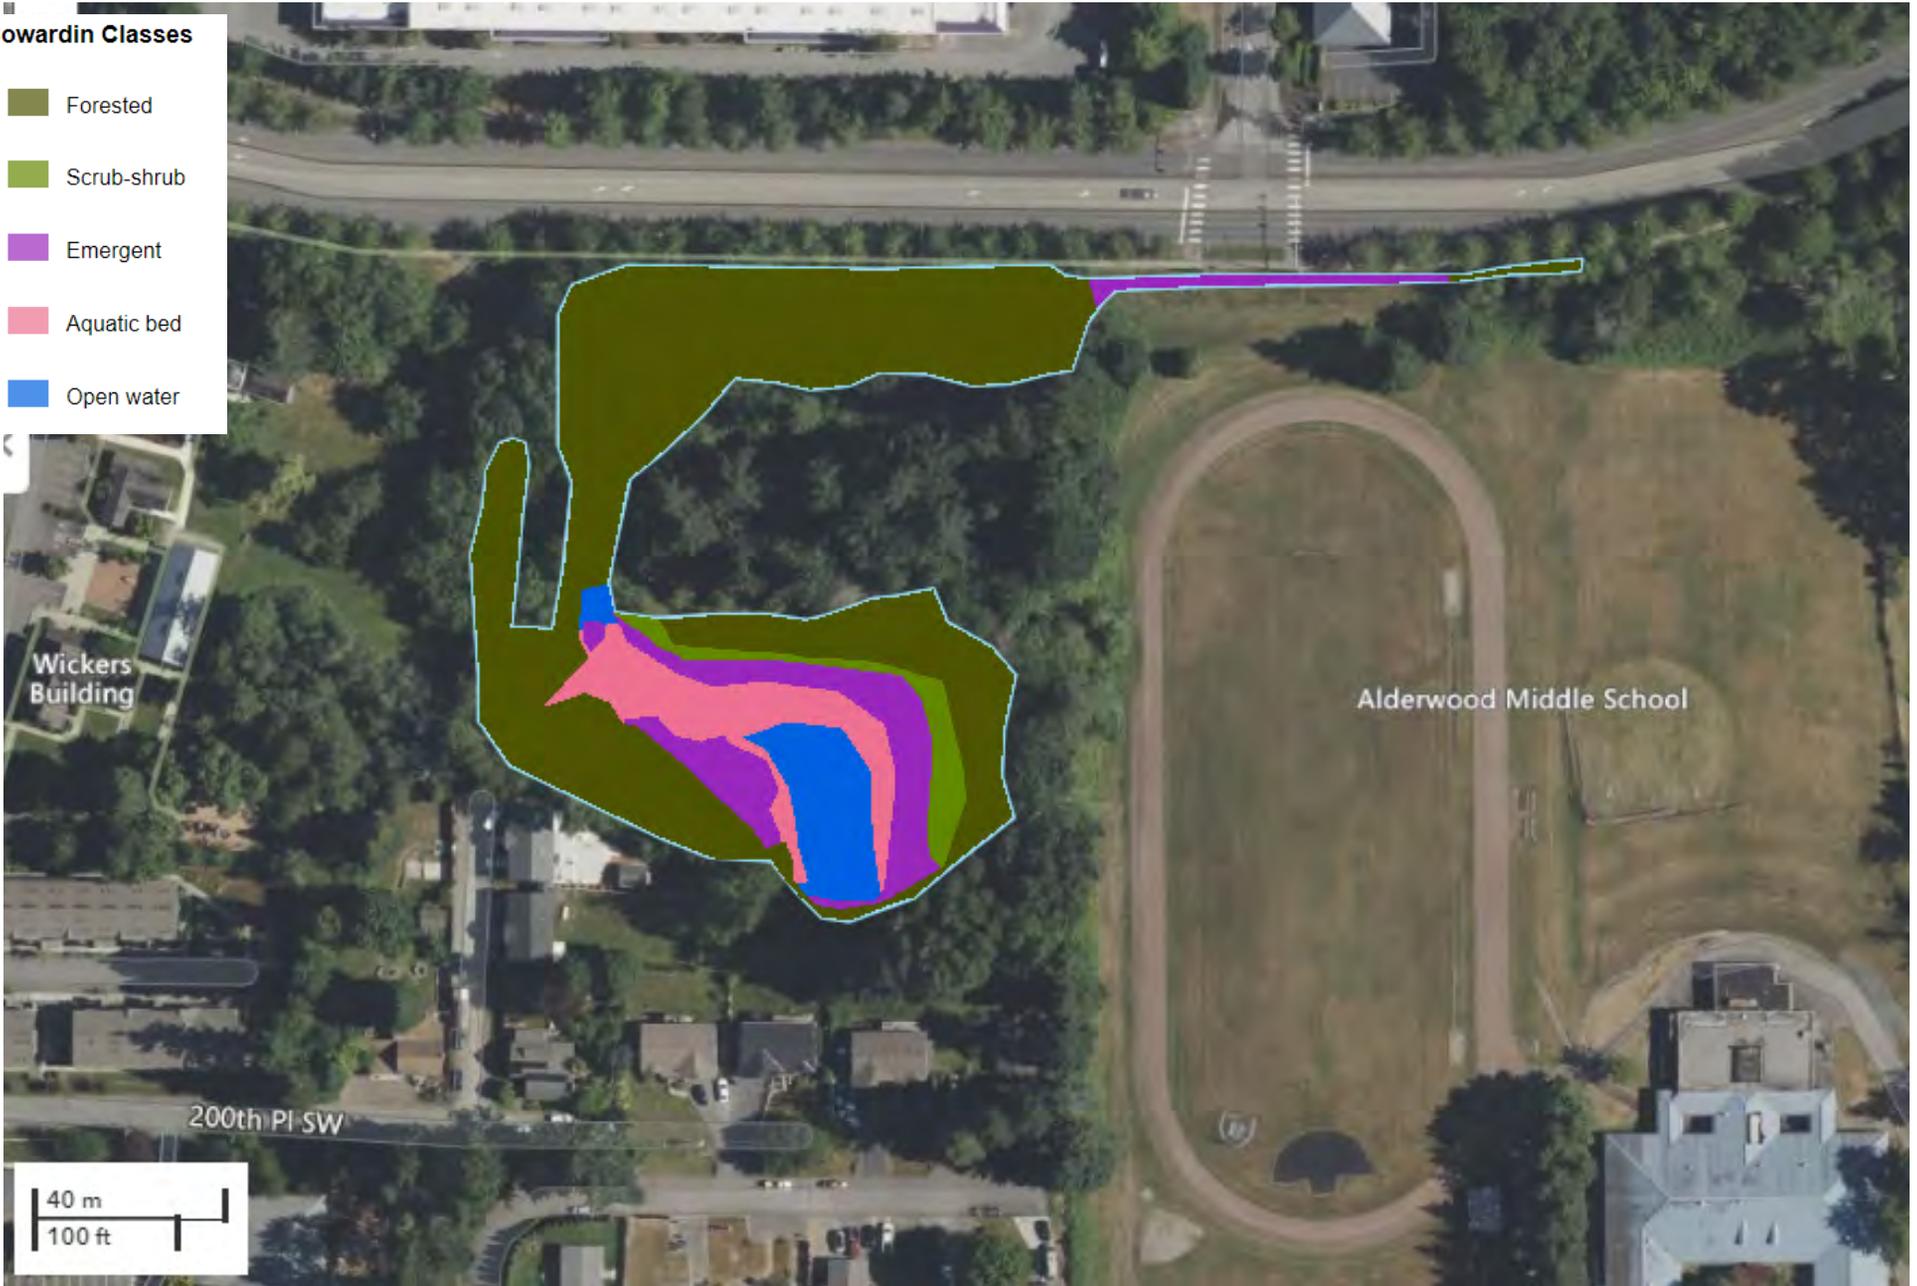
Rating Figure C-1
Cowardin Classes

These figures were generated using the Washington State Department of Ecology "Washington Tool for Online Rating (WATOR)" web tool.

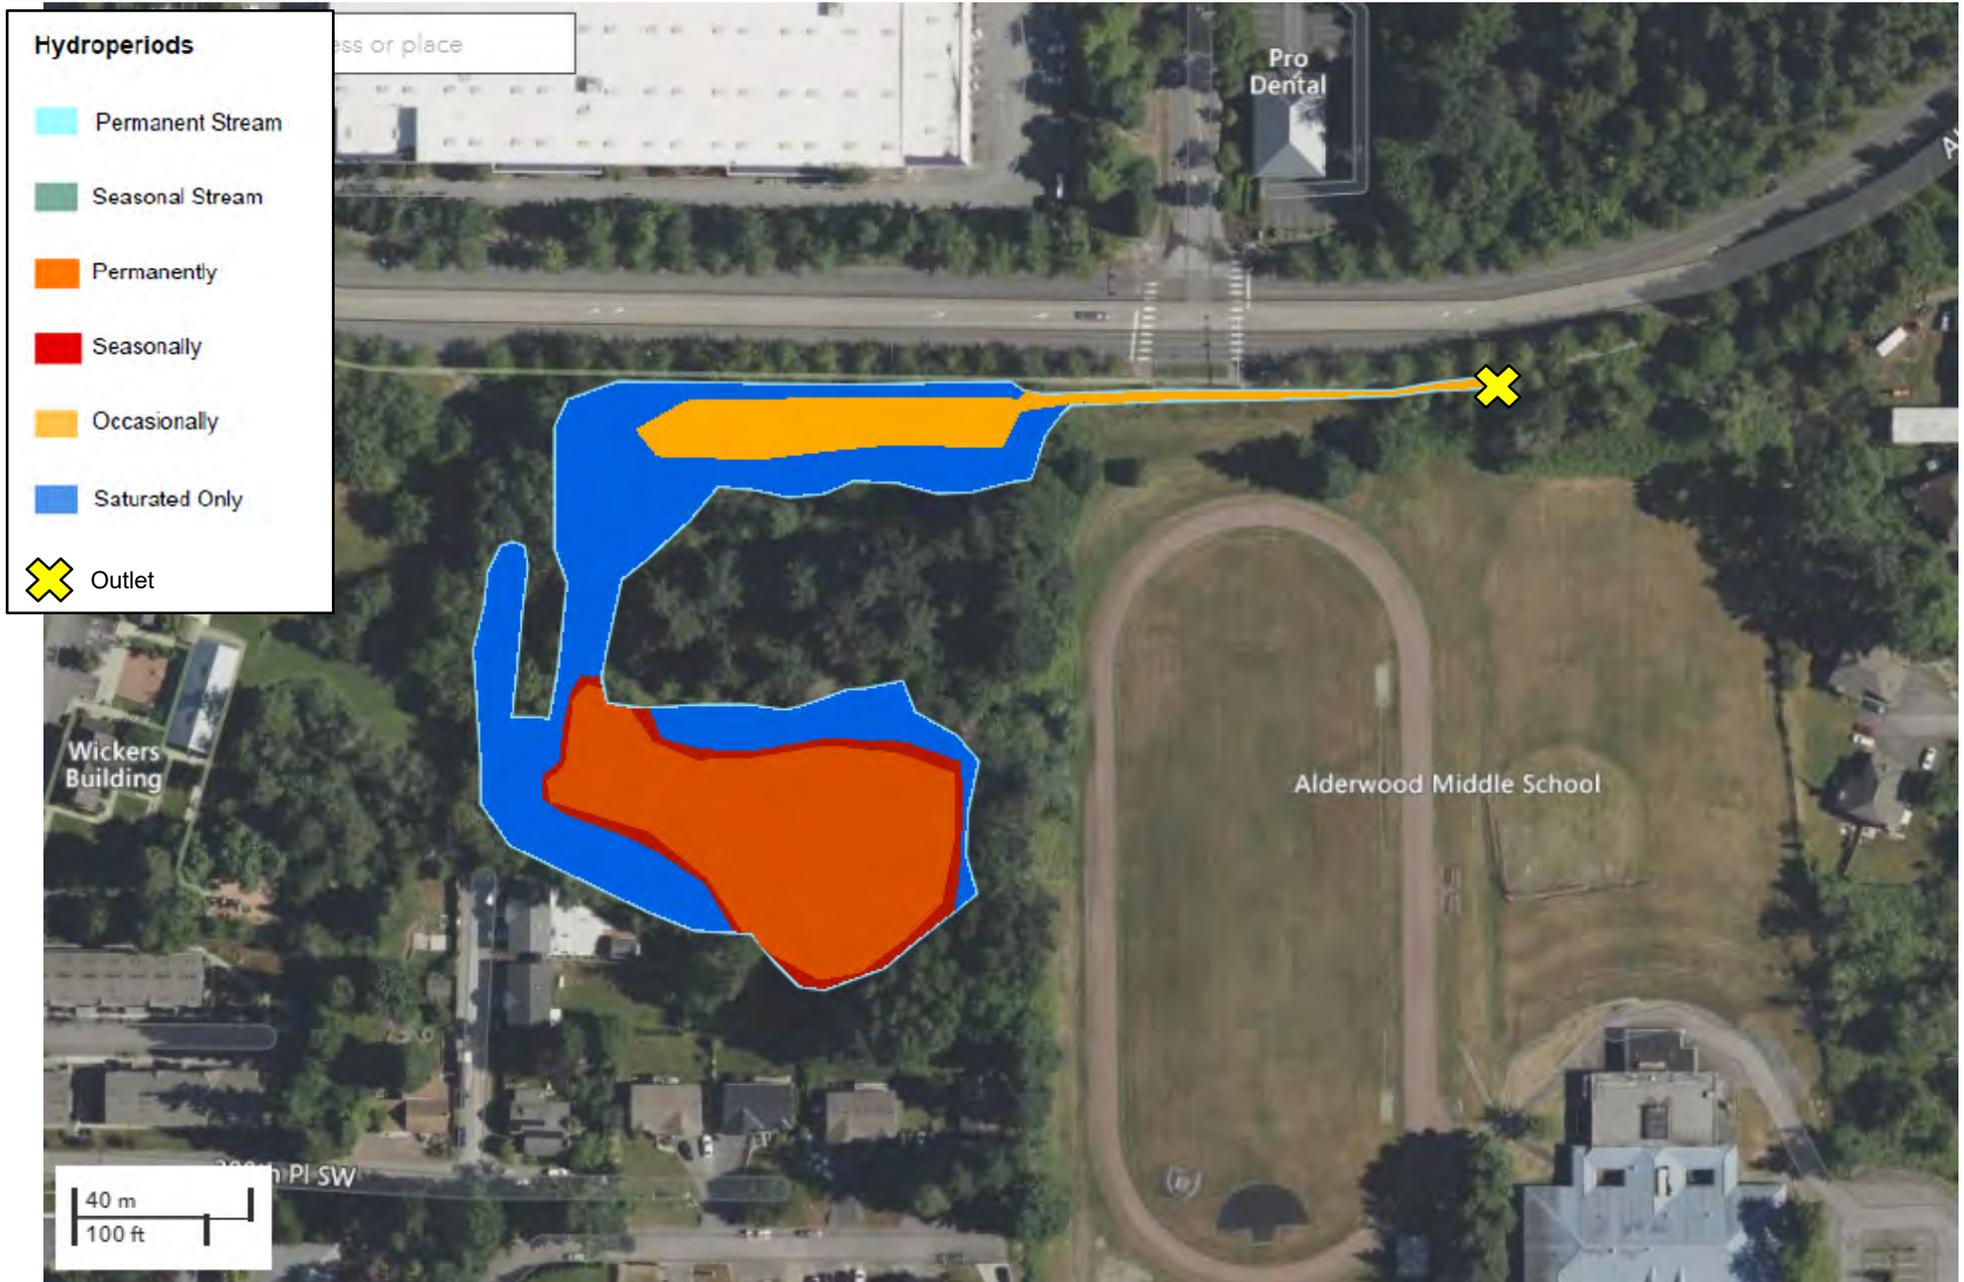
Rating Figure C-2
Hydroperiods

These figures were generated using the Washington State Department of Ecology "Washington Tool for Online Rating (WATOR)" web tool.

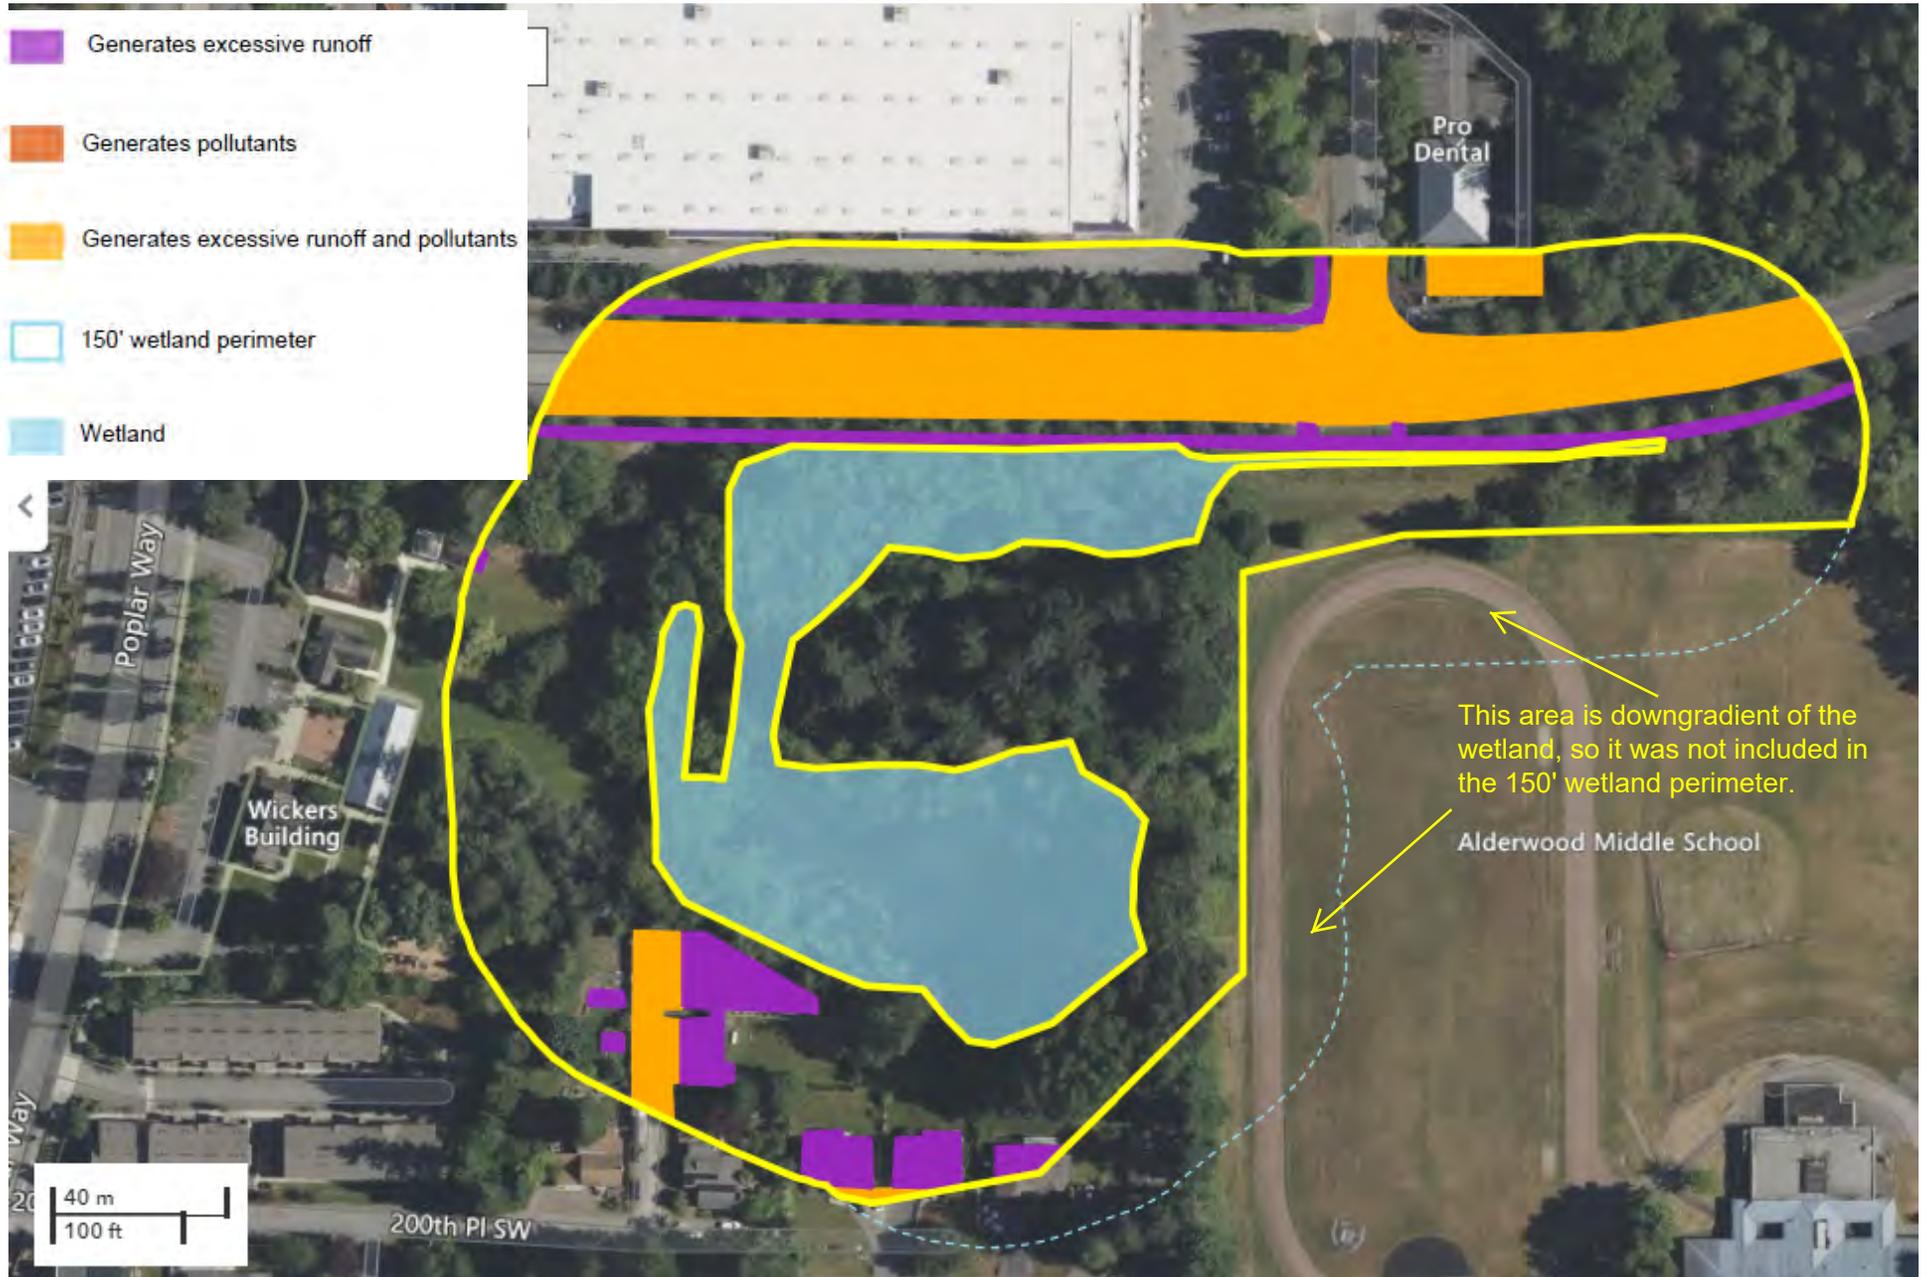
Rating Figure C-3
Land Use Within 150 Feet

These figures were generated using the Washington State Department of Ecology "Washington Tool for Online Rating (WATOR)" web tool.
