REVISED CRITICAL AREAS REPORT
New Middle School
CITY OF LYNNWOOD, WASHINGTON

Subject: REVISED CRITICAL AREAS REPORT, NEW MIDDLE SCHOOL, CITY OF
LYNNWOOD, WASHINGTON

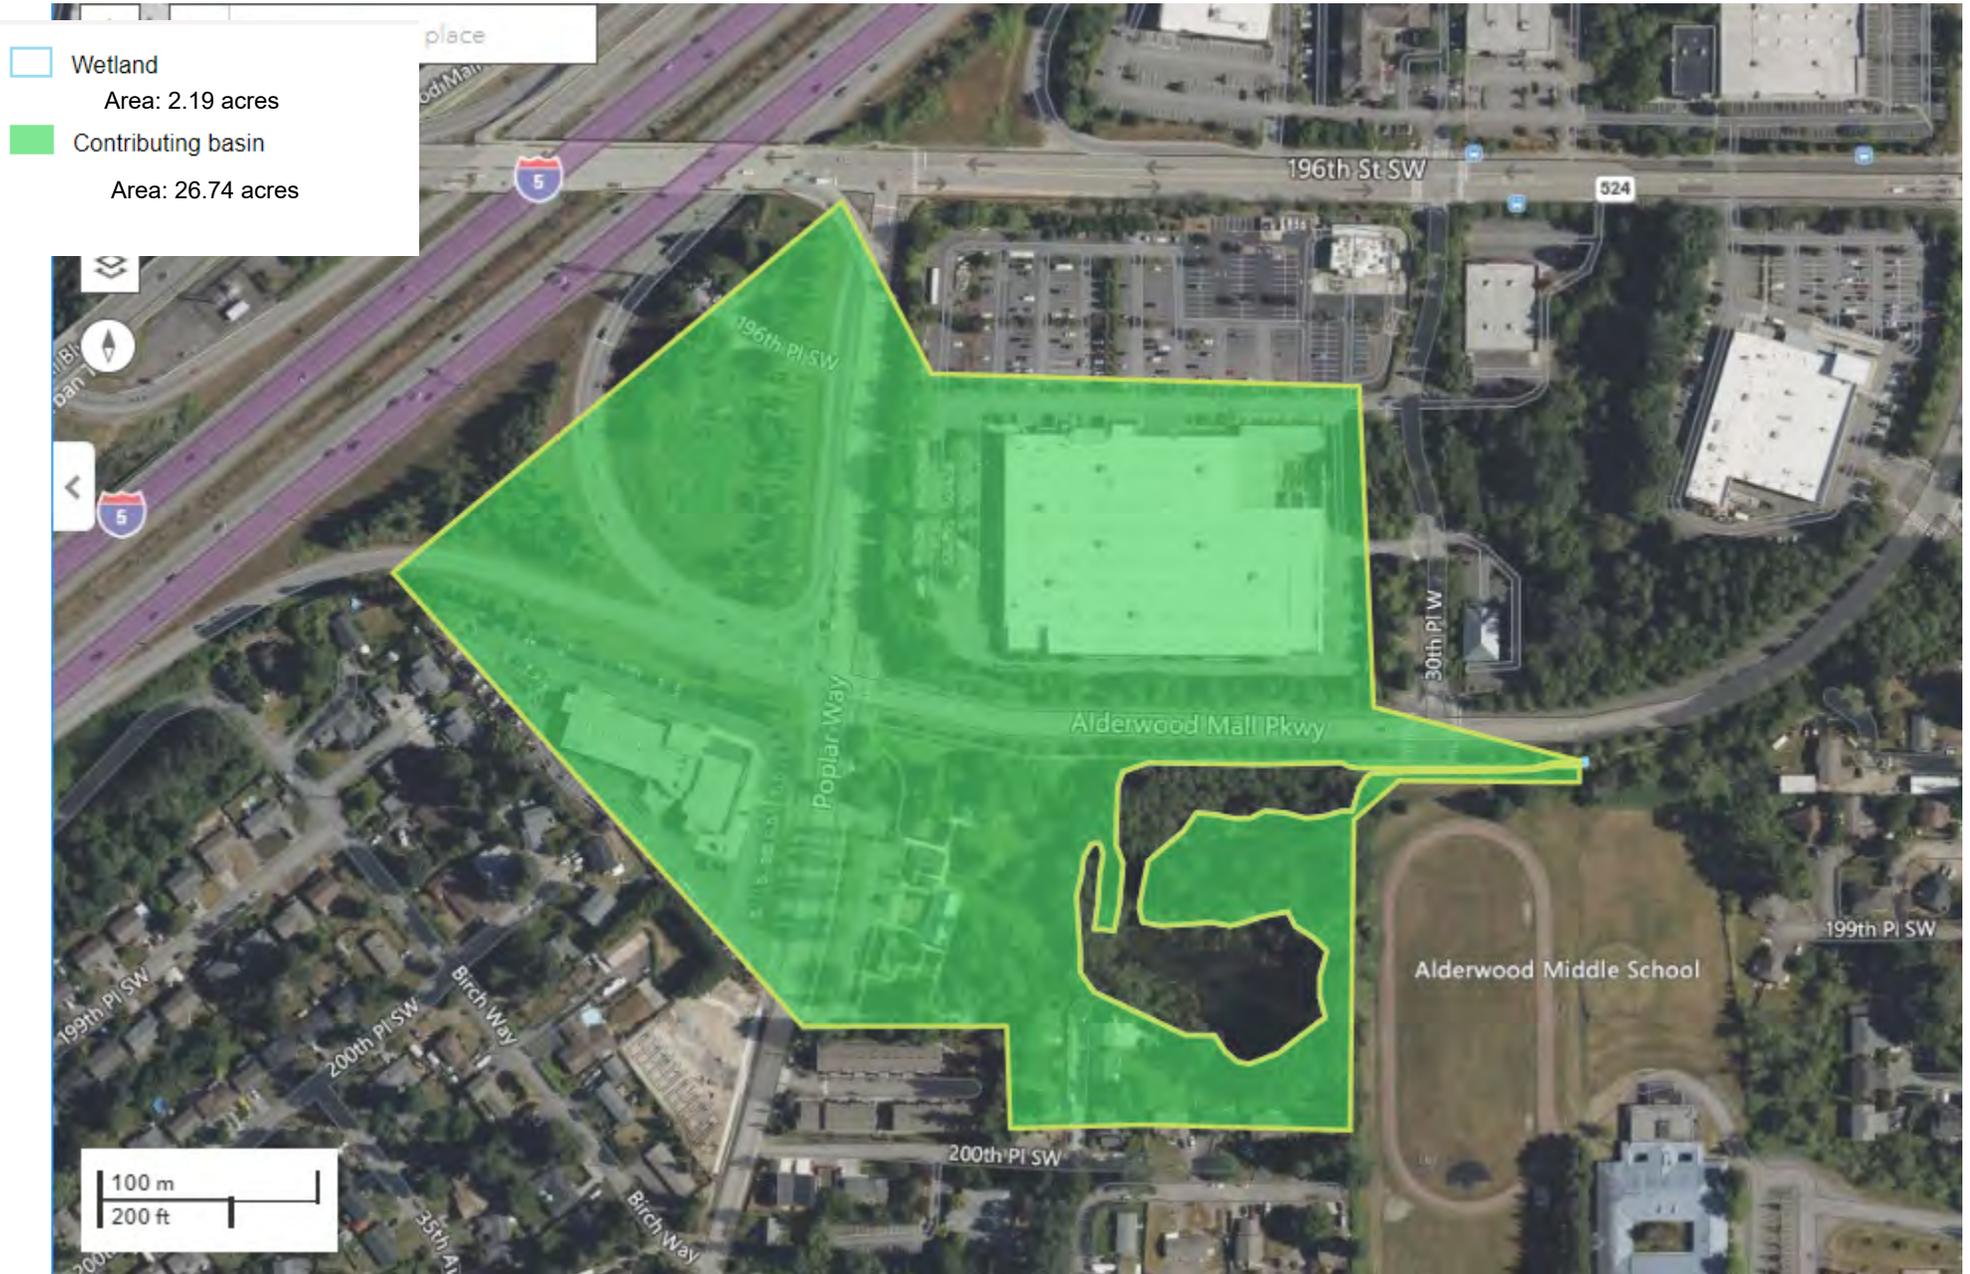
Rating Figure C-4
Contributing Basin

N
These figures were generated using the Washington State Department of Ecology "Washington Tool for Online Rating (WATOR)" web tool.

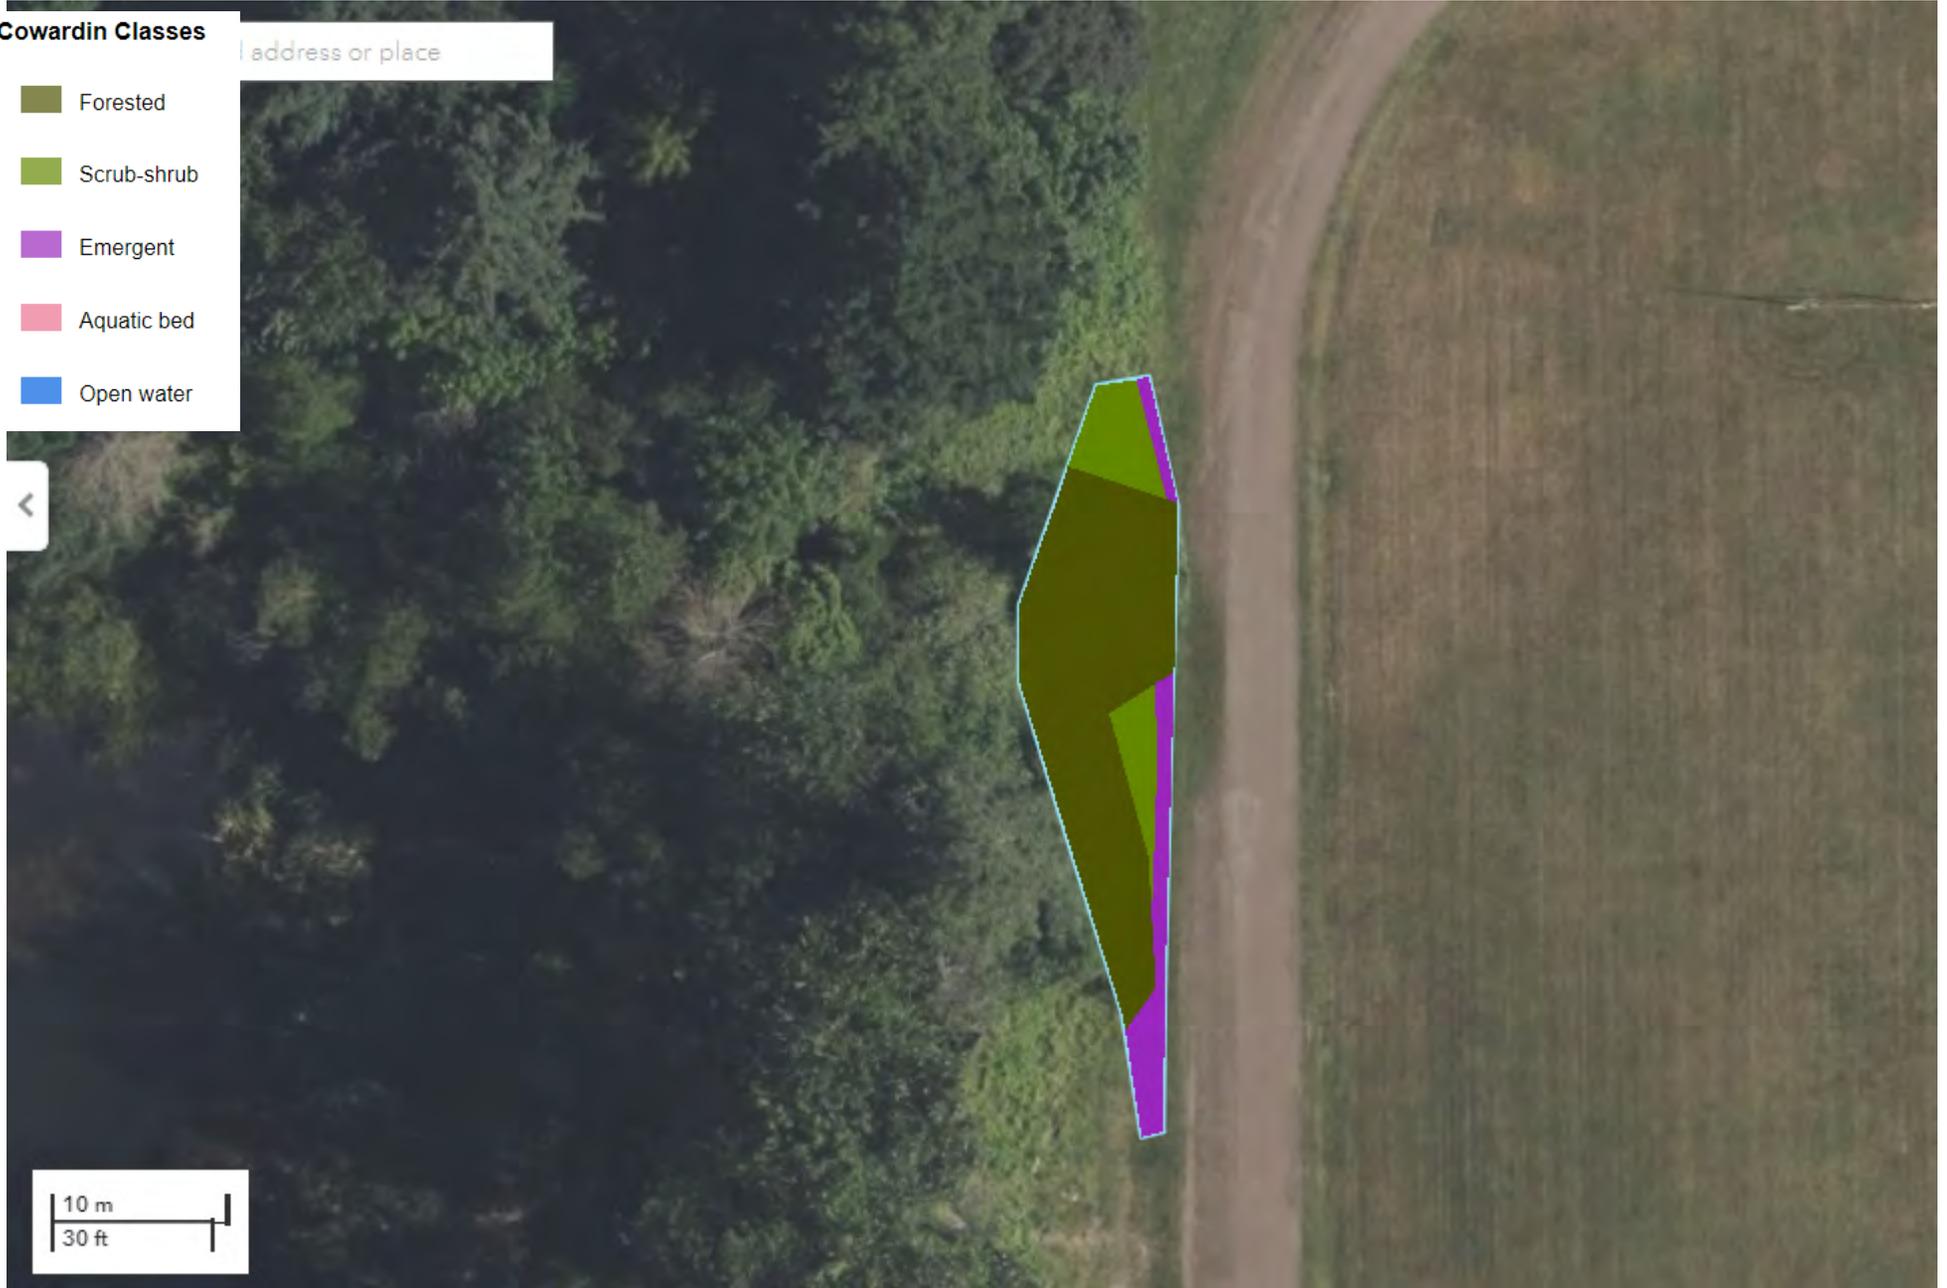
Rating Figure D-1
Cowardin Classes

These figures were generated using the Washington State Department of Ecology "Washington Tool for Online Rating (WATOR)" web tool.

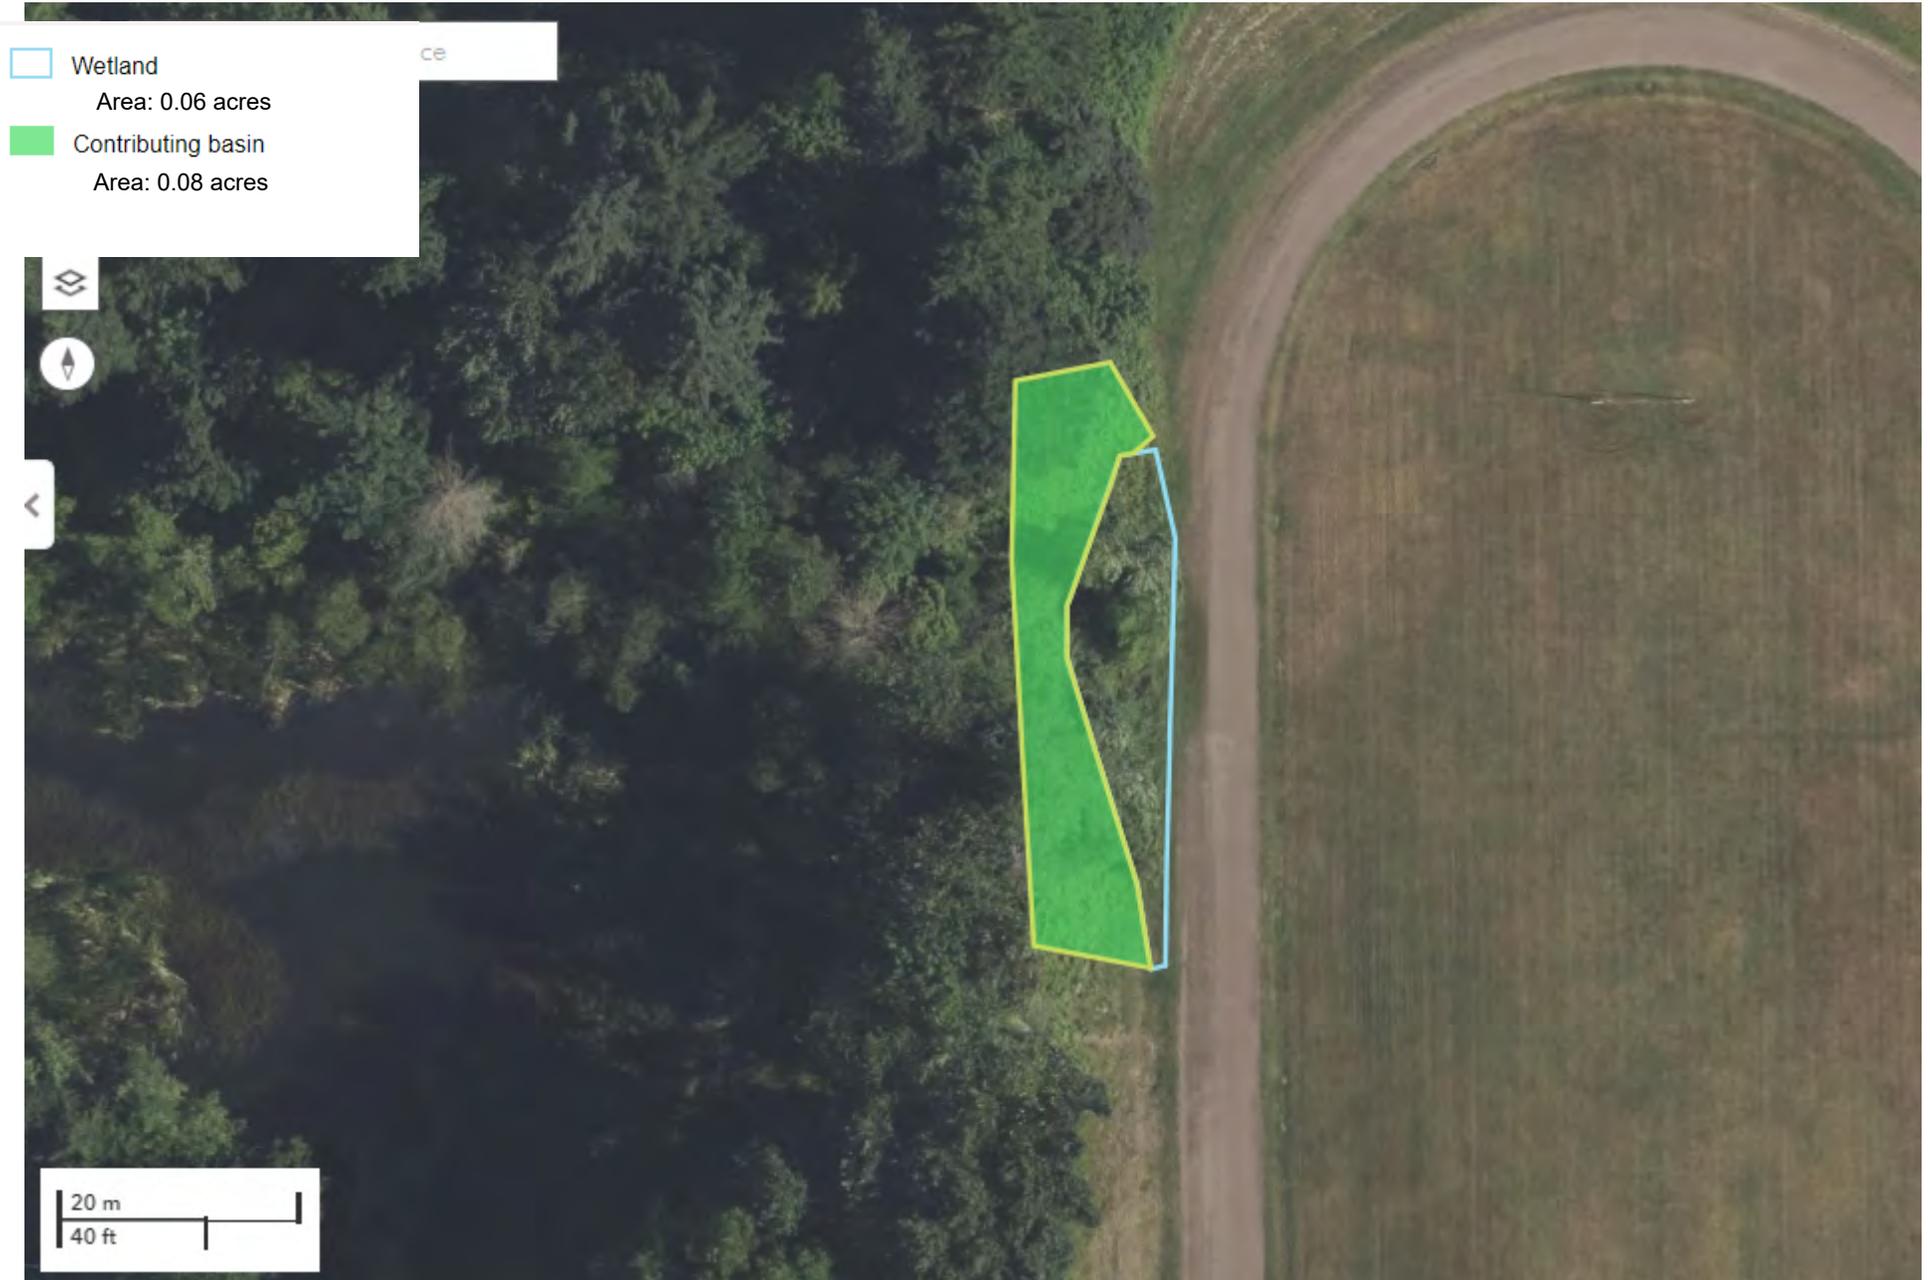
Rating Figure D-4
Contributing Basin

These figures were generated using the Washington State Department of Ecology "Washington Tool for Online Rating (WATOR)" web tool.

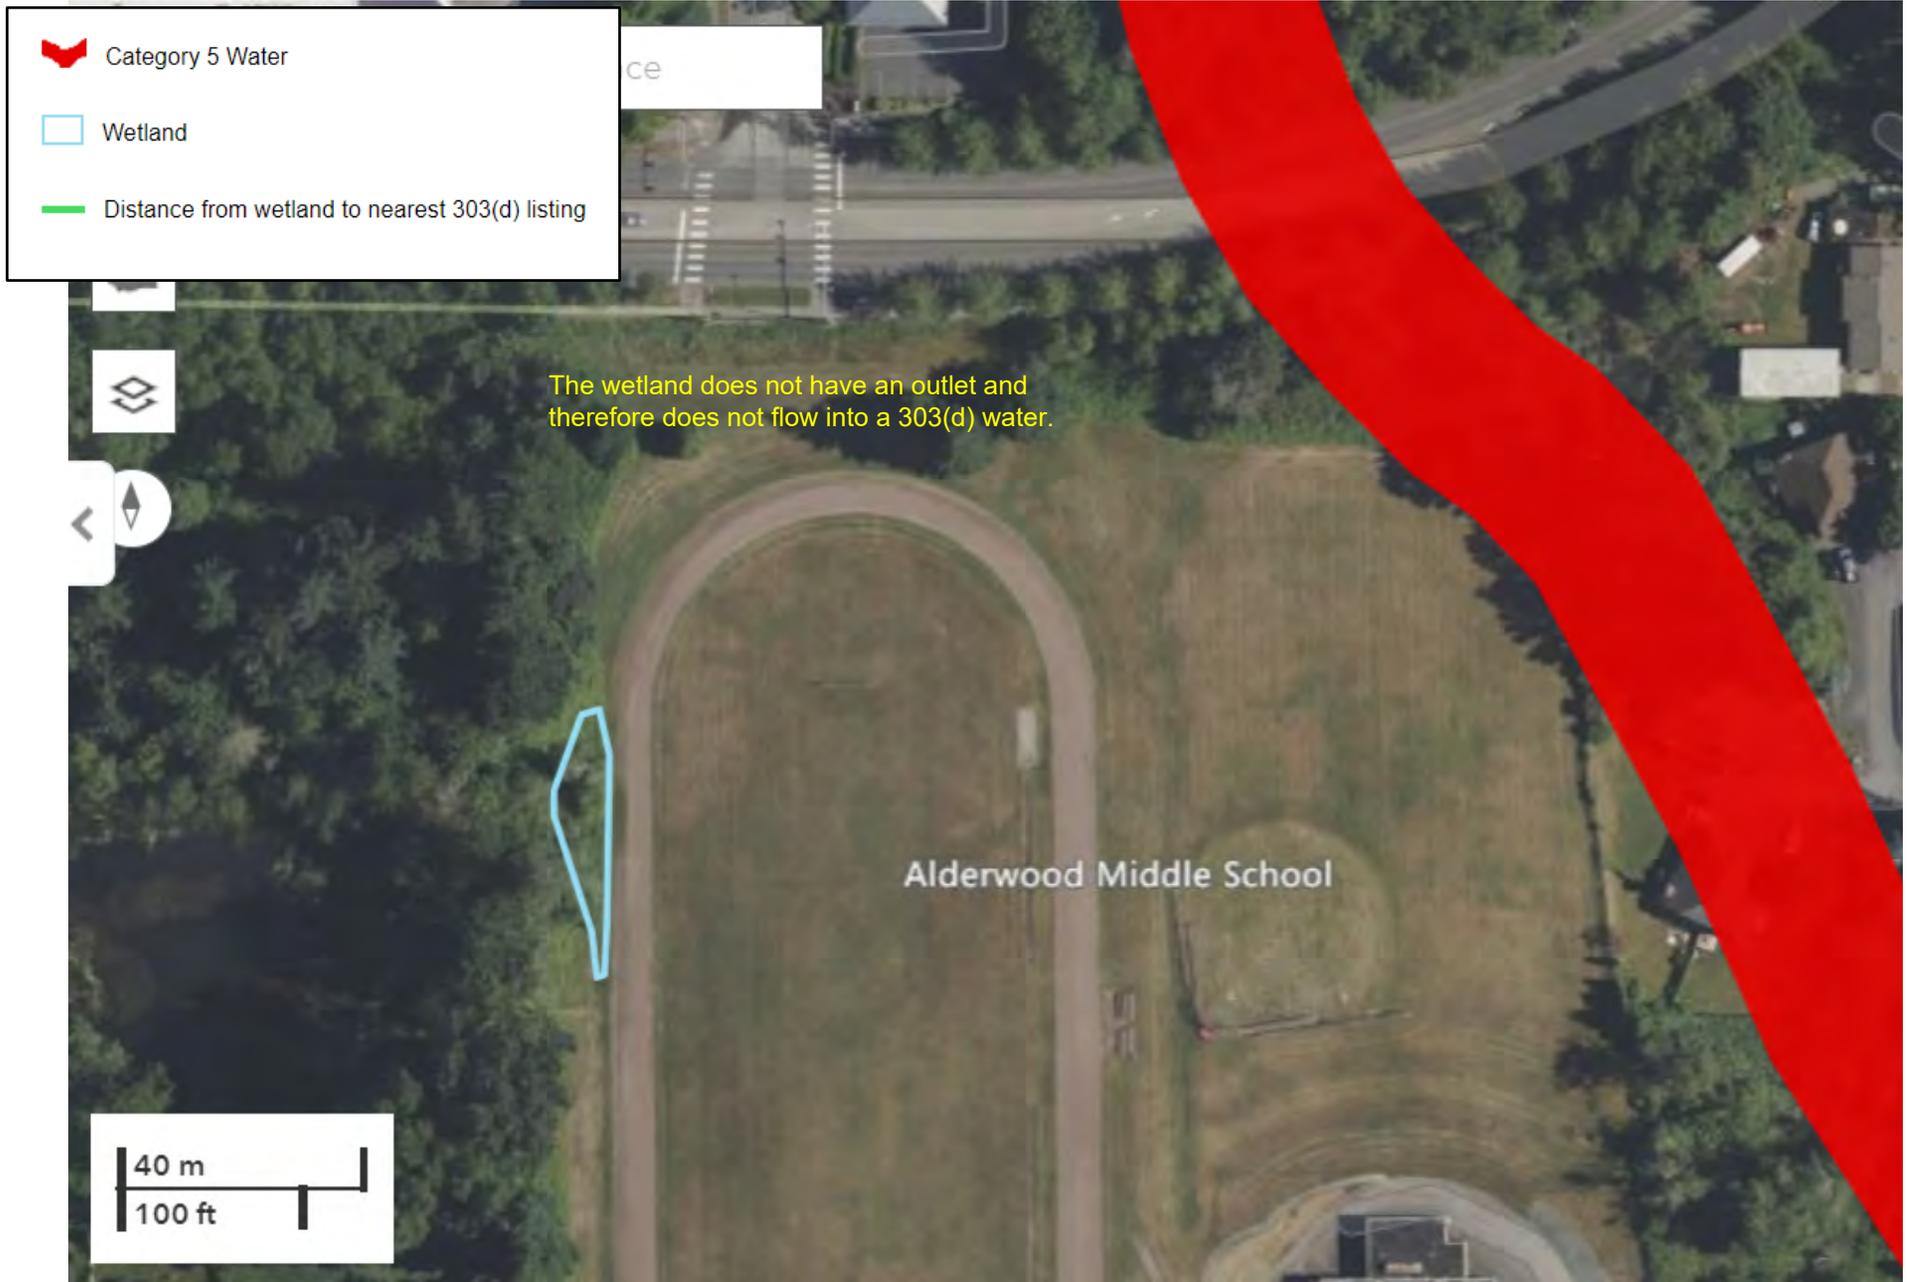
Rating Figure D-6
303d Listings

These figures were generated using the Washington State Department of Ecology "Washington Tool for Online Rating (WATOR)" web tool.

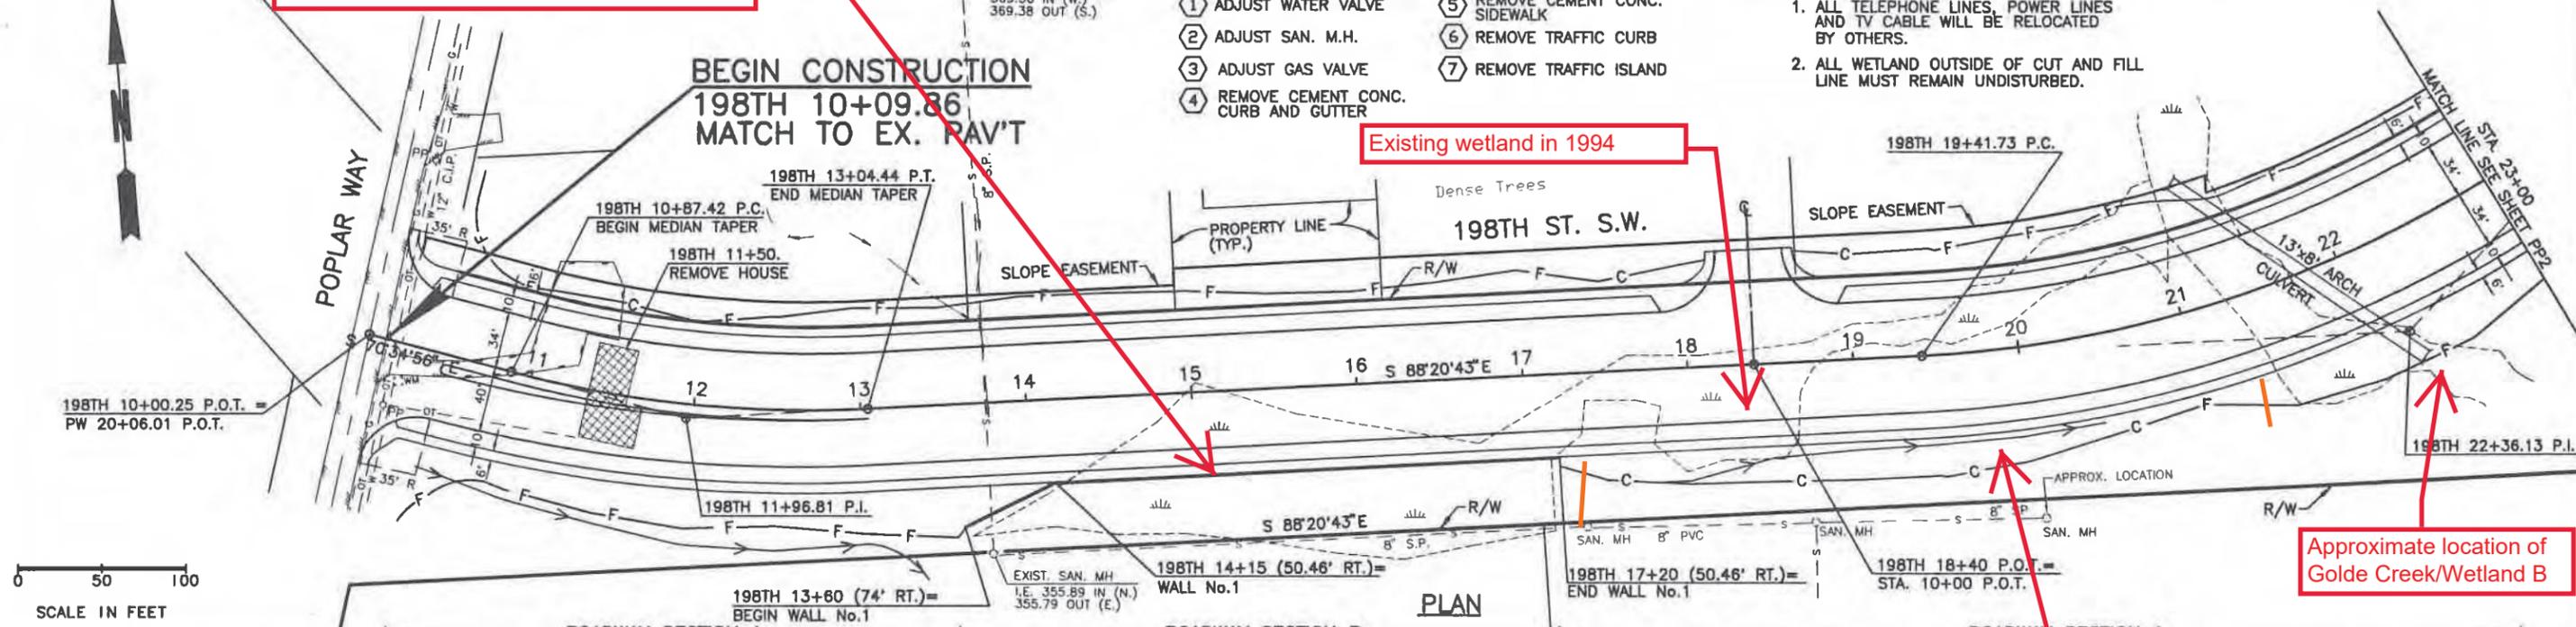
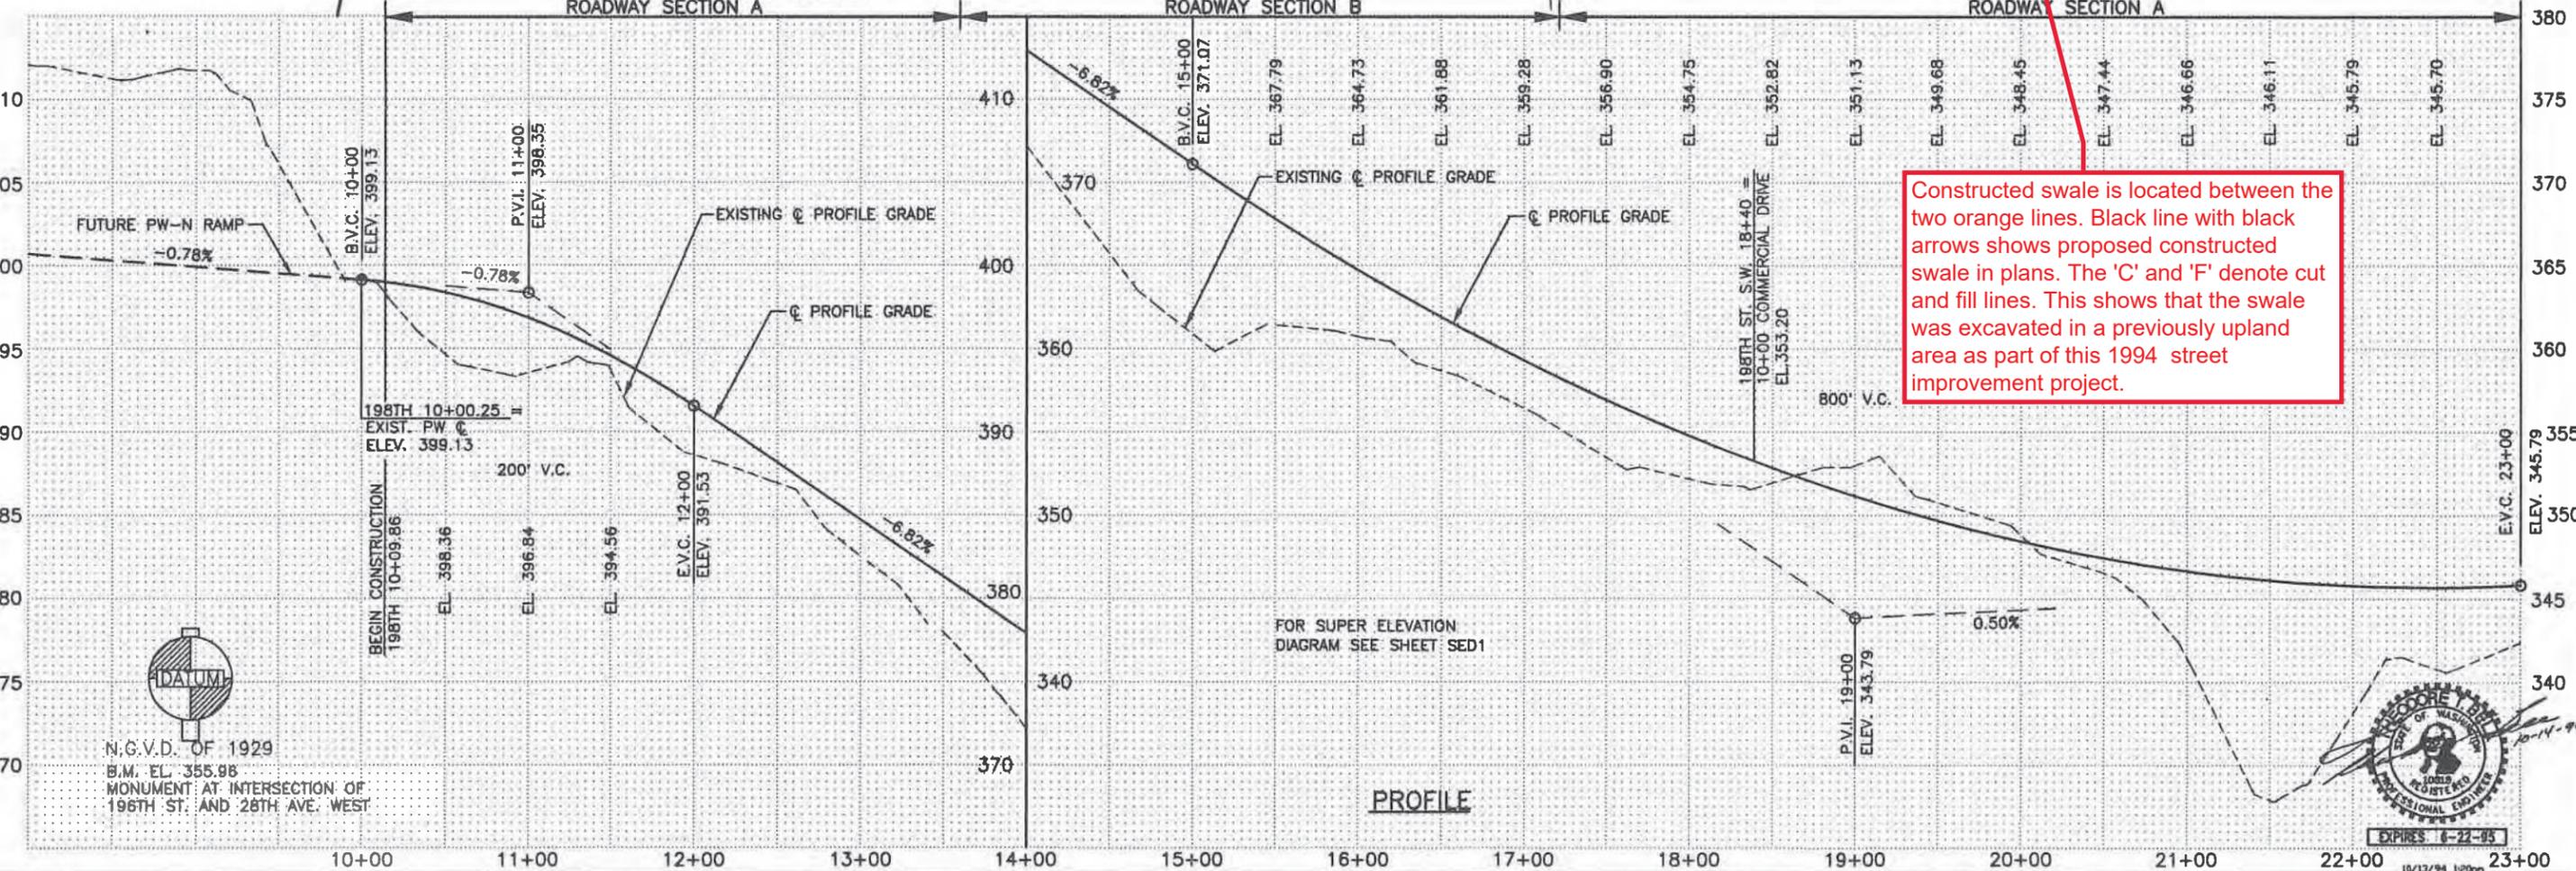
Constructed swale is located between the two orange lines. Black line with black arrows shows proposed constructed swale in plans. The 'C' and 'F' denote cut and fill lines. This shows that the swale was excavated in a previously upland area as part of this 1994 street improvement project.

The 1994 design sheet excerpt in Appendix D also contains plan sheet 11, the plan and profile of 198th Street SW (now Alderwood Mall Parkway) (Bell Walker Engineers, 1994). Design sheet 11 shows the proposed cut and fill lines associated with the construction of Alderwood Mall Parkway, including the proposed (now existing) wall along the northern boundary of Wetland C. At the wall's eastern end (where the existing swale starts), the plan sheets show the start of a "cut" and proposed ditch that aligns with the existing swale. Sheet 11 also depicts the existing wetlands in 1994, which documents that the swale was constructed in an upland area.

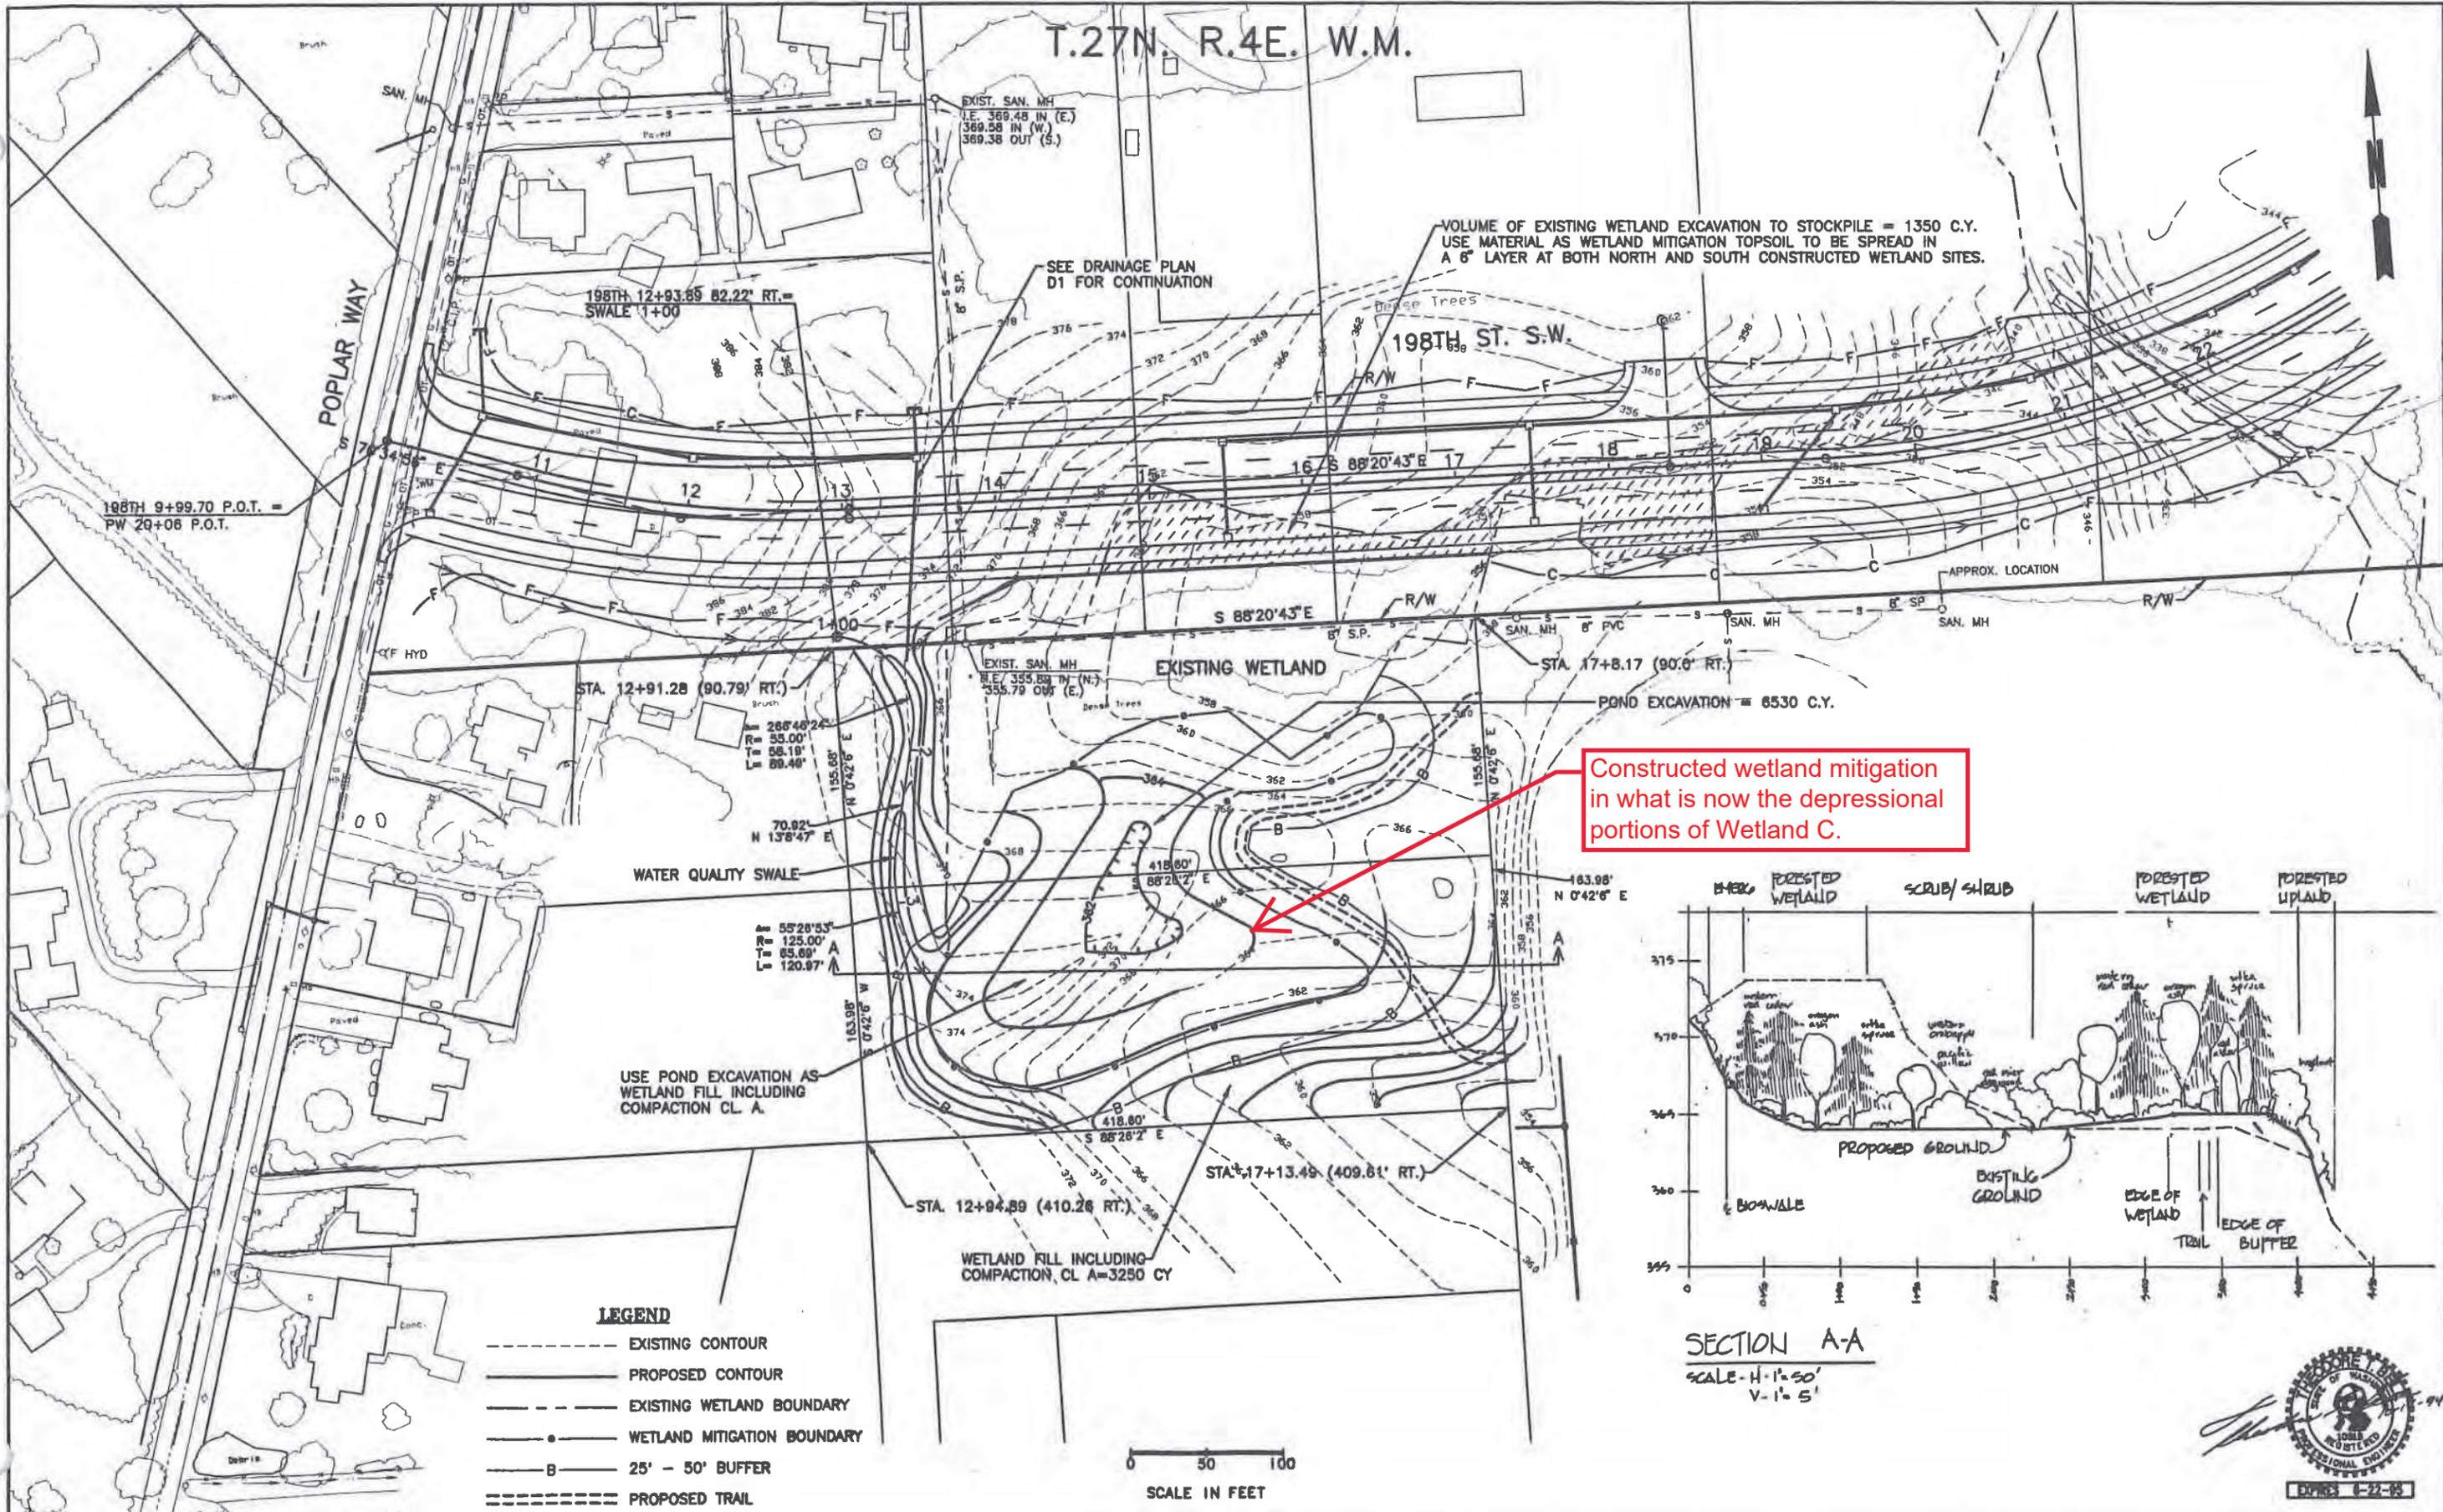
Constructed wetland mitigation in what is now the depressional portions of Wetland C.

The City provided the District with the design set for the 1994 28th Avenue West and 198th Street SW (now Alderwood Mall Parkway) Street Improvements project (Bell Walker Engineers, 1994). Appendix D contains an excerpt of the design sheets. The design sheet excerpt includes a grading plan and planting plan that document that the majority of Wetland C, specifically the southern area, was constructed as compensatory mitigation to offset the Alderwood Mall Parkway construction impacts.
