# Critical Areas Report & Mitigation Plan

The School Project  
Lynnwood, Washington

5 January 2024  
(Revised 6 February 2026)

PREPARED BY:  
Wet.land, LLC  
206-309-8100  
[Wet.land](http://Wet.land)

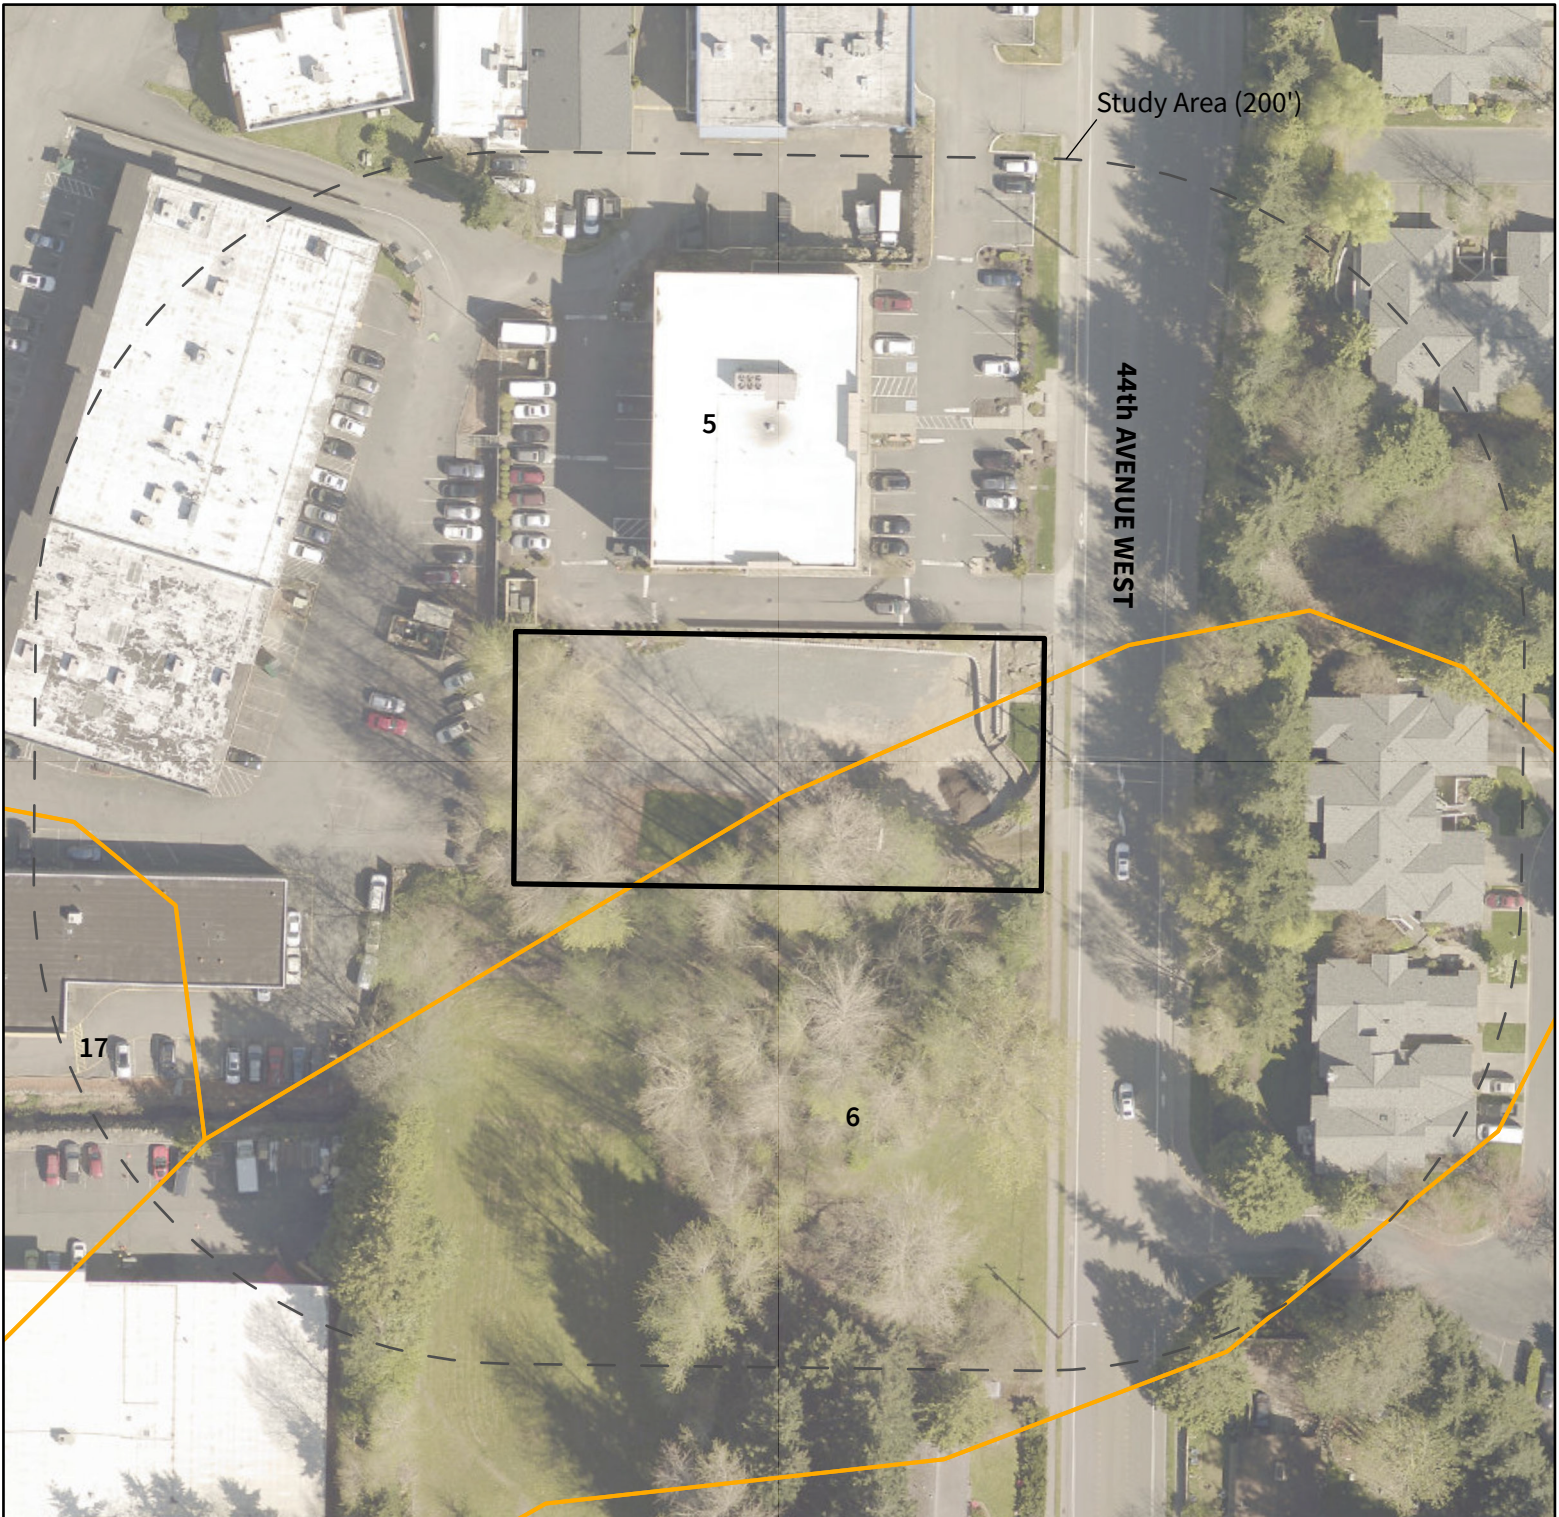
**FIGURE 2**

**Soil Map Units Within Study Area**

- 5 – Alderwood-Urban land complex, 2 to 8% slopes
  - 6 – Alderwood-Urban land complex, 8 to 15% slopes
  - 17 – Everett very gravelly sandy loam, 0 to 8% slopes
- None of the soil map units listed as hydric.

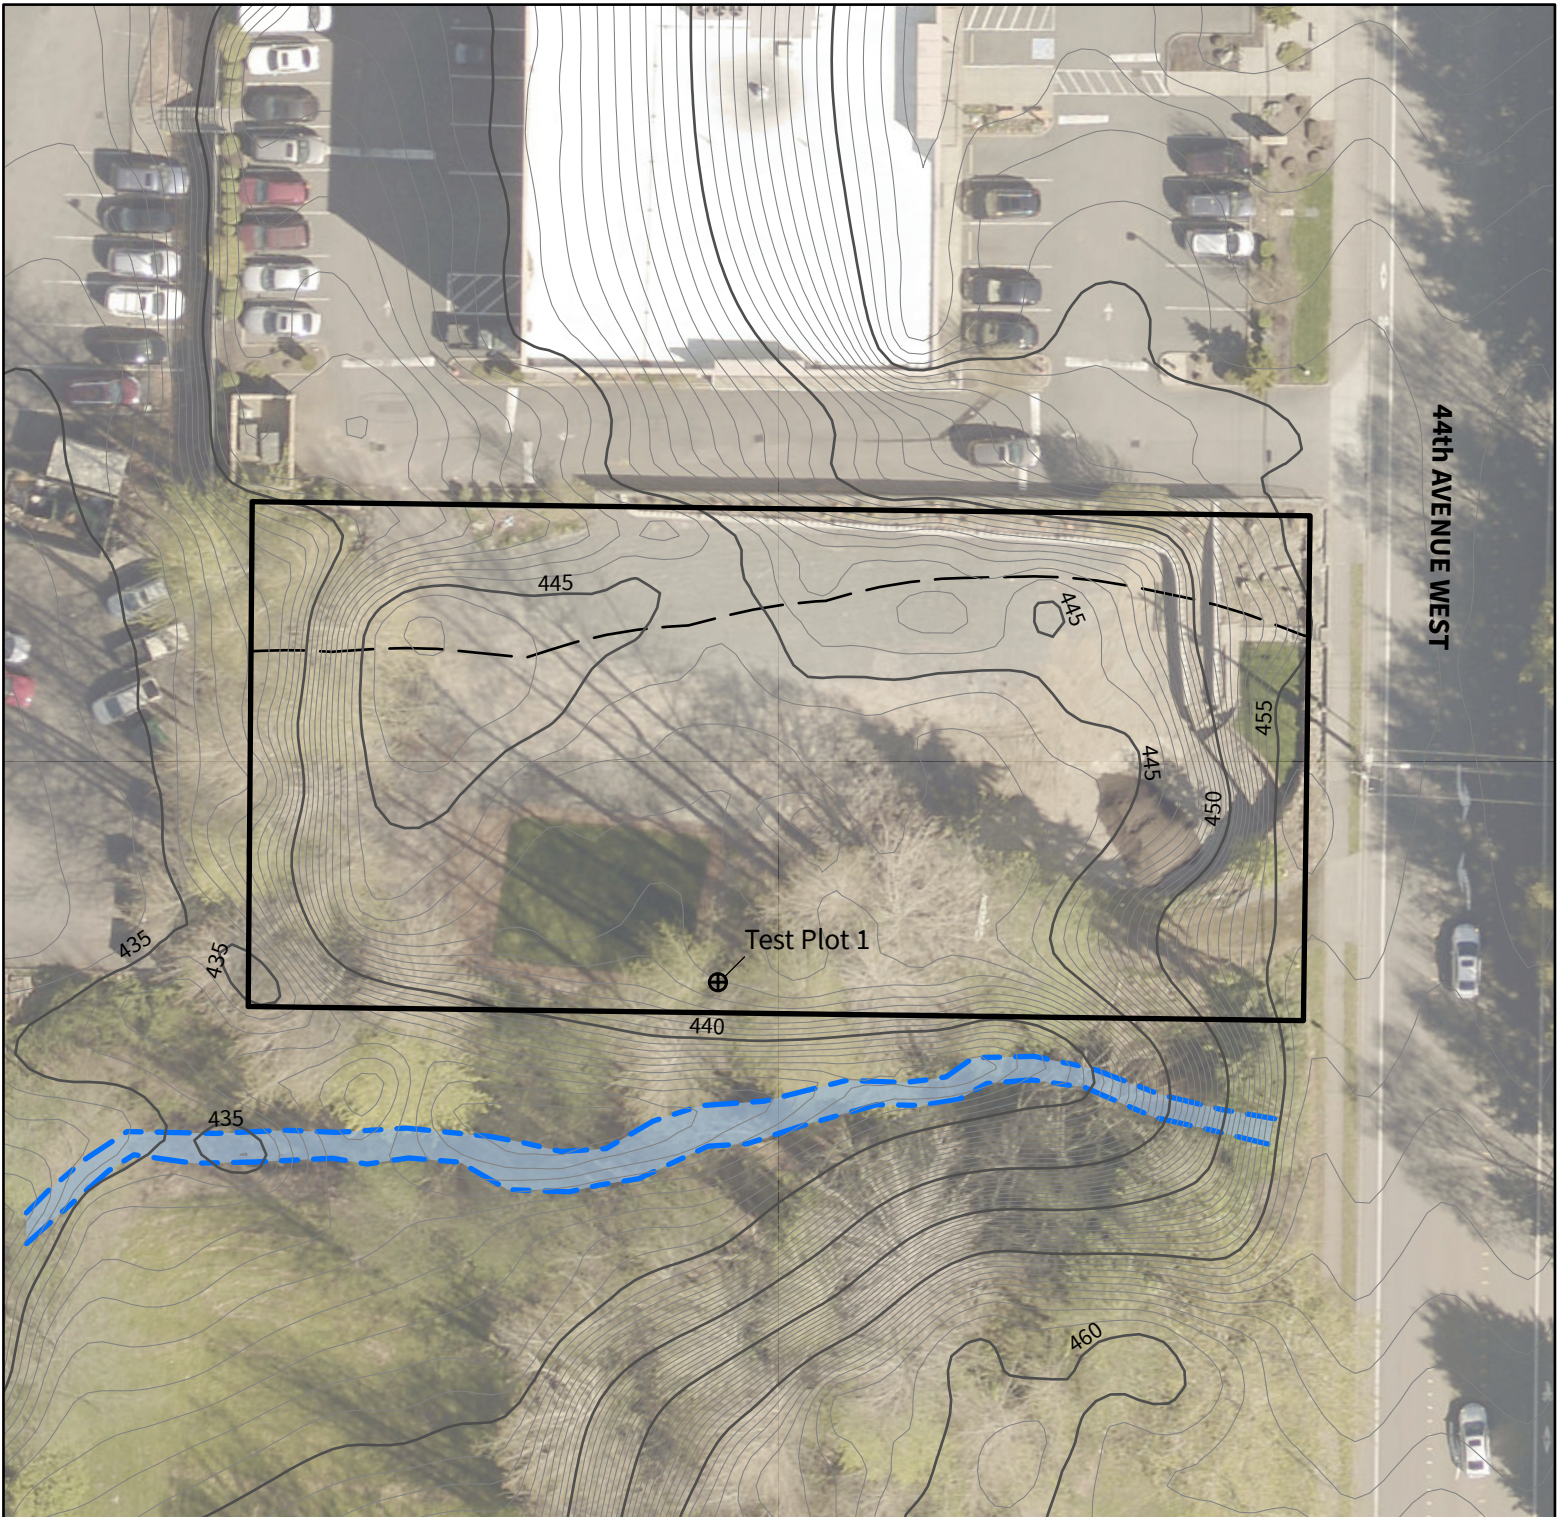
**FIGURE 4**

SOURCE: KING COUNTY AERIAL 2021, EXISTING CONDITIONS DRAWING BY FISHERIES ENGINEERS, INC.

**EXISTING CONDITIONS MAP**

No streams were delineated on the property. One stream, a tributary to Scriber Creek, was observed south of the property, and flowed to the west (**Appendix B, Figure 4**). The ordinary high water mark (OHWM) ranged from three (3) to five (5) feet wide with 80 – 90% cover of native trees. The stream habitat was primarily run type and several snags were observed in the stream corridor offsite. Based on available physical evidence, a stream type of fish-bearing is most appropriate for this stream based on the physical characteristics observed. Up and downstream connections were not evaluated as part of this study.

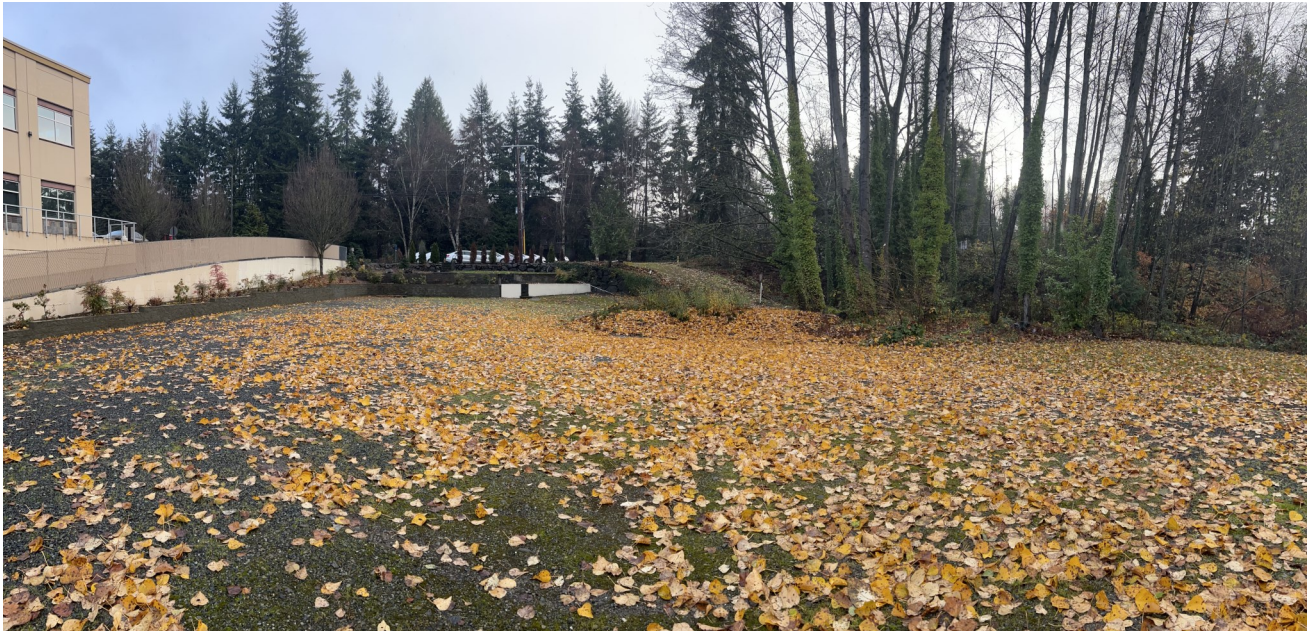
Panorama of Project Site, facing east.

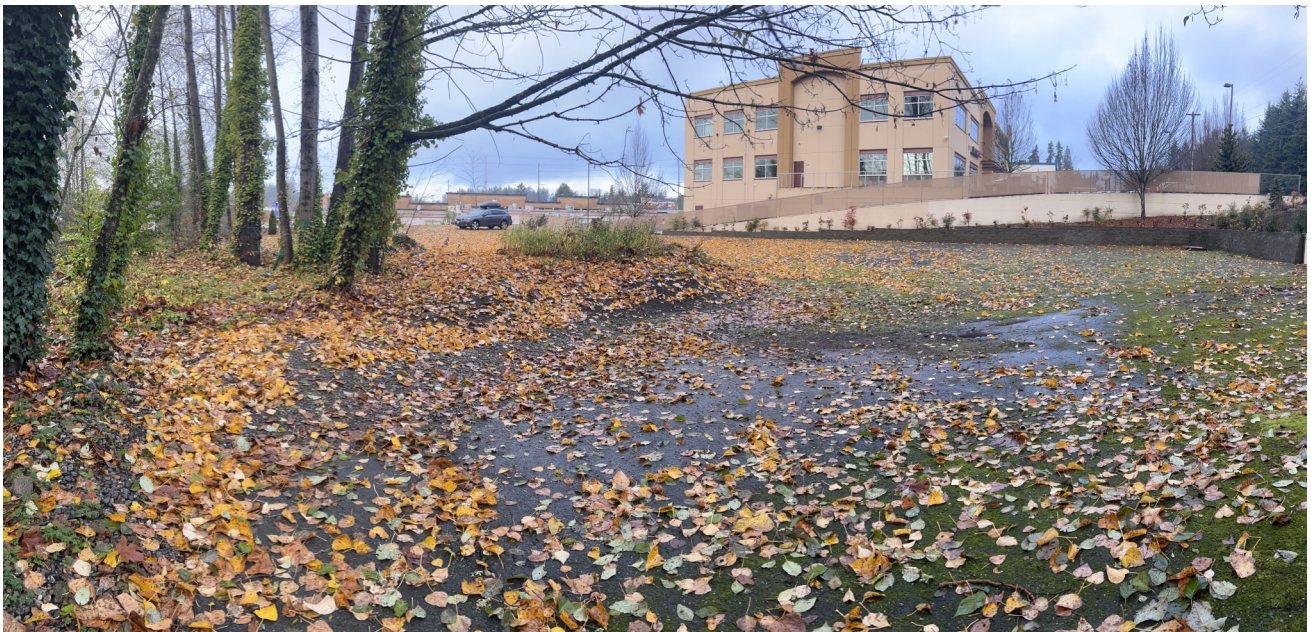
Panorama of Project Site, facing northwest.

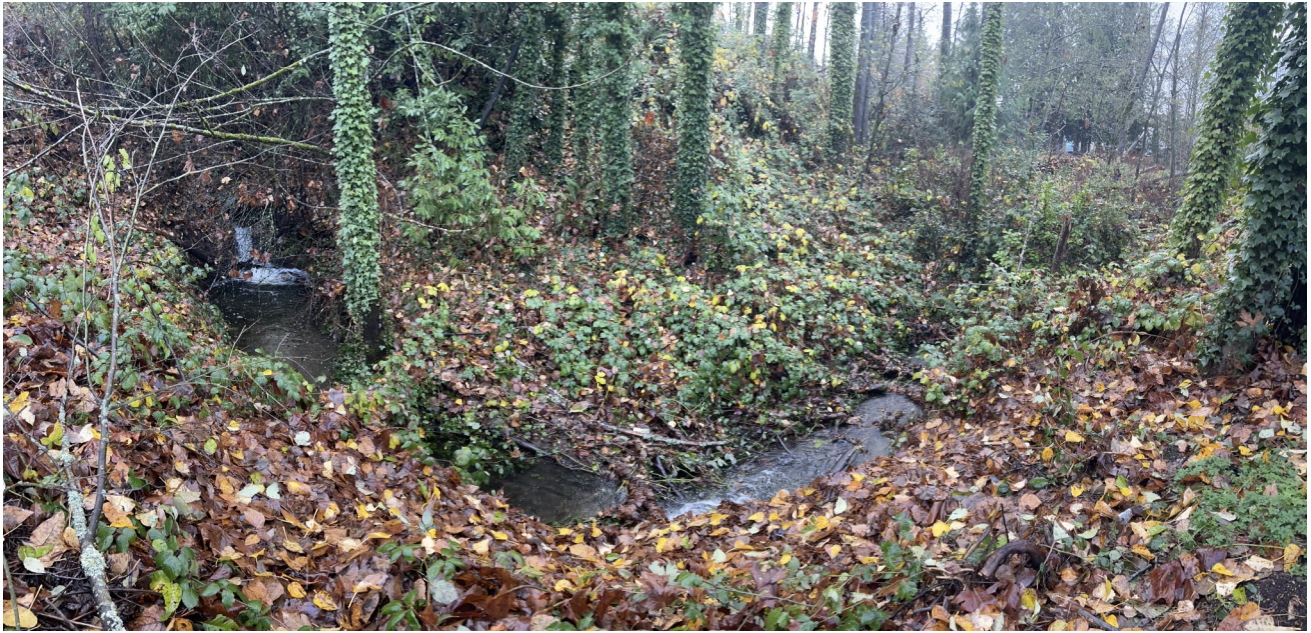
Panorama of off-site stream from the southeast corner of Project Site.

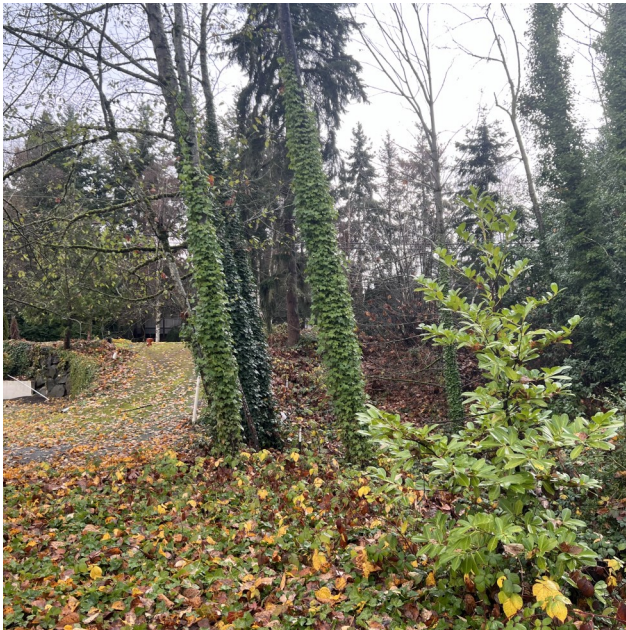
Existing native trees with understory of invasive species.

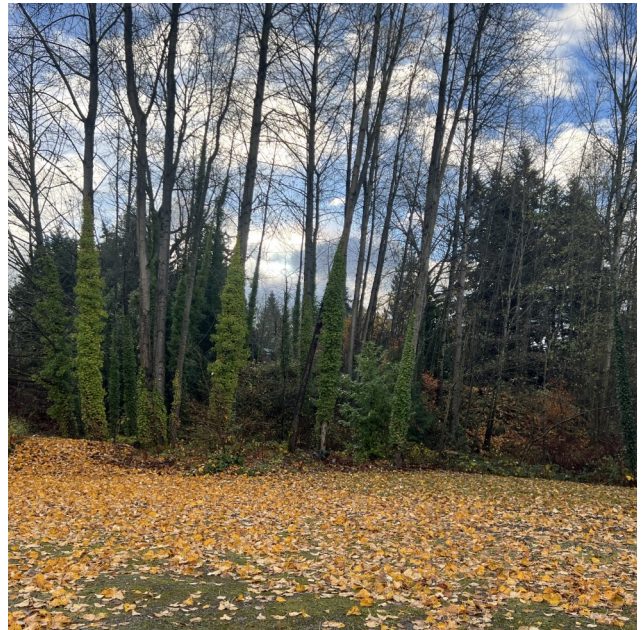
Existing trees onsite along south property line.

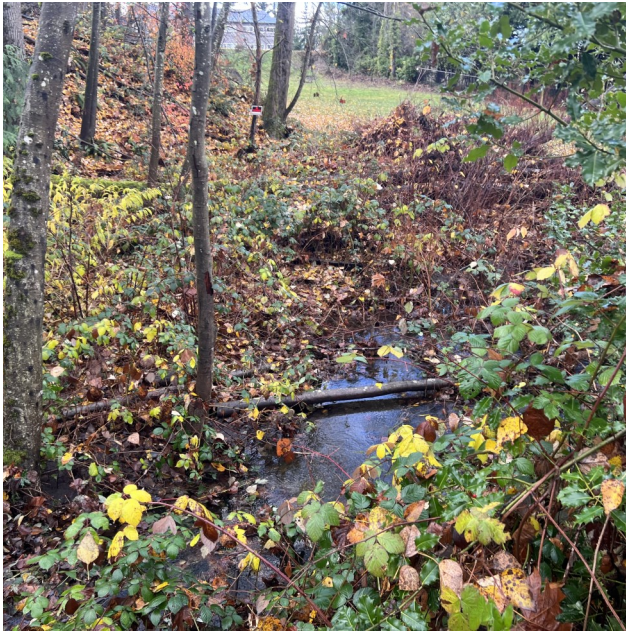
Photo of stream from Project Site.

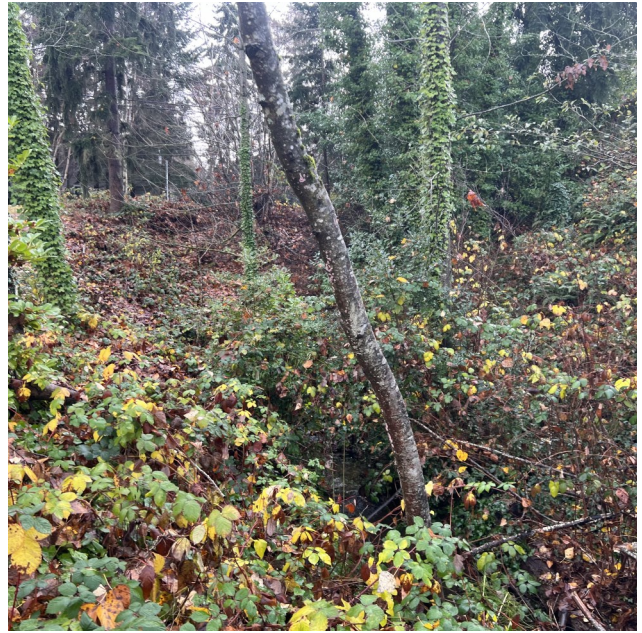
Riparian corridor vegetation, typical.

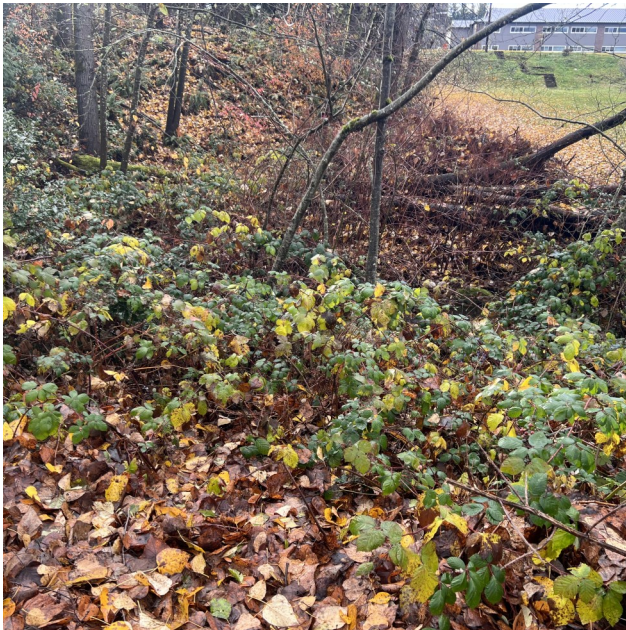
Riparian corridor vegetation, typical.

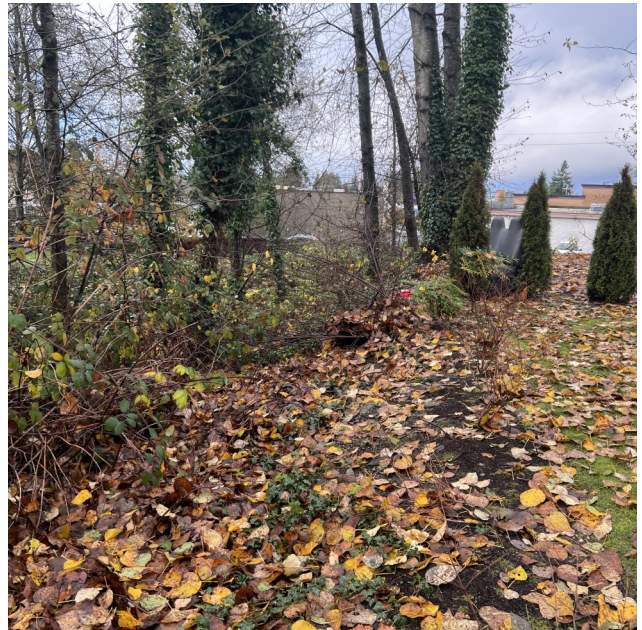
Location of Test Plot 1.

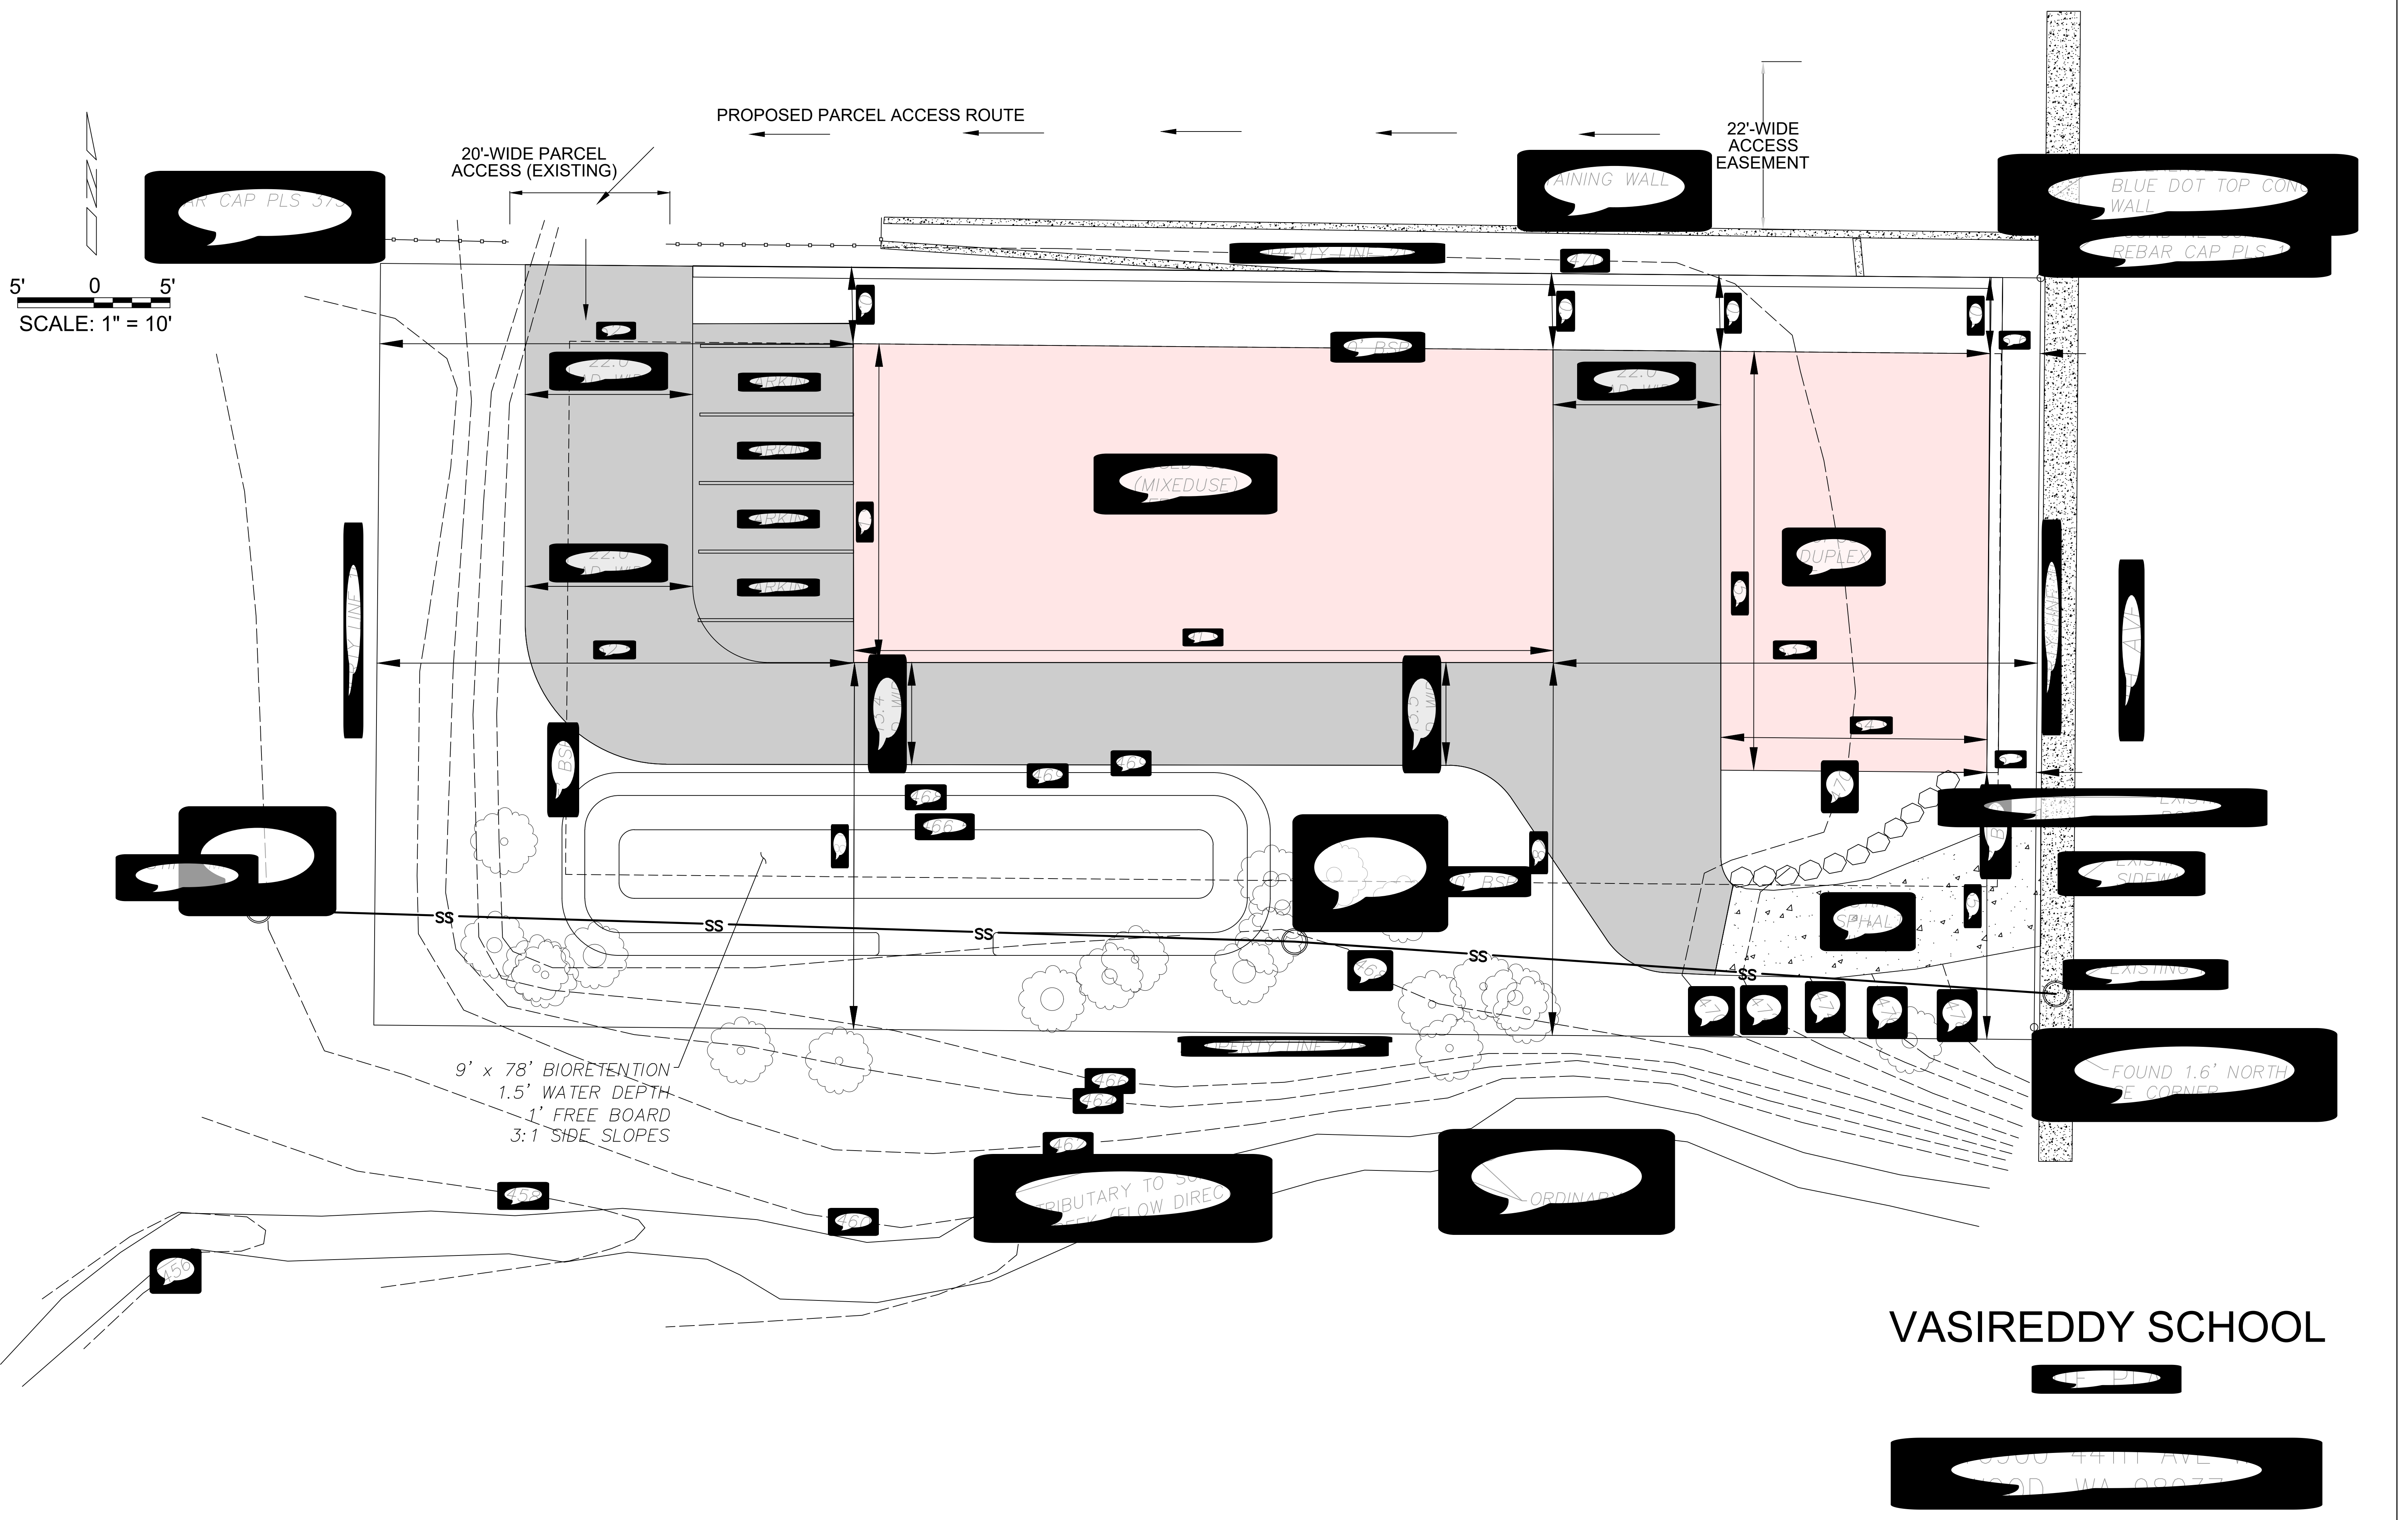
Site Plan

PROPOSED PARCEL ACCESS ROUTE

20'-WIDE PARCEL ACCESS (EXISTING)
