Lynndale Elementary School Assessment Finding

Lynndale ES

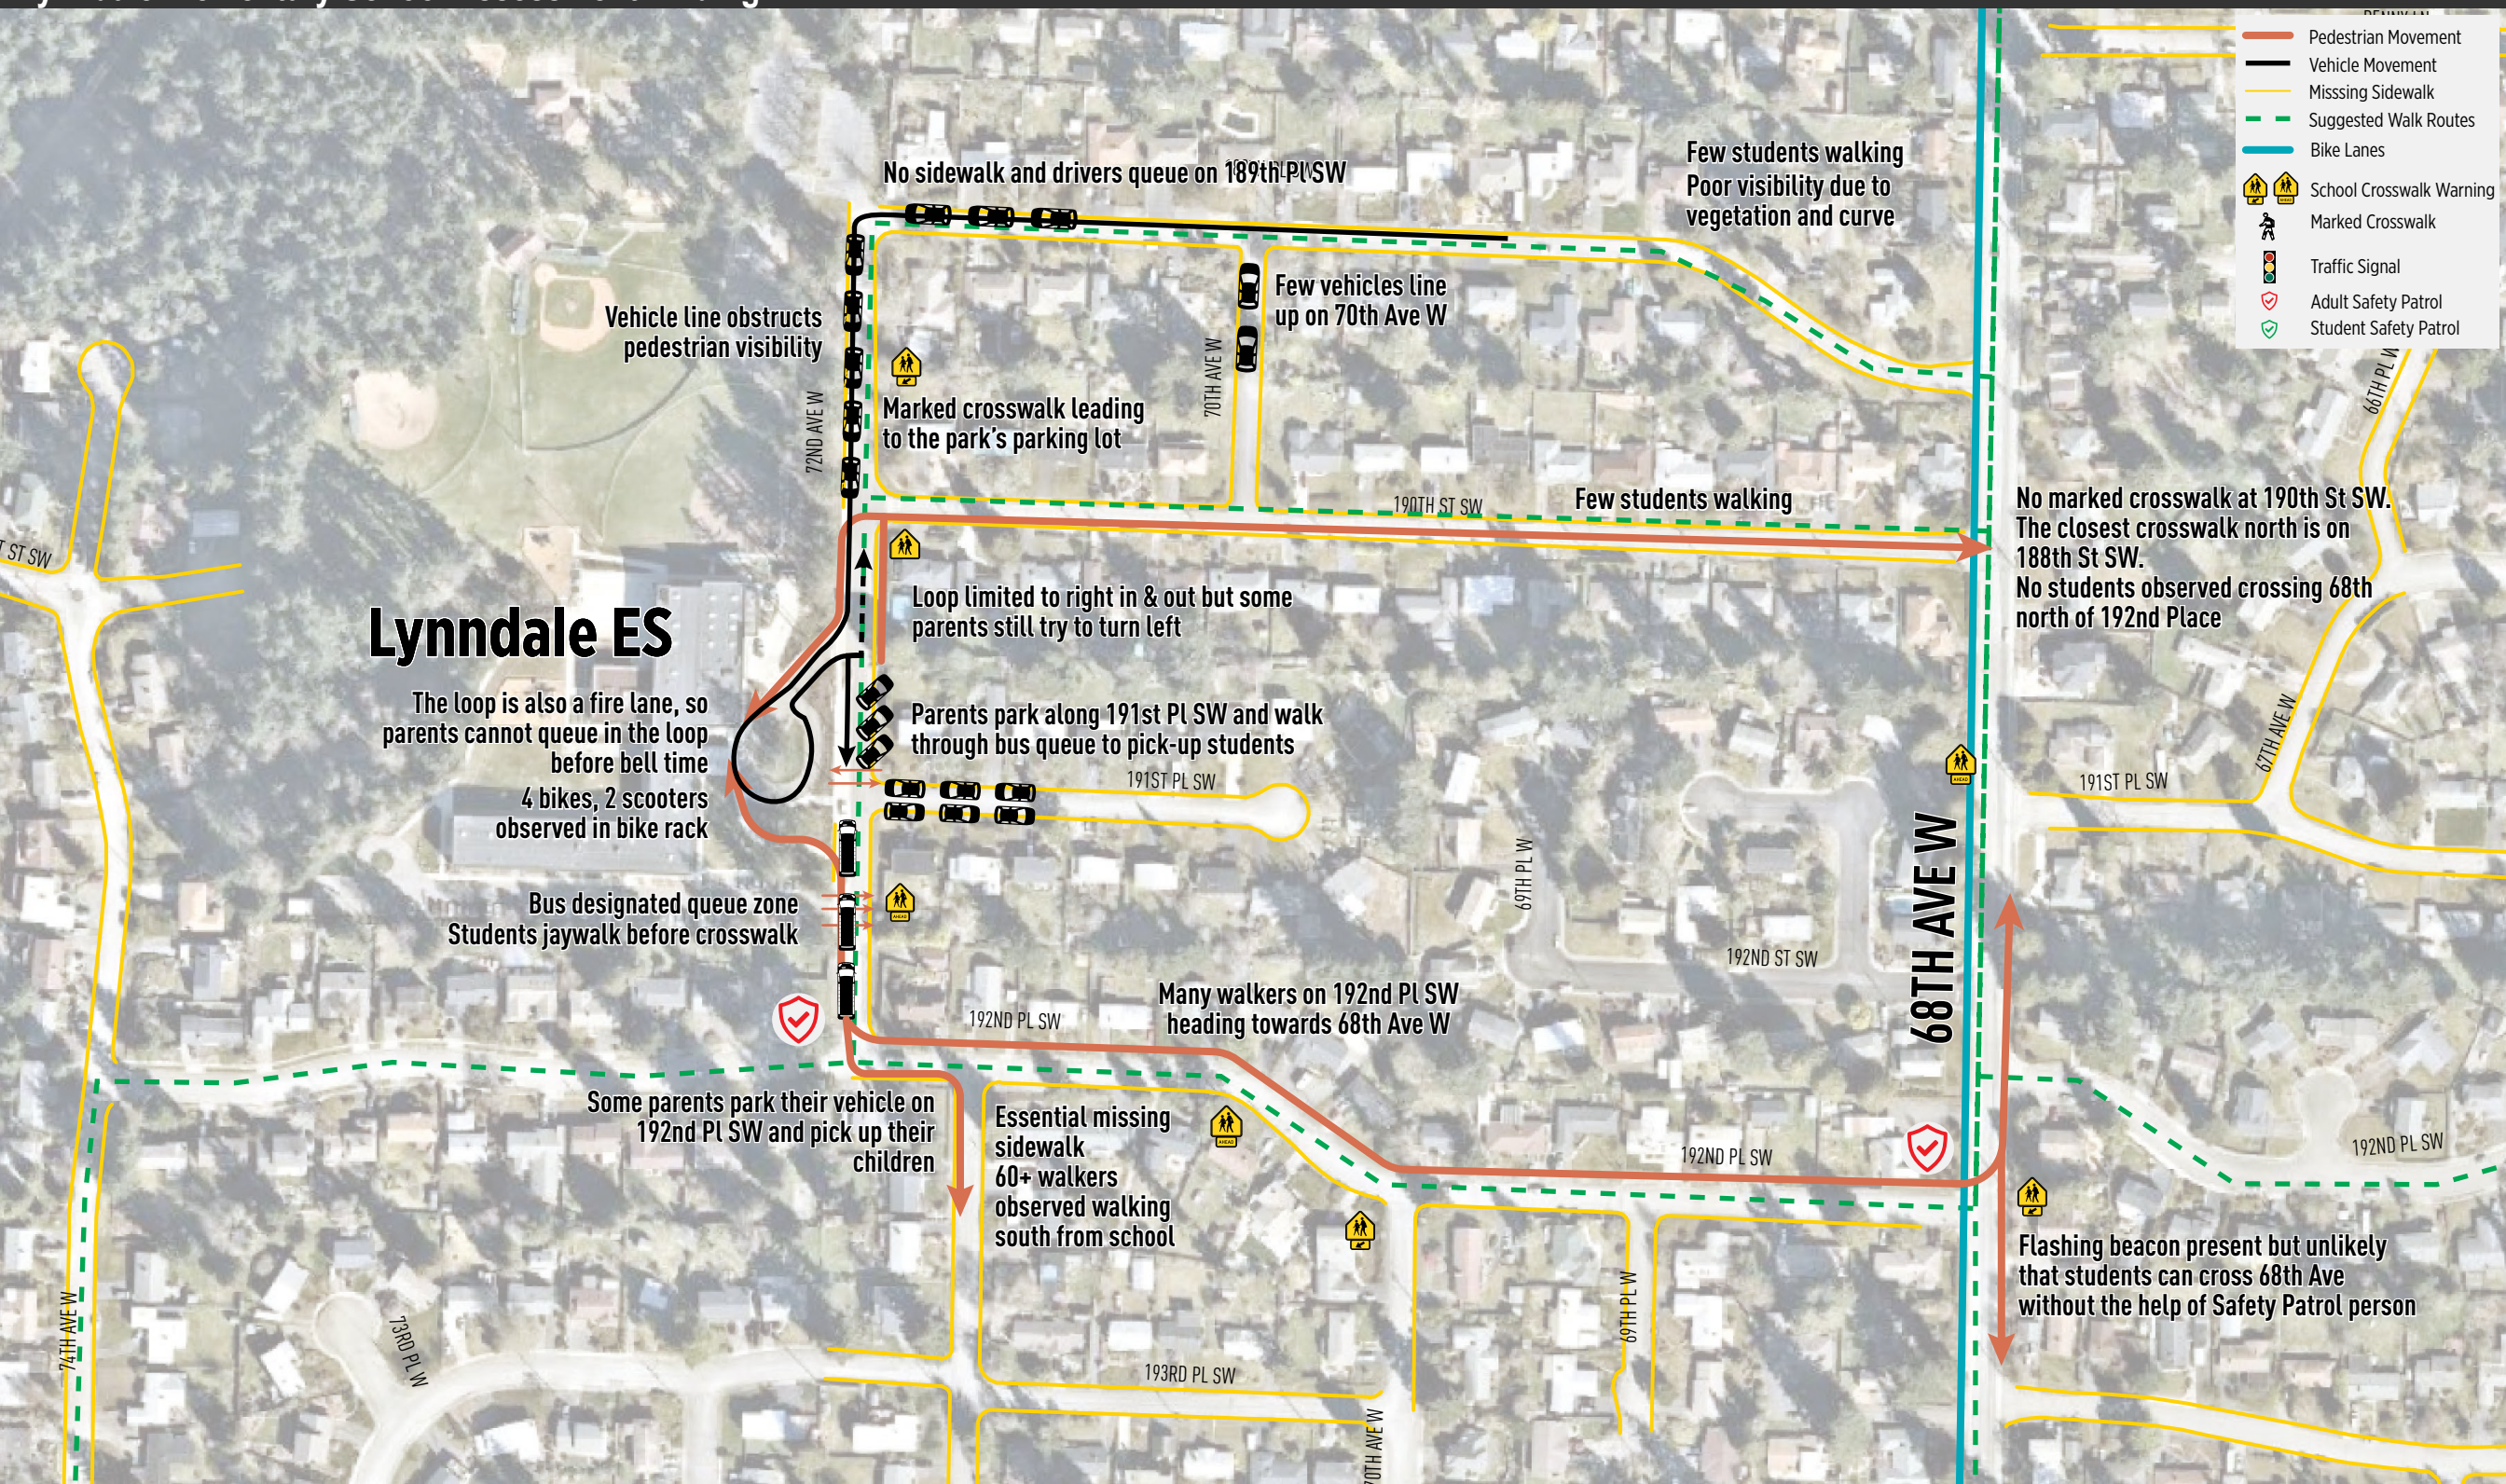
The loop is also a fire lane, so parents cannot queue in the loop before bell time
4 bikes, 2 scooters observed in bike rack

Bus designated queue zone
Students jaywalk before crosswalk

Some parents park their vehicle on 192nd Pl SW and pick up their children

No sidewalk and drivers queue on 189th Pl SW

Vehicle line obstructs pedestrian visibility

Marked crosswalk leading to the park's parking lot

Few vehicles line up on 70th Ave W

Few students walking
Poor visibility due to vegetation and curve

Loop limited to right in & out but some parents still try to turn left

Parents park along 191st Pl SW and walk through bus queue to pick-up students

Many walkers on 192nd Pl SW heading towards 68th Ave W

Essential missing sidewalk
60+ walkers observed walking south from school

No marked crosswalk at 190th St SW. The closest crosswalk north is on 188th St SW. No students observed crossing 68th north of 192nd Place

Flashing beacon present but unlikely that students can cross 68th Ave without the help of Safety Patrol person
