FIELD REPORT – LYNNWOOD RECREATION CENTER – FIELD REPORT

REPORT #01

Date: September 11th, 2013

Location(s) of Work: Natatorium roof.

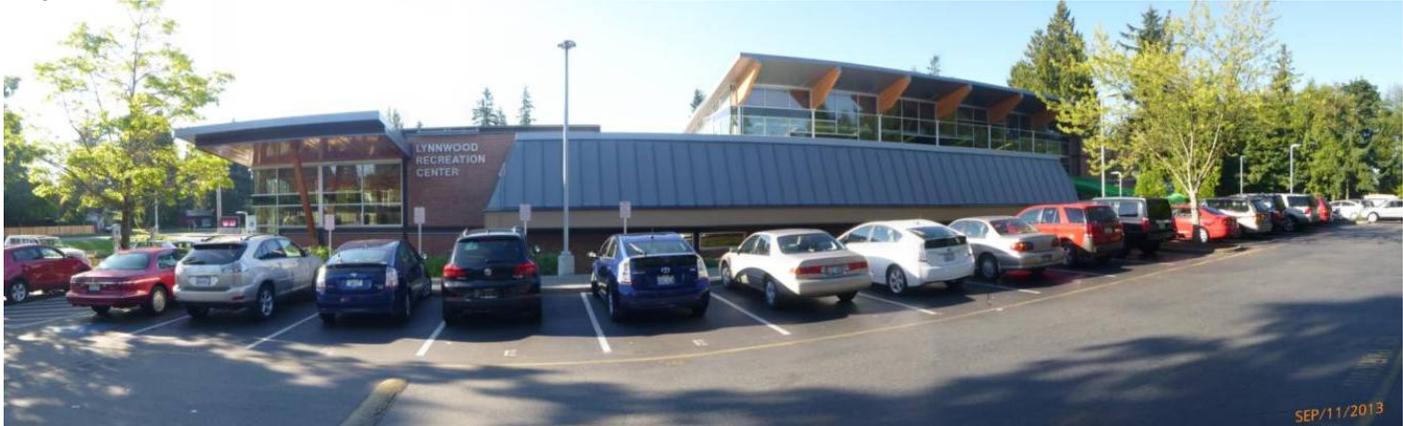
Project Conditions Photo:

Photo of the east elevation of the north elevation of the Lynnwood Recreation Center building taken facing south.
