FIELD REPORT – LYNNWOOD RECREATION CENTER – FIELD REPORT
REPORT #12

Job No. 10-100622B1

Date: January 3rd, 2014
Page 1 of 12

This writer was onsite with Shane West, Wetherholt and Associates, Inc. to perform a punchlist inspection of the upper and lower roof areas that were re-roofed. Hand-written copy of Field Notes #12 was reviewed with Keith Skore (City of Lynnwood) and is left in the onsite job trailer for storage. The following items were observed, noted and/or discussed regarding the roof.

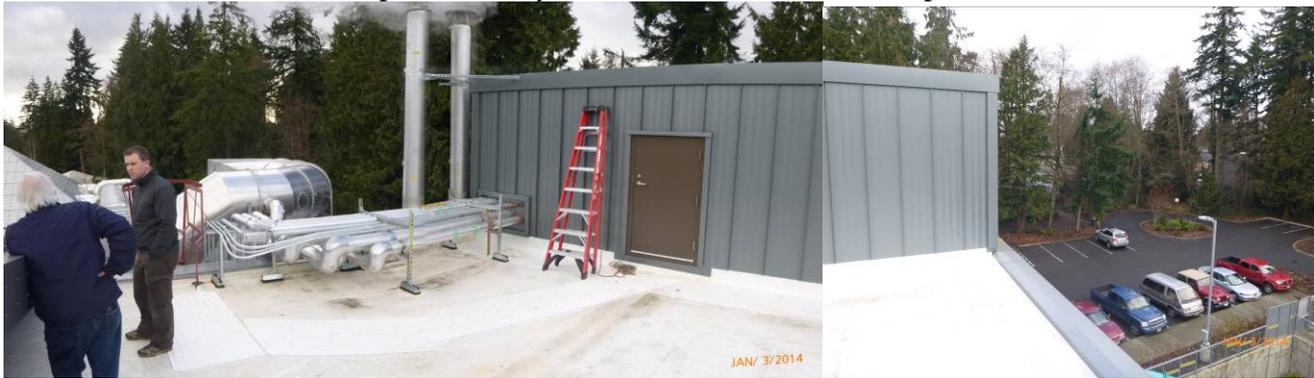
12.1 To date, Holmberg and Queen City Roofing is demobilized and offsite. The mechanical penthouse is clad in sheet metal as performed by Kenco Construction and the penthouse roof is installed.

Overview of the chiller room roof taken facing west.
