FIELD REPORT – LYNNWOOD RECREATION CENTER – FIELD REPORT

REPORT #04

Date: September 19th, 2013

Location(s) of Work: Natatorium roof.

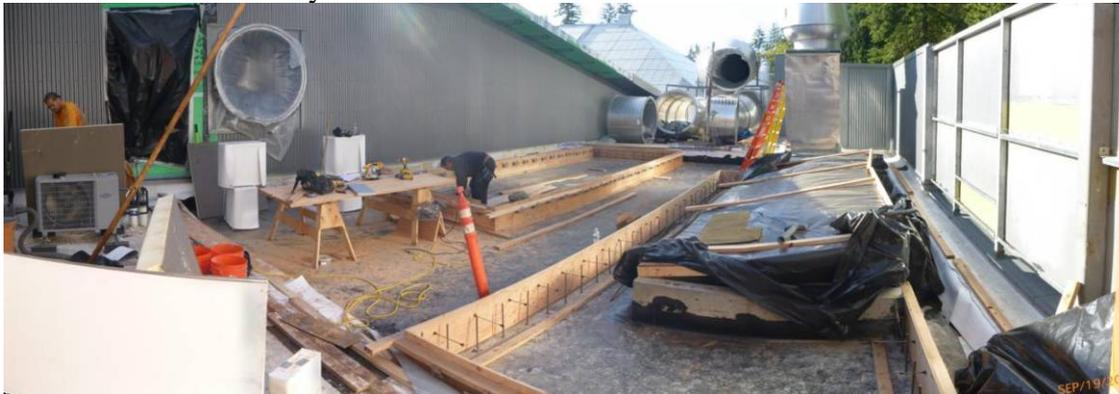
4.1 Holmberg is installing formwork for concrete curbs at the Natatorium Roof. Queen City Roofing is removing some of the existing roofing above the chiller room and installing the temporary roof/ vapor retarder assembly.

Overview of the Natatorium Roof taken facing southeast.

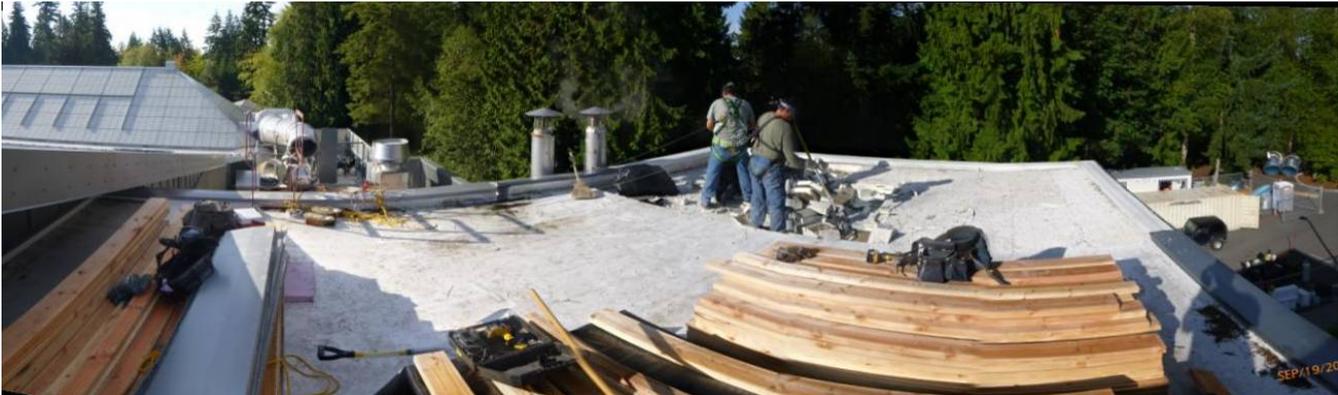
4.2 Queen City Roofing is removing approximately 12-feet of the existing roof assembly at the west side of the chiller room roof.

Overview of the chiller room roof taken facing southwest.

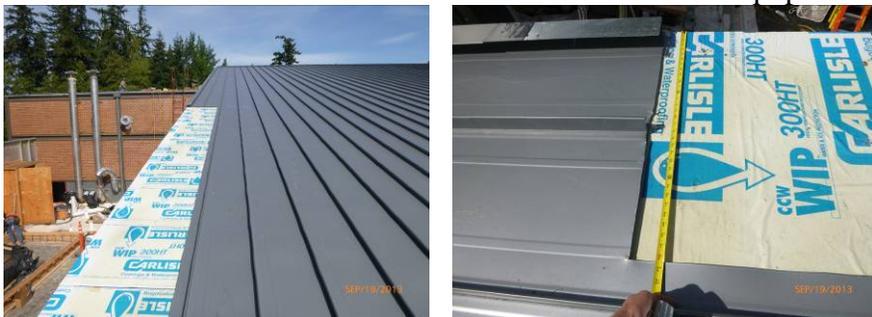
4.4 At the east side of the roof above the Natatorium Roof, a portion of the existing standing seam roof is to be cut back to accommodate the new mechanical equipment.

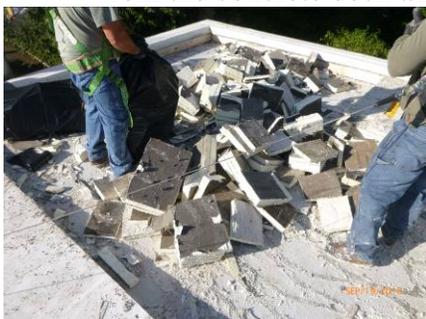
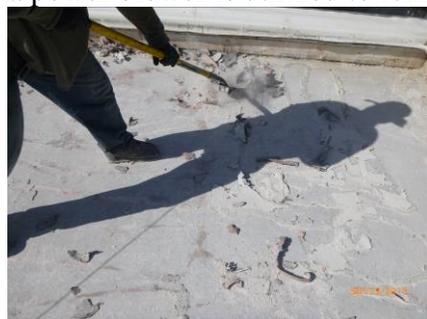
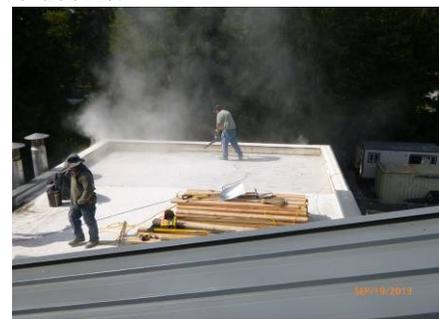
4.5 At the chiller room roof, debris is bagged and removed from the roof. Insulation adhesive is scraped from the concrete deck and a power blower is utilized to remove debris.

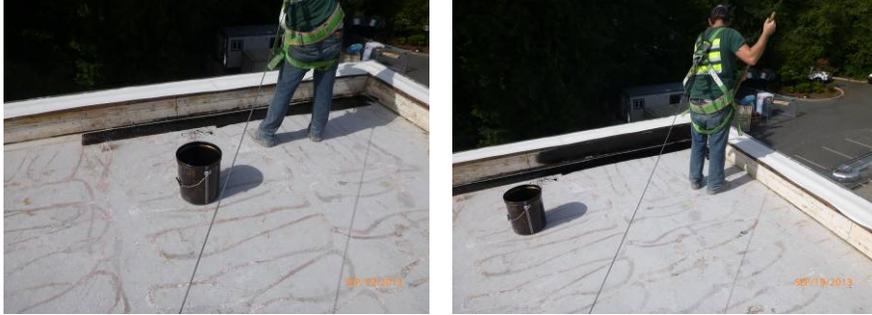
- 4.5a Karnak 108 Asphalt primer is roller applied onto the concrete roof and up the wall board. Per conversation with Rich (Foreman, QCR) the new vapor retarder layer is to be installed during this workday after the primer tacks off.
