FIELD REPORT – LYNNWOOD RECREATION CENTER – FIELD REPORT

REPORT #08

Job No. 10-100622B1

Date: October 2nd, 2013

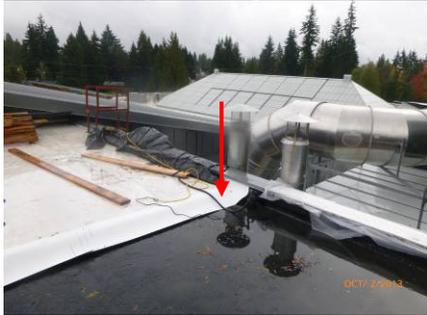
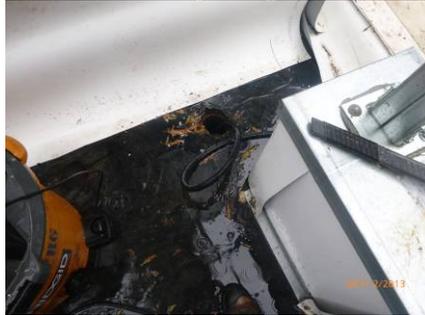
8.3 At the north end of the upper sheet metal roof (cut back to accommodate new HVAC units) a 4-inch downspout is observed mechanically fastened with gasketed fasteners. This writer will review the area above during dry conditions when the metal deck dries out.
