Preliminary Roof Infrared Survey Report

Lynnwood Recreation Center
18900 44th Avenue West
Lynnwood, Washington

SITE VISITS – September 4 and 11, 2013

Project No. 1006-22B1
October 18, 2013

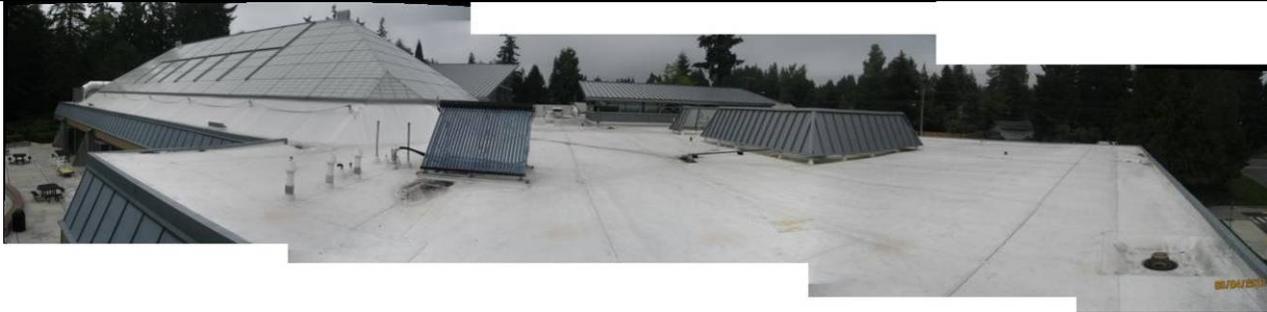
Photograph #1
Panoramic overview of main low sloped roof area as seen from the southeast.

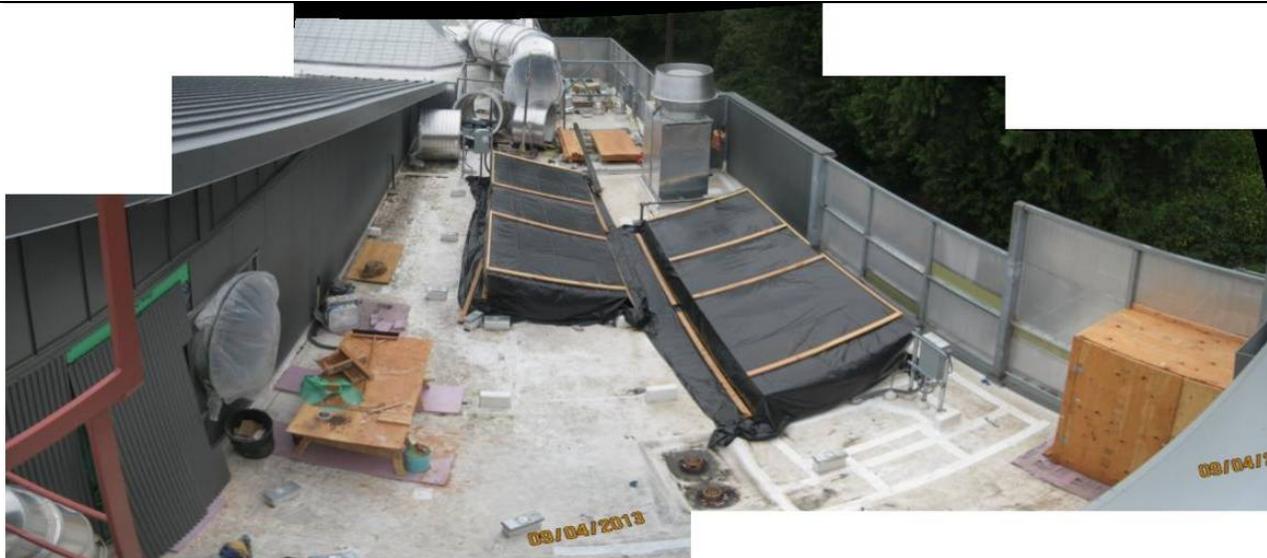
Photograph #2
Panoramic overview of west lower elevation roof where majority of current HVAC replacement work is scheduled, as seen from higher elevation roof to the north.

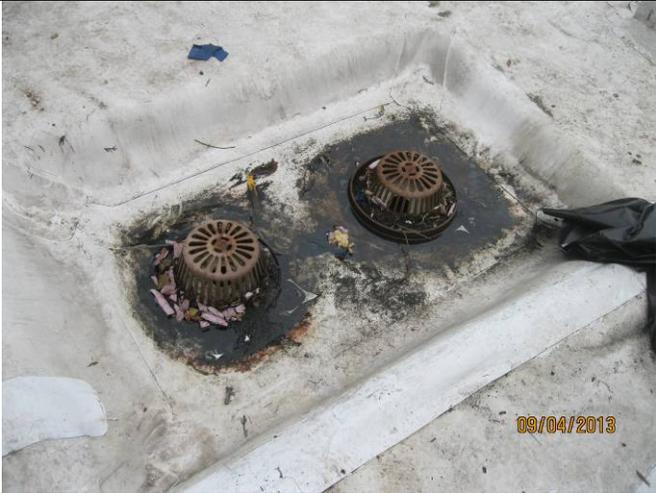
<p>Photograph #8</p> <p>Drain and overflow in typical sump.</p>

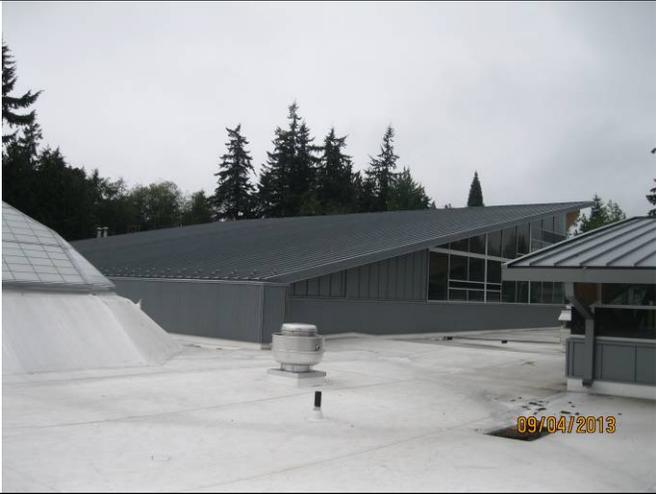
A photograph showing a wide view of a large, steeply sloped metal roof structure. The roof is grey and appears to be made of metal panels. In the foreground, there is a concrete surface with a white cylindrical object and a date stamp '09/04/2013'. The background shows some trees and a cloudy sky.	<p>Photograph #13</p> <p>Overview of steep sloped metal roof over north natatorium.</p>
