**Arborist Report
DRAFT**

Site: 200th Street Development
5710 - 5722 200th St SW, Lynnwood, WA 98036

Re: Tree Inventory and Assessment

Date: February 12, 2026

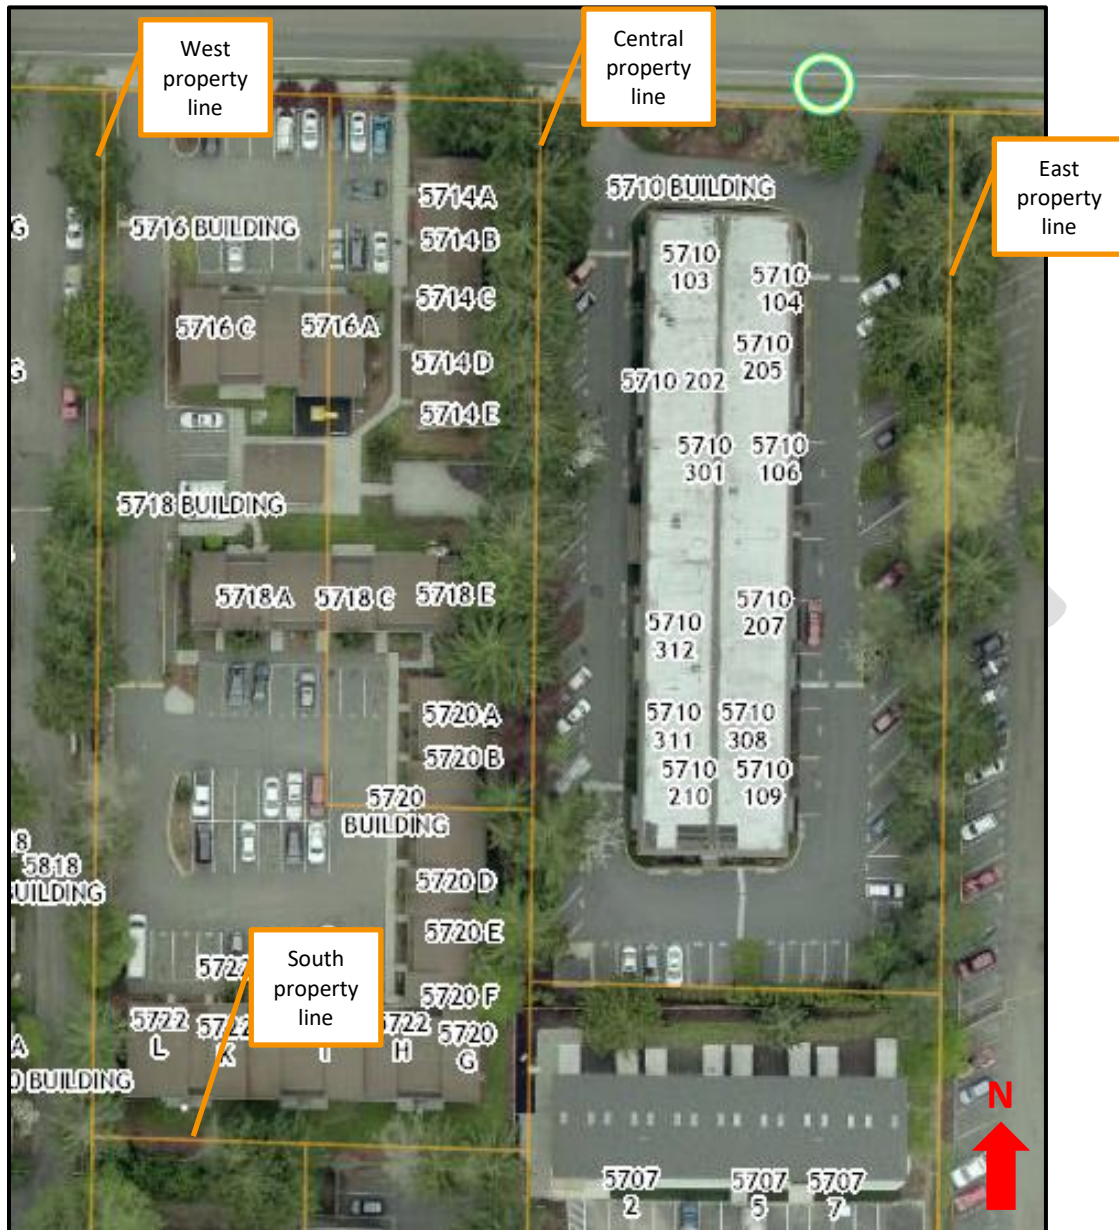
Figure 1. Site Map (PDS Map Portal, 2022 Aerial images). The tree groves along the west, central and east property lines are the most valuable onsite. Many of the trees on the west and east property lines are on the neighboring properties.
