FLOW METER SETUP REFERENCE SHEETS

CITY OF LYNNWOOD
 FIGURE B-1
 1992 & 2009 SMOKE TESTING RESULTS

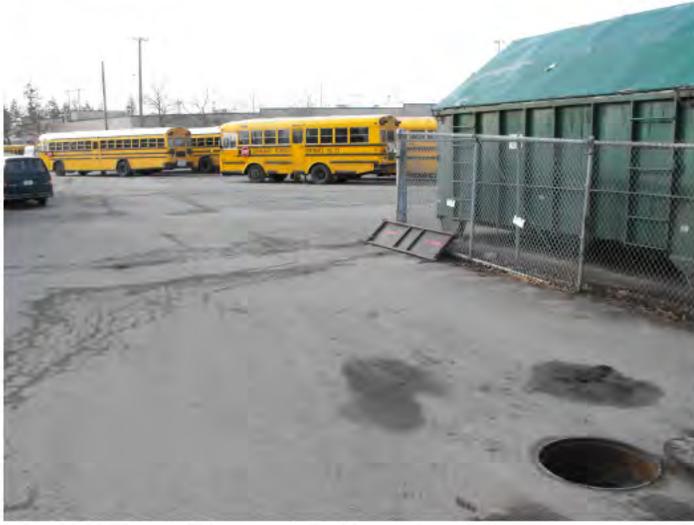
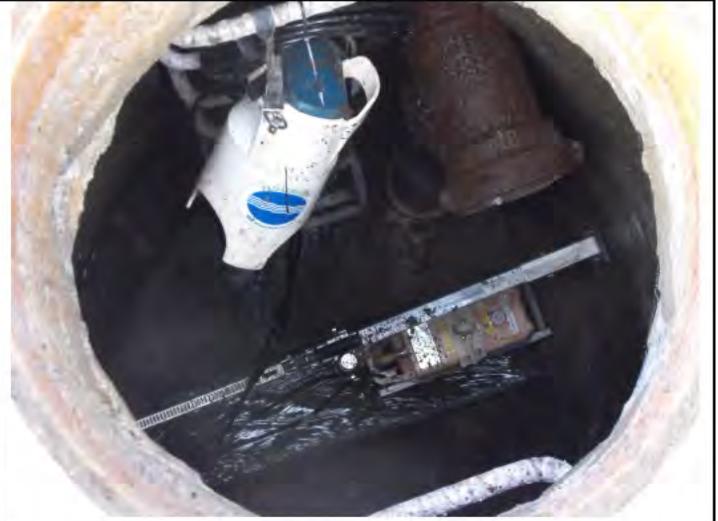
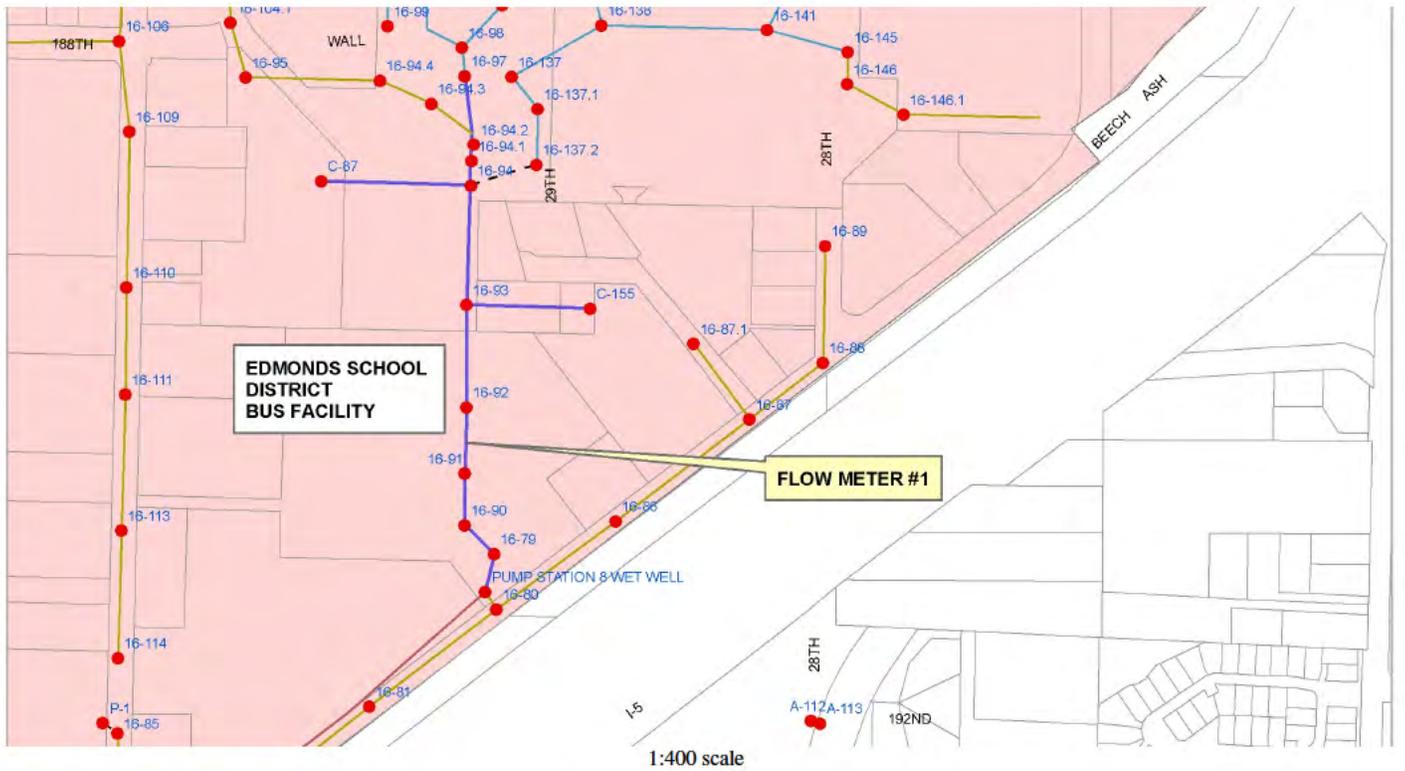
FLOW METER #1

Basin: Lift Station #8

Notes: This site is located along the Alderwood Mall Parkway next to a roll-off dumpster within the Edmonds School District Bus Facility. (SSMH 16-91)

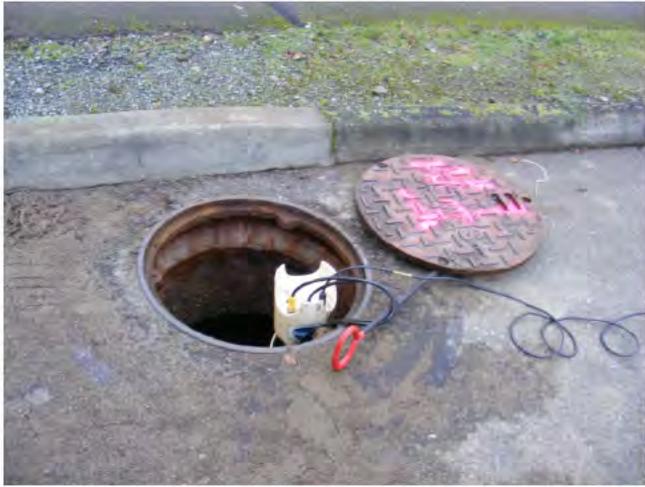
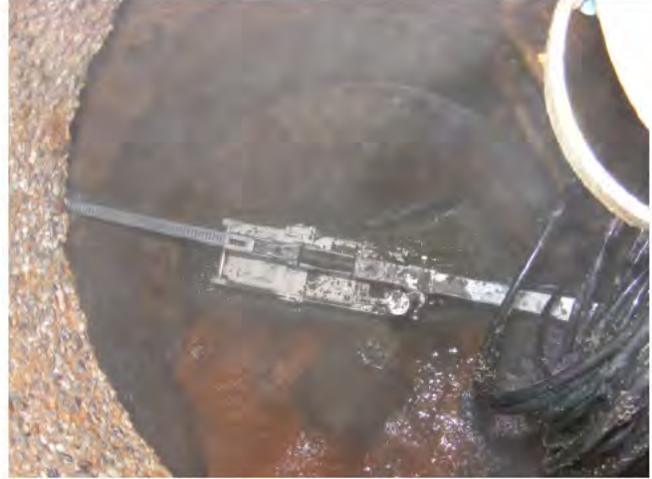
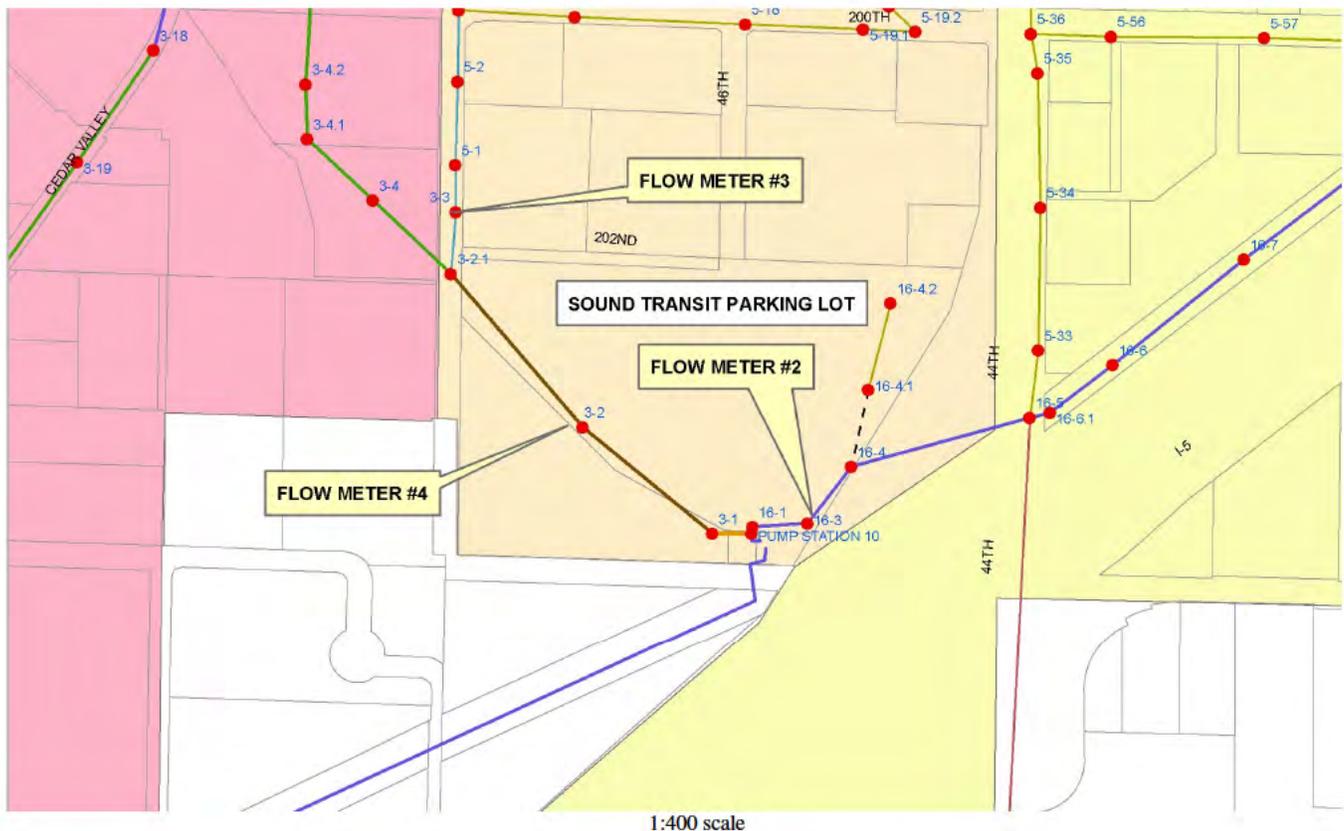
FLOW METER #2

Basin: Lift Station #10

Notes: This site is located along the Interurban trail near lift station #10 in the Levitz / mass transit parking lot. Mild infiltration was observed within this manhole (SSMH 16-3). One side sewer lateral from the northwest contributes some flow to this manhole not accounted for by the flowmeter. The subsequent manhole downstream was the preferred location for flow monitoring but this manhole channel directed flow in a manner which would cause significant measurement error.

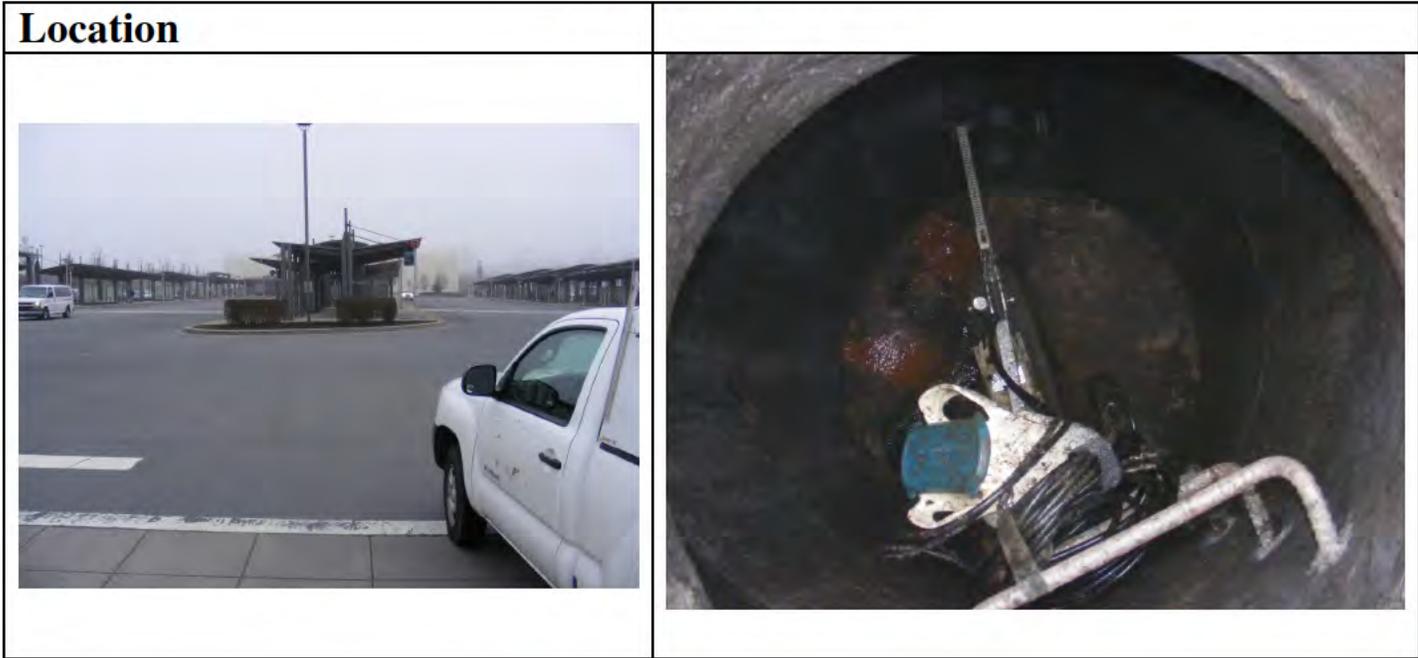
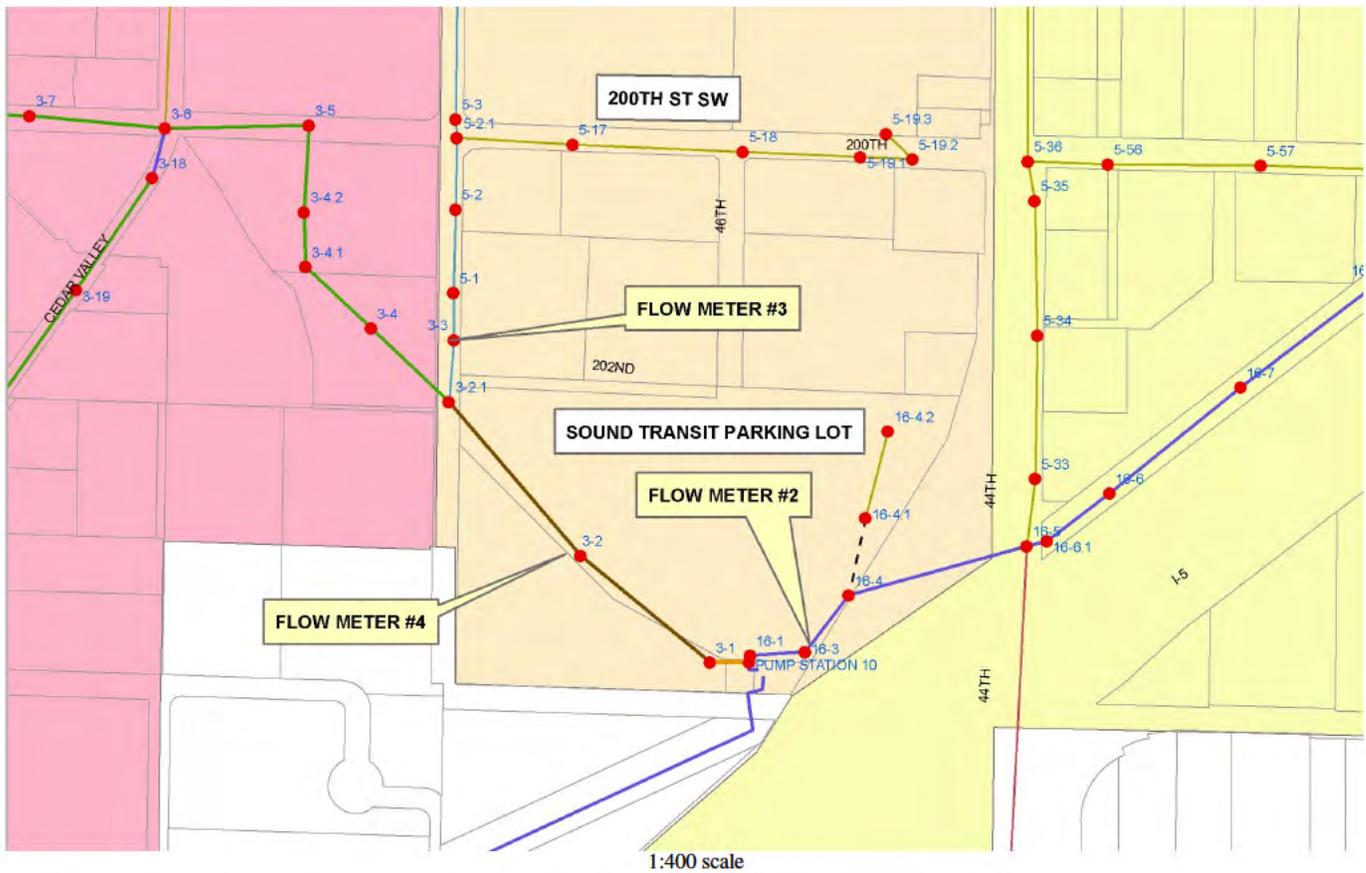
FLOW METER #3

Basin: Lift Station #10

Notes: This site is located at the entrance to the Sound Transit Park and Ride off of 48th Ave. SSMH 3-3

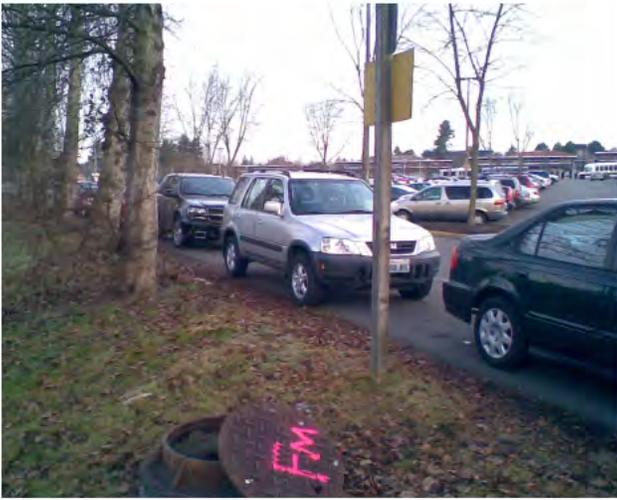
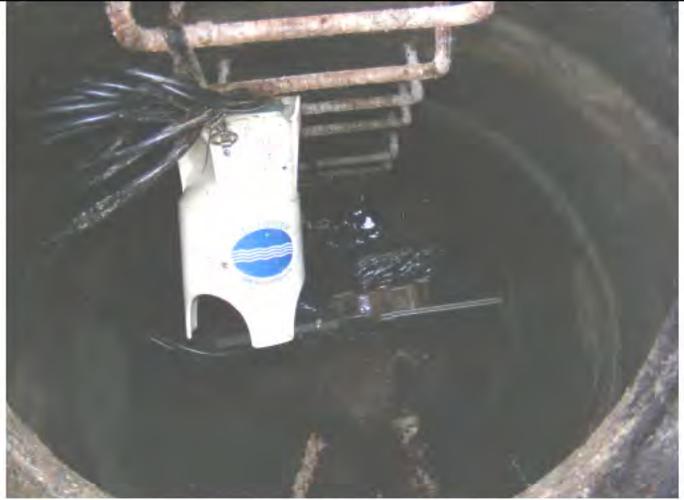
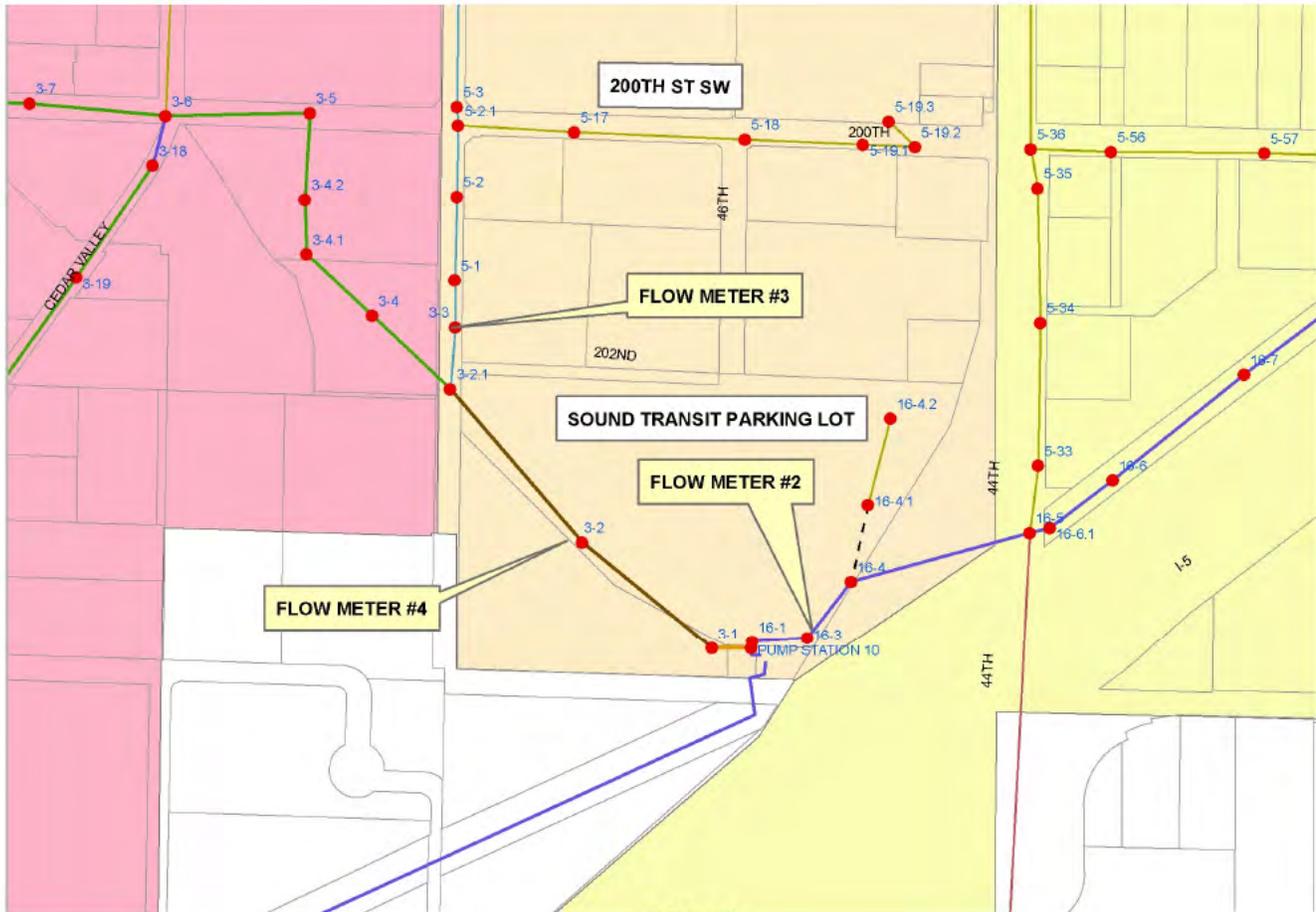
FLOW METER #4

Basin: Lift Station #10

Notes: This site is located at the entrance to the Sound Transit Park and Ride off of 48th Ave. SSMH 3-2

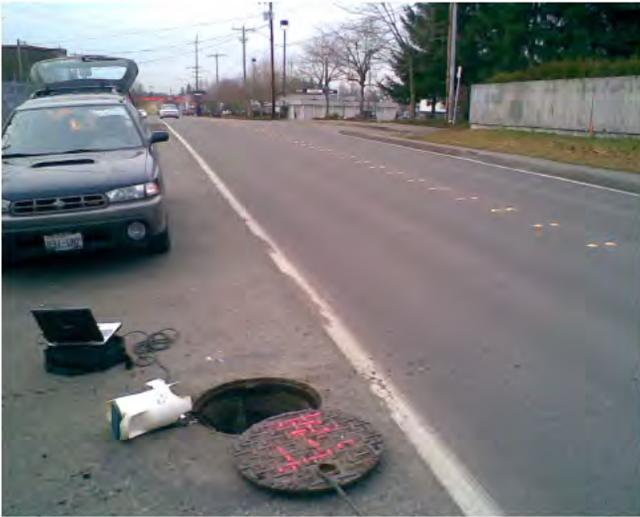
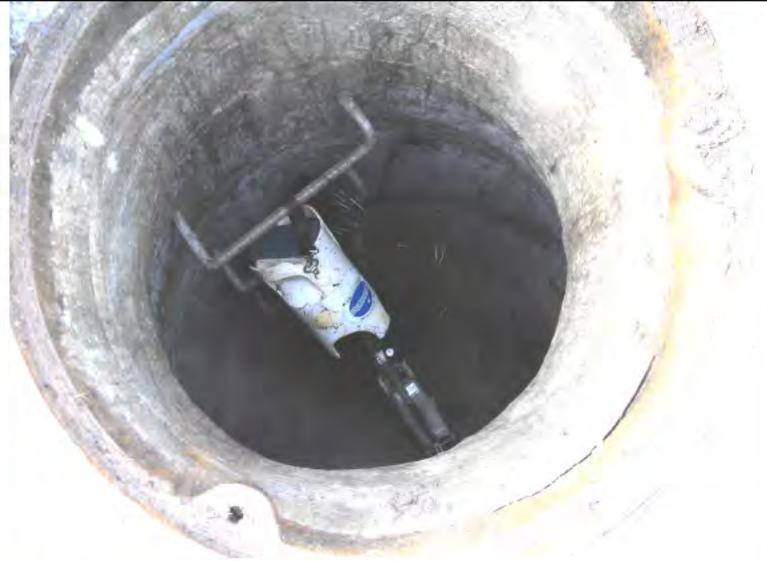
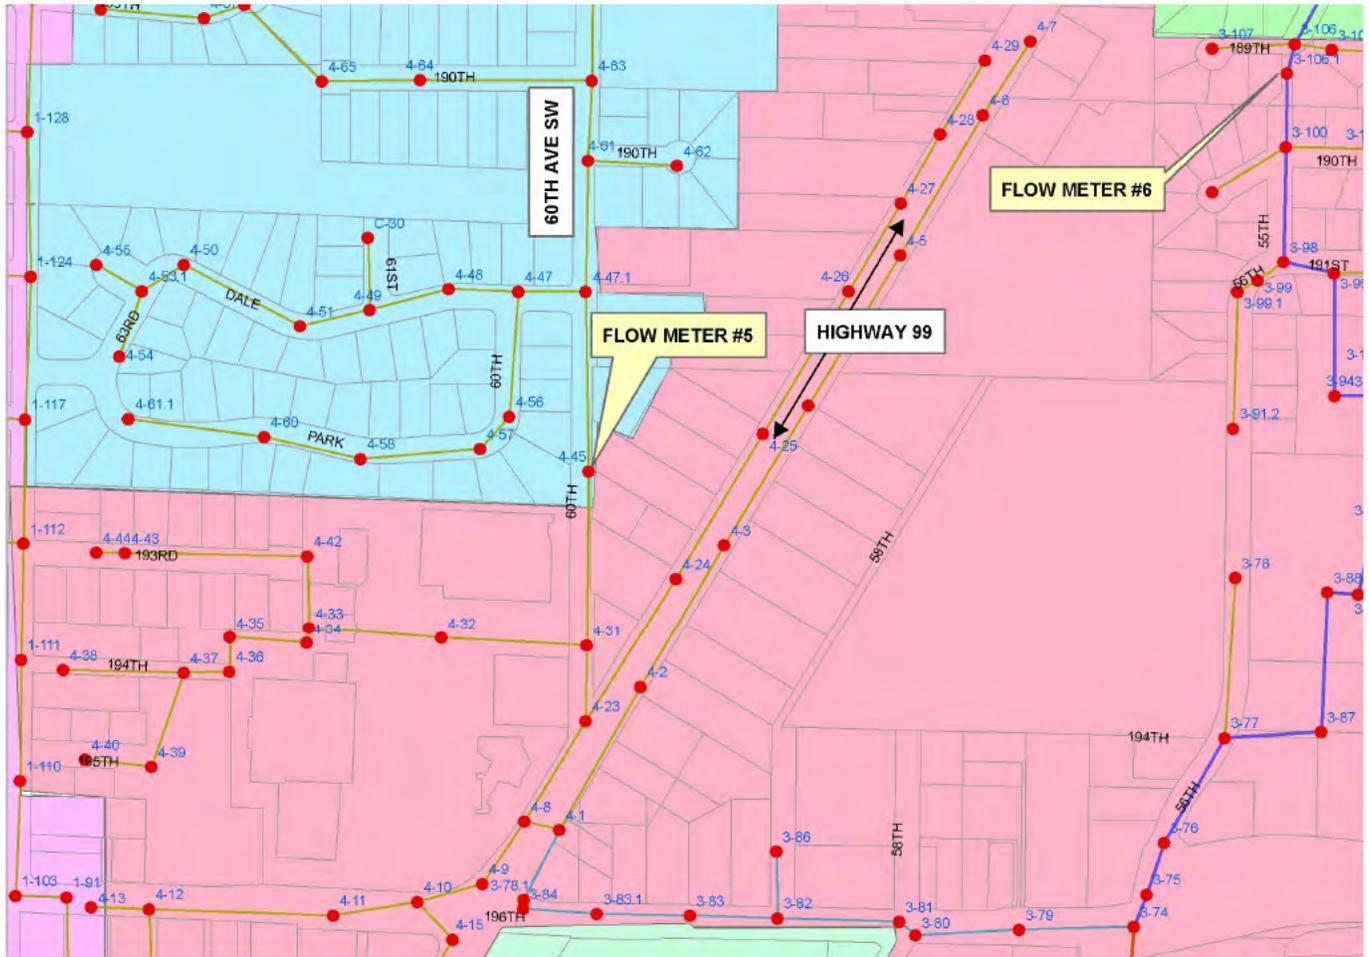
FLOW METER #5

1:400 scale

Basin: Lift Station #10

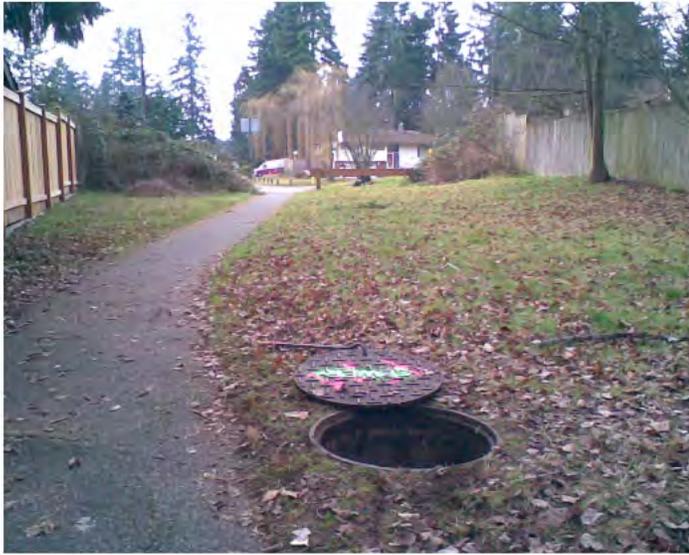
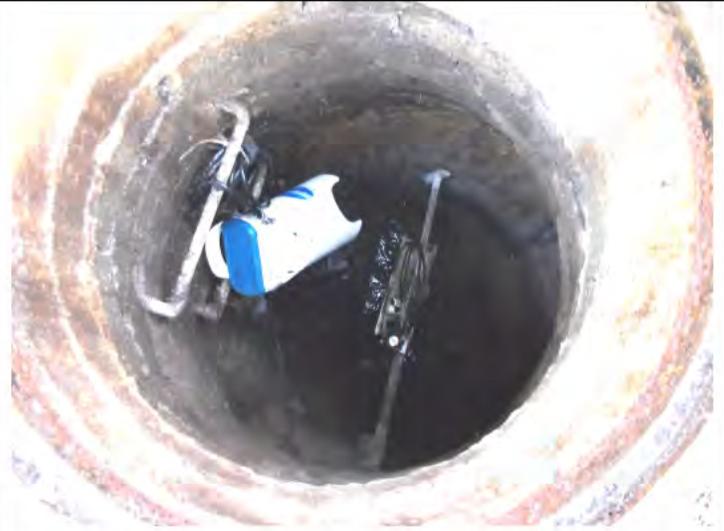
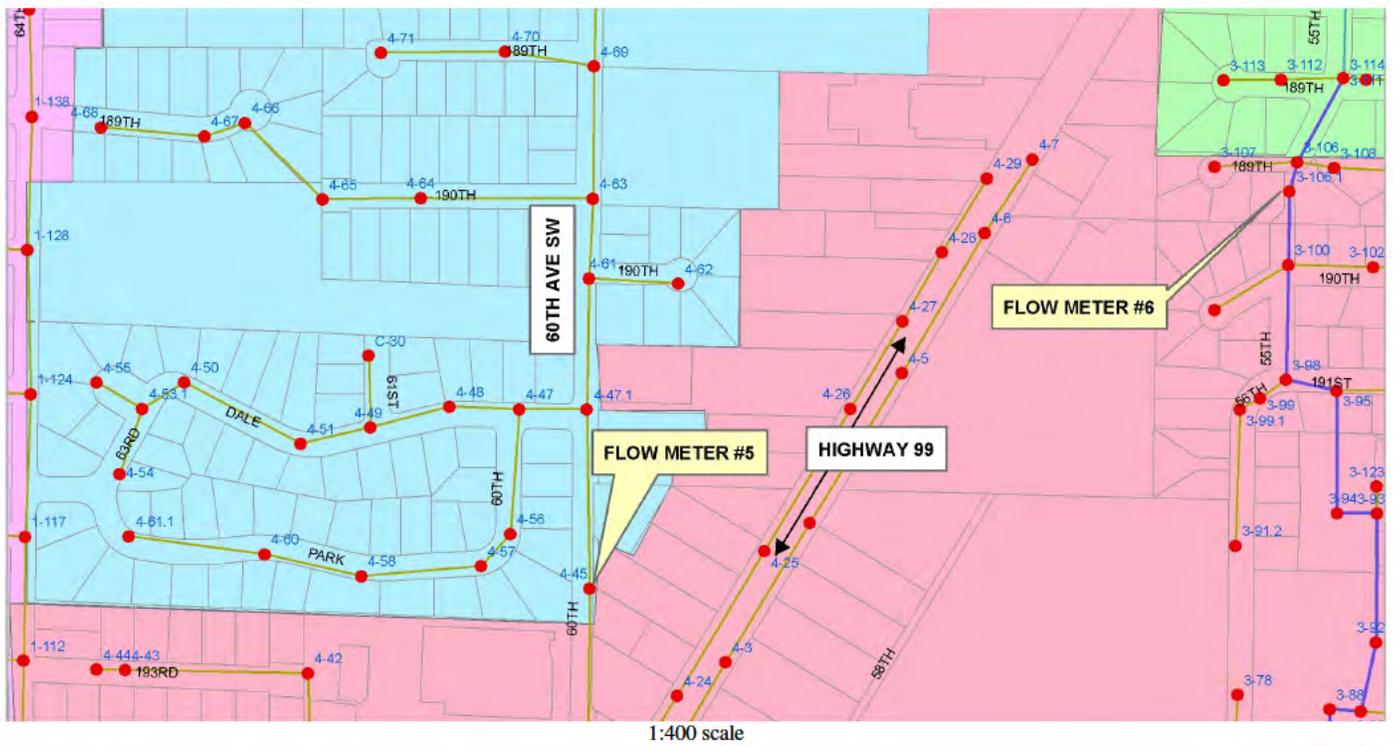
FLOW METER #6

Basin: Lift Station #10

Notes: This site is located in a grassy easement between two cul-de-sacs at the end of 189th St. SW and 190th St. SW. The manhole was downstream of the preferred site SSMH 3-106. The preferred manhole was actively surcharging at the time of installation. This manhole SSMH 3-106.1 has surcharged since installation of the flowmeter.

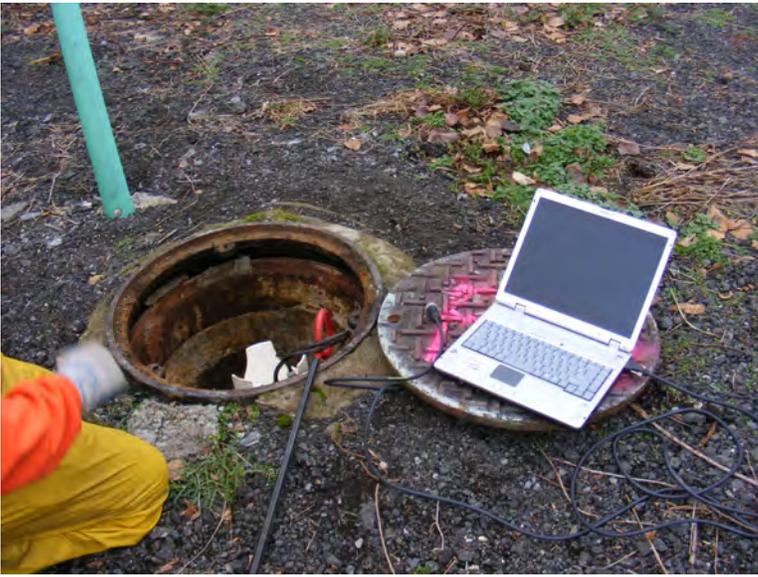
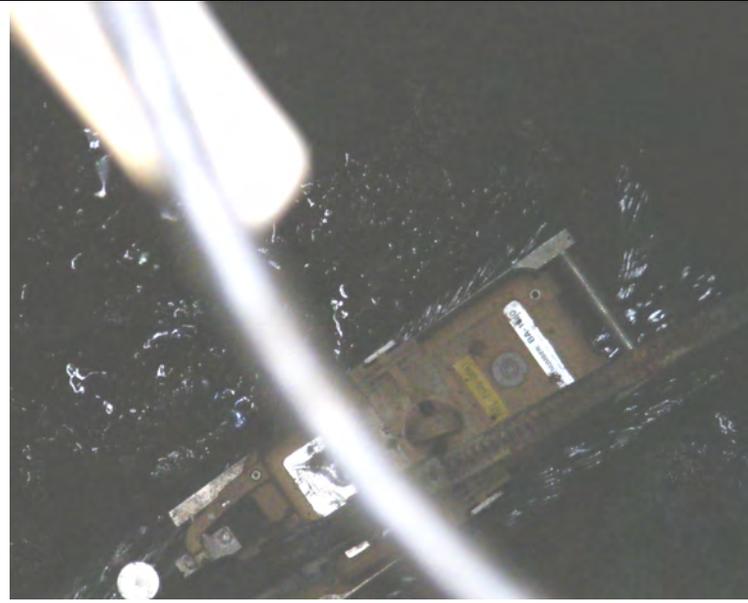
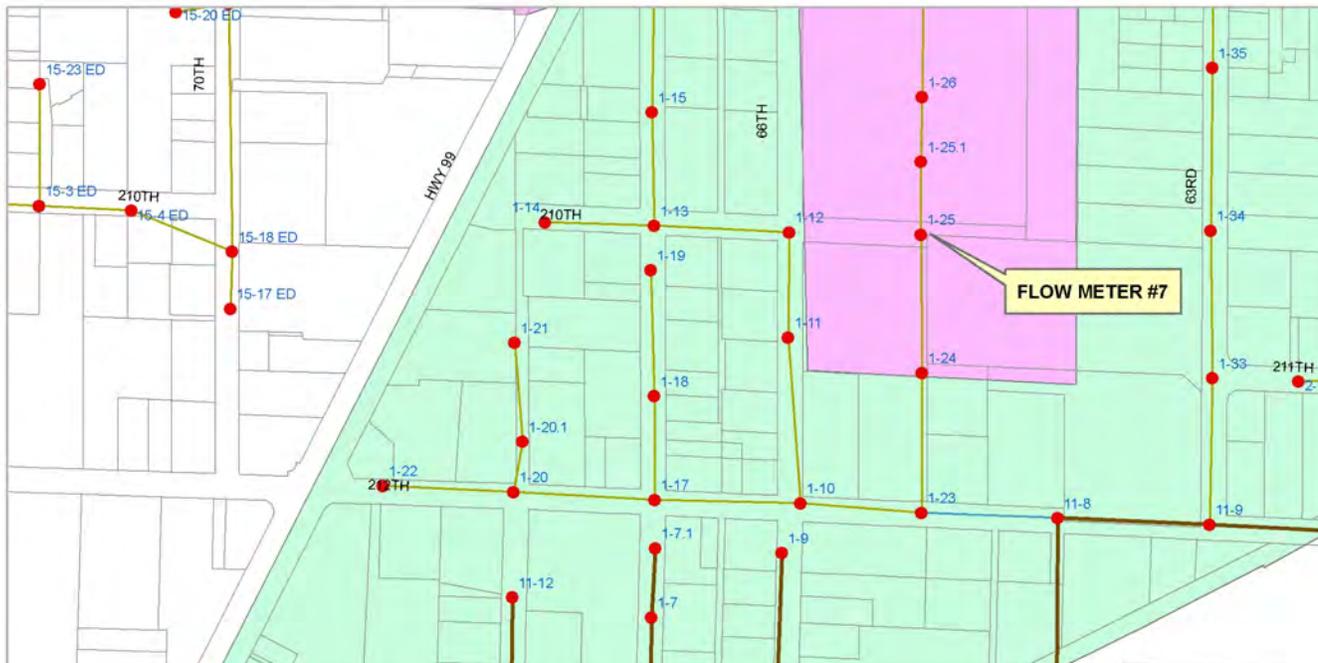
FLOW METER #7

1:400 scale

Basin: Lift Station #12

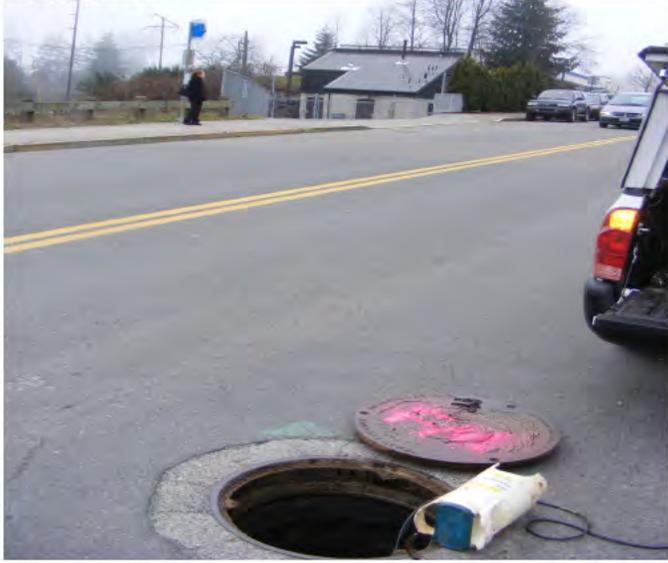
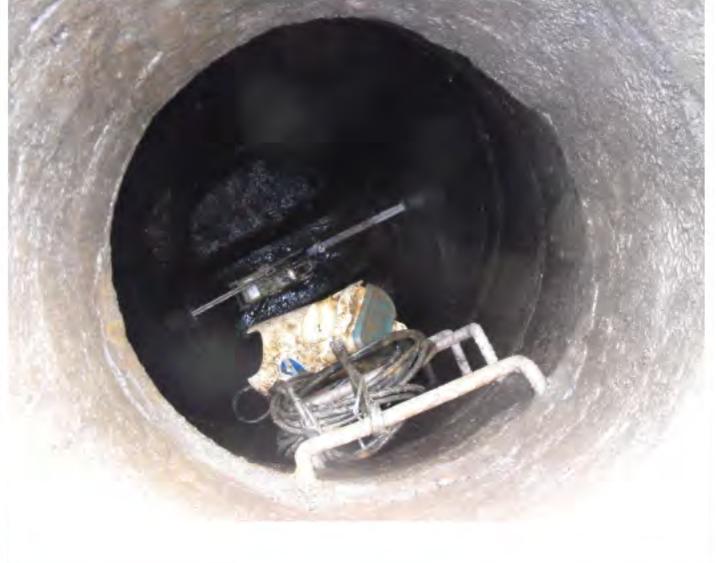
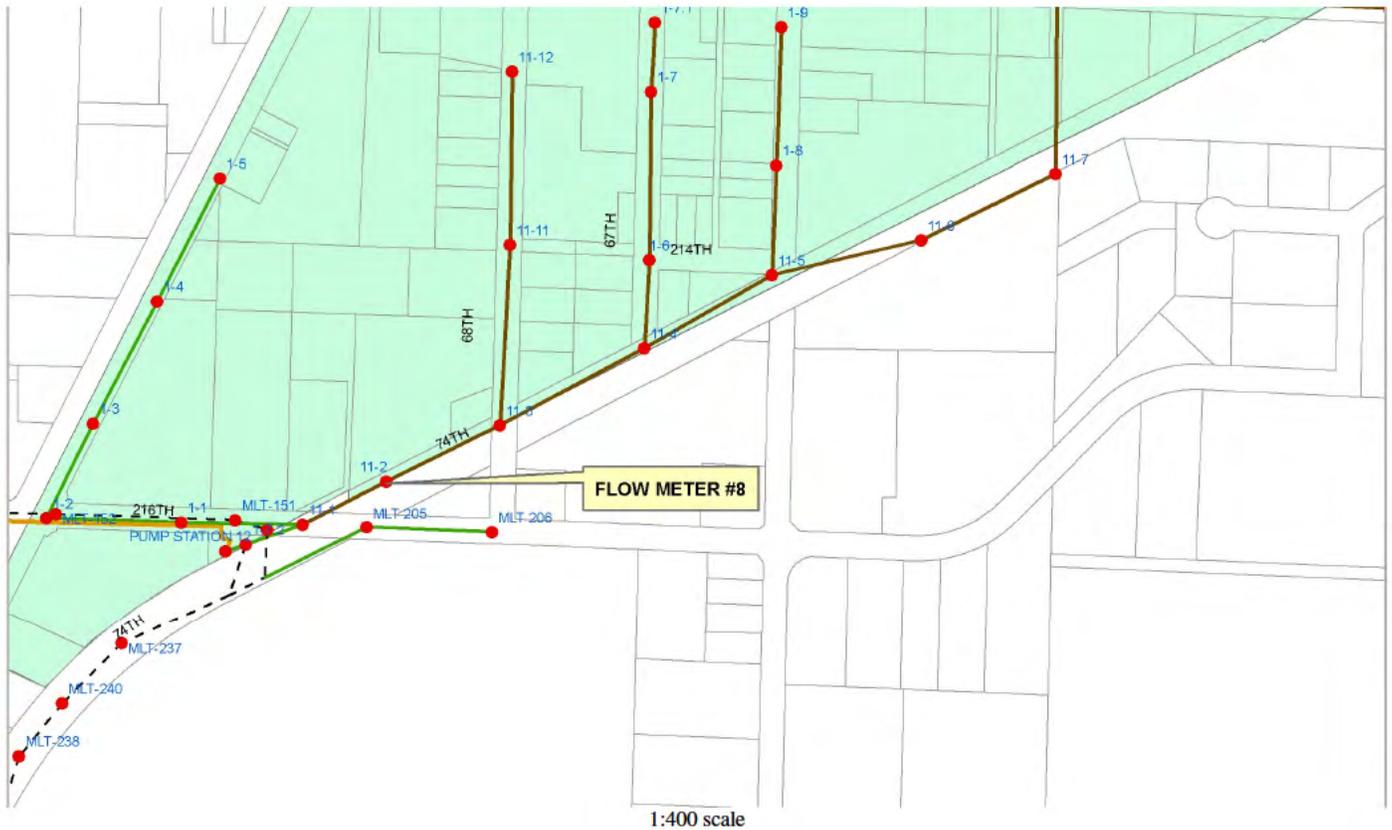
FLOW METER #8

Basin: Lift Station #12

Notes: This site (SSMH 11-2) is located at the approximate intersection of the Interurban Trail and 216th St. SW.

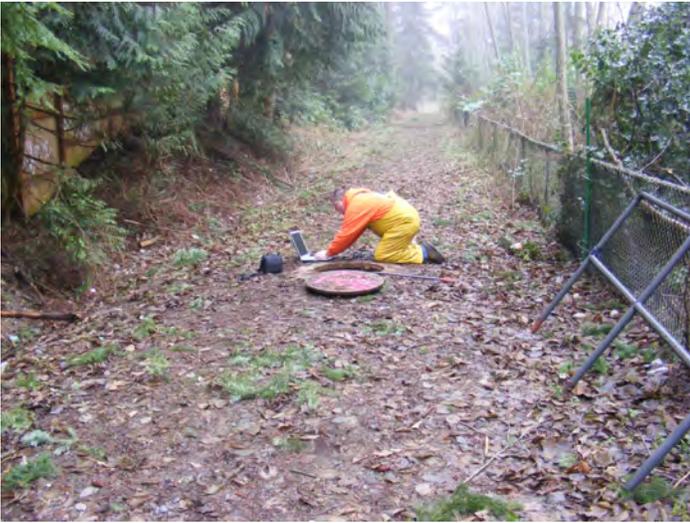
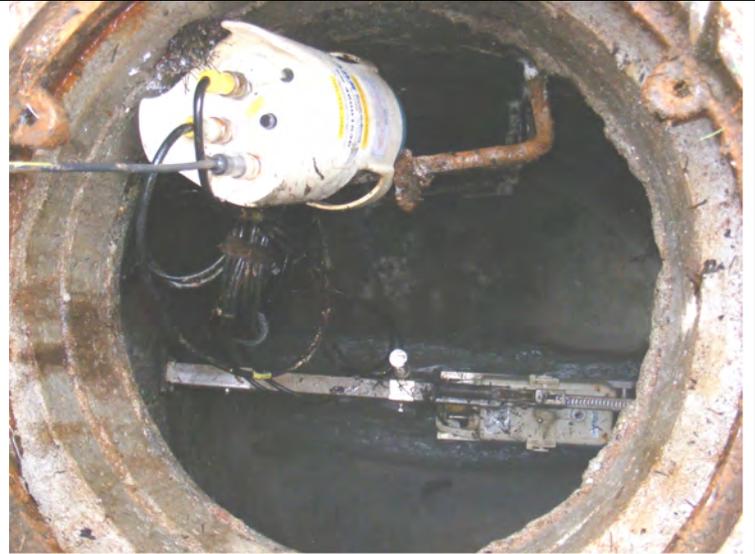
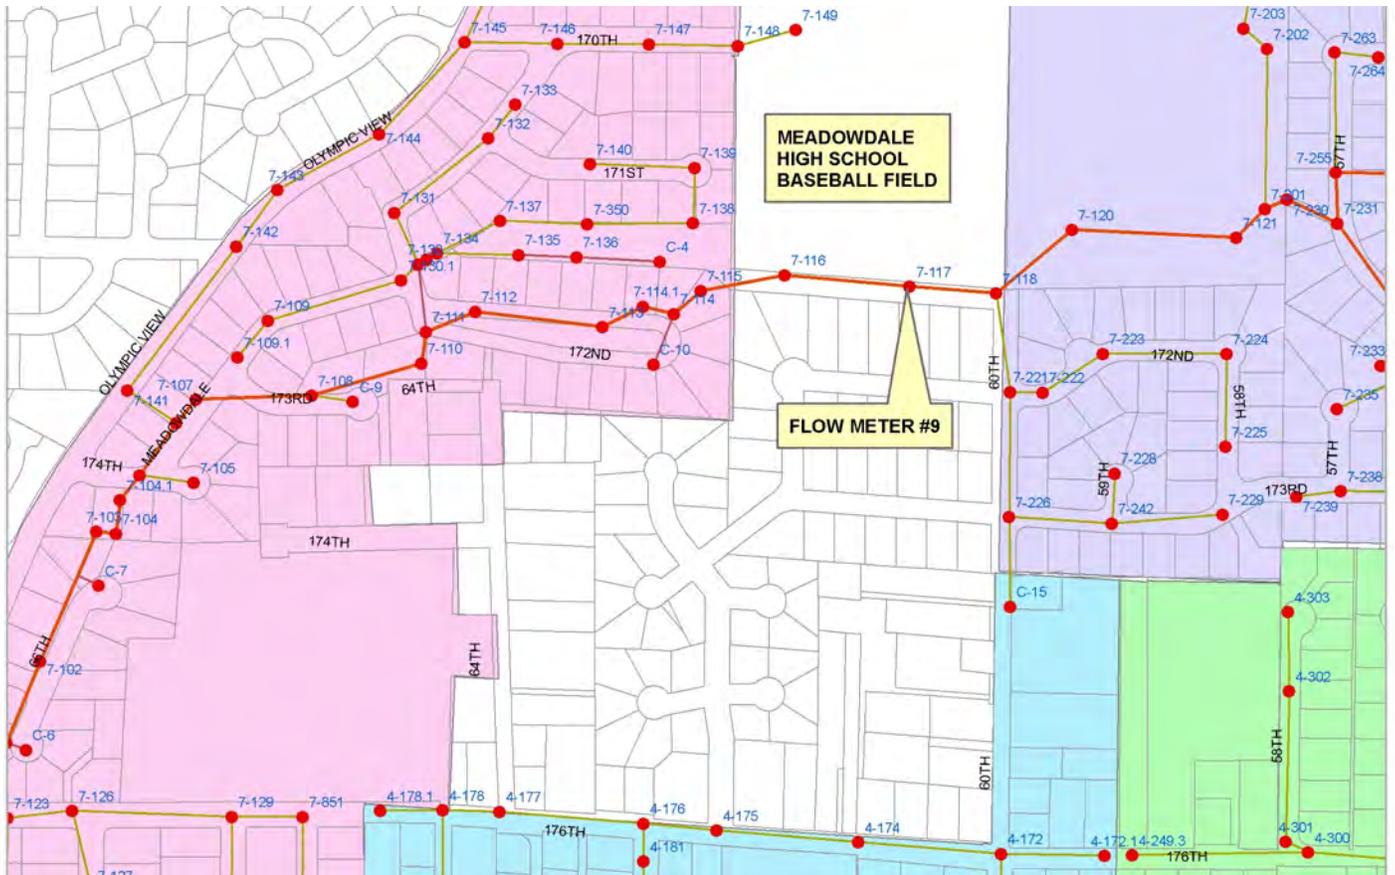
FLOW METER #9

Basin: NE gravity

Notes: This site (SSMH 7-117) is located in an easement at the back of the Meadowdale High School baseball field.

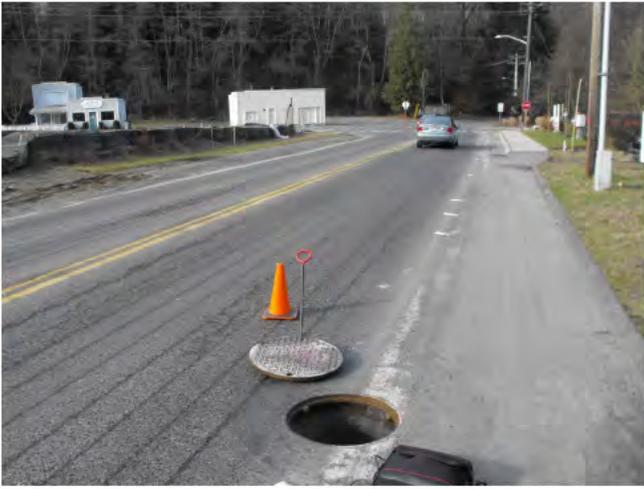
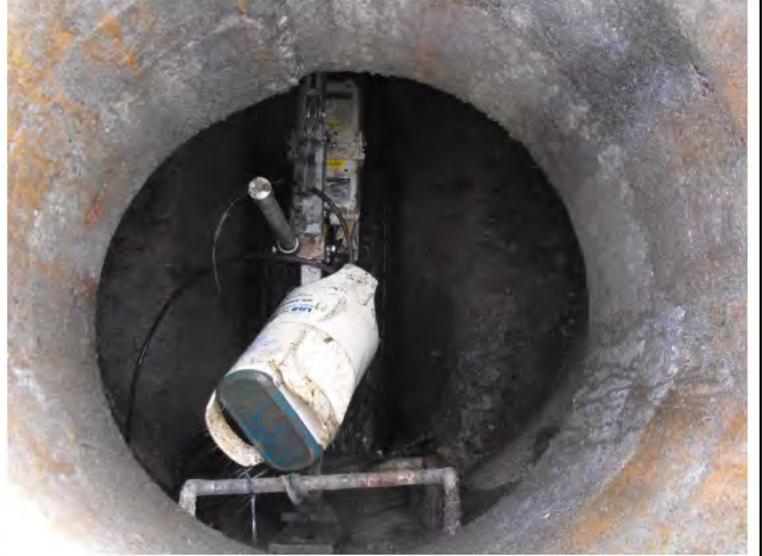
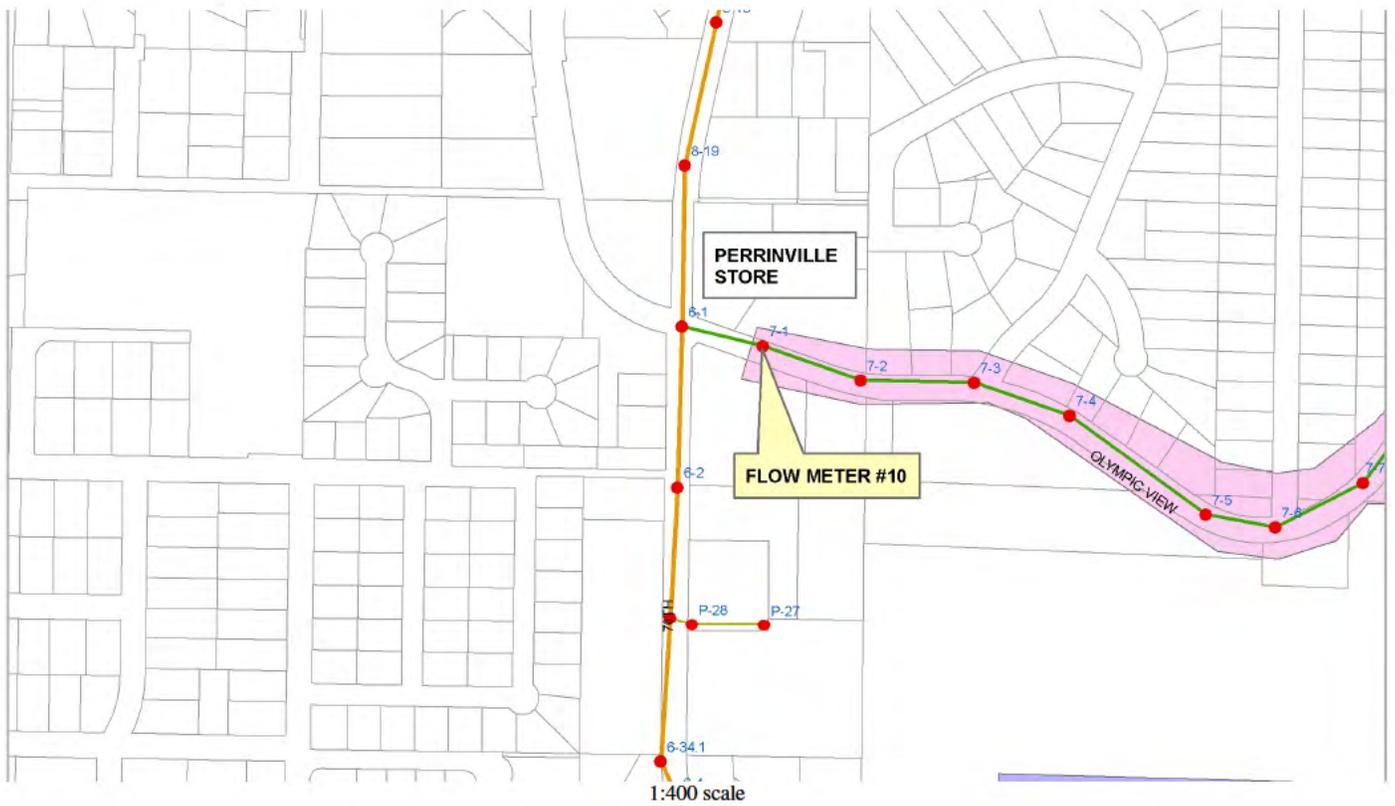
FLOW METER #10

Basin: NW gravity

Notes: This site (SSMH 7-1) is located along the westbound lane of Olympic View Dr.

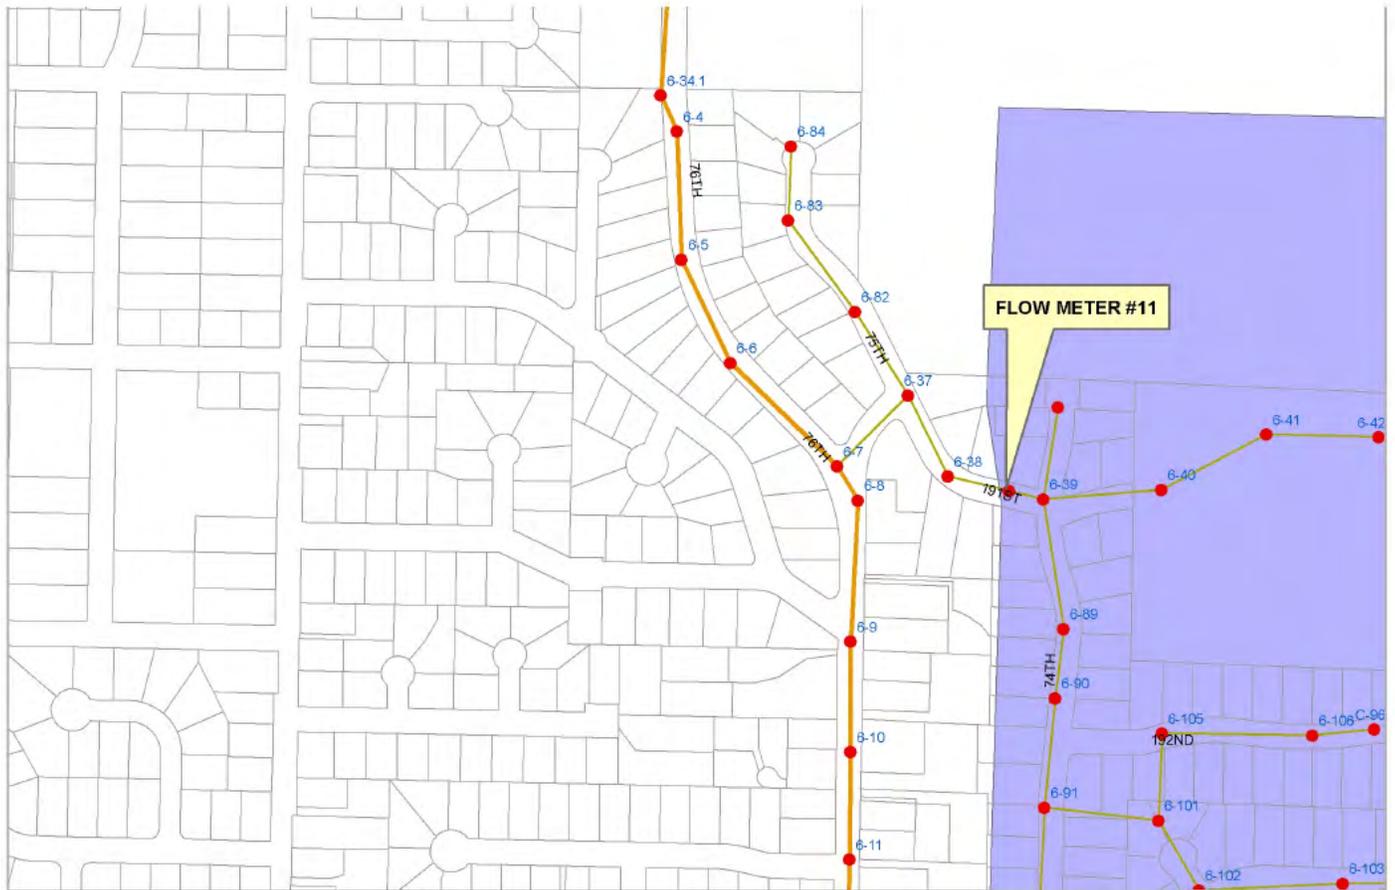
FLOW METER #11

1:400 scale

Basin: W gravity

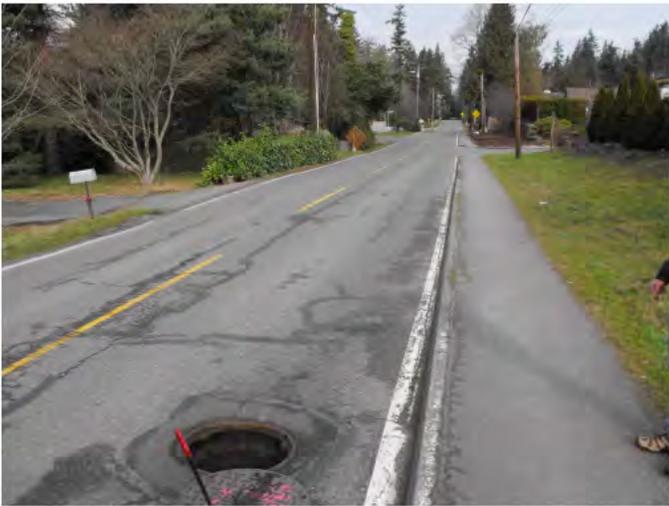
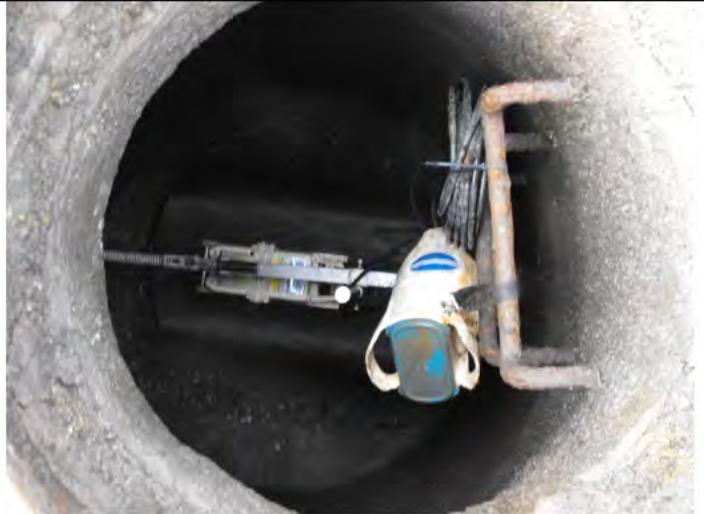
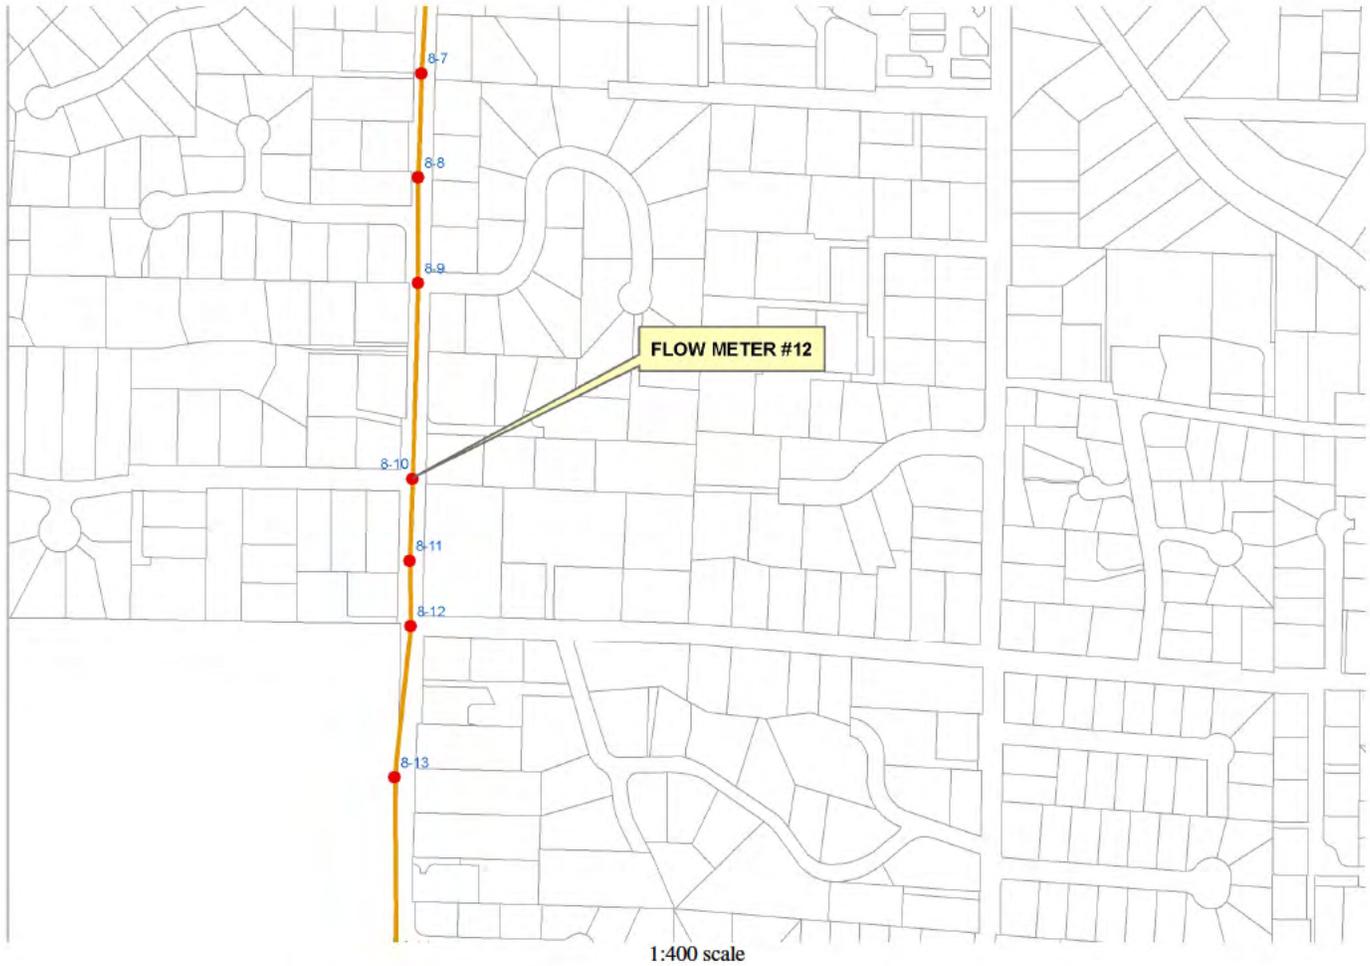
FLOW METER #12

Basin: To WWTP

Notes: This site (SSMH 8-10) is located along the northbound lane of 76th Ave. SW.
