FLOW METER SETUP REFERENCE SHEETS

CITY OF LYNNWOOD
 FIGURE B-1
 1992 & 2009 SMOKE TESTING RESULTS

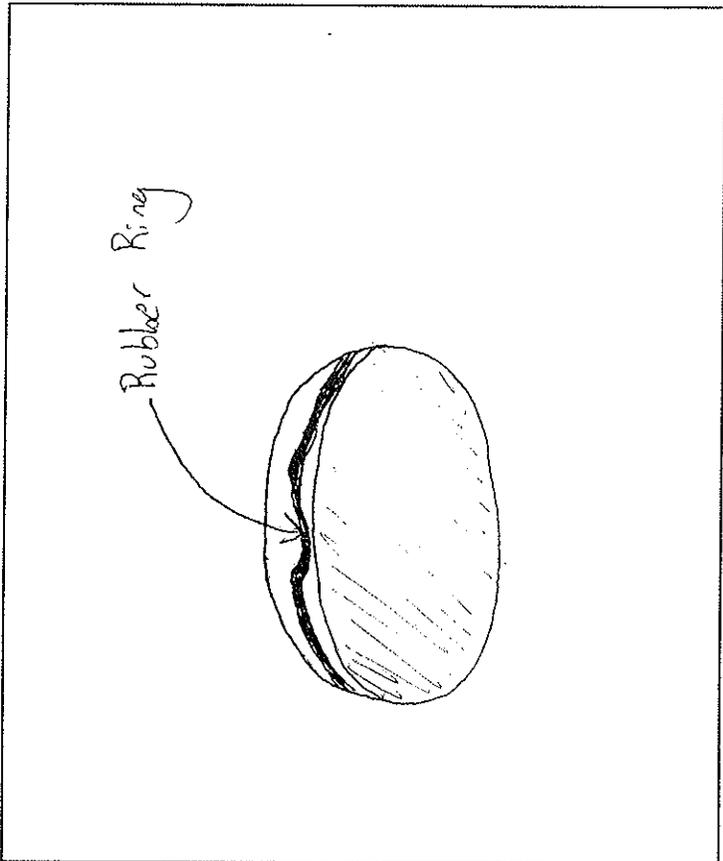
DESCRIPTION: Rubber ring around the man
hole is coming undone
-Minor

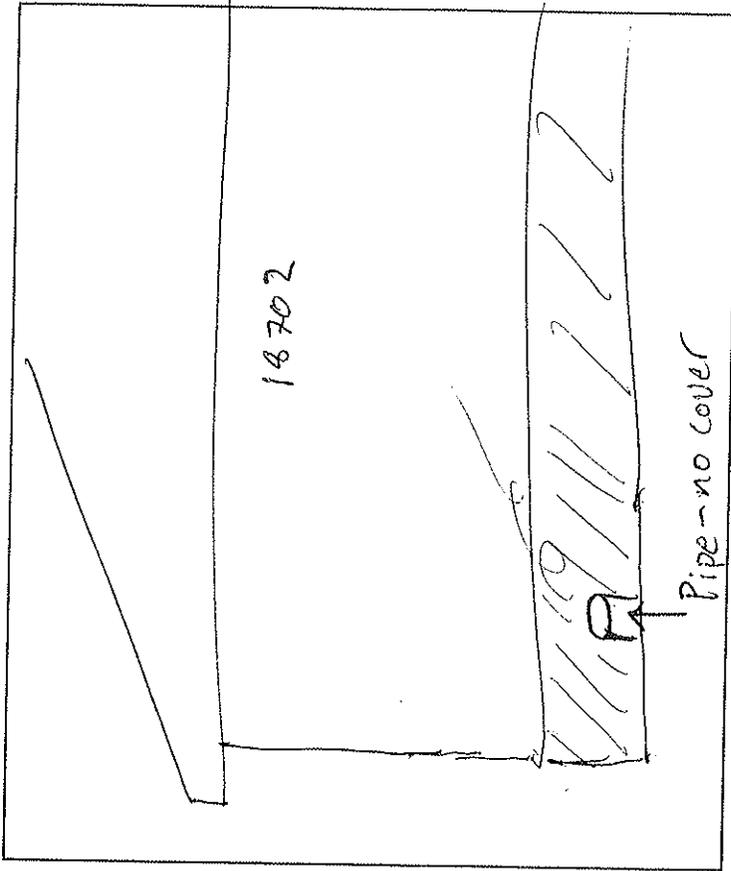
Pipe in the flower bed - looks like there is tape covering it; Minor

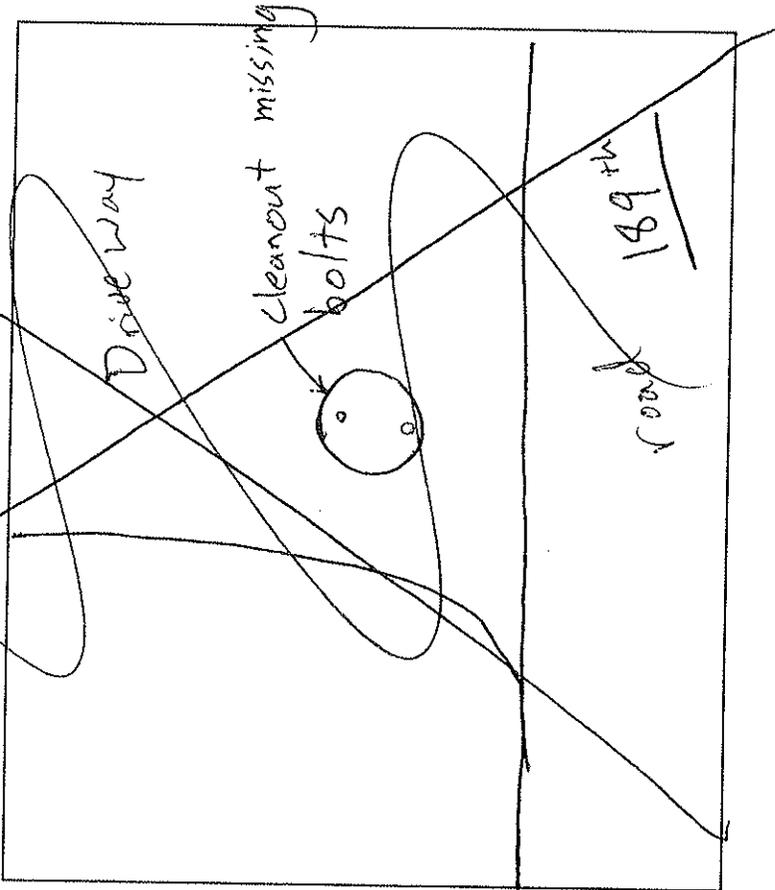
Cleanout missing bolts; Minor

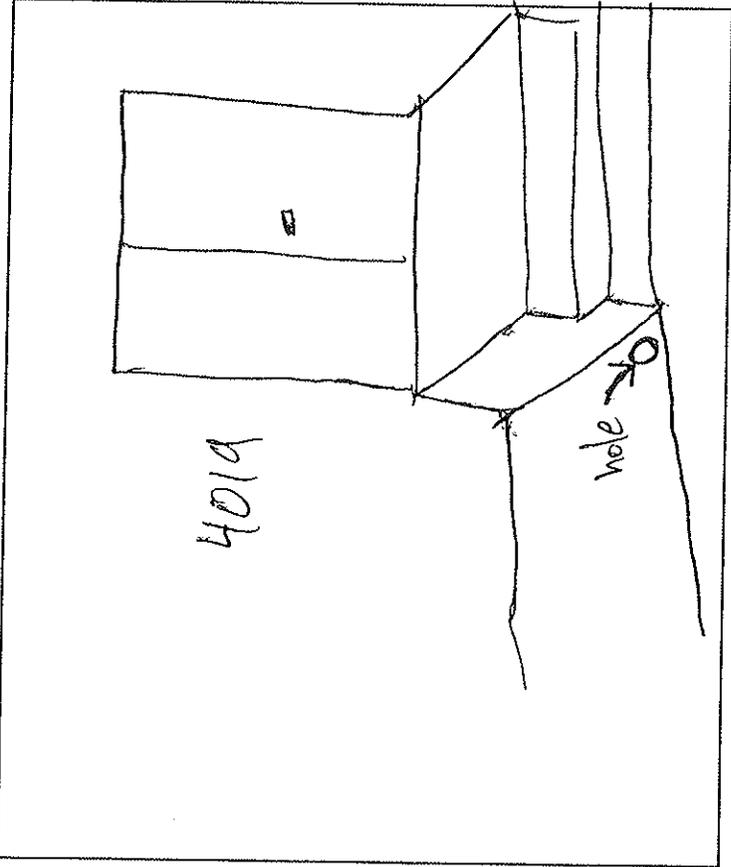
Small hole by steps to front door
- minor

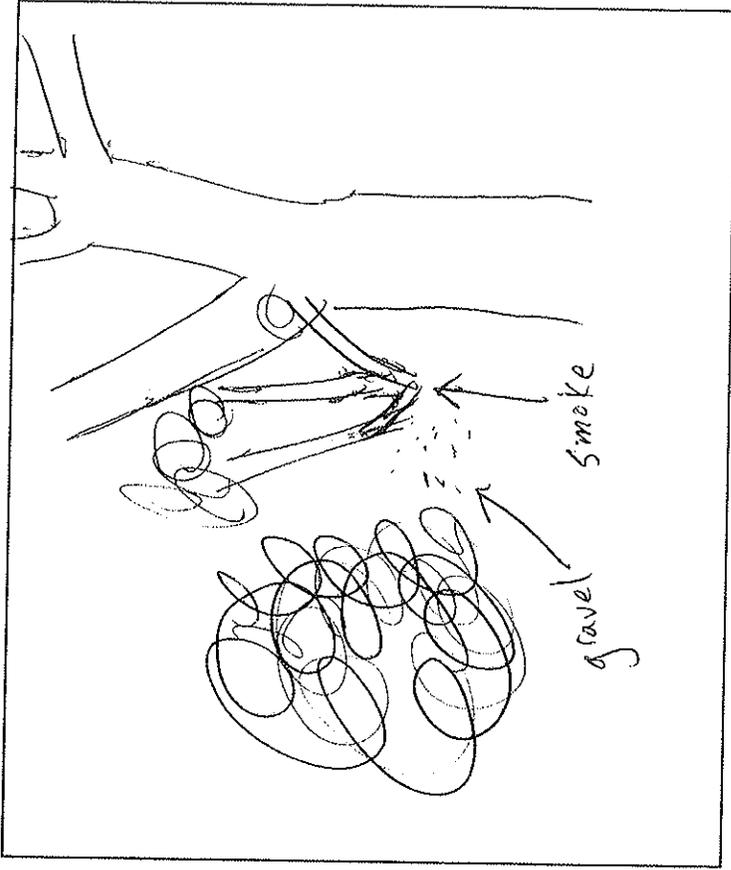
The base of the bush directly
in back of the tree.
medium - drains front lawn.

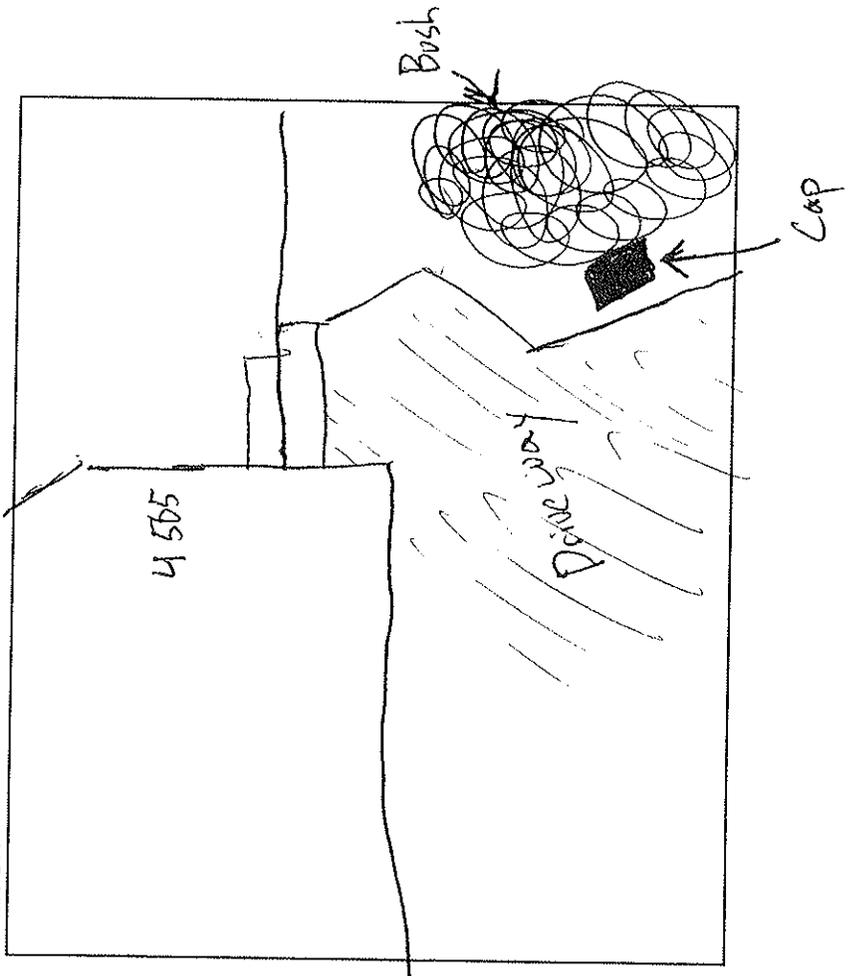
A covering from a storm water cap - ~~medium~~

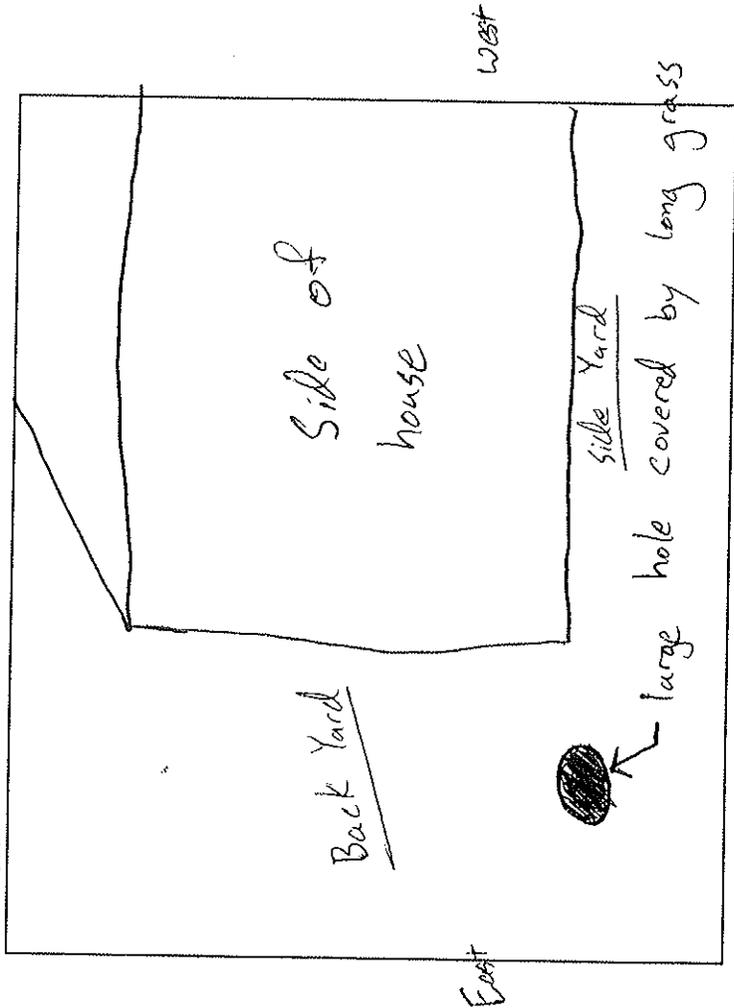
Large hole covered by long grass on the ~~side yard~~ north side yard. Medium drains yard.

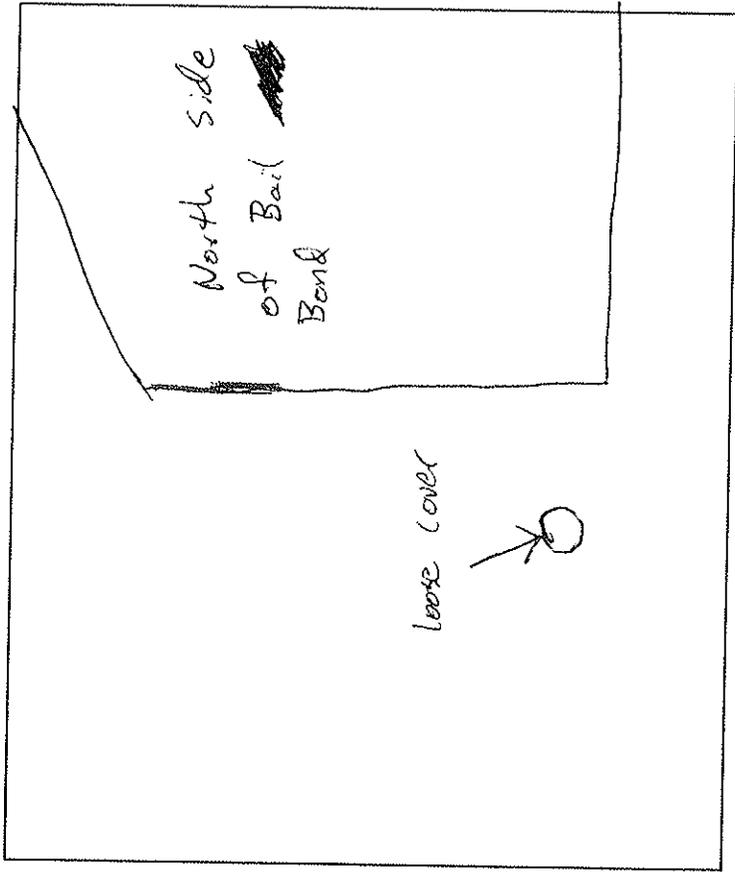
Very minor, probably not an issue. loose cover pushed up from smoke.

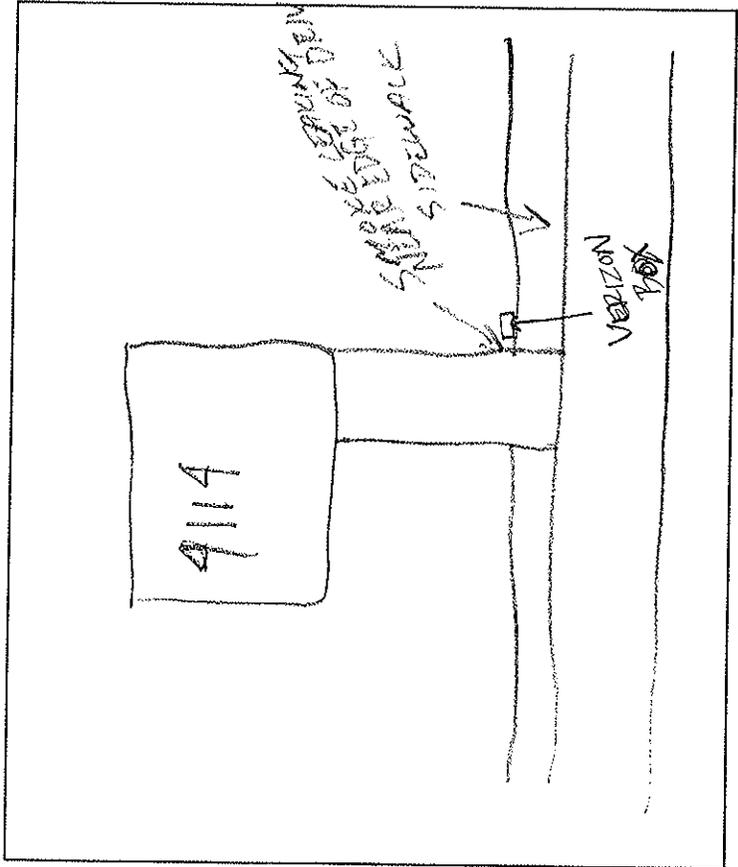
~~SMOKE~~ LEAK THROUGH DRIVEWAY

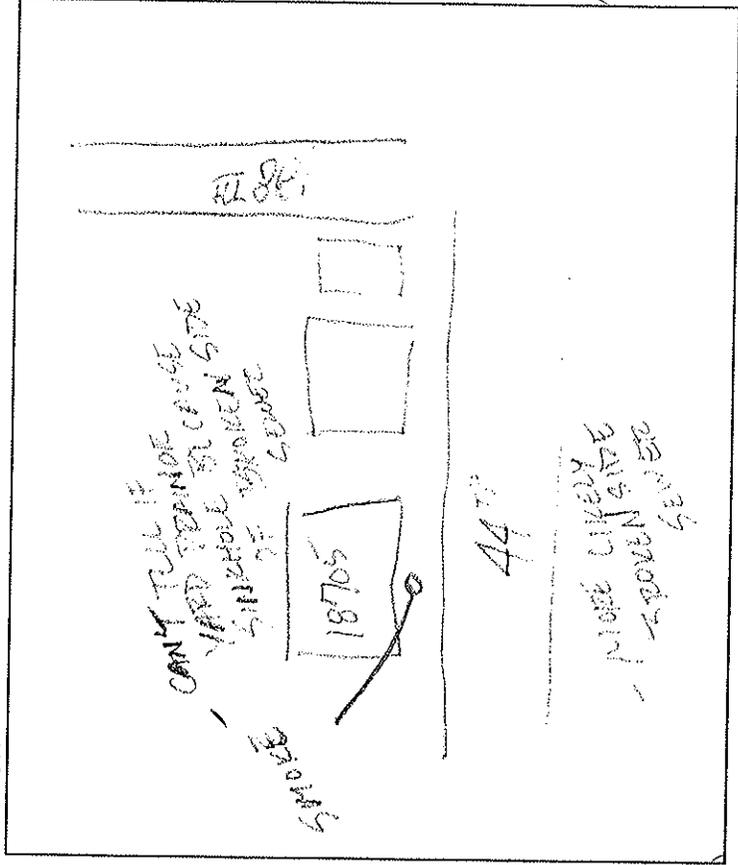
SMOKE COMING OUT OF
GROUND IN FRONT YARD
HOLE WHERE SMOKE COMES OUT

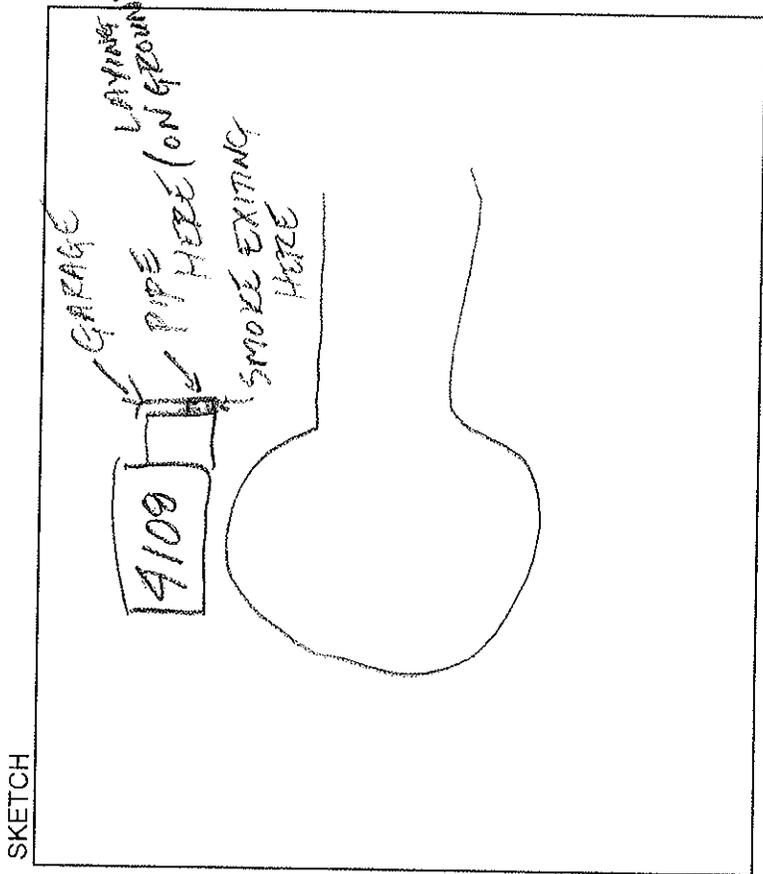
REF#: S-12 DATE: 7/15
INSPECTOR: MSF PHOTO NO.
LOCATION: 4108 106th SW

DESCRIPTION:
SMOKE POURING OUT OF
PIPE NEAR GARAGE

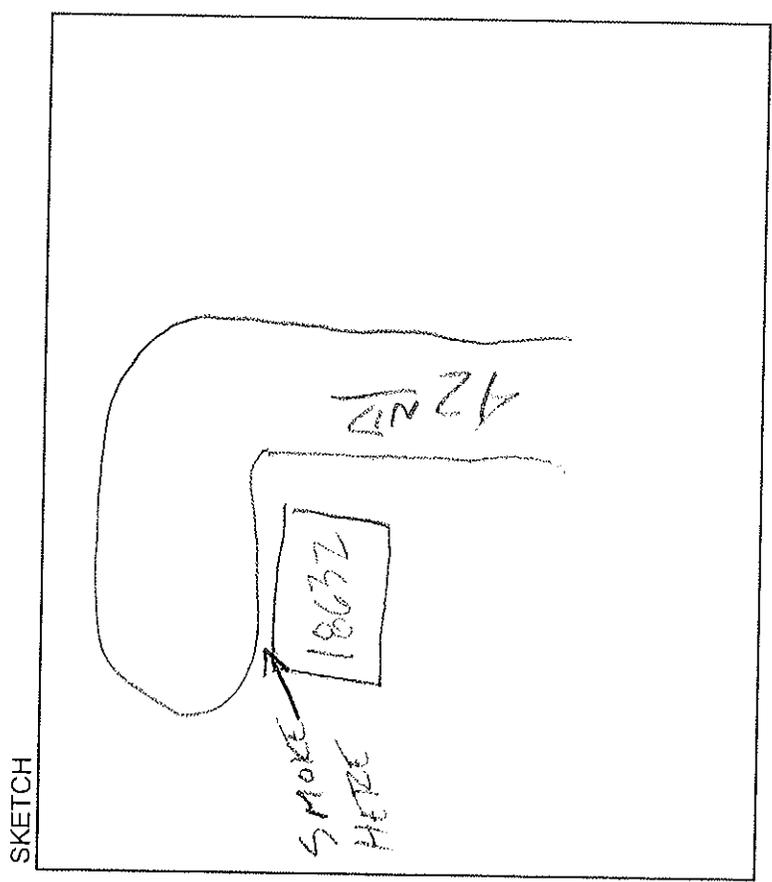
REF#: S-13 DATE: 7/15
INSPECTOR: MSF PHOTO NO.
LOCATION: 18632 42nd AVE

DESCRIPTION:
SMOKE COMING OUT
DOWNSPOUTS

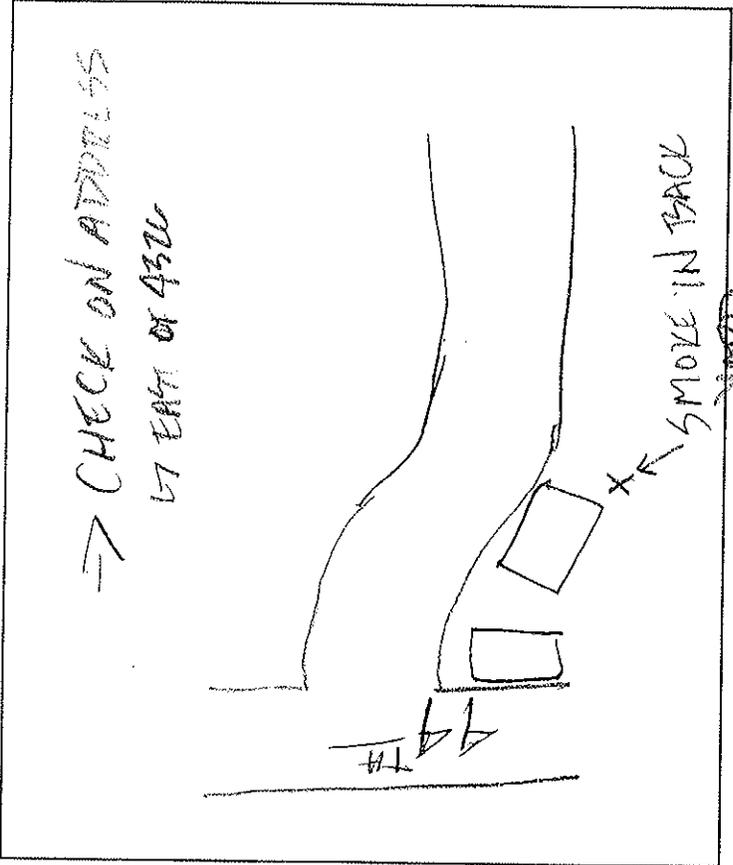
DESCRIPTION: YARD DRAIN

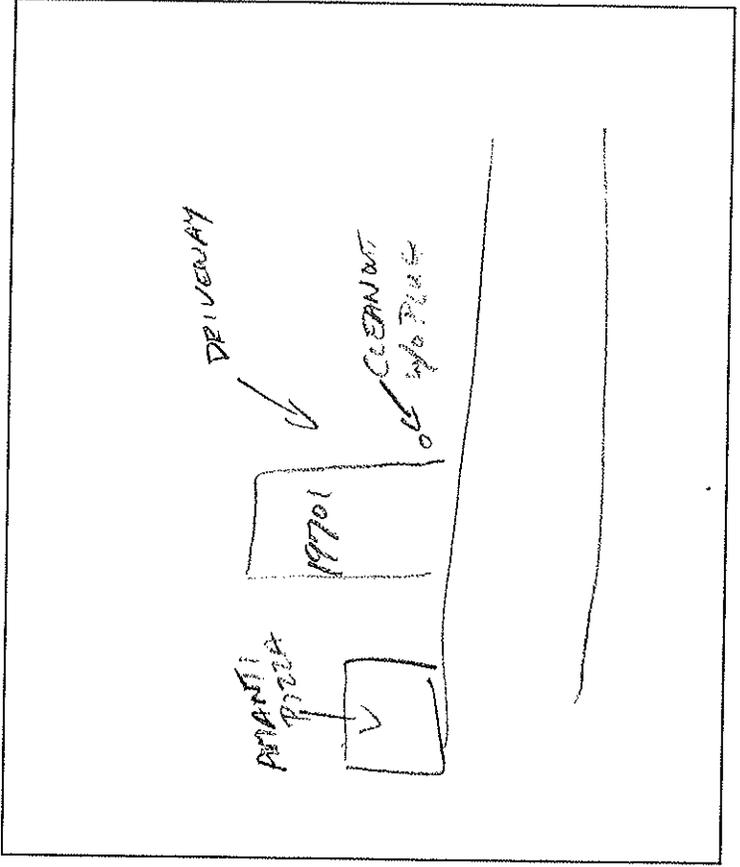
DESCRIPTION: CLEANOUT MISSING PLUG

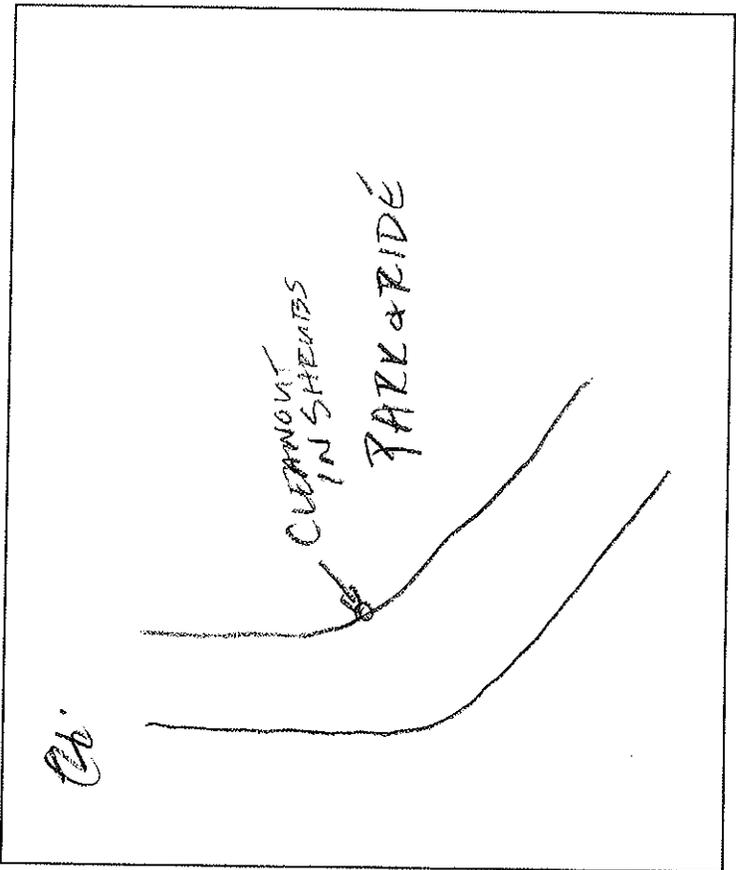
DESCRIPTION: CLEANOUT IN SHRUBS

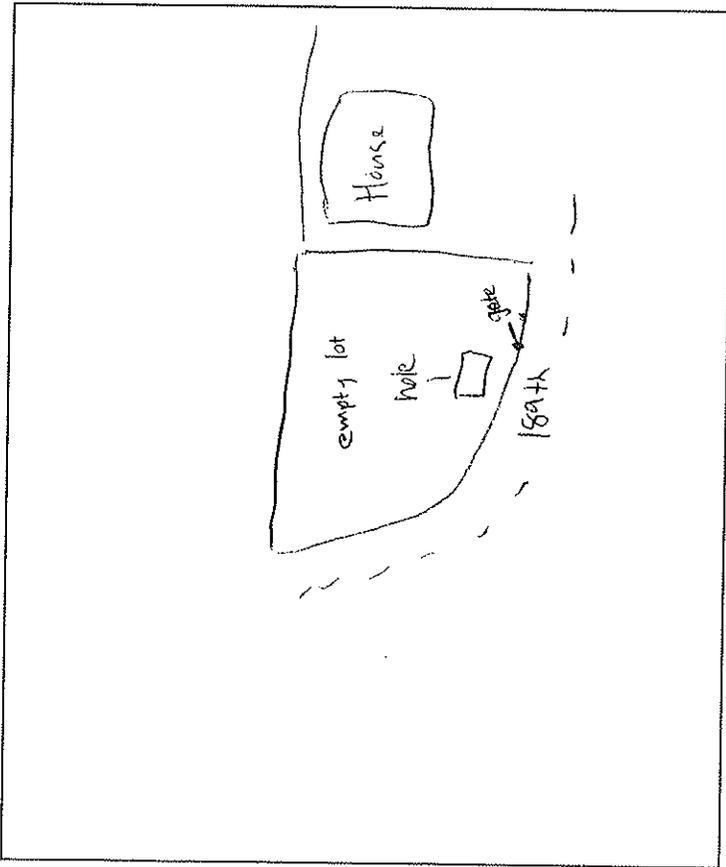
hole in ground in empty lot

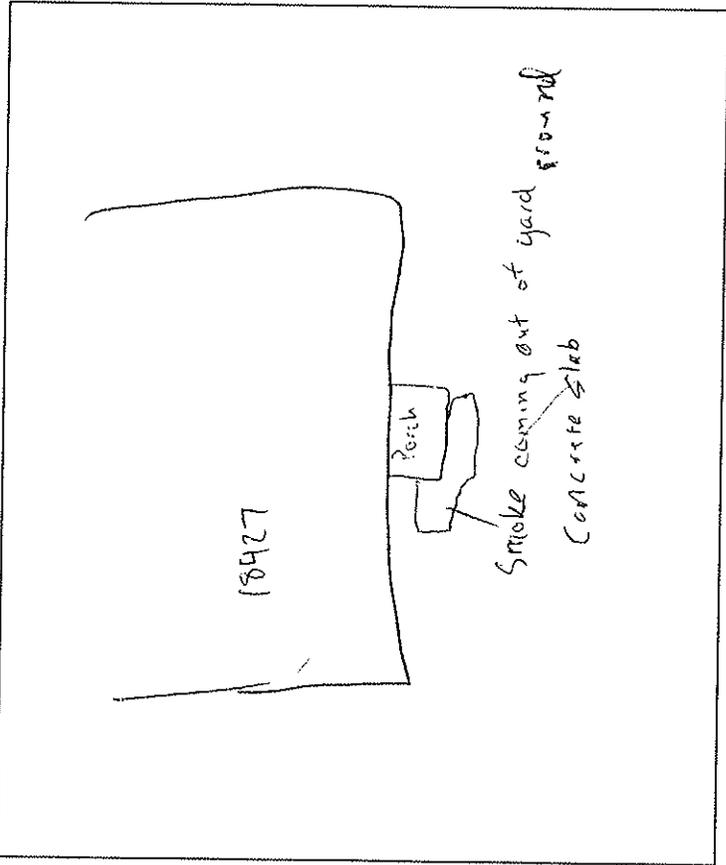
Smoke coming up through dirt around concrete slab. Pretty substantial

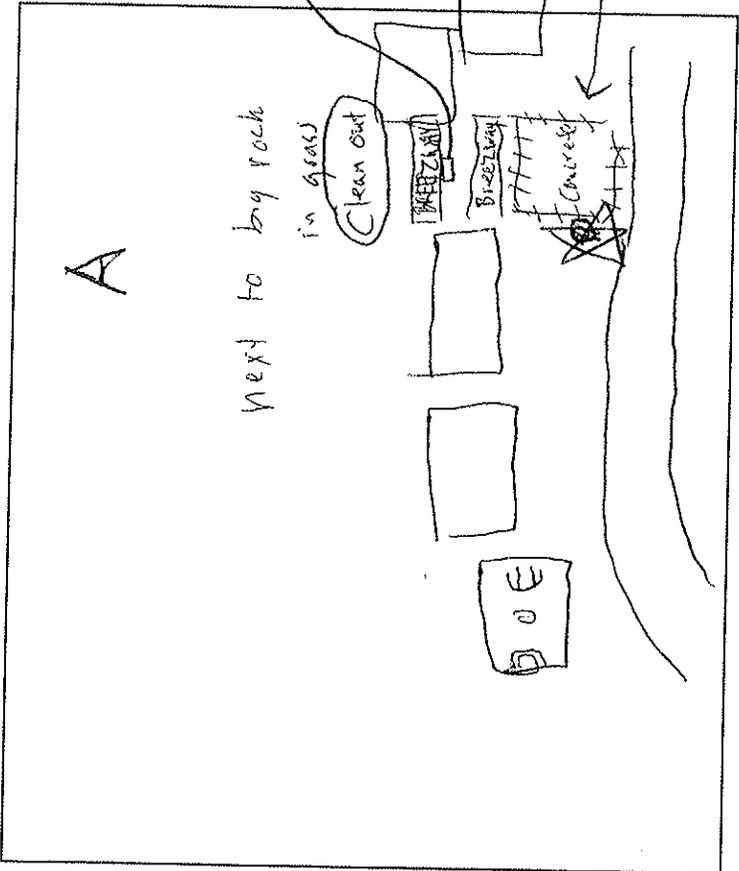
Cleared w/ loose lid in grass just off concrete slab.

Moderate potential for inflow

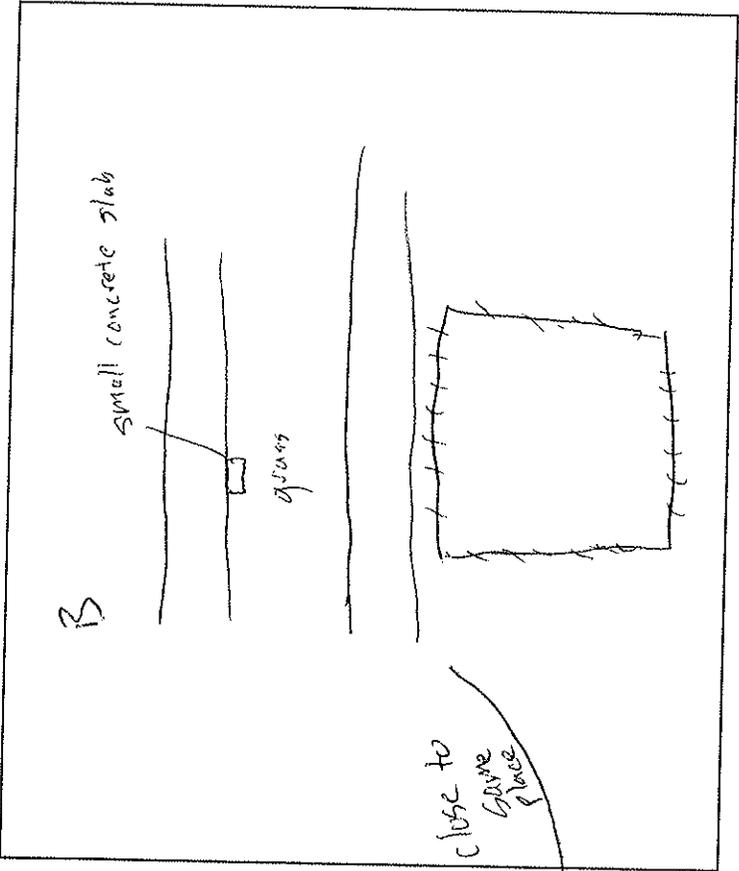
Moderate potential for inflow

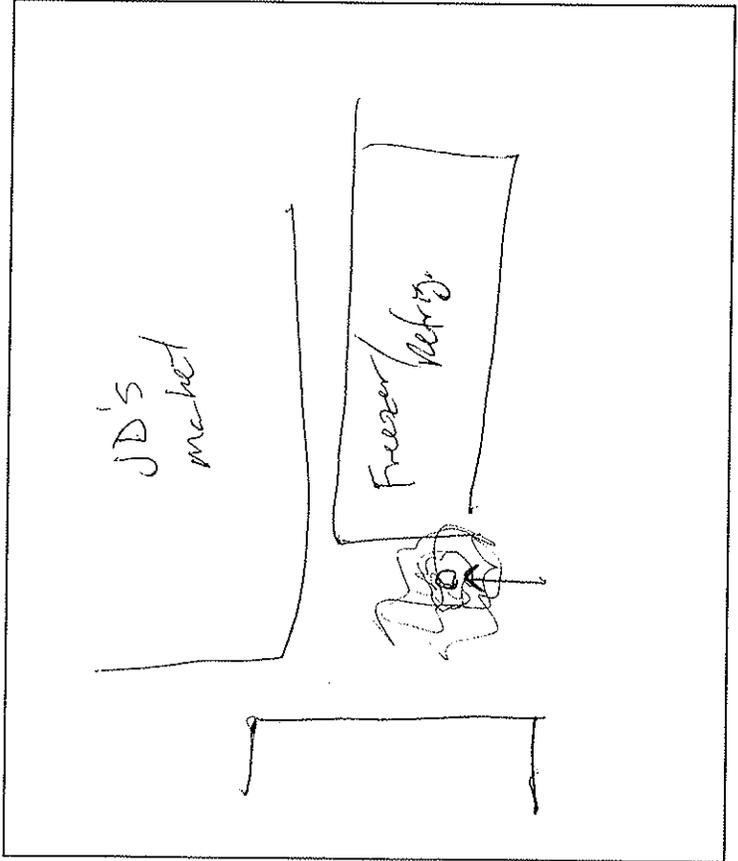
Cap loose on hole to sewer
behind freezer/refrig.

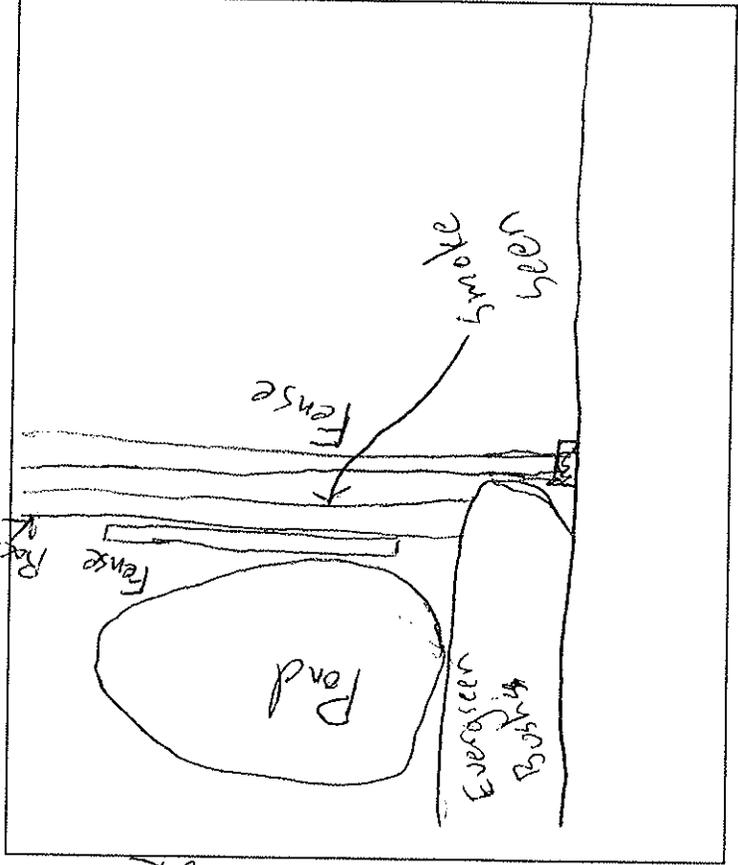
Smoke coming from ground and ceiling

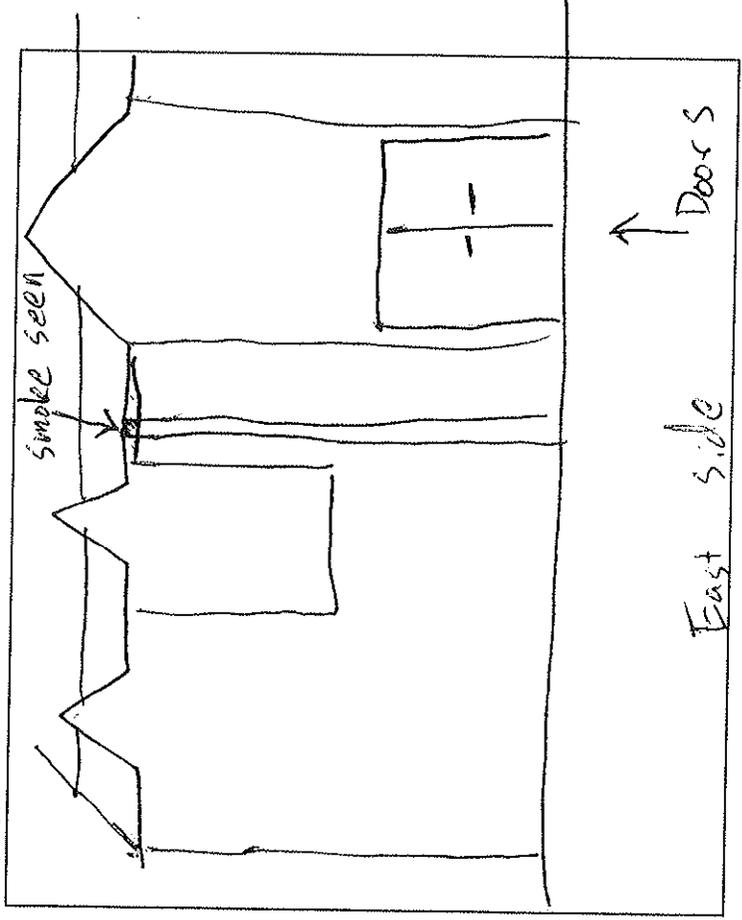
REF #: 5-23

East side of Building
Smoke seen from down spout

S-23	5-123-N/A	5-123	5-122	5108 196th St. SW, Lynnwood, WA	4	Downspout connected to sanitary sewer (smoke seen coming from downspout on the east side of the building).	Stormwater runoff from the building roof.	Medium	2009	Maintenance Issue
S-24	3-68.1-N/A	3-68.1	3-68	Southwest corner of Scriber Lake Ave. and 198th St. SW, Lynnwood, WA	4	Malfunctioning sewer (smoke seen coming from crack in sidewalk and from the side of the sidewalk).	Stormwater entering pipe through runoff from sidewalk. Potential groundwater infiltration.	Medium	2009	Infiltration / Inflow
S-25	3-70.1-N/A	3-70.1	3-68	5824 196th St SW, Lynnwood, WA (Jo-Ann Fabric)	4	Malfunctioning sewer connection (smoke seen coming from under concrete slab on southwest corner of Jo-Ann Fabric).	Stormwater entering pipe through runoff from sidewalk. Potential groundwater infiltration.	Medium	2009	Infiltration / Inflow
S-26	3-101-N/A	3-101	3-100	5521 190th St SW Lynnwood, WA	4	Downspout connected to sanitary sewer.	Stormwater runoff from the building roof.	Medium	1992	Maintenance Issue

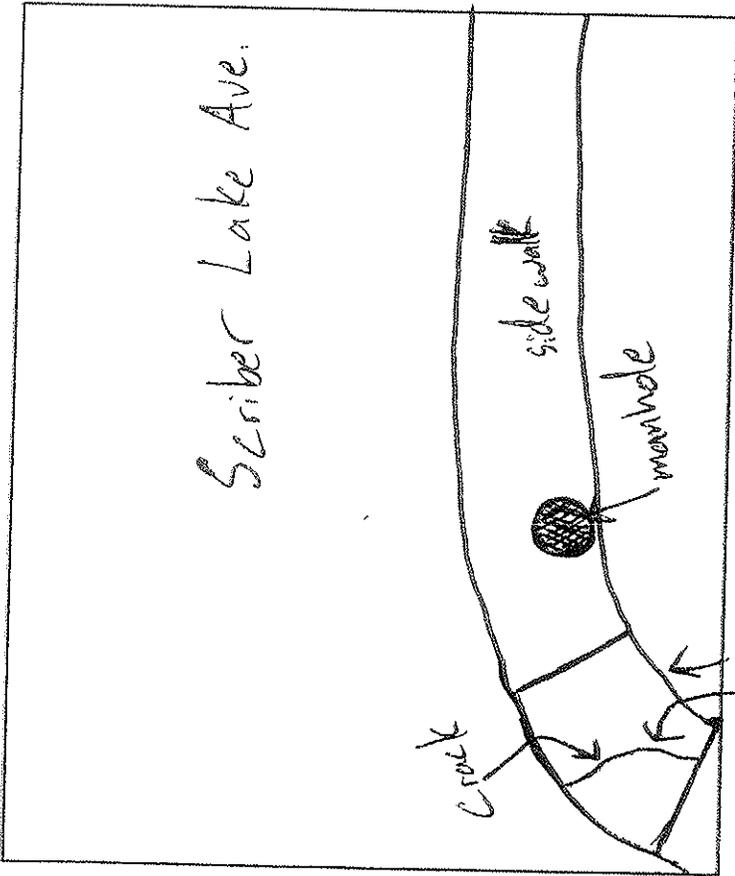
REF#: S-24 DATE: 8/6/09
INSPECTOR: DK PHOTO NO. 81-~~84~~ 84

DESCRIPTION: smoke coming from crack in sidewalk
and from pop hole of the side walk

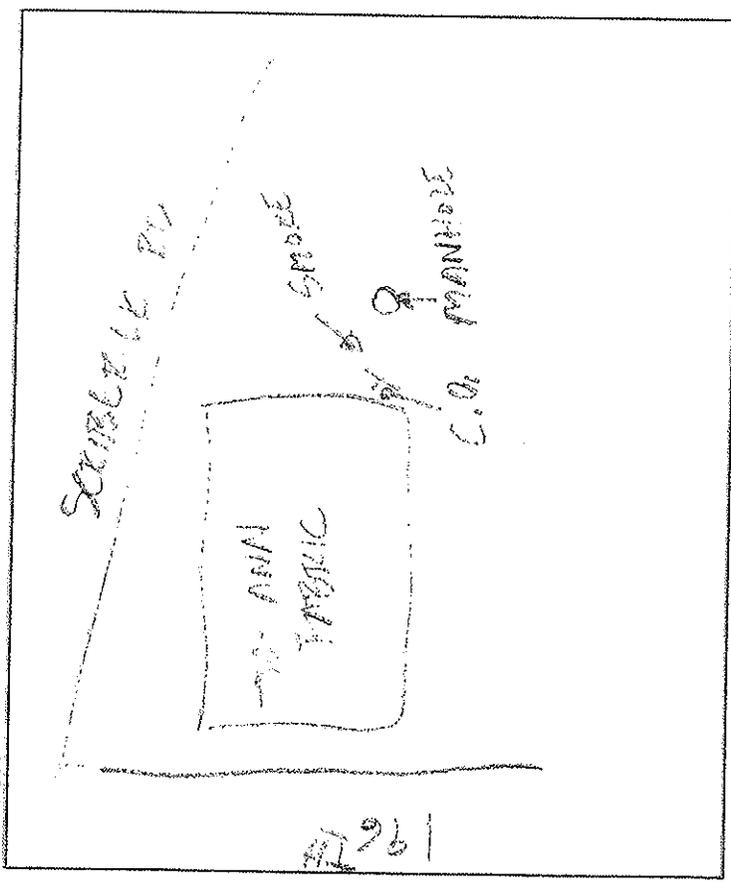
DESCRIPTION: SAMPLE EXAMINATING FROM
UNDER CONCRETE

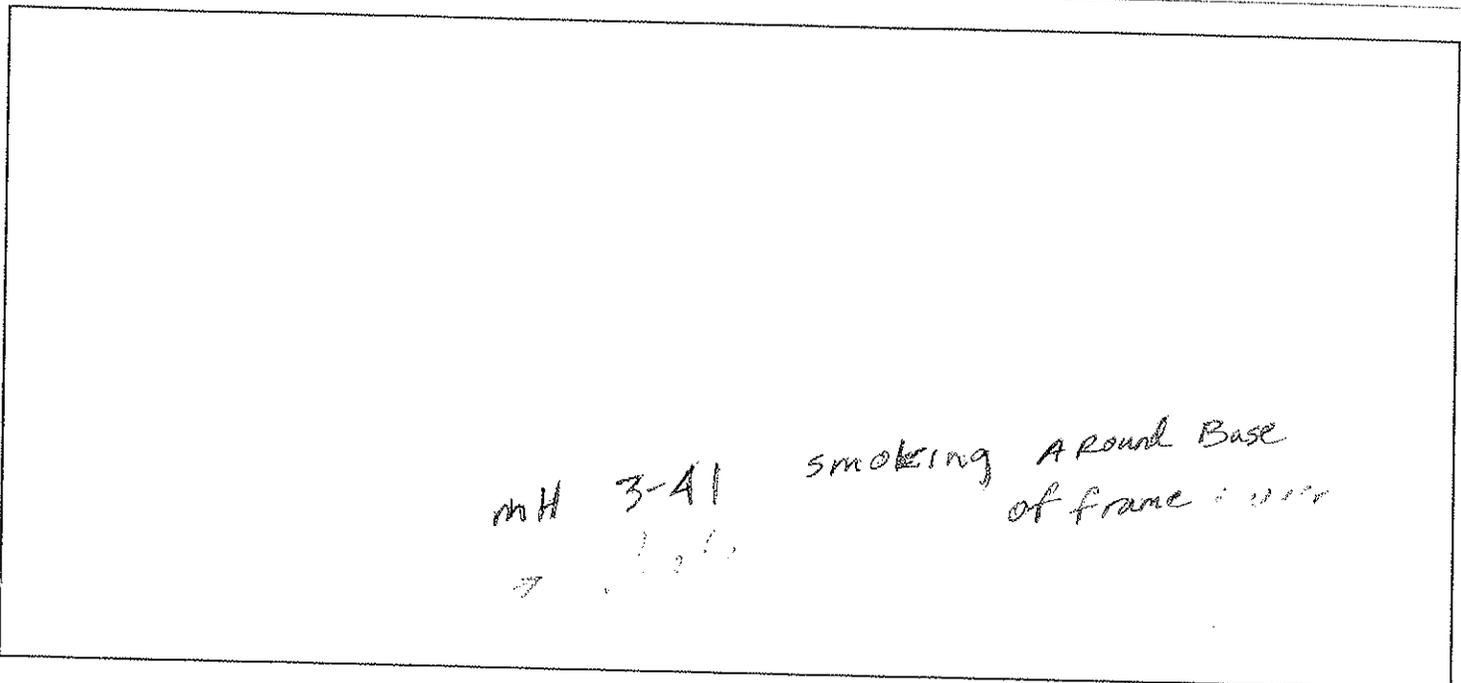
mH 3-41 smoking around Base of frame

Observed Smoke Return

Photo No.: DR 11A
Probable Cause: _____

Recommended Rehab: replace frame
d. Dunbar

S-39	3-45-N/A	3-45	3-45	MH 3-45 in Lynnwood, WA	4	Brick and mortar missing in manhole neck.	Potential groundwater infiltration.	Light	1992	Maintenance Issue
S-40	3-41-N/A	3-41	3-41	MH 3-41 in Lynnwood, WA	4	Smoke emanating from base of manhole frame and cover.	Stormwater runoff from area adjacent to manhole. Potential groundwater infiltration.	Light	1992	Maintenance Issue
S-41	3-60-N/A	3-60	3-59	5502 200th St SW, Lynnwood, WA	4	Missing cleanout cap and/or plug.	Stormwater entering cleanout.	Light	1992	Maintenance Issue
S-42	3-15-N/A	3-15	3-10	19925 53rd Ave W, Lynnwood, WA	4	Drain in front of garage at base of driveway.	Stormwater runoff from driveway	Medium	1992	Maintenance Issue
S-43	3-12-N/A	3-12	3-11	20020 53rd Pl W, Lynnwood, WA	4	Smoke emanating from joint between concrete sidewalk and asphalt. (Possibly either leaky side sewer pipe or unplugged cleanout under asphalt)	Stormwater runoff from concrete. Potential groundwater infiltration.	Medium	1992	Infiltration / Inflow

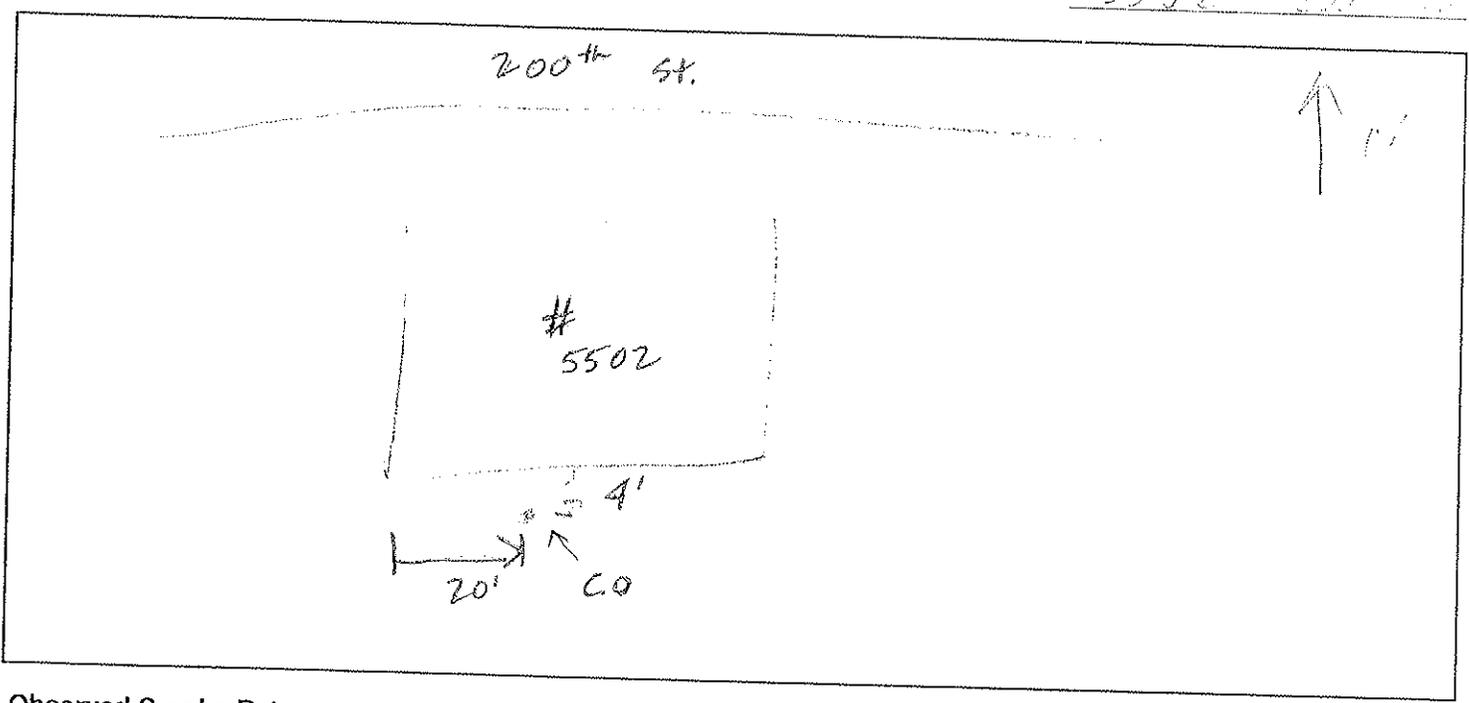
SMOKE TEST RESULTS

Client: City of Lynnwood
 Project: LS#10 I/I Study
 Date: _____
 Time: 10:55
 Observer: DK

Job Number: 91795.04
 Sewer Reach: MH 3-53 to
MH 3-60
 Smoke Bomb at MH: 3-60
 Smoke Return No.: _____
 Street Location: 5502 200th St

Observed Smoke Return

Photo No.: DR 15 (DR)
 Probable Cause: _____
cleared inlet
MC cover on
plug

Recommended
 Rehab: _____
install plug in
cleared

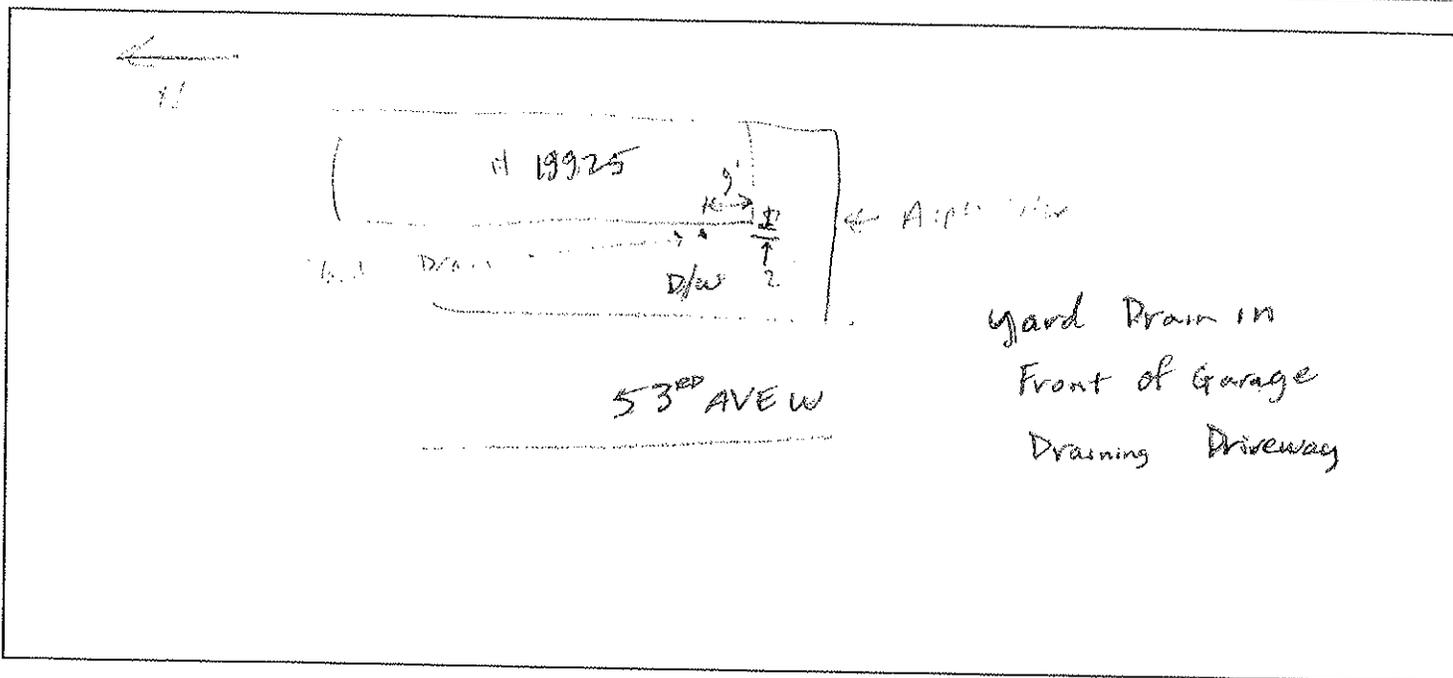
S-42

SMOKE TEST RESULTS

Client: City of Lynnwood
 Project: LS#10 I/I Study
 Date: 12-4-92
 Time: 1:40 PM
 Observer: DS

Job Number: 91795.04
 Sewer Reach: MH 3-5 to
MH 3-10
 Smoke Bomb at MH: 3-15
 Smoke Return No.: _____
 Street Location: 19925 53RD AVE

Observed Smoke Return

Photo No.: DR 16 (12)
 Probable Cause: _____

Yard Drain -
Very good source of
inflow - which
Drains Asph. Driveway

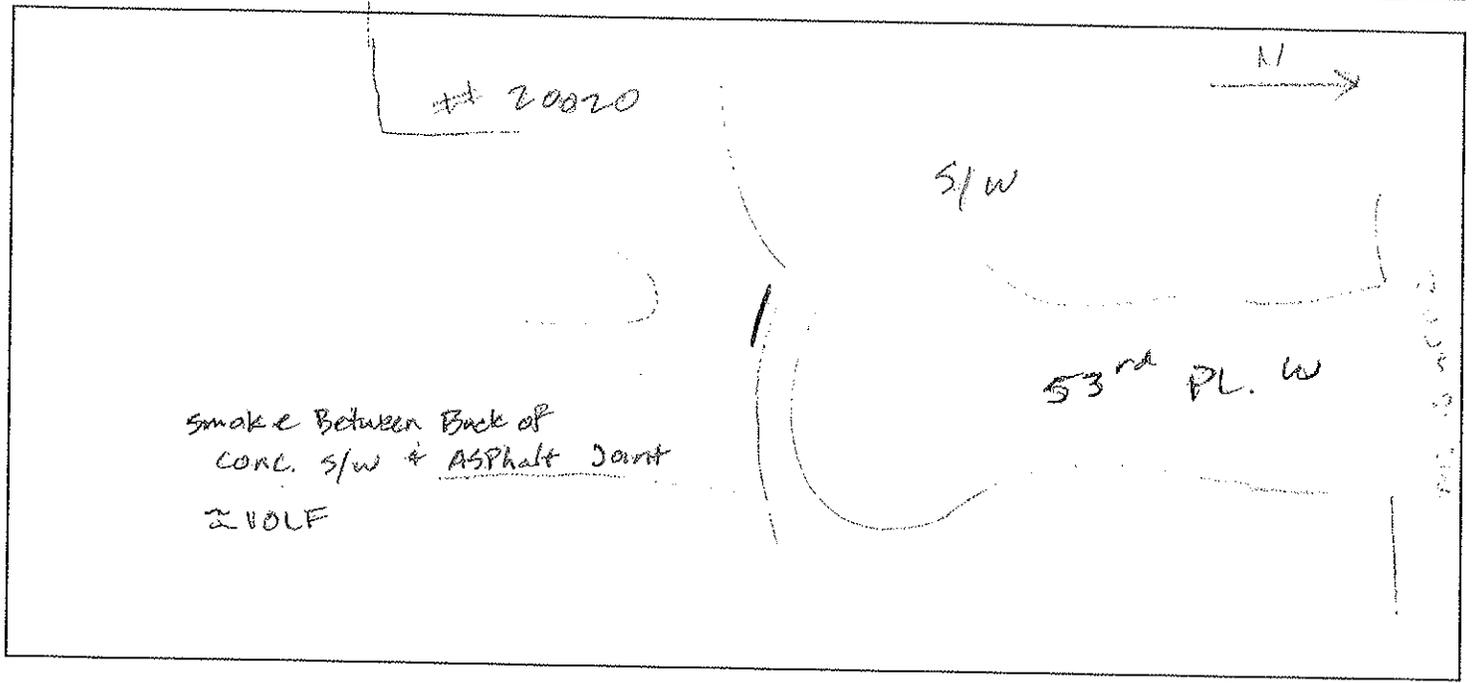
S-43

SMOKE TEST RESULTS

Client: City of Lynnwood
 Project: LS#10 I/I Study
 Date: _____
 Time: 2:15 PM
 Observer: [Signature]

Job Number: 91795.04
 Sewer Reach: MH 3.5 to
MH 3.2
 Smoke Bomb at MH: S-12
 Smoke Return No.: _____
 Street Location: 20070 53rd Ave

Observed Smoke Return

Photo No.: DR17
11/11/10
 Probable Cause: _____
S/W seen
Leaking, possible
C.O. under asphalt
and plugged

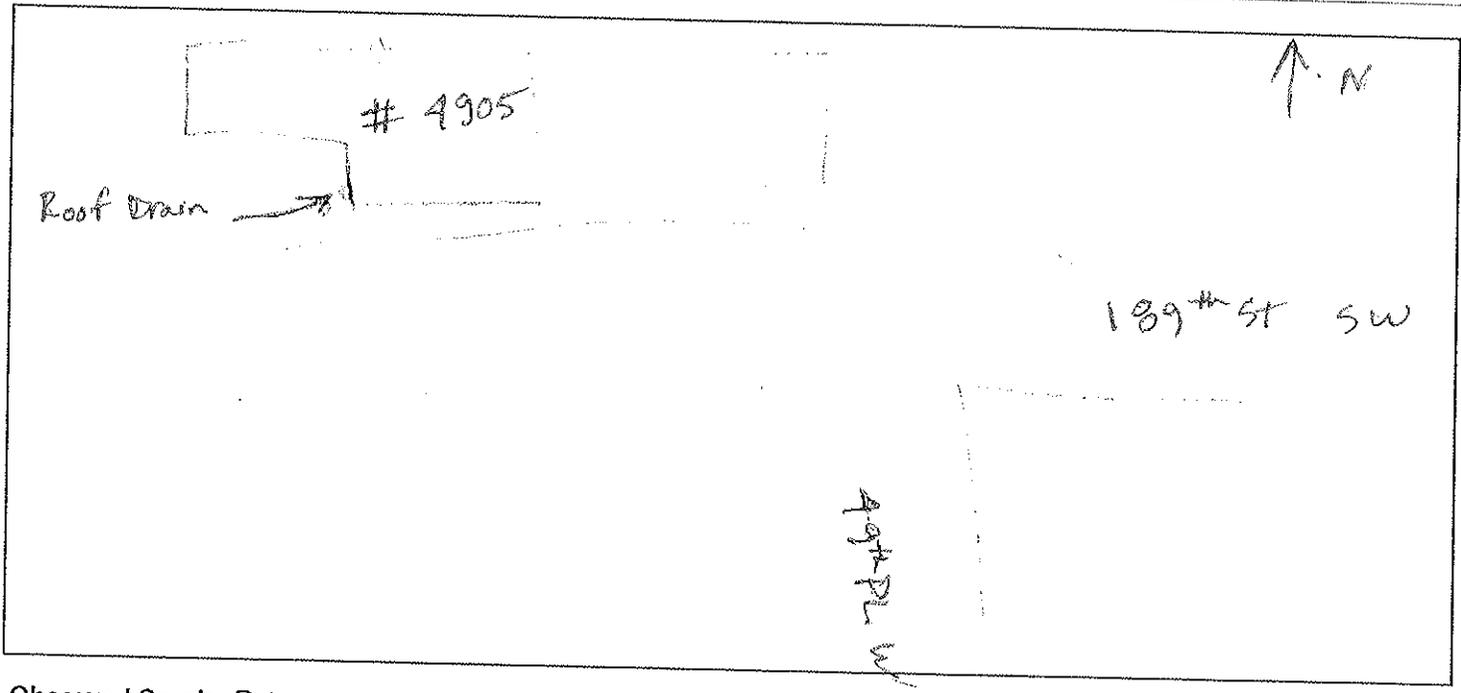
SMOKE TEST RESULTS

Client: City of Lynnwood
 Project: LS#10 I/I Study
 Date: 12/7/92
 Time: 9:10
 Observer: D, R

Job Number: 91795.04
 Sewer Reach: MH 5-167 to
MH 5-164
 Smoke Bomb at MH: 5-166
 Smoke Return No.: _____
 Street Location: 189th ST SW

Observed Smoke Return

Photo No.: OR 18
 Probable Cause: _____
Roof Drain @ #
4905 180th ST.
only one Roof Drain
smoking

S-44	5-166-N/A	5-166	5-164	4905 189th St SW, Lynnwood, WA	4	Downspout connected to sanitary sewer.	Stormwater runoff from the building roof.	Medium	1992	Maintenance Issue
S-45	5-152-N/A	5-152	5-152	MH 5-152 in Lynnwood, WA	4	Manhole located in drainage way. Puddles form on manhole cover.	Stormwater entering through manhole. Potential groundwater infiltration.	Medium	1992	Issue, Infiltration/Inflow
S-46	5-152-N/A_2	5-152	5-151	4928 190th St SW, Lynnwood, WA	4	Loose cleanout cap under deck on rear of house.	Stormwater entering cleanout.	Light	1992	Maintenance Issue
S-47	C-71-N/A	C-71	3-70	19620 Scriber Lake Road, Suite A, Lynnwood, WA	4	Smoke emanating from hole next to sidewalk in planter.	Stormwater and/or groundwater entering cleanout cap. Potential groundwater infiltration through malfunctioning sewer pipe.	Unknown	1992	Unknown
S-48	3-27-N/A	3-27	3-26	5320 201st Pl SW, Lynnwood, WA	4	Drain in driveway.	Stormwater runoff from driveway	Medium	1992	Maintenance Issue
