FLOW METER SETUP REFERENCE SHEETS

CITY OF LYNNWOOD
 FIGURE B-1
 1992 & 2009 SMOKE TESTING RESULTS

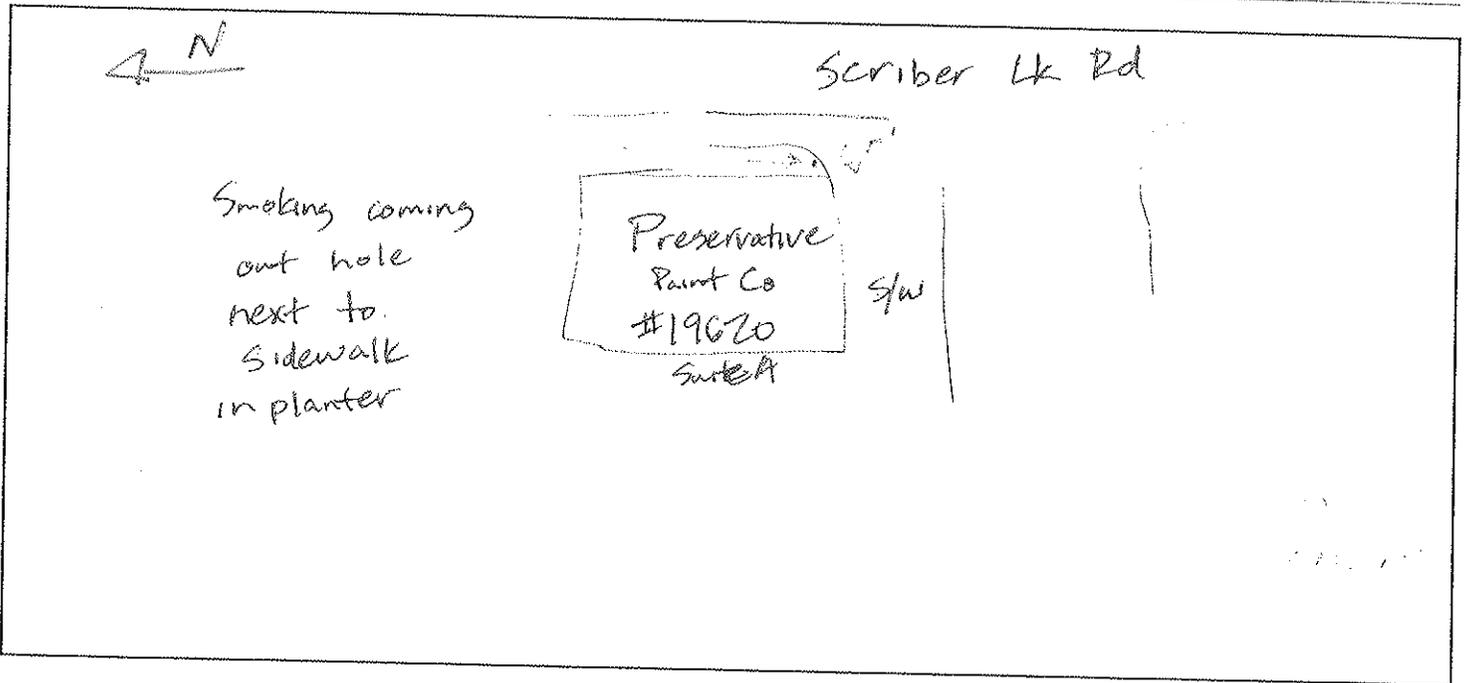
S-47

SMOKE TEST RESULTS

Client: City of Lynnwood
 Project: LS#10 I/I Study
 Date: 12-7-92
 Time: 11:30
 Observer: D.R.

Job Number: 91795.04
 Sewer Reach: MH to MH
 Smoke Bomb at MH: _____
 Smoke Return No.: _____
 Street Location: _____

Observed Smoke Return

Photo No.: DR 19

Probable Cause: _____
Broken S/S
or Cleanout with
No Cover

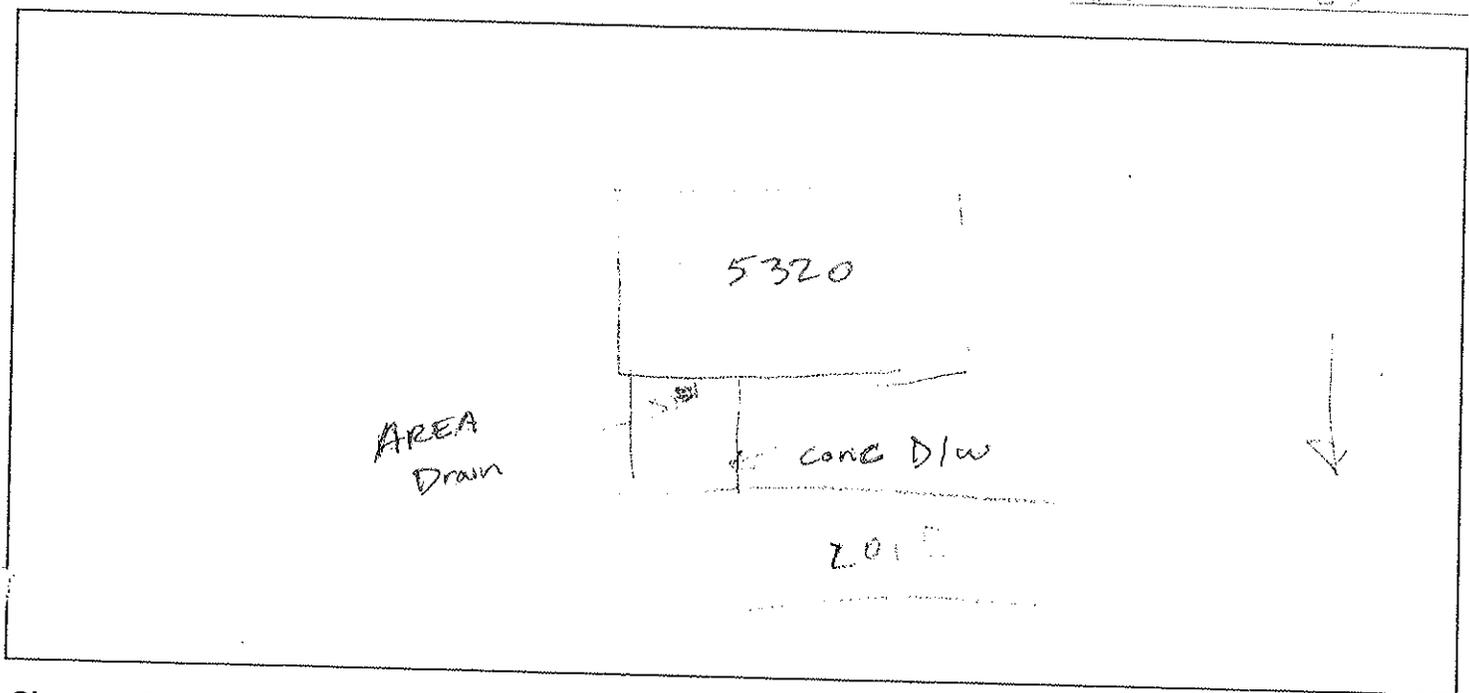
5-48

SMOKE TEST RESULTS

Client: City of Lynnwood
 Project: LS#10 I/I Study
 Date: 2-7-
 Time: 7:00 AM
 Observer: ---

Job Number: 91795.04
 Sewer Reach: MH 327 to
MH 324
 Smoke Bomb at MH: 327
 Smoke Return No.: ---
 Street Location: 5300 22nd

Observed Smoke Return

Photo No.: 120
 Probable Cause: Area Drain collecting
All of DIW
Drainage

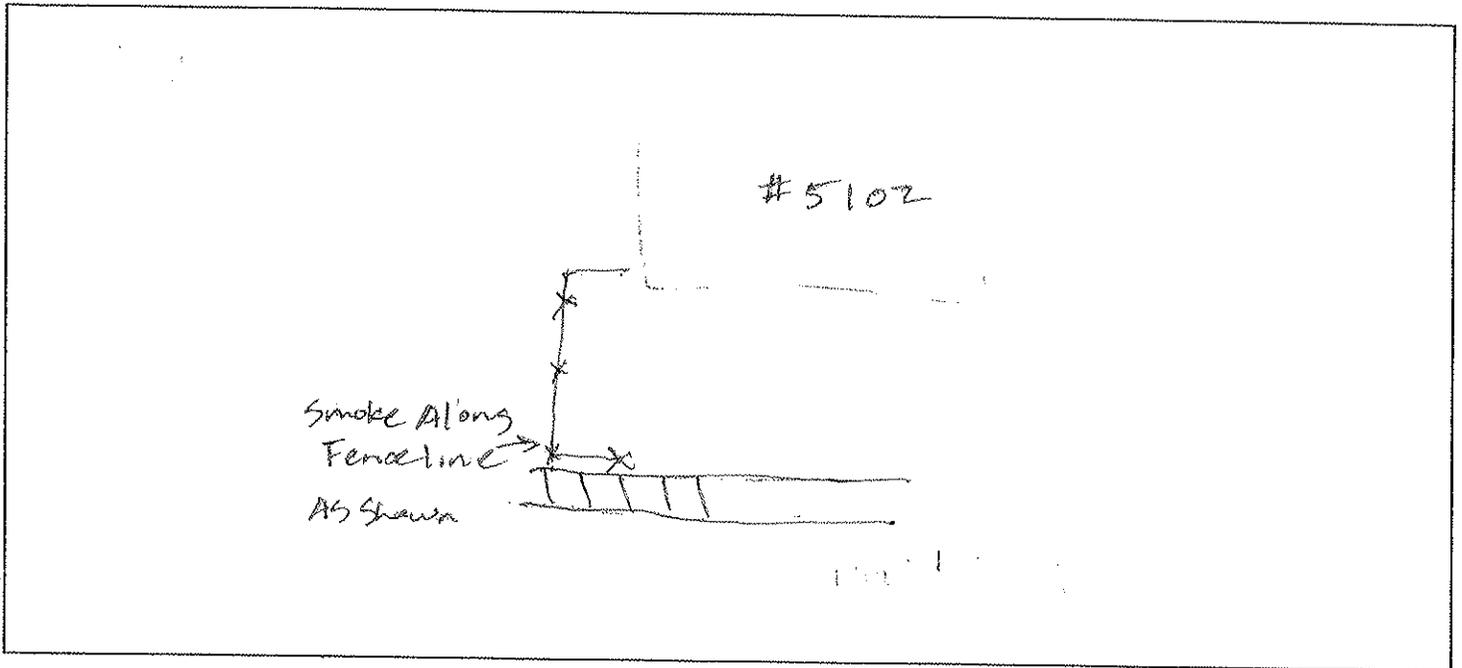
SMOKE TEST RESULTS

Client: City of Lynnwood
 Project: LS#10 I/I Study
 Date: 12-8-92
 Time: 4:30AM
 Observer: D.R.

Job Number: 91795.04
 Sewer Reach: MH 5-150 to
MH 5-141 to 5-151
 Smoke Bomb at MH: 5-149
 Smoke Return No.: _____
 Street Location: _____

Observed Smoke Return

Photo No.: DR #21-23
 Probable Cause: _____
Broken Side Sewer
Smoke seen along
Fence line AS shown
50 LF

S-49	C5-131-N/A	C5-131	5-149	5103 192nd St SW, Lynnwood, WA	4	Smoke emanating from ground along fence line. (Likely broken side sewer.)	Possibly stormwater and/or groundwater infiltrating pipe.	Medium	1992	Infiltration / Inflow
S-50	3-20-N/A	3-20	3-19	20121 Cedar Valley Rd, Lynnwood, WA (Stoneway Electric Supply)	4	Smoke emanating from unknown source in ground. Source covered with stickers. Possibly a bad cleanout.	Stormwater and/or groundwater entering cleanout cap. Potential groundwater infiltration through malfunctioning sewer pipe.	Unknown	1992	Unknown
S-51	5-163-N/A	5-163	5-163	MH 5-163 in Lynnwood, WA	4	Manhole below grade.	Stormwater entering through manhole cover.	Light	1992	Issue,
S-52	5-160-N/A	5-160	5-159	18915 51st Pl W, Lynnwood, WA	4	Missing cleanout cap.	Stormwater entering cleanout.	Light	1992	Maintenance Issue
S-53	5-132-N/A	5-132	5-132.1	52nd Ave W and 191st St SW in Lynnwood, WA	4	Smoke emanating from ground near old house foundation with side sewer connection not plugged.	Stormwater and/or groundwater entering pipe through uncapped cleanout at grade and/or infiltration of side sewer.	Medium	1992	Maintenance Issue, Infiltration/Inflow

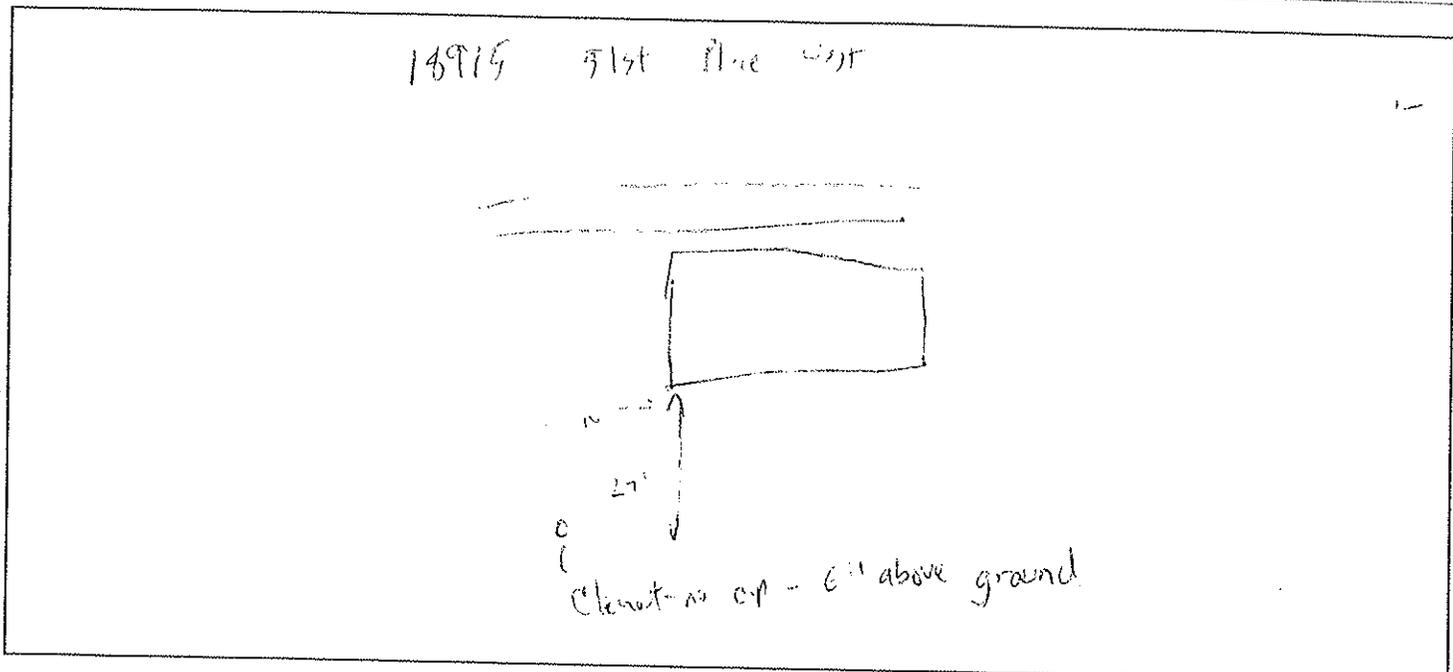
5-52

SMOKE TEST RESULTS

Client: City of Lynnwood
 Project: LS#10 I/I Study
 Date: 11/1/12
 Time: 1:30
 Observer: DRH

Job Number: 91795.04
 Sewer Reach: MH 5-113 to MH 5-113
 Smoke Bomb at MH: 5-113
 Smoke Return No.: _____
 Street Location: _____

Observed Smoke Return

Photo No.: DR-01
 Probable Cause: Cleanout
w. no cap

Recommended
 Rehab: inst cap

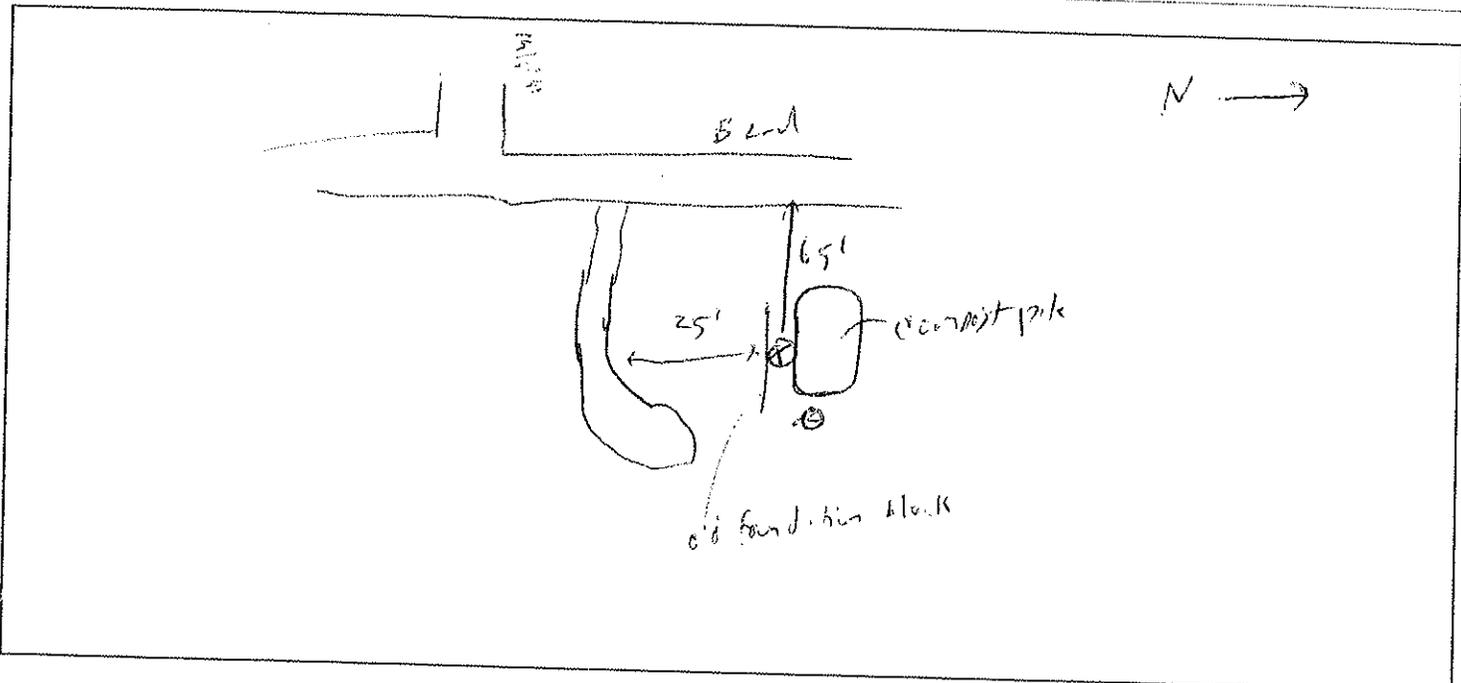
S-53

SMOKE TEST RESULTS

Client: City of Lynnwood
Project: LS#10 I/I Study
Date: 12/18/12
Time: 3:30
Observer: DWH

Job Number: 91795.04
Sewer Reach: MH 5-132 to
MH 5-130
Smoke Bomb at MH: 5-132
Smoke Return No.: _____
Street Location: 52nd ~ 1st St

Observed Smoke Return

Photo No.: 2
Probable Cause: _____
- old brick foundation with
SS connection not plugged
(buried, so hard to fill)

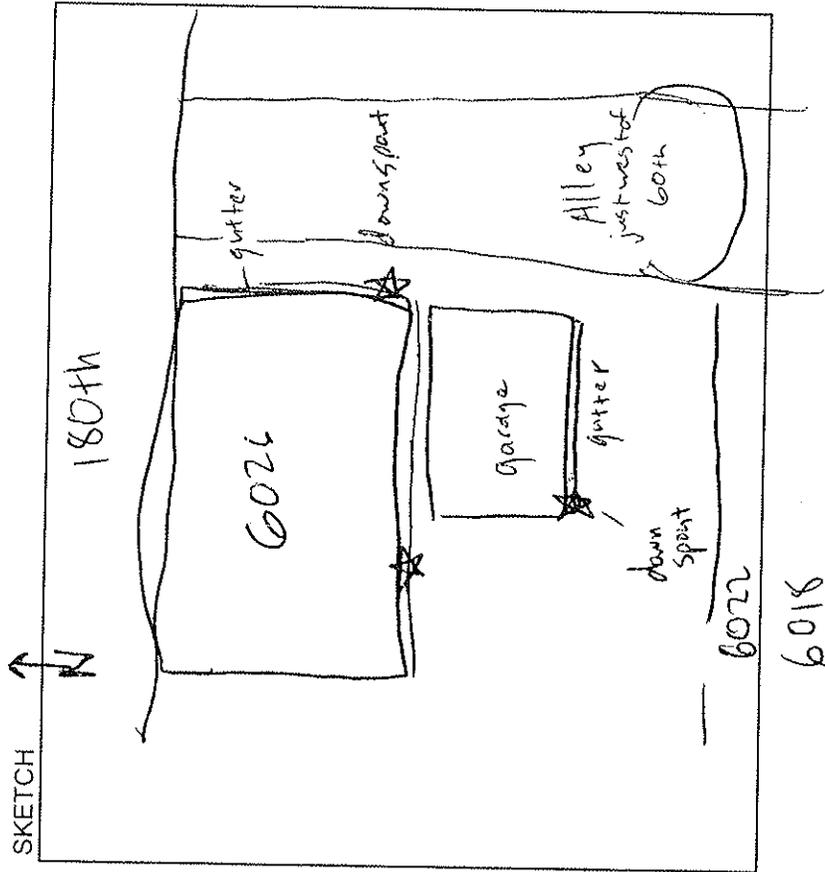
REF #: 5-60

two gutter down spouts striking on east side corner of house

SKETCH

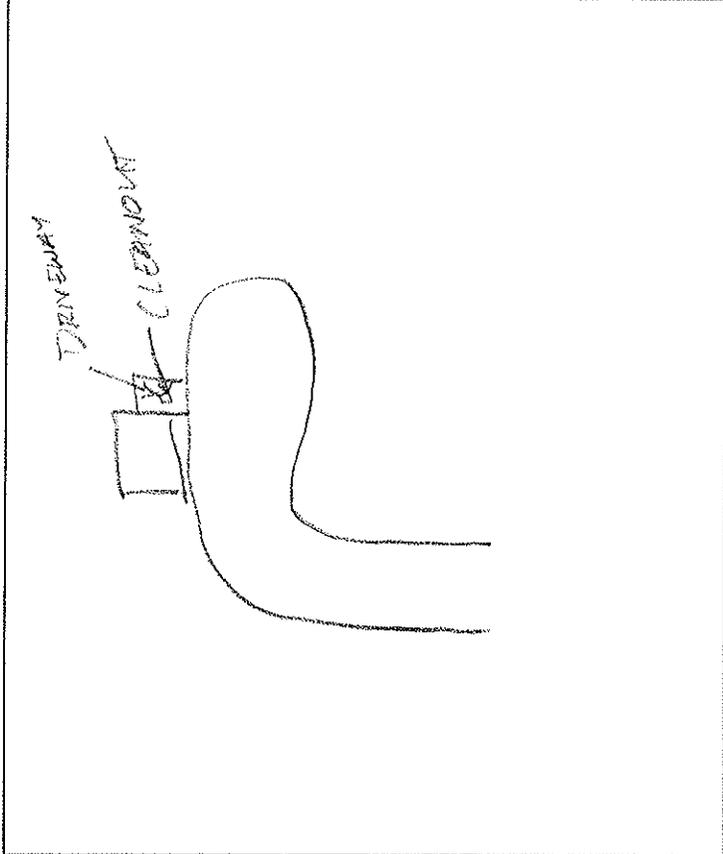
REF #: 5-63 DATE: 7/23/09

DESCRIPTION:
DRAIN IN DRIVEWAY

SKETCH

S-63	4-117-N/A	4-117	4-116	5902 183rd St. SW, Lynnwood, WA	5	Storm drain in depression at the bottom of driveway connected to sanitary sewer.	Stormwater runoff from driveway.	Medium	2009	Maintenance Issue
S-64	4-71-N/A	4-71	4-70	6031 189th Pl. SW, Lynnwood, WA	5	Malfunctioning sewer connection (smoke seen coming under concrete porch).	Stormwater entering through crack. Potential groundwater infiltration.	Medium	2009	Infiltration / Inflow
S-65	4-60-N/A	4-60	4-58	6131 Park Way, Lynnwood, WA	5	Malfunctioning sewer connection (smoke seen coming from surfaced pipe with no cap and ground around pipe).	Stormwater entering through pipe. Potential groundwater infiltration.	Medium	2009	Infiltration / Inflow
S-66	4-76-N/A	4-76	4-75	6303 188th St. SW, Lynnwood, WA	5	Large uncapped cleanout in yard at grade (smoke seen from open cleanout).	Stormwater entering through large uncapped cleanout	Medium	2009	Maintenance Issue

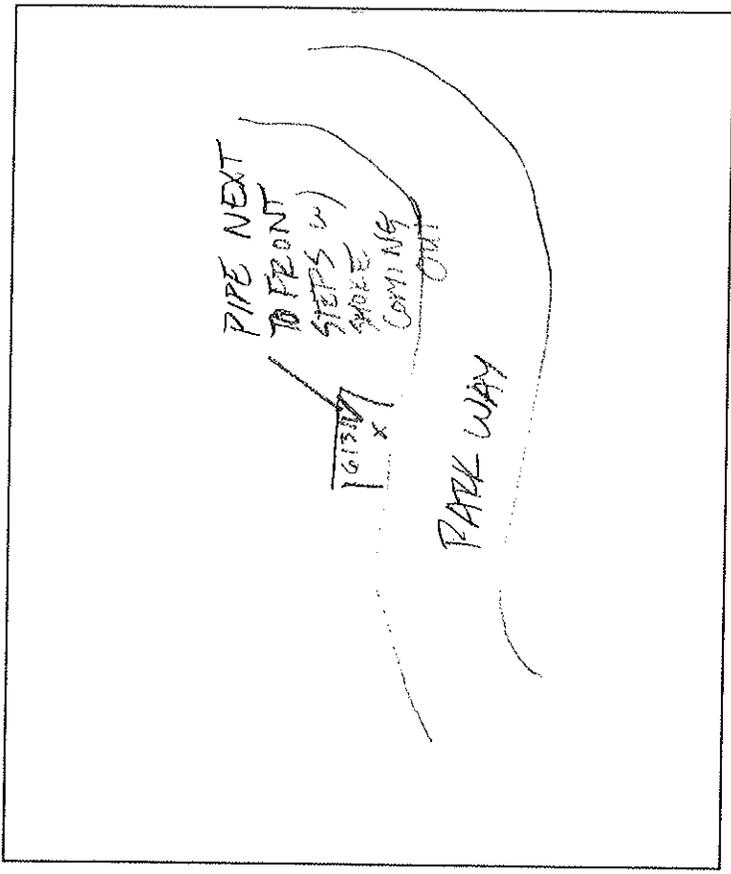
REF#: 5-66

RV hook up leaking

SKETCH

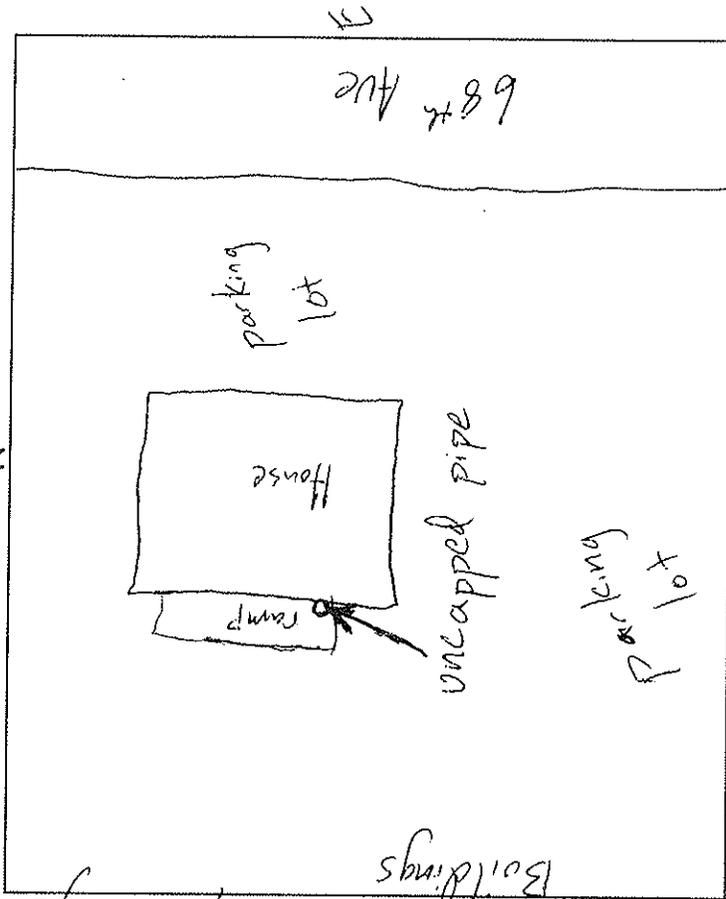
REF #: S-70 DATE: 8/13/09

DESCRIPTION: smoke seen from uncapped pipe on back side of house

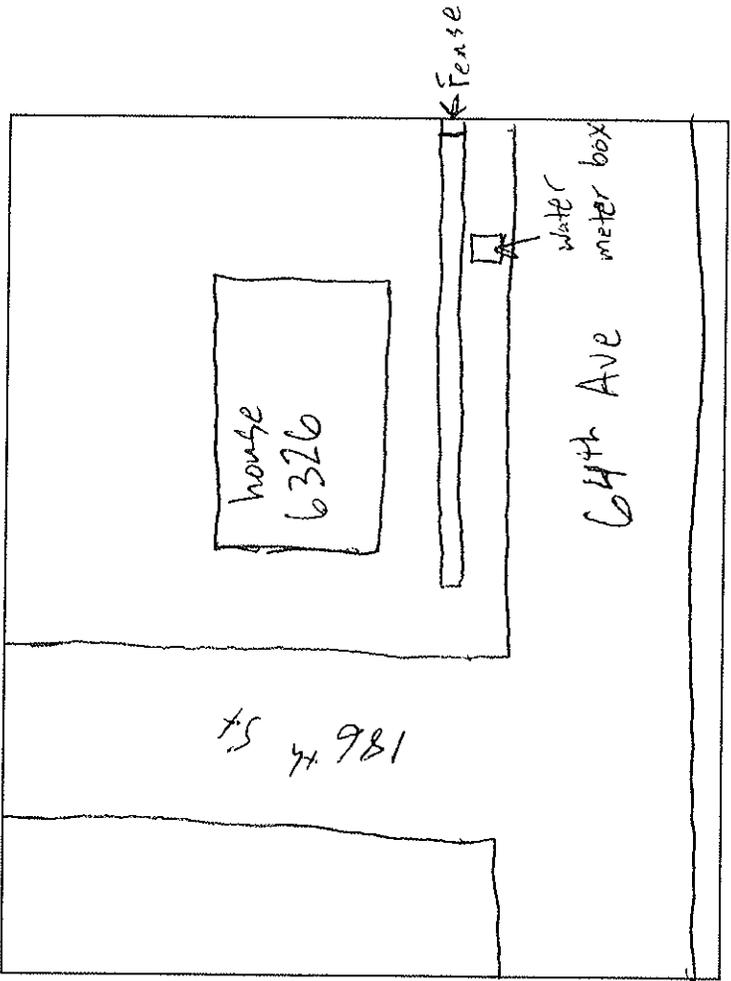
REF #: 5-72 DATE: 8/14/09

DESCRIPTION: Smoke coming from water meter box, probably just a cleanout.

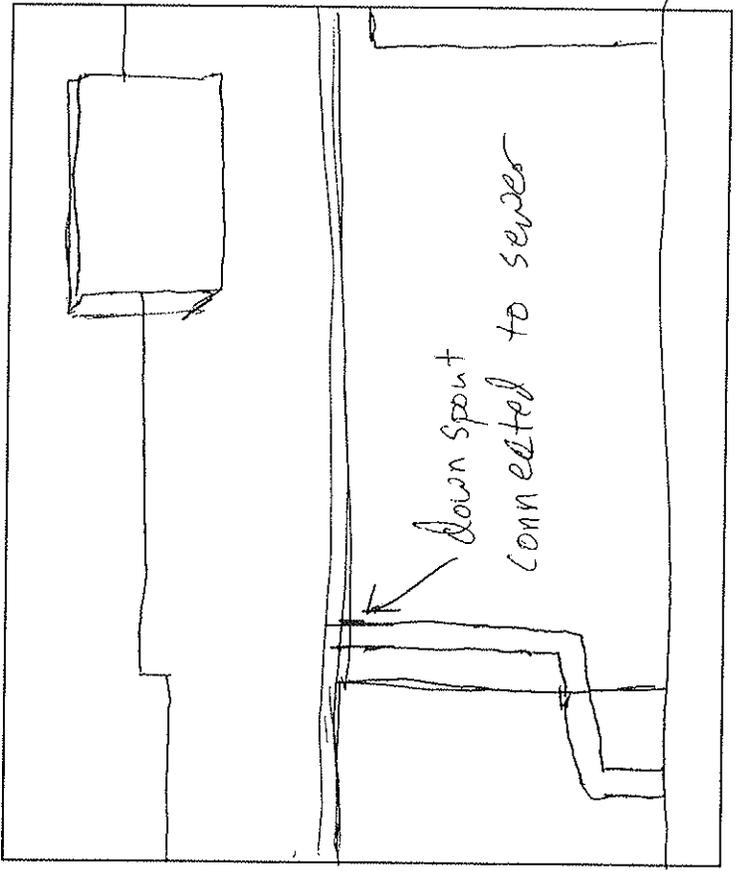
REF #: 5-73 DATE: 8/14/09

DESCRIPTION: Downspout connected to sewer

LOCATION: Between Buildings G 6533 and H 6511

DESCRIPTION: Small stream
Water was leak into manhole near stream

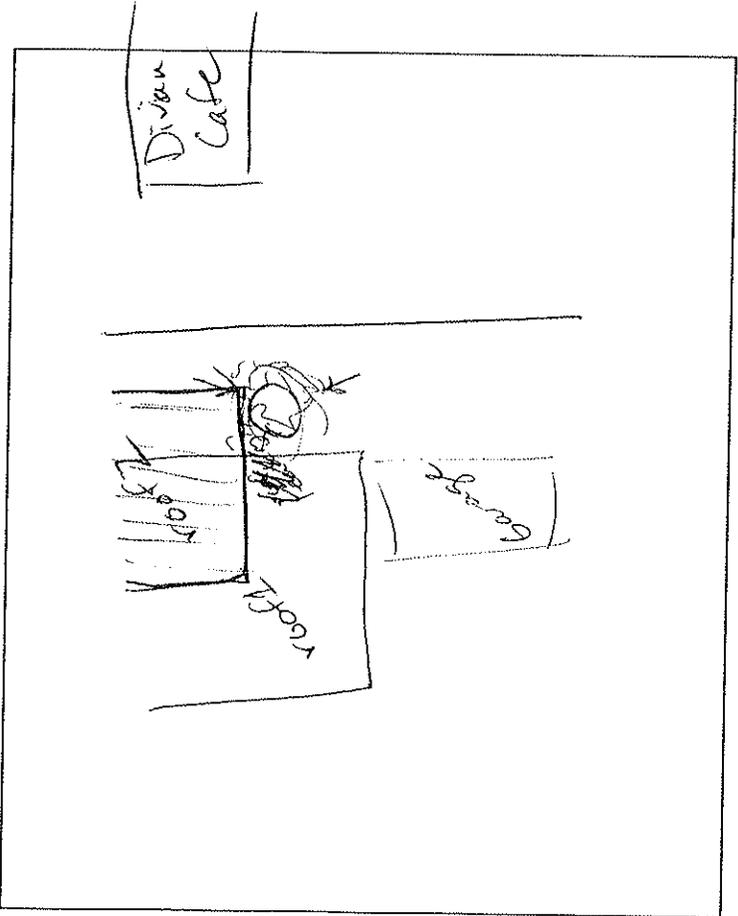
REF #: 5-77

yard seems to be vent small amount of smoke

S-76	1-96-N/A	1-96	1-95	20107 68th Ave W, Lynnwood, WA (adjacent to 20113 68th Ave W)	7	Smoke emanating from yard	Direct inflow from open vent connected to sewer system	Light	2009	Maintenance Issue
S-77	1-96-N/A_2	1-96	1-95	20113 68th Ave W, Lynnwood, WA (in front of Divan Café)	7	Smoke emanating through hole in sewer cleanout cover	Direct inflow through small hole in cover	None	2009	Not an Issue
S-78	2-73-N/A	2-73	2-71	6001 202nd St. SW, Lynnwood, WA	8	Unknown source (smoke seen coming from ivy near a tree on the southwest corner of lot).	Stormwater and/or groundwater entering through leaky cleanout cap or malfunctioning sewer pipe.	Unknown	2009	Unknown
S-79	2-73-N/A_2	2-73	2-71	6001 202nd St. SW, Lynnwood, WA	8	Uncapped pipe in flowerbed on the east side of the building	Stormwater entering pipe.	Light	2009	Maintenance Issue
S-80	2-53-N/A	2-53	2-52	6109 208th St. SW, Lynnwood, WA	8	Cracked pipe cap just above grade on east side of abandoned house.	Stormwater entering pipe.	Light	2009	Maintenance Issue

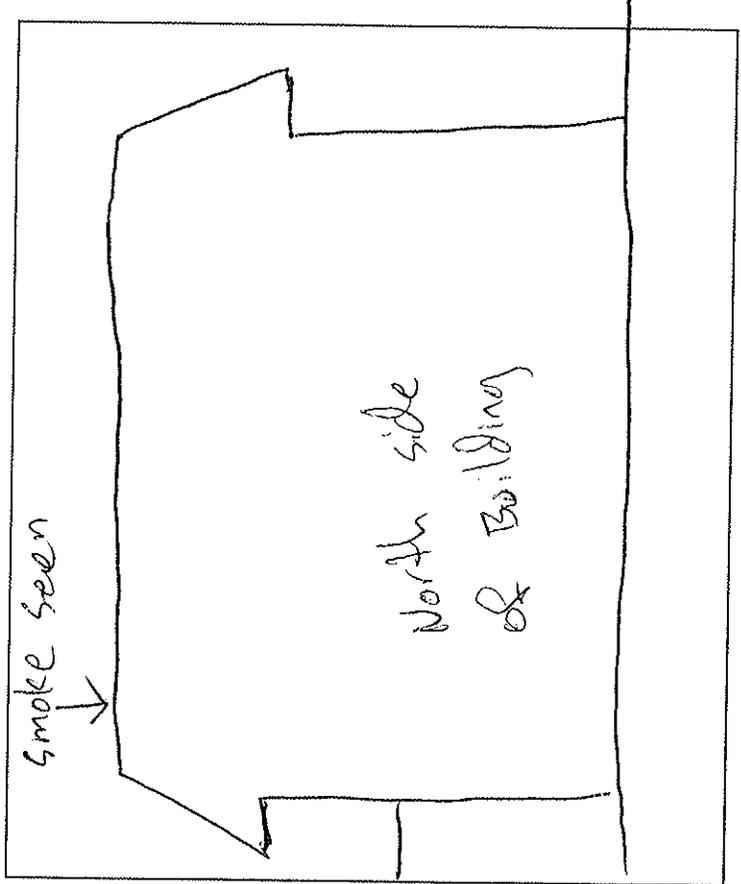
Smoke seen from roof, not
sure from what

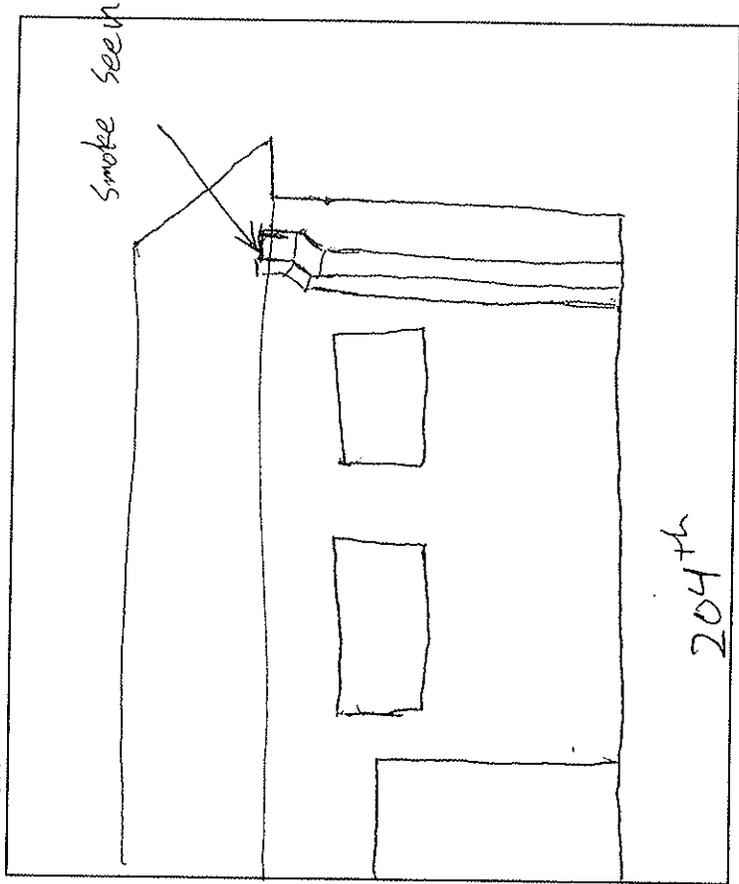
REF#: S-86 DATE: 8/6/09
INSPECTOR: DK PHOTO NO. 93-96
LOCATION: 5523 204th St. SW

DESCRIPTION:
Gutter connected to sewer
on the south east corner

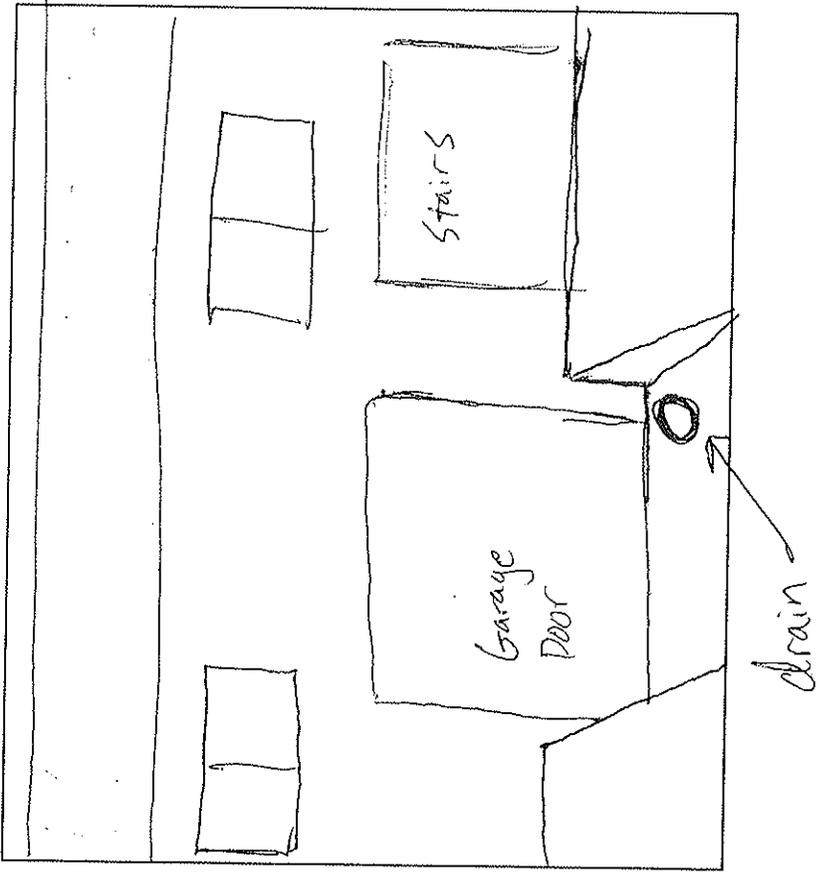
REF#: S-87 DATE: 8/7/09
INSPECTOR: DK PHOTO NO. 97-99
LOCATION: 5910 207th Pl SW

DESCRIPTION:
storm drain at bottom
of driveway connected to
sewer

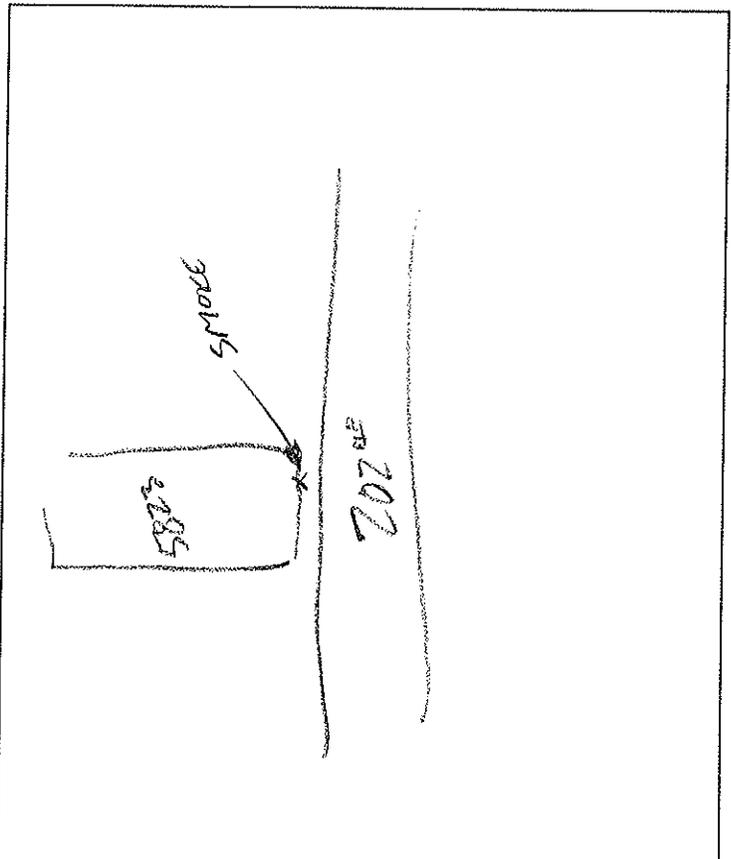
DESCRIPTION:
SMOKE EMANATING
FROM HOLE IN GROUND

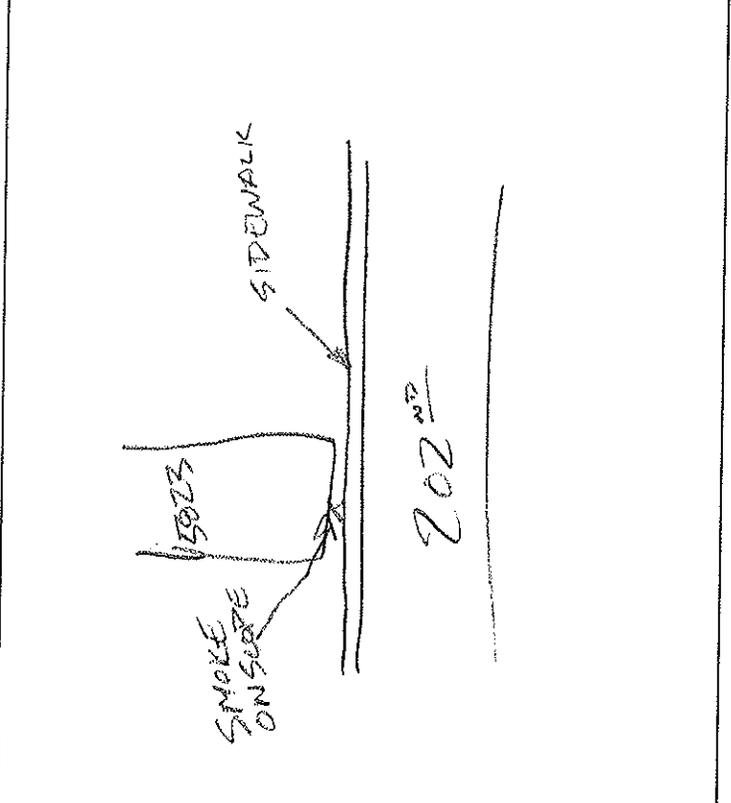
REF #: S-92 DATE: 8-6-09

DESCRIPTION:
SMOKE EMANATING
FROM HOLE ON SLOPE
NEXT TO SIDEWALK

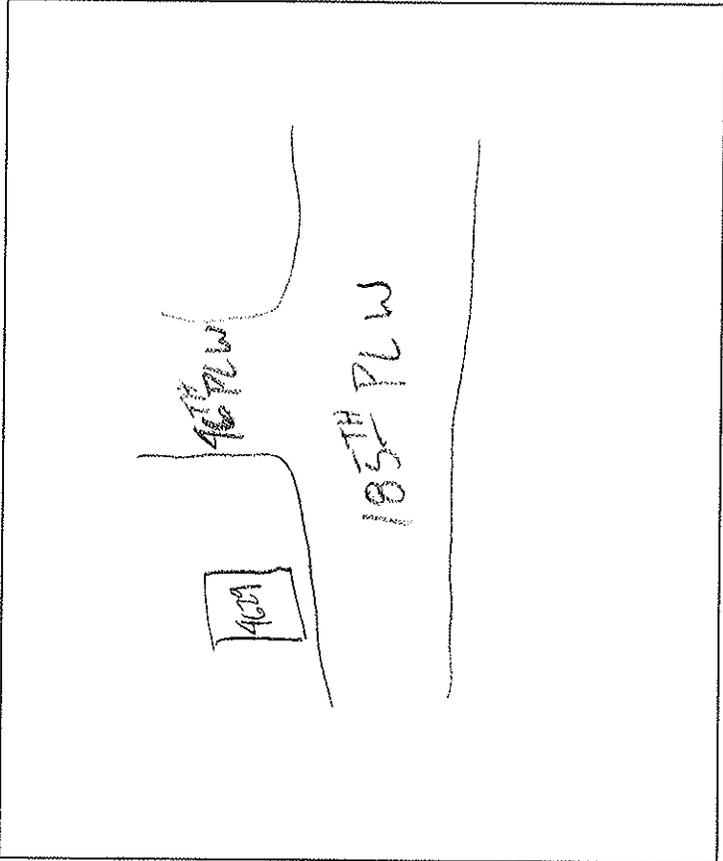
DESCRIPTION: COMPLAINED OF
SMOKE IN HOUSE

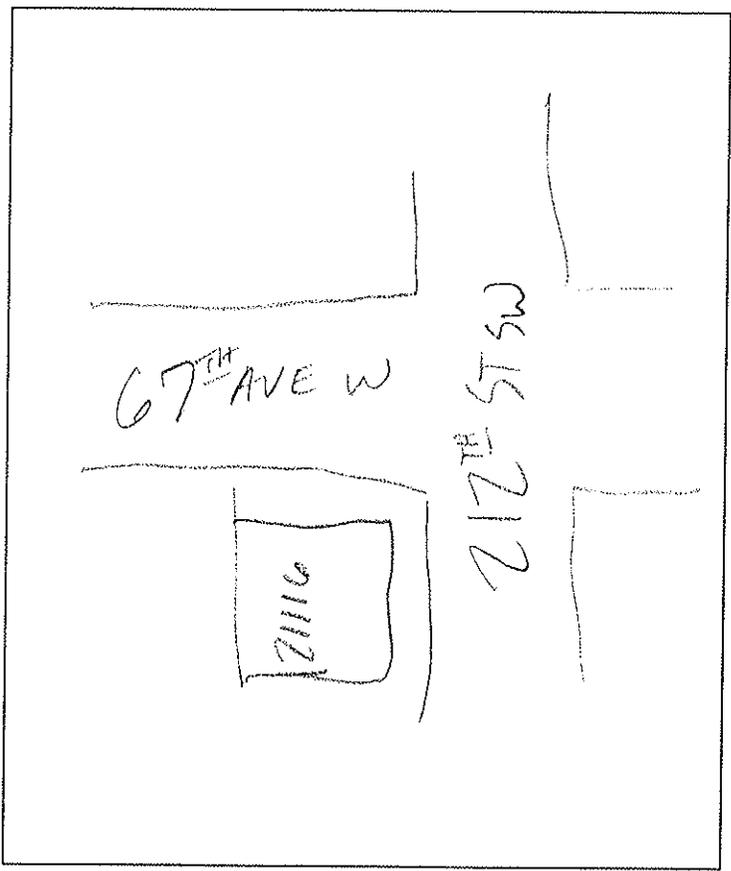
REF #: S-95 DATE: 8-7-09
INSPECTOR: MSF PHOTO NO. 8
LOCATION: 2119 67TH AVE WEST

DESCRIPTION: SMOKE BLOWING OUT
OF OPENING IN WATER
METER BOX COVERING

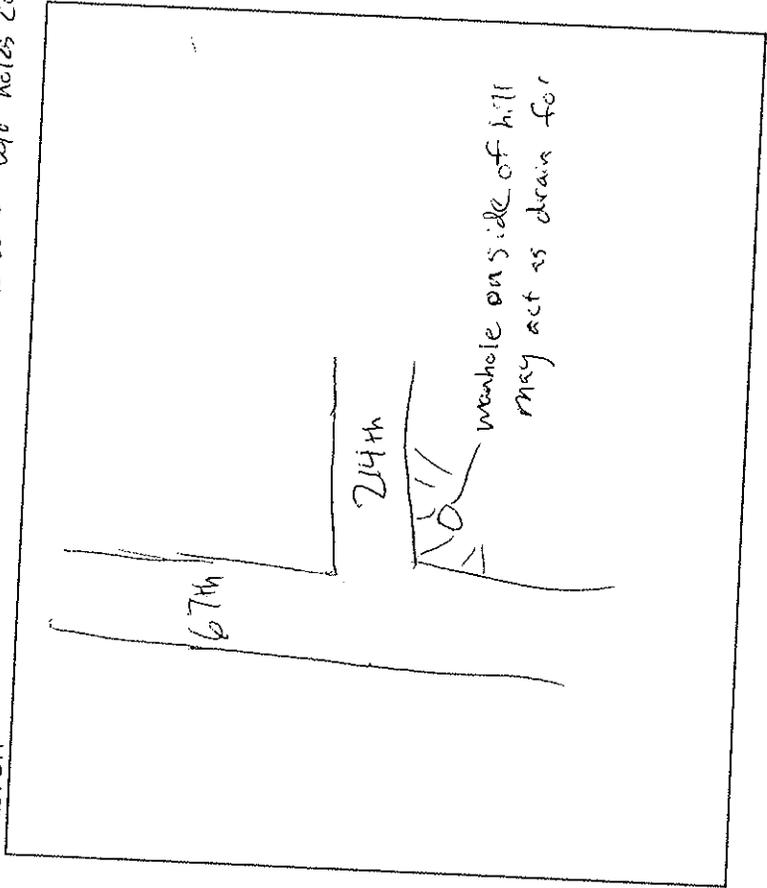
REF #: 5-98

a new seal and manhole cover w/o holes could reduce inflow

Reference Number	Problem Number	Upstream MH	Downstream MH	Location	Basin	Description	Potential Source of Flow	Severity	Year Tested	Category
S-98	1-6-N/A	1-6	11-4	67th Ave W and 214th St SW, Lynnwood, WA	8	Manhole on side of hill in depression with a leaky seal.	Stormwater runoff depression on side of hill.	Light	2009	Maintenance Issue, Infiltration/Inflow

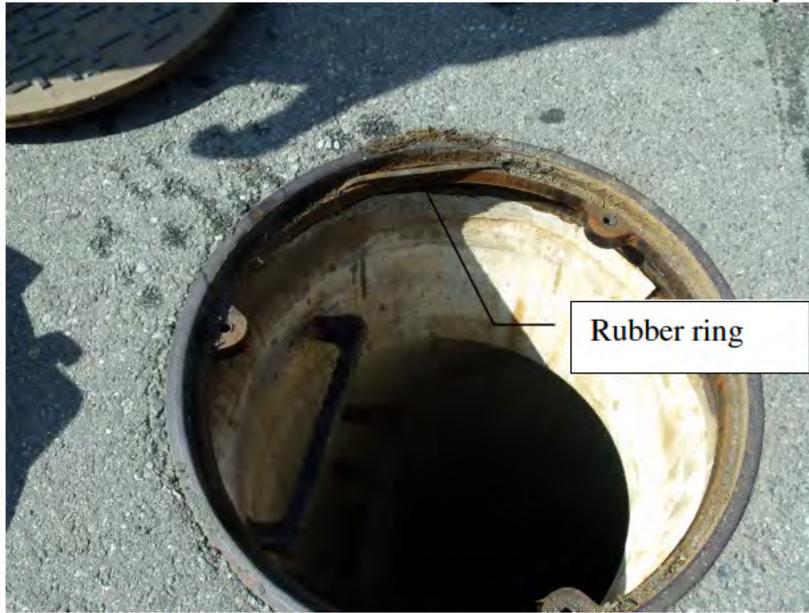
40th Ave and 185th Pl. SW, Lynnwood, WA. MH # 17-87.5 (S-1)

Rubber ring around the manhole rim is coming undone.

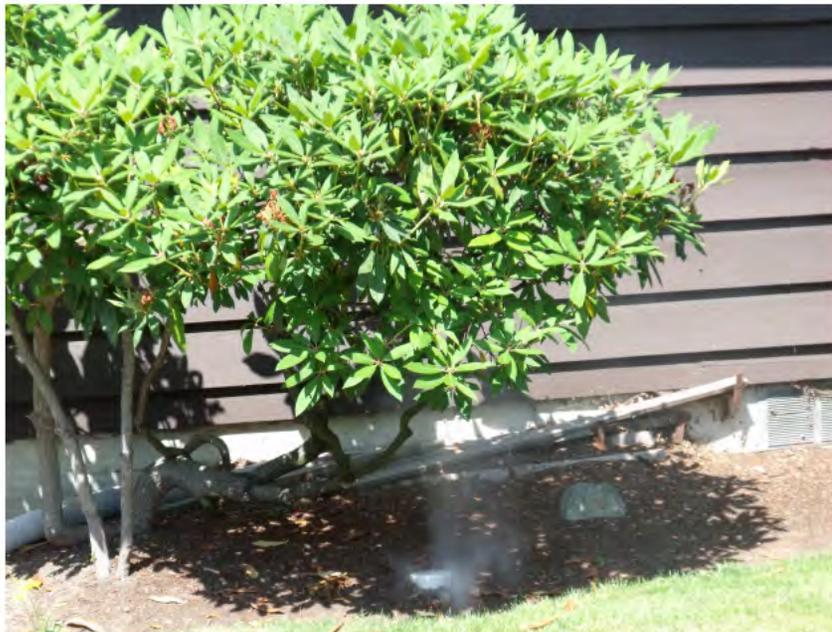
18702 40th Ave, Lynnwood, WA (S-2)

Uncapped cleanout

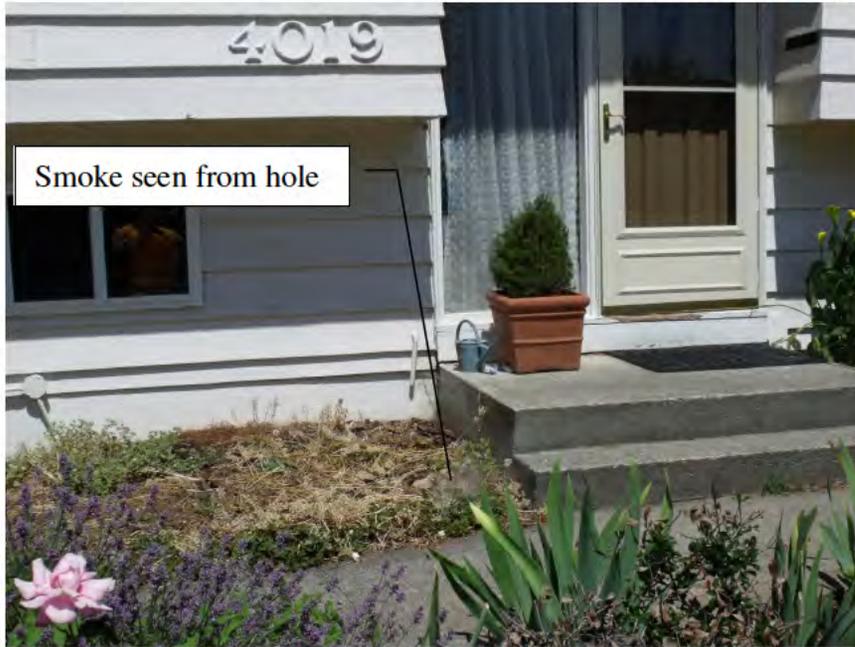
4019 189th Pl. SW, Lynnwood, WA (S-3)

Smoke seen from hole

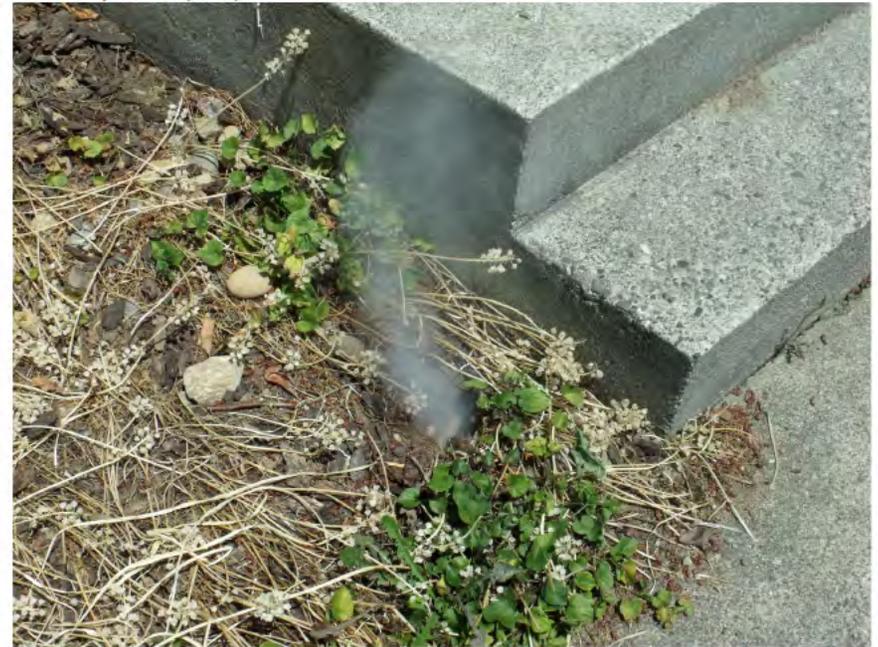
View of front of house at 4019 189th Pl SW in Lynnwood

Smoke seen emanating from hole alongside front door landing.

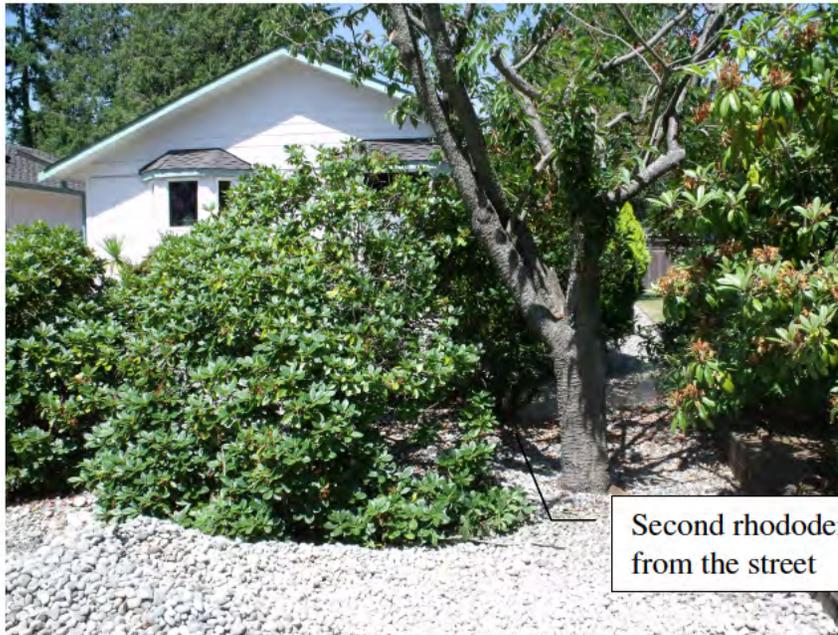
4221 189th Pl. SW, Lynnwood, WA (S-4)

Second rhododendron bush
from the street

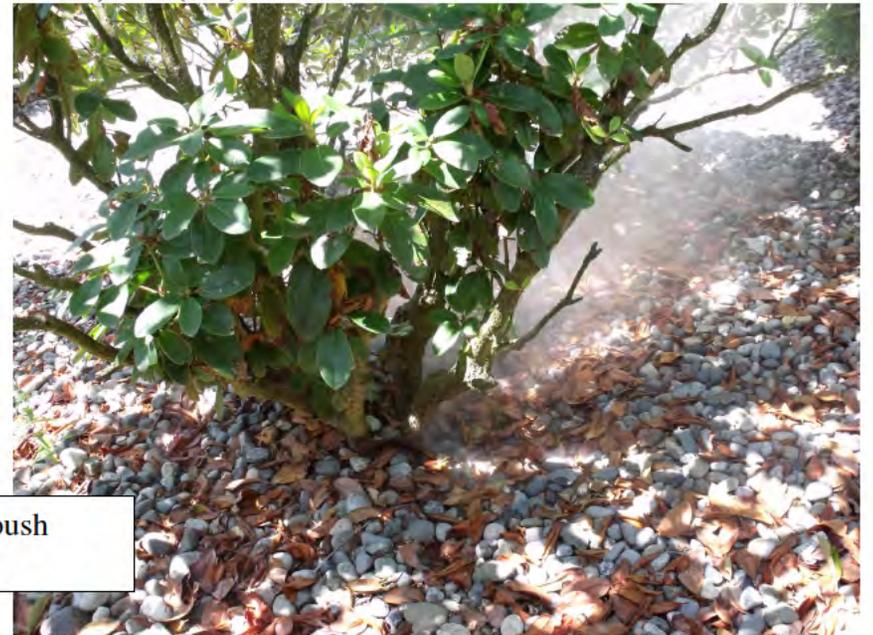
Rhododendron bush behind tree and bush

Smoke seen coming out of the gravel at the base of the bush.

DESCRIPTION: Smoke seen from gravel under bush, probably cracked sewer line.

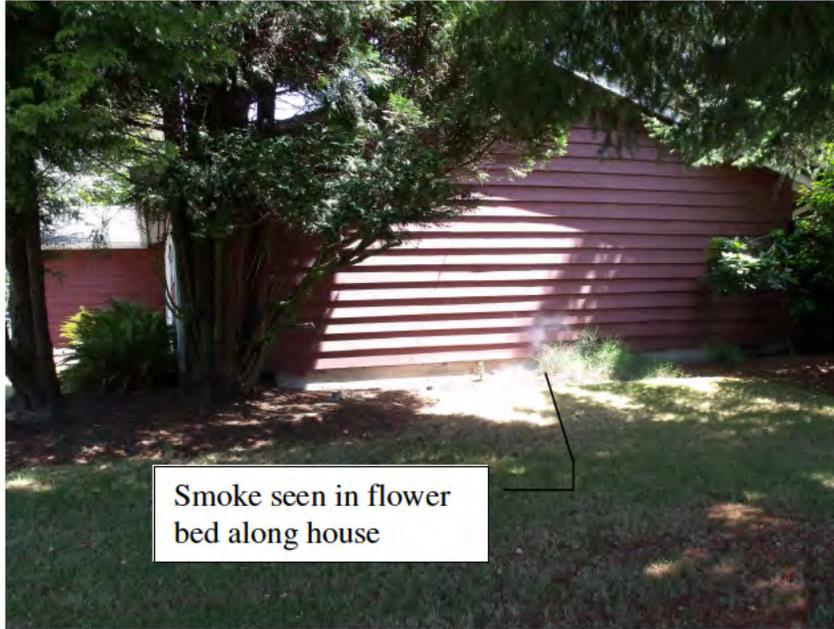
4326 189th Pl. SW, Lynnwood, WA (S-5)

Smoke seen in flower bed along house

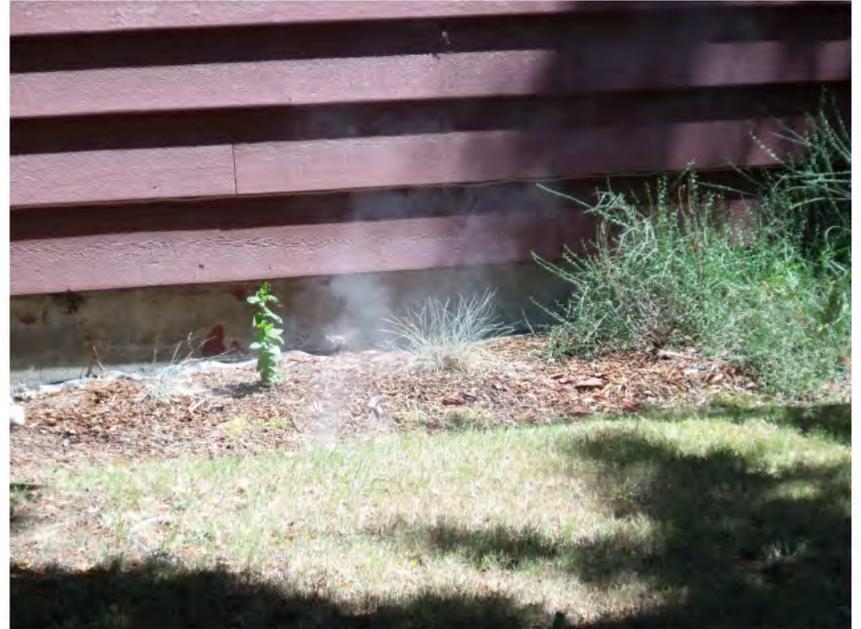
West side of house

Flower bed on west side of house

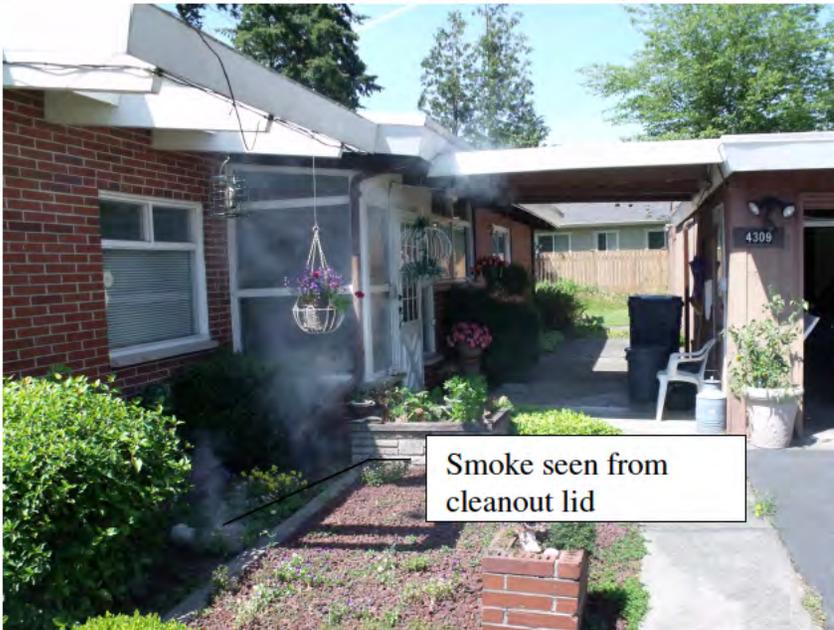
4309 191st. St. SW, Lynnwood, WA (S-6)

Smoke seen from cleanout lid

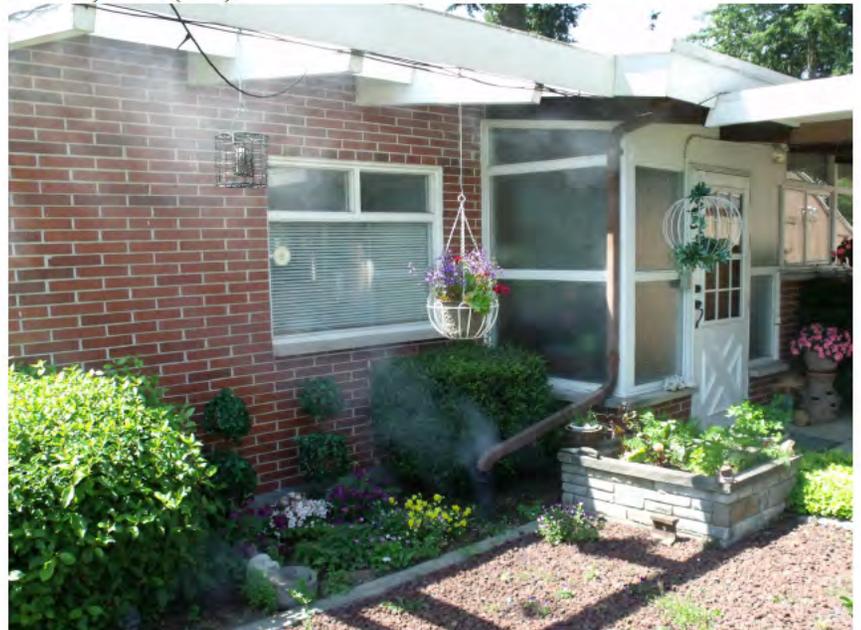
Southeast side of house

Smoke emanating from downspout.
