APPENDIX C
MANHOLE INSPECTION

Gray & Osborne, Inc. conducted manhole inspections in the City of Lynnwood on March 9th and 11th of 2010 by a crew of two people. No precipitation occurred on March 9th, however, there was steady rainfall during inspection on March 11th. In addition, the manhole inspection followed a significant period of wet weather, so the groundwater level was higher. Manhole inspections included a visual inspection of the area surrounding the manhole lid and removing the lid and conducting a visual inspection of the inside of the manhole.

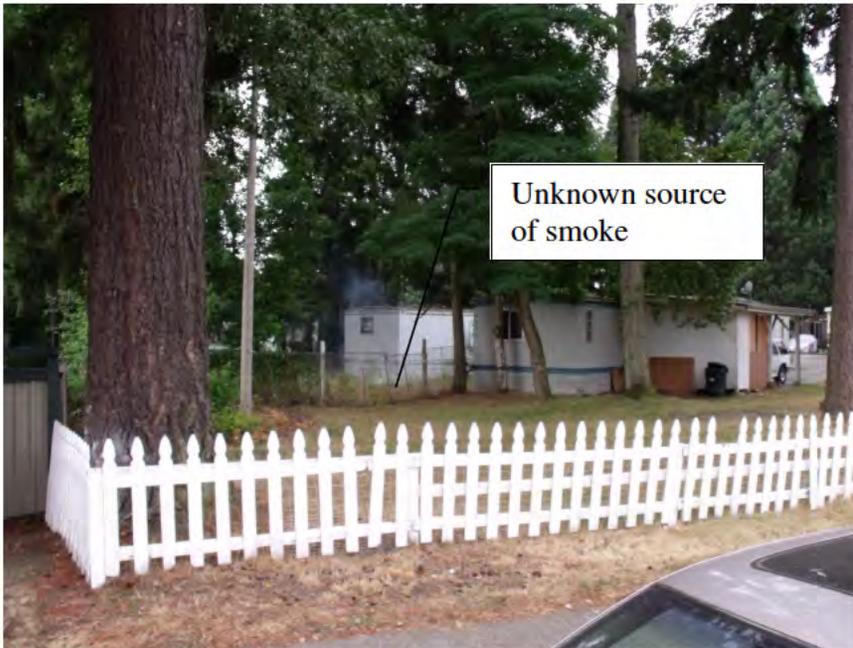
6208 202nd St. SW, Lynnwood, WA (S-83)

View from 202th St. SW in Lynnwood

Smoke emanating from unknown source behind trailer.

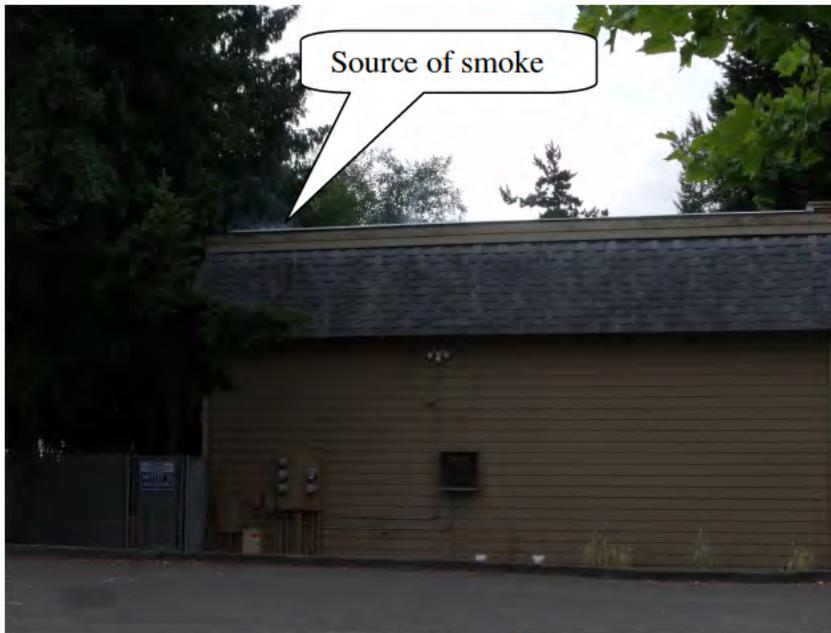
5703 202nd St. SW, Lynnwood, WA (S-85)

North side of building.

Smoke emanating from unknown source on roof top.

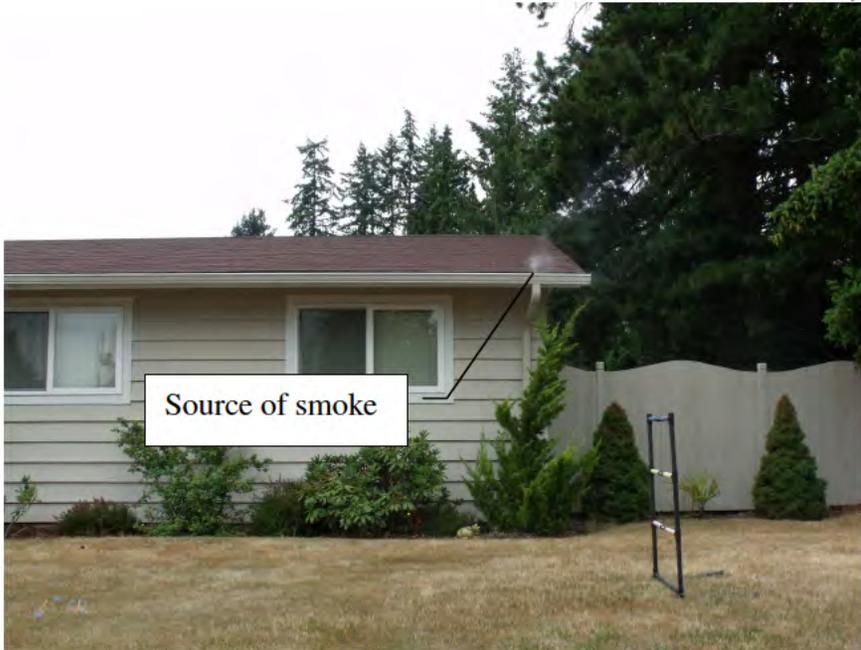
5523 204th St. SW, Lynnwood, WA (S-86)

View of south side and southeast corner of house.

Smoke emanating from downspout.

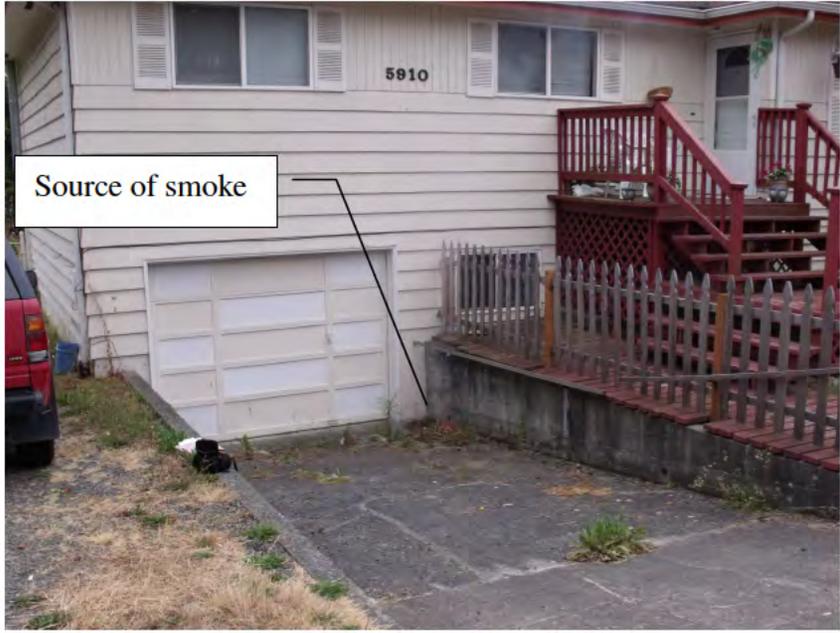
5910 207th Pl. SW, Lynnwood, WA (S-87)

Front of house and driveway.

Smoke emanating from drain at base of driveway.

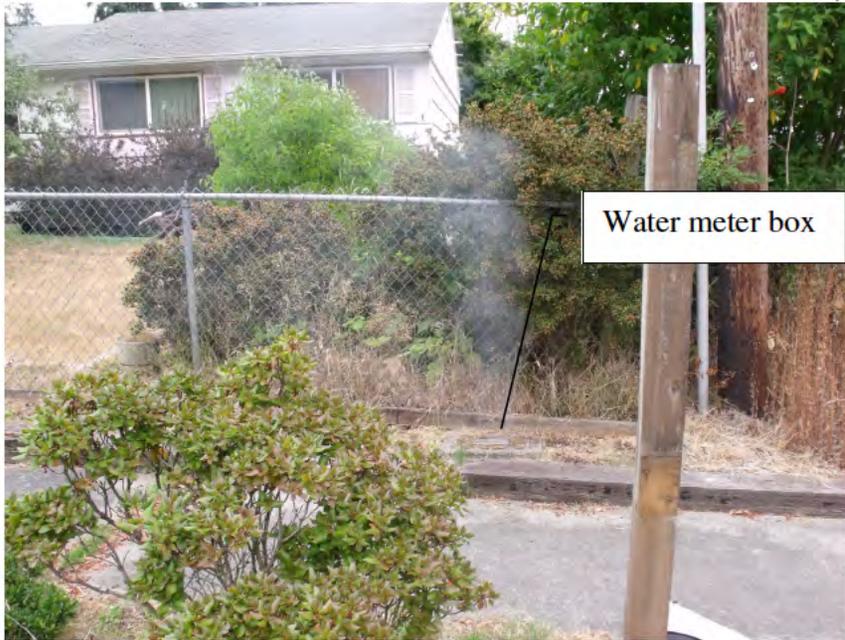
20923 59th Pl. W, Lynnwood, WA (S-88)

Area surrounding water meter box.

Smoke emanating from water meter box cover.

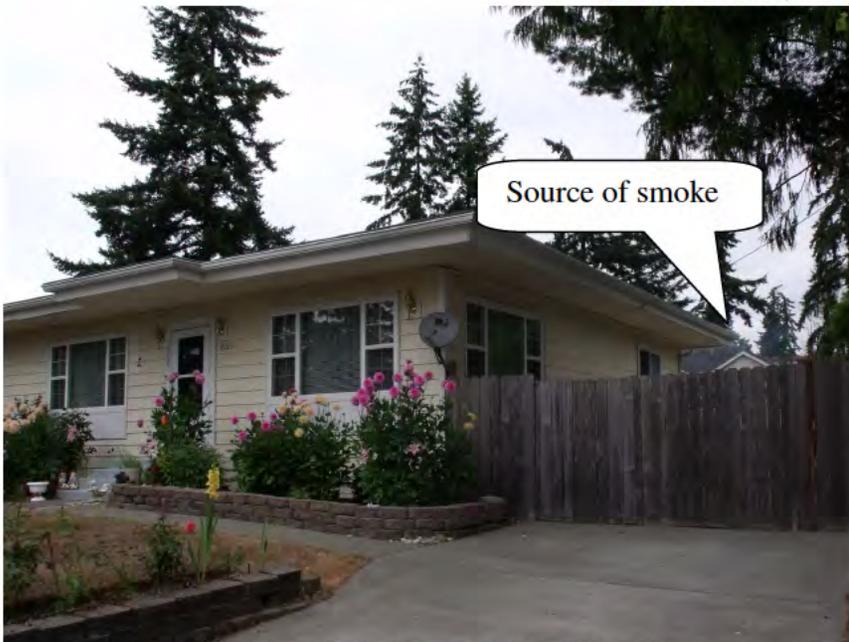
6207 211th St. SW, Lynnwood, WA (S-89)

View of east and north sides of house.

Smoke emanating from rain gutter.

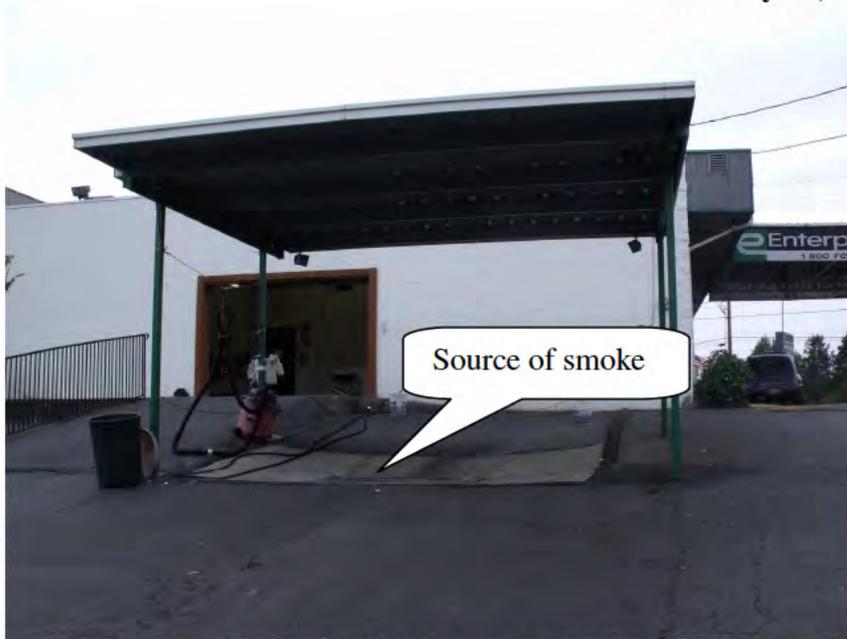
21101 Hwy 99, Lynnwood, WA (S-90)

Car wash under carport at Enterprise Rent-a-Car

Smoke emanating from grate under carport.

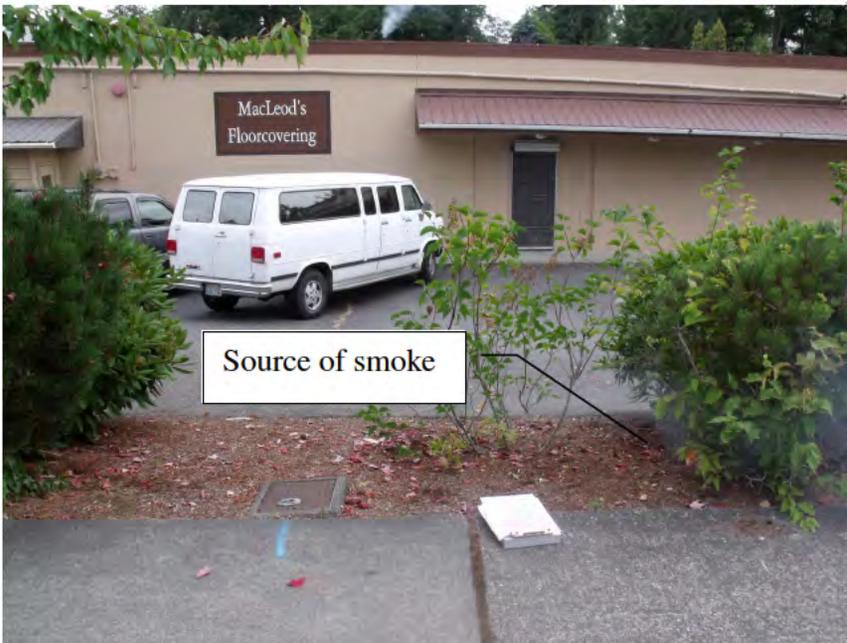
6125 202nd St. SW, Lynnwood, WA (S-91)

View of south side of building and area surrounding hole in ground.

Smoke emanating from hole in ground.

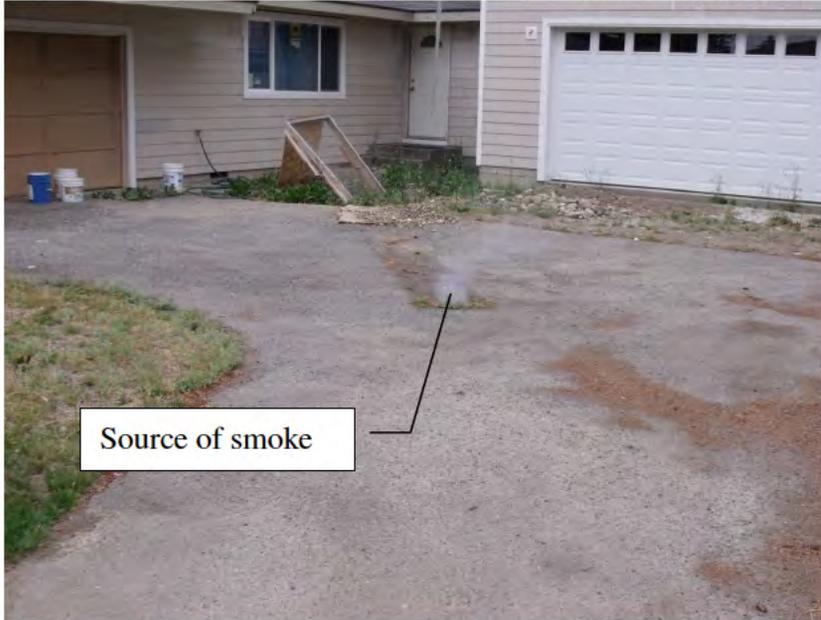
5827 207th Pl. SW, Lynnwood, WA (S-93)

Smoke seen from storm drain in driveway.

Smoke emanating from drain in driveway.

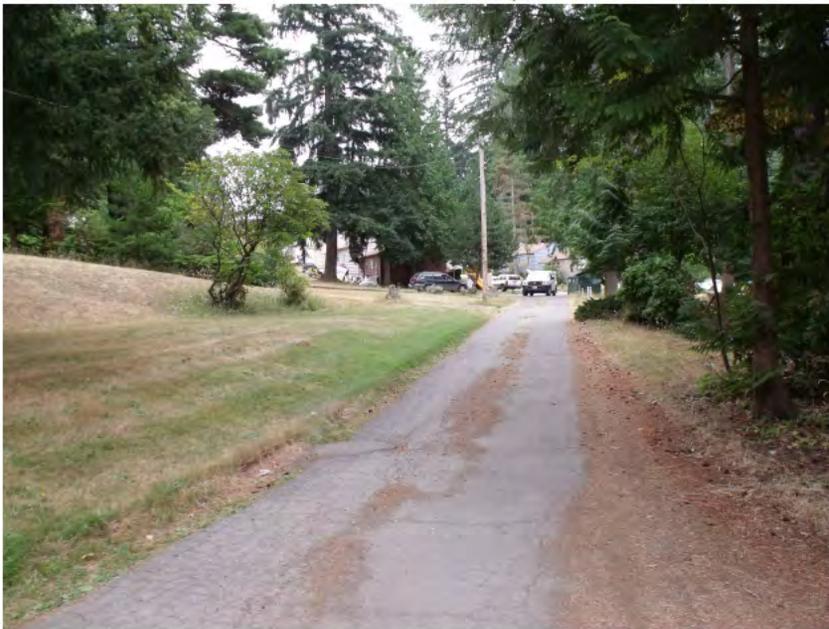
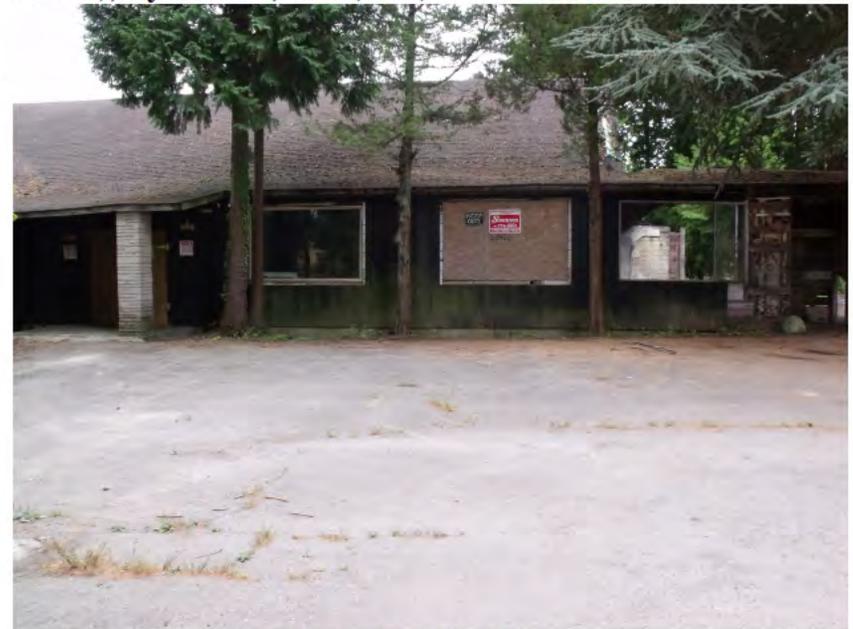
20920 (Near 55th Ave W and 210th St. SW), Lynnwood, WA (S-94)

Private driveway.

East side of building

Smoke emanating from depression in the ground.

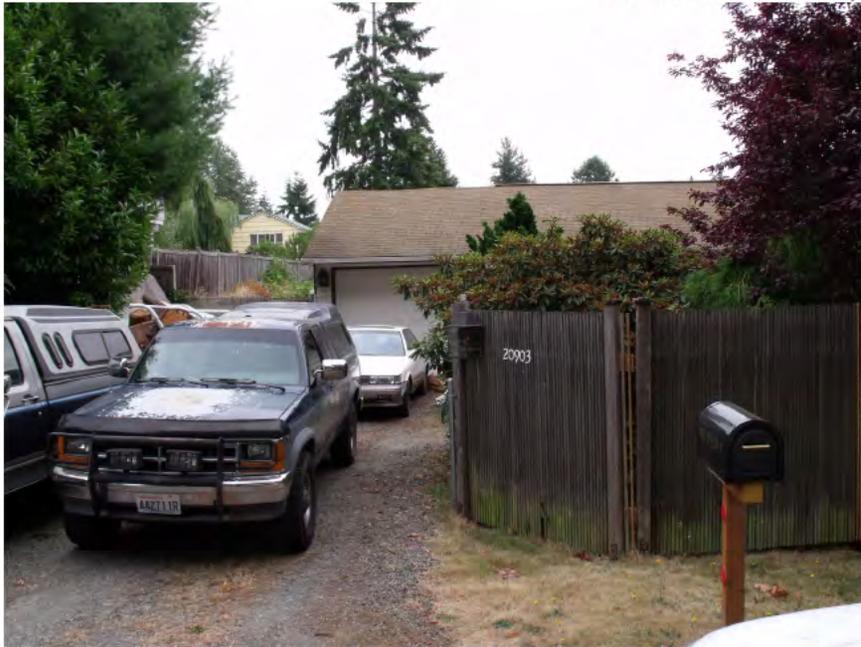
20903 54th Ave W, Lynnwood, WA (S-96)

Front of house and driveway

Smoke emanating from under the deck.

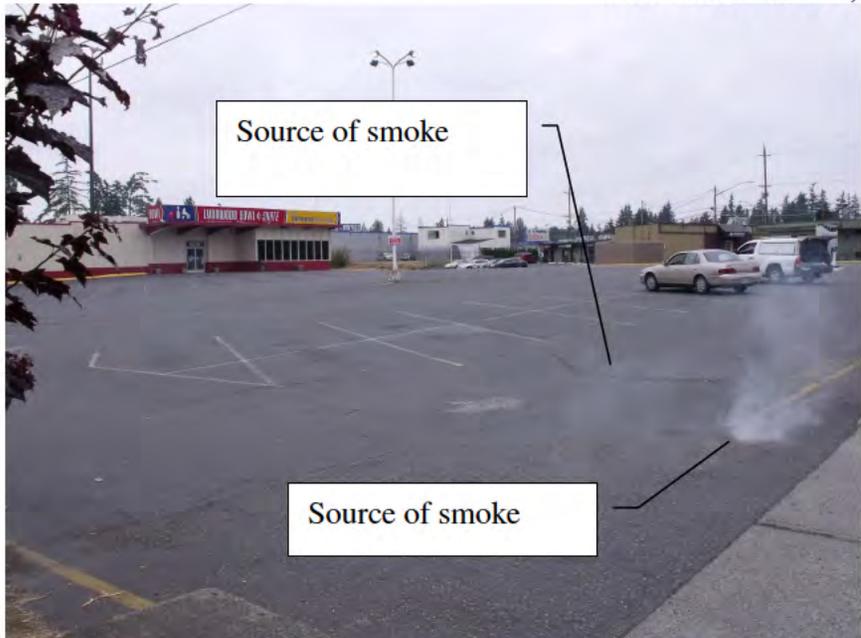
6210 200th St. SW, Lynnwood, WA (S-97)

Lynnwood Bowl and Skate's parking lot.

Smoke emanating from cleanout cap.

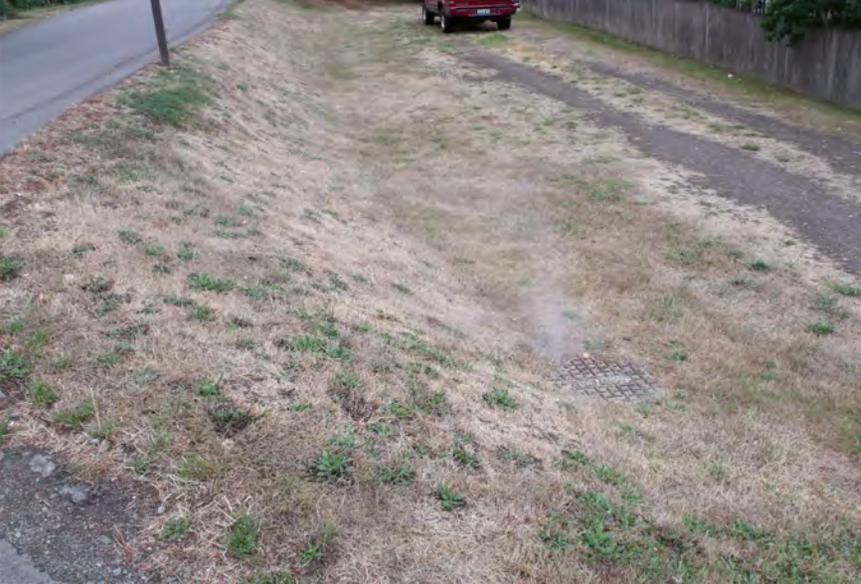
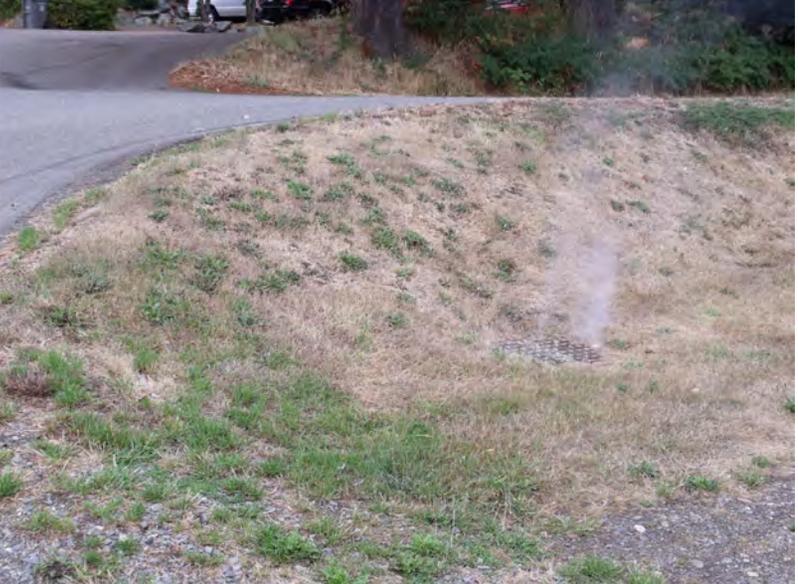
67th Ave W and 214th St SW in Lynnwood (S-98)

Area surrounding manhole.

Smoke emanating from manhole cover.

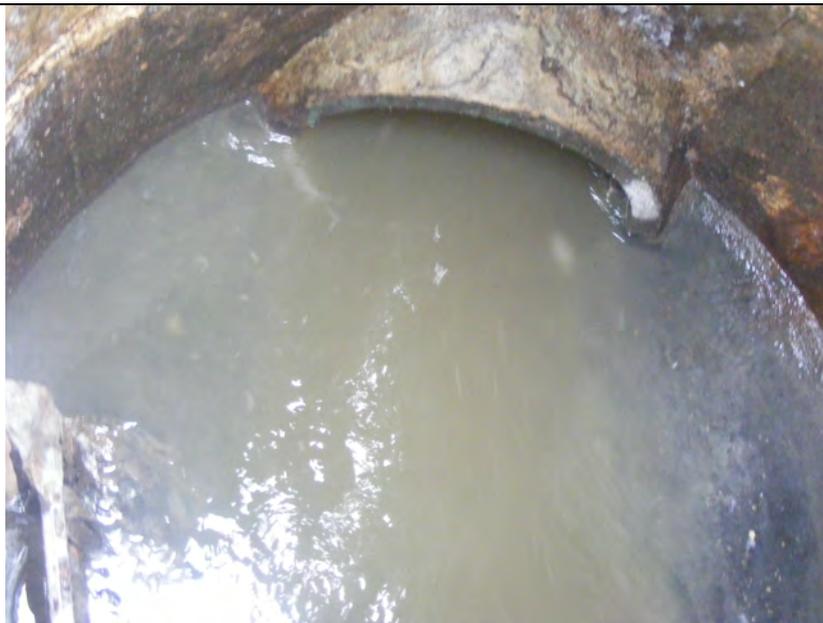
Substantial flows through manhole including flow on benches.

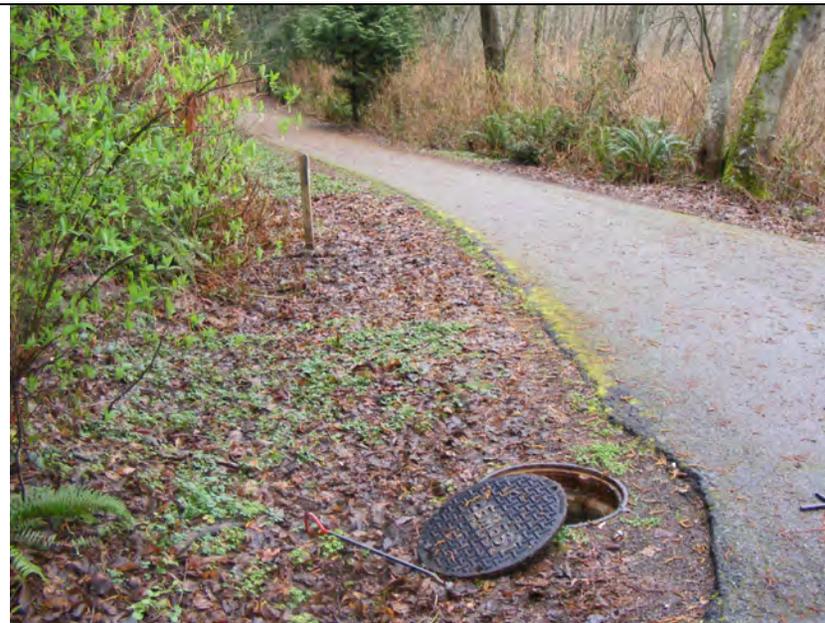
Manhole rim at or above adjacent grade.

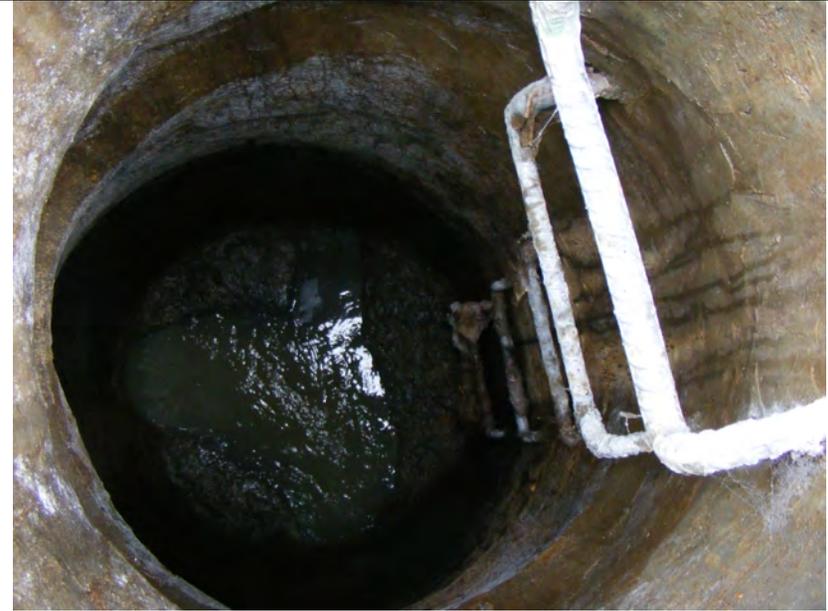
- Benches are wet
- Heavy flows through manhole
- Toilet paper on 2nd highest rung of manhole ladder
- Streaks down interior riser section walls
- Light mineral deposits on interior manhole walls

Streaks on interior riser section walls.

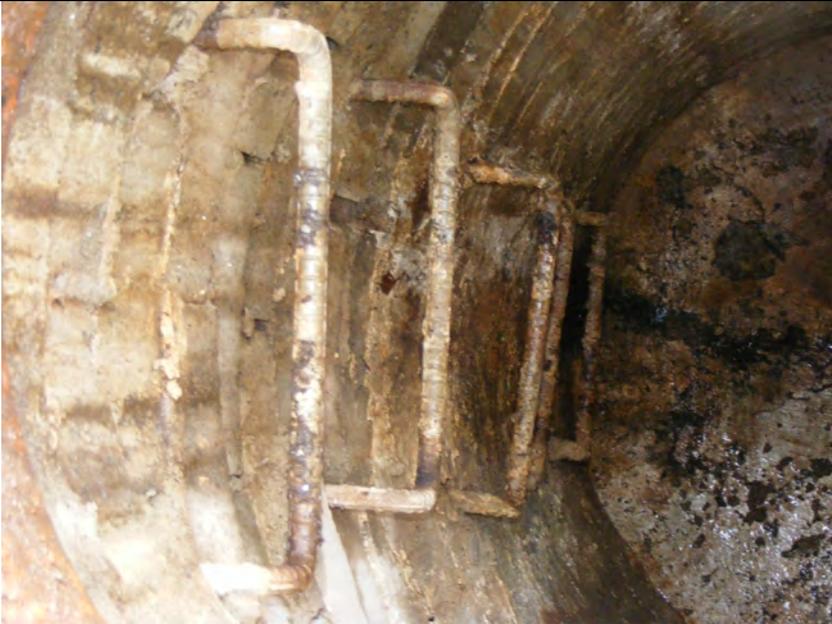
East interior manhole wall is wet.

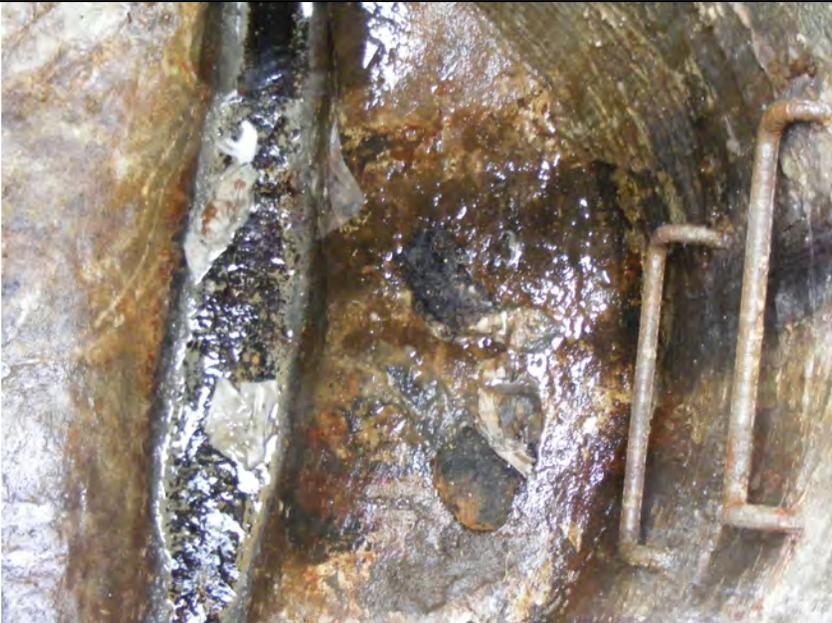
Minimal flow through manhole. North side bench is wet.

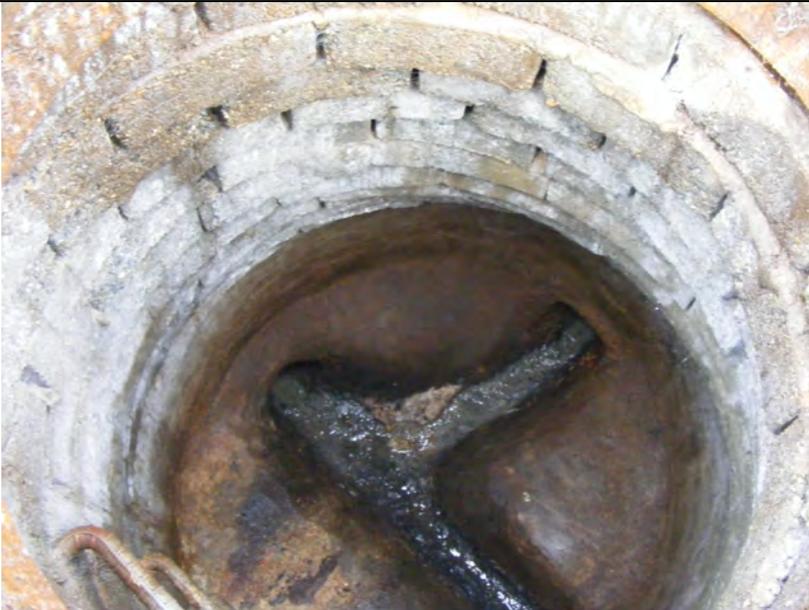
Brick manhole.

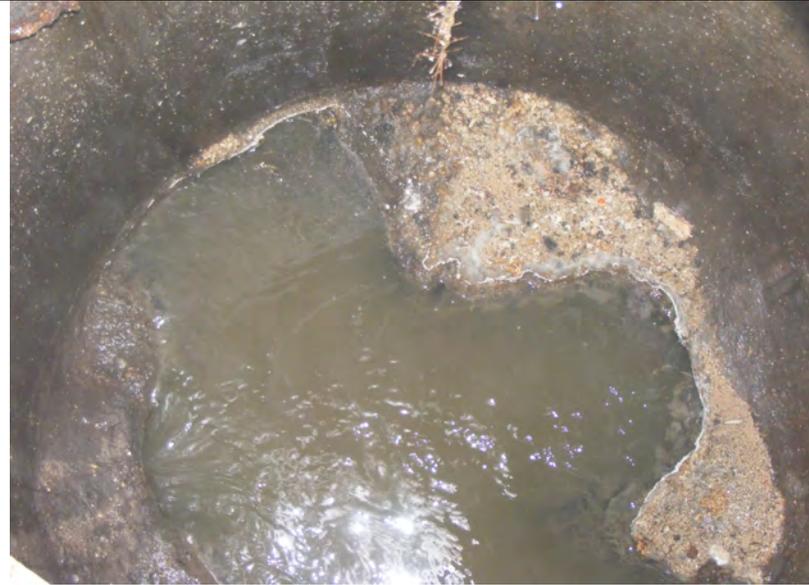
- Manhole is surcharging
- Roots pushing through between riser sections (minor)
- Mineral deposits formed outside north and east inlets
- Interior walls are wet

Heavy flows through manhole.

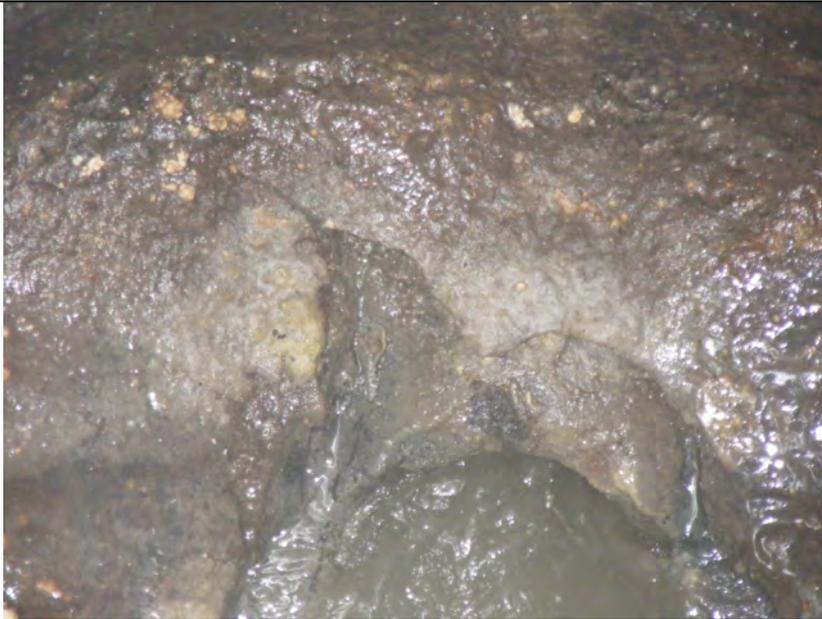
Mineral deposits on manhole benches.
